15 Nile Street, Emsworth, Hampshire

### - Preliminary Bat Roost Assessment

### January 2013 – Planning Issue

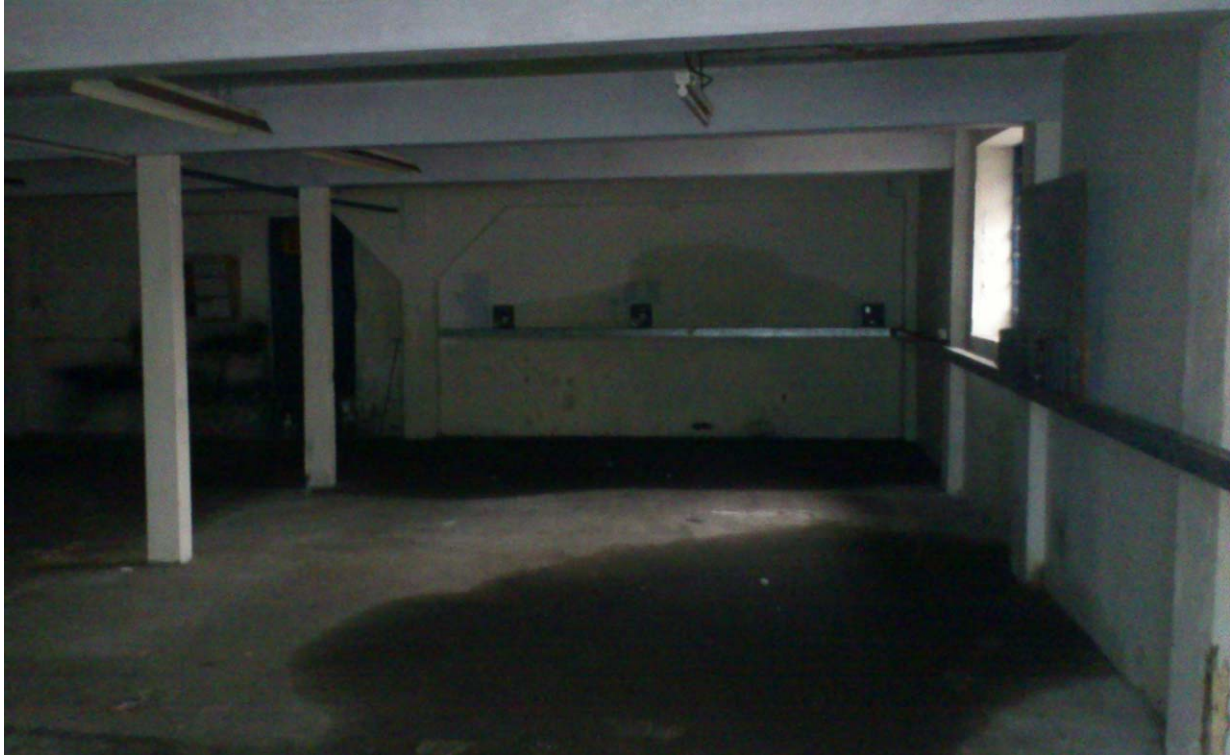
**Photograph No. 1 - Ground floor - Photograph taken from the main access door looking northward. The room is relatively light, with no access points for bats, minimal suitable crevices / cavities for bats, and 'Nil' Bat Roost Potential.**

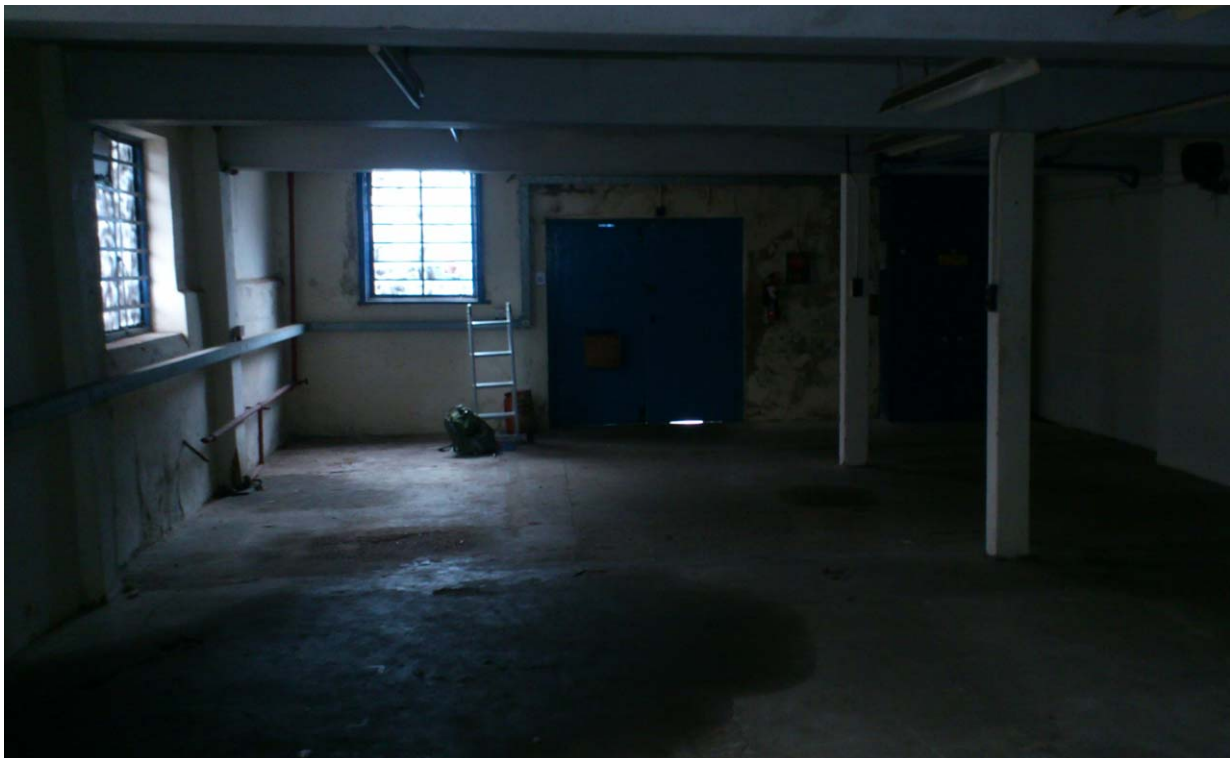
**Photograph No. 2 - Ground floor - Photograph taken from the northern wall looking eastward. the room is relatively light, with no access points for bats, minimal suitable crevices / cavities for bats, and 'Nil' Bat Roost Potential.**

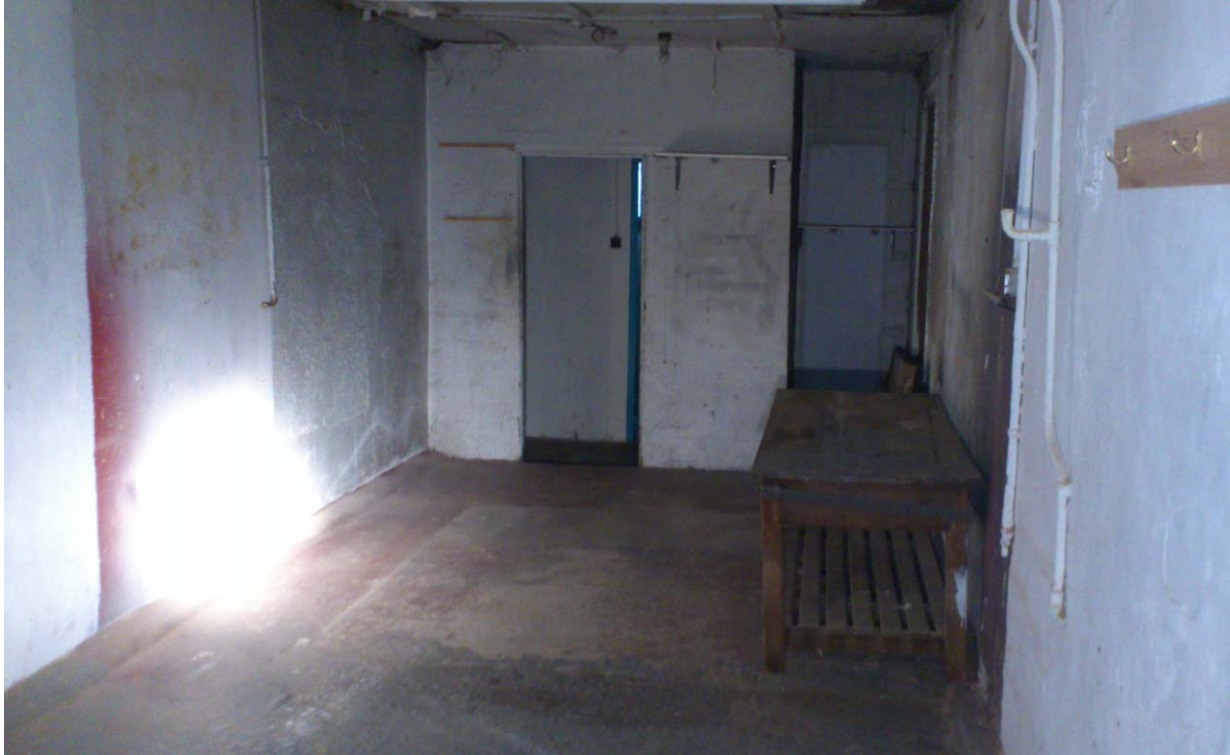
**Photograph No. 3 - Room found to the western edge of the ground floor. Dark but with no bat access and no suitable crevices / cavities, and 'Nil' Bat Roost Potential.**

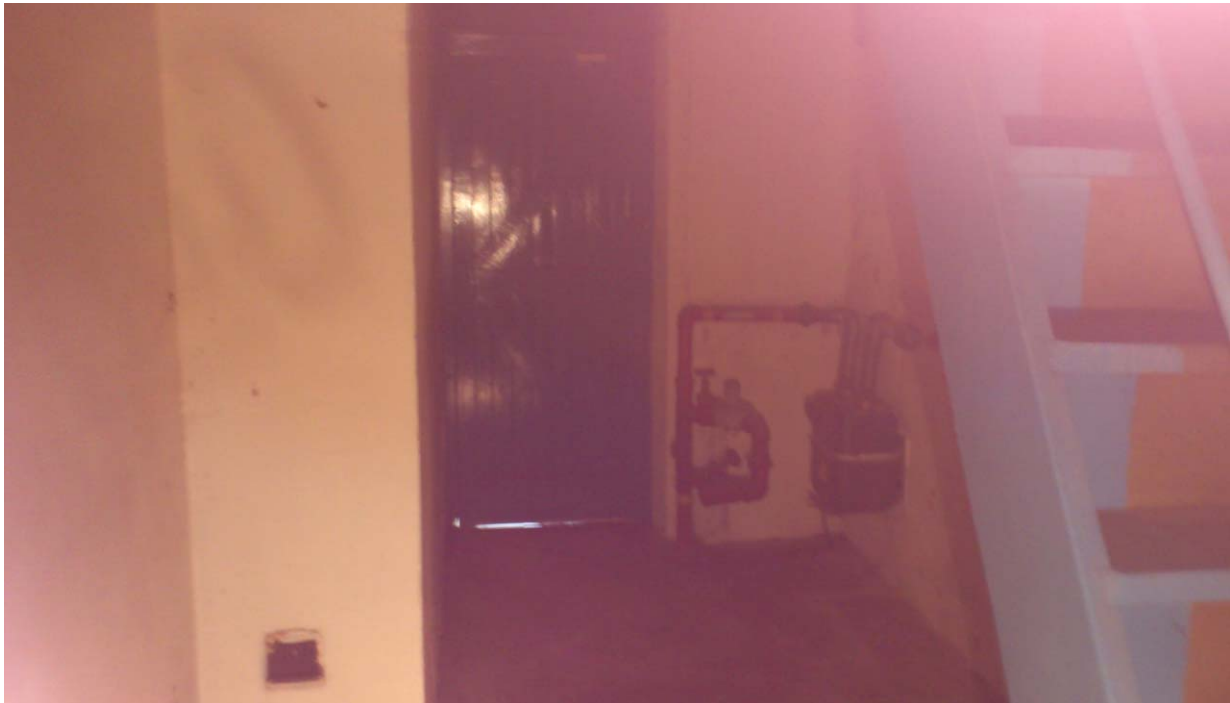
**Photograph No. 4 - Secondary access point to Nile Street. The area is dark but in keeping with the rest of the ground floor has no viable roost space for bats and no access, and 'Nil' bat Roost Potential.**

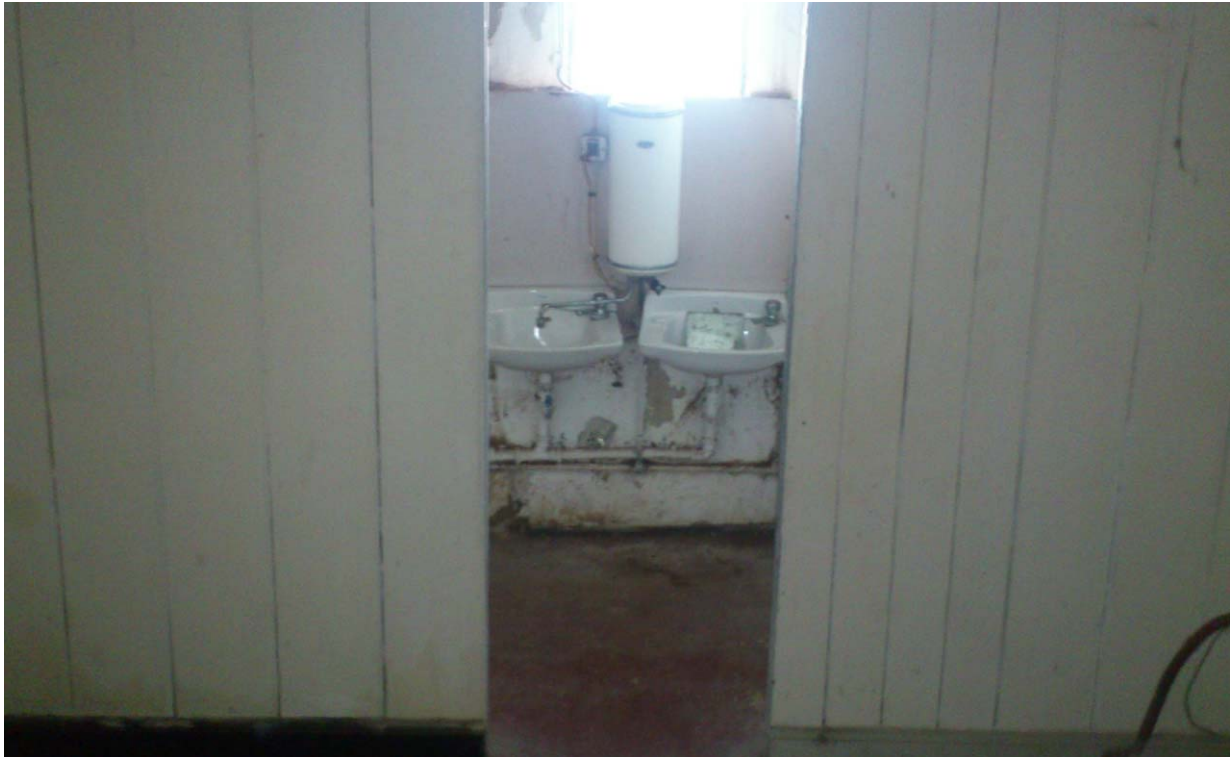
**Photograph No. 5 - Toilet on the ground floor, which is too light for bats, with 'Nil' Bat Roost Potential.**

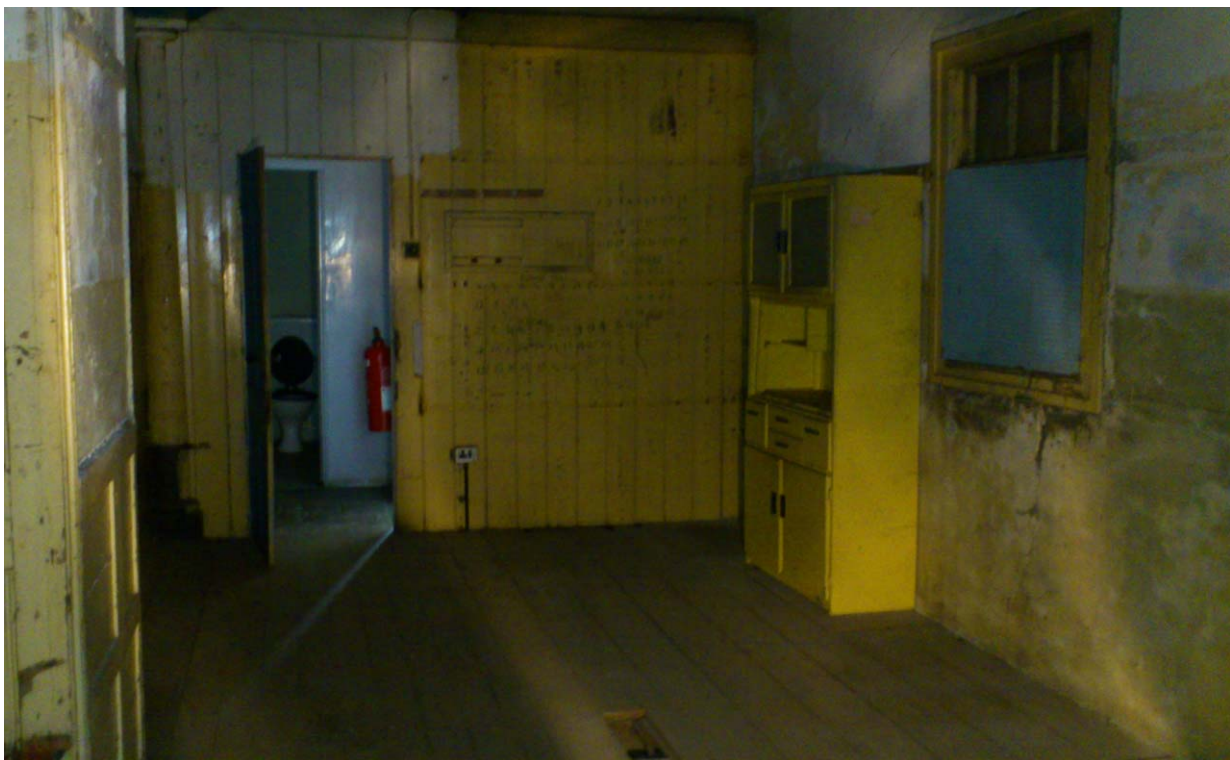
**Photograph No. 6 - Kitchen / dining area on the first floor, with no bat access and no viable bat roost space, and 'Nil' Bat Roost Potential.**

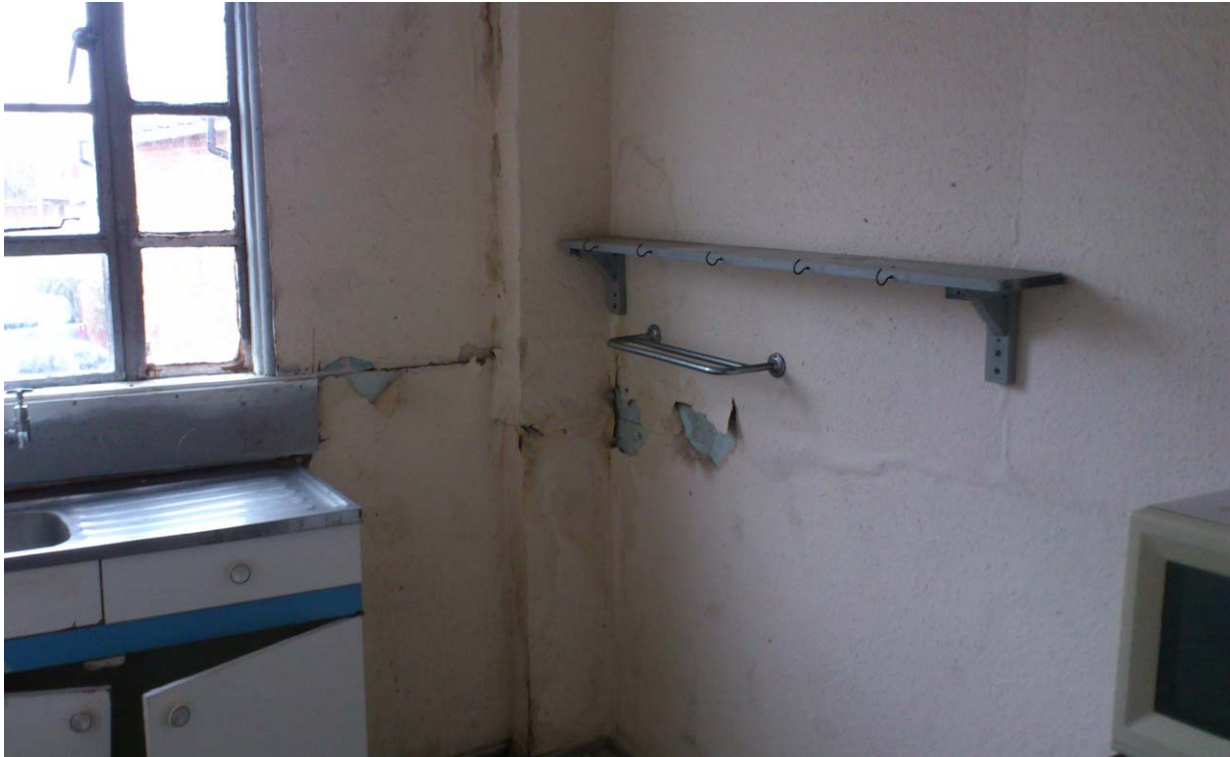
**Photograph No. 7 - Utility room on the first floor, which is too light and not viable roosting space for bats, with 'Nil' Bat Roost Potential.**

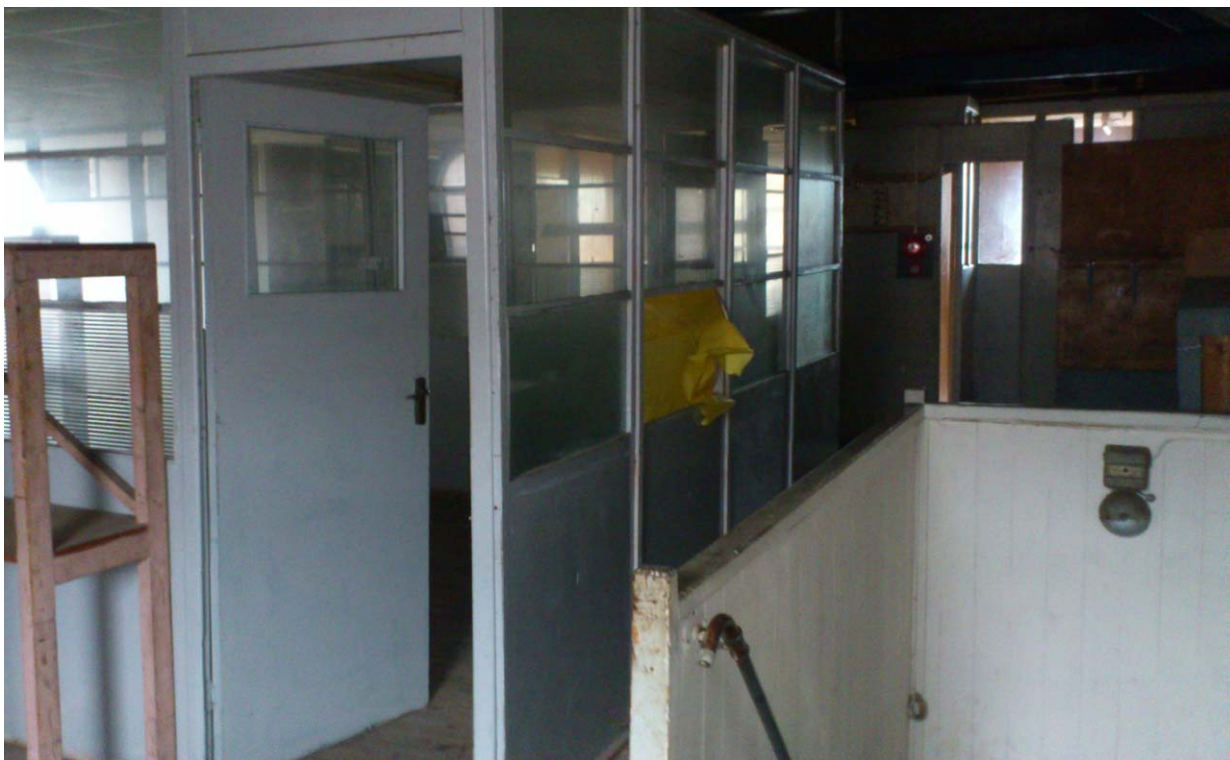
**Photograph No. 8 - Office spaces on the first floor, with 'Nil' Bat Roost Potential.**

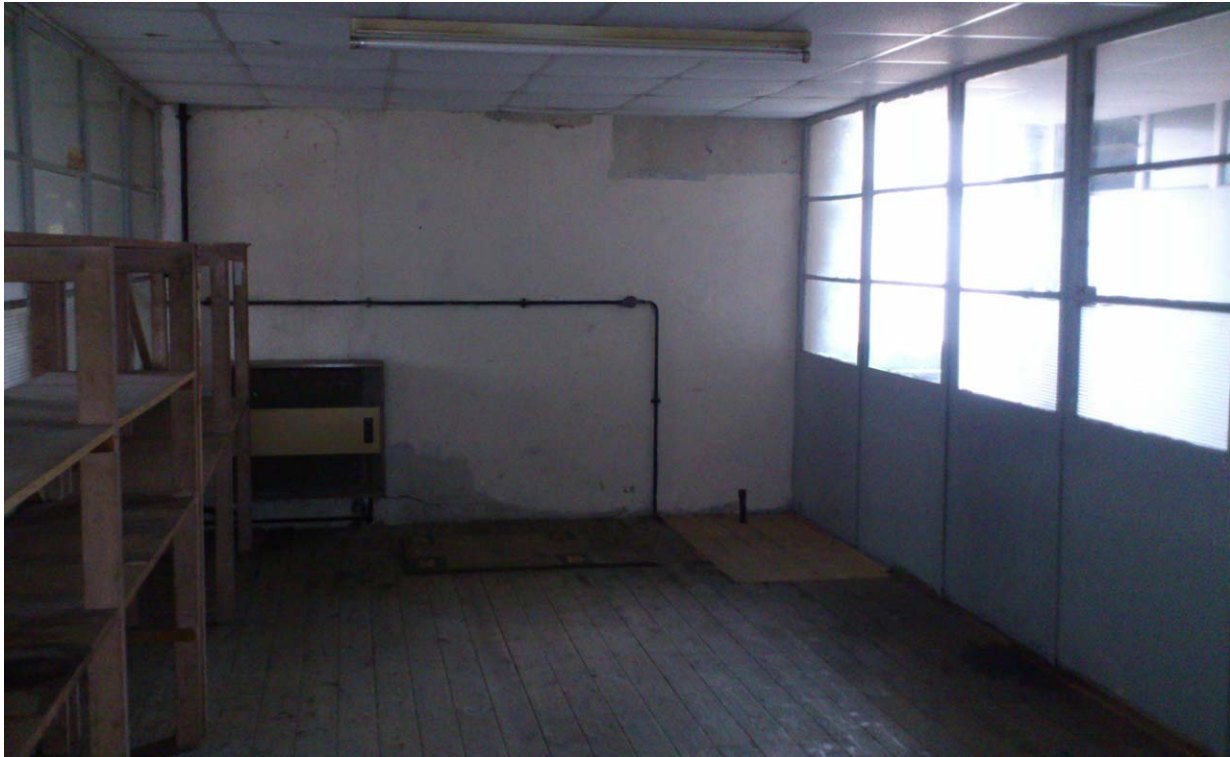
**Photograph No. 9 - Office spaces on the first floor, with 'Nil' Bat Roost Potential.**

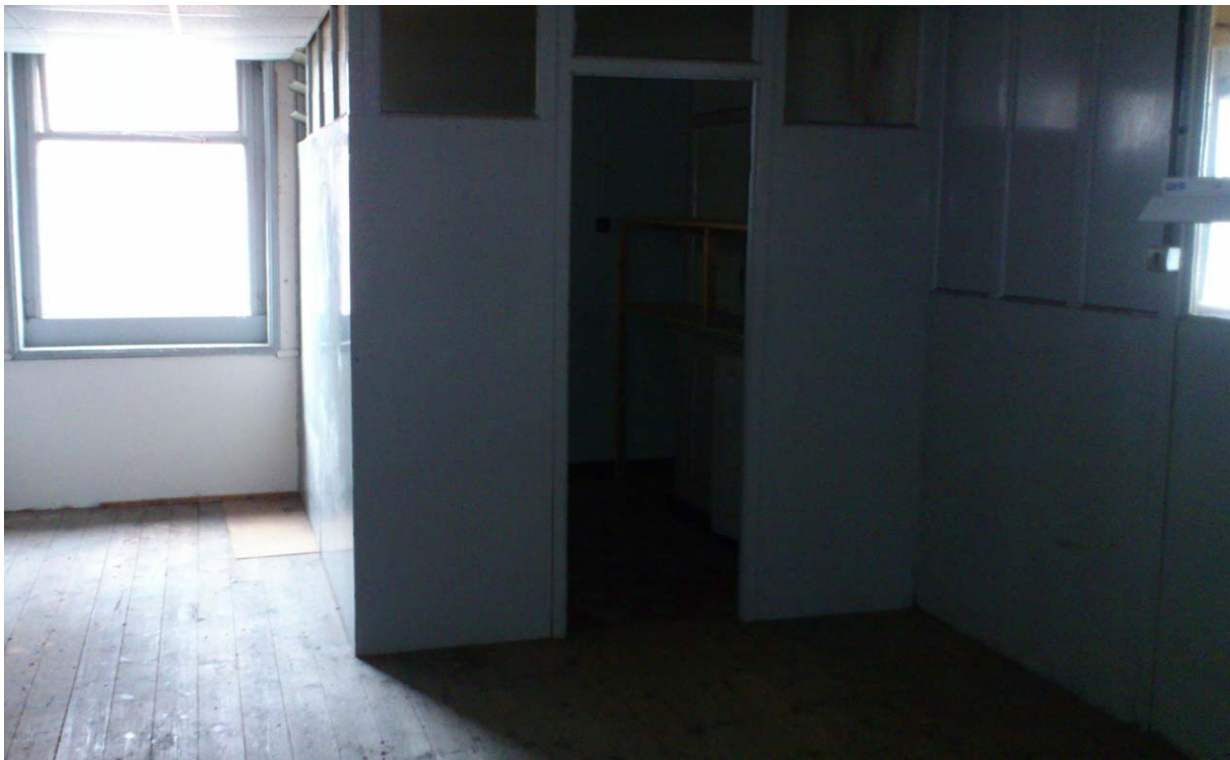
**Photograph No. 10 - Office spaces on the first floor, with 'Nil' Bat Roost Potential.**

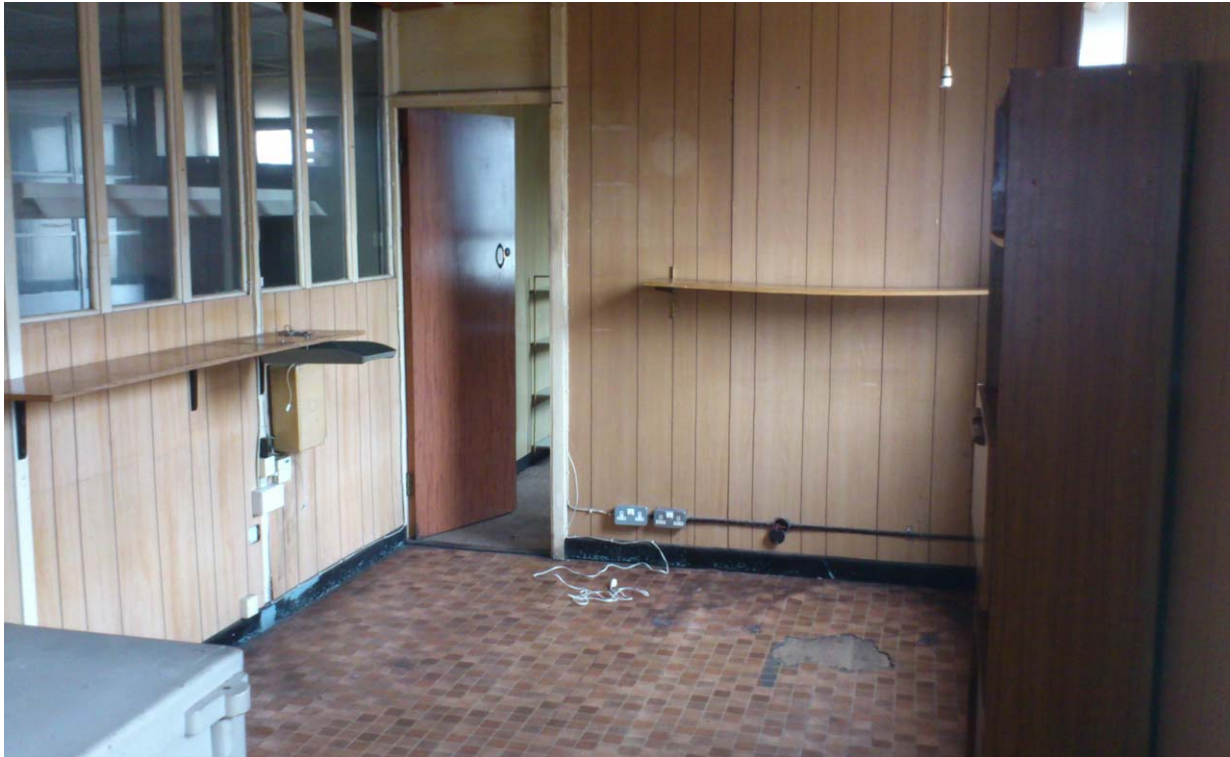
**Photograph No. 11 - Office spaces on the first floor, with 'Nil' Bat Roost Potential.**

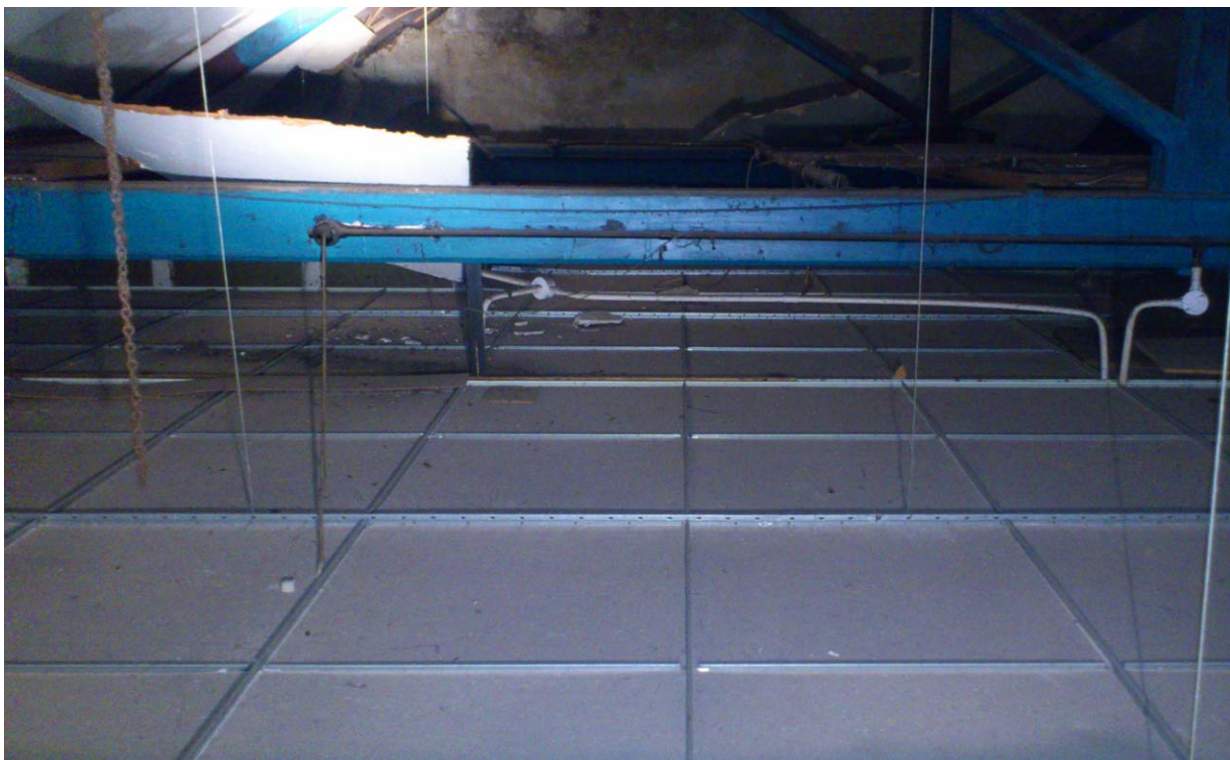
- 4.2.1 No direct evidence of bats was found during the Preliminary Bat Roost Assessment site survey. Areas that would typically retain evidence of bats such as within the roof space above the existing offices on the first floor were noticeably clean (*Refer to Photographs No. 12, 13, and 14 – Appendix No. 1*). Likely absence of roosting bats has been designated to the site.
- 4.2.2 The potential for roosting bats on site has been designated as being '*negligible*'. This is primarily because the surrounding habitat is suggested to provide a poor bat foraging resource for all species of British bat. In this context therefore the potential places in which a bat could roost assume reduced prominence. Other factors such as the orientation of the building will also reduce the likelihood of bat roosts being found on site as ambient temperatures in favoured roosting spaces will be reduced.

**Photograph No. 12 - Roof space above the offices on the first floor. This area is conspicuously clean and free of any evidence of bat occupation. There is good access to the main loft void and is unlikely to have been cleaned.**

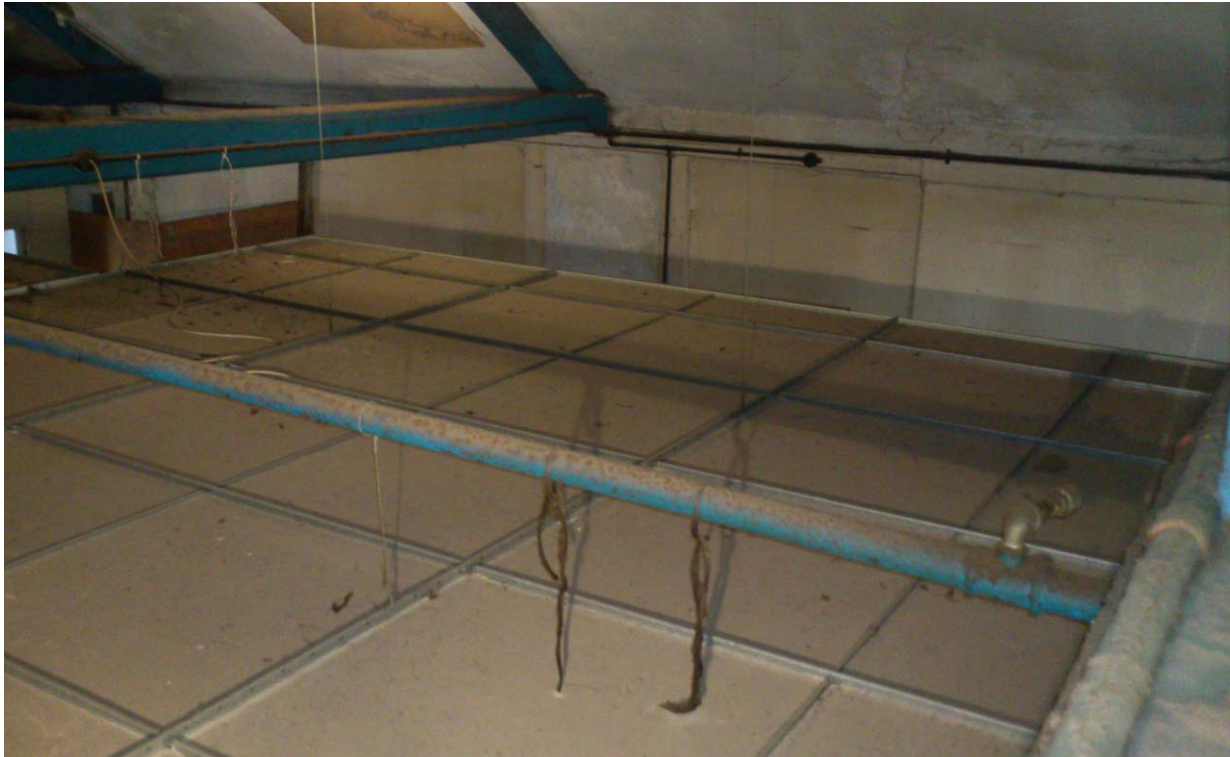
**Photograph No. 13 - Southern area of roof space above offices on first floor. The area is clean and free of any evidence of bat occupation. There is good access to the main loft void and is unlikely to have been cleaned.**

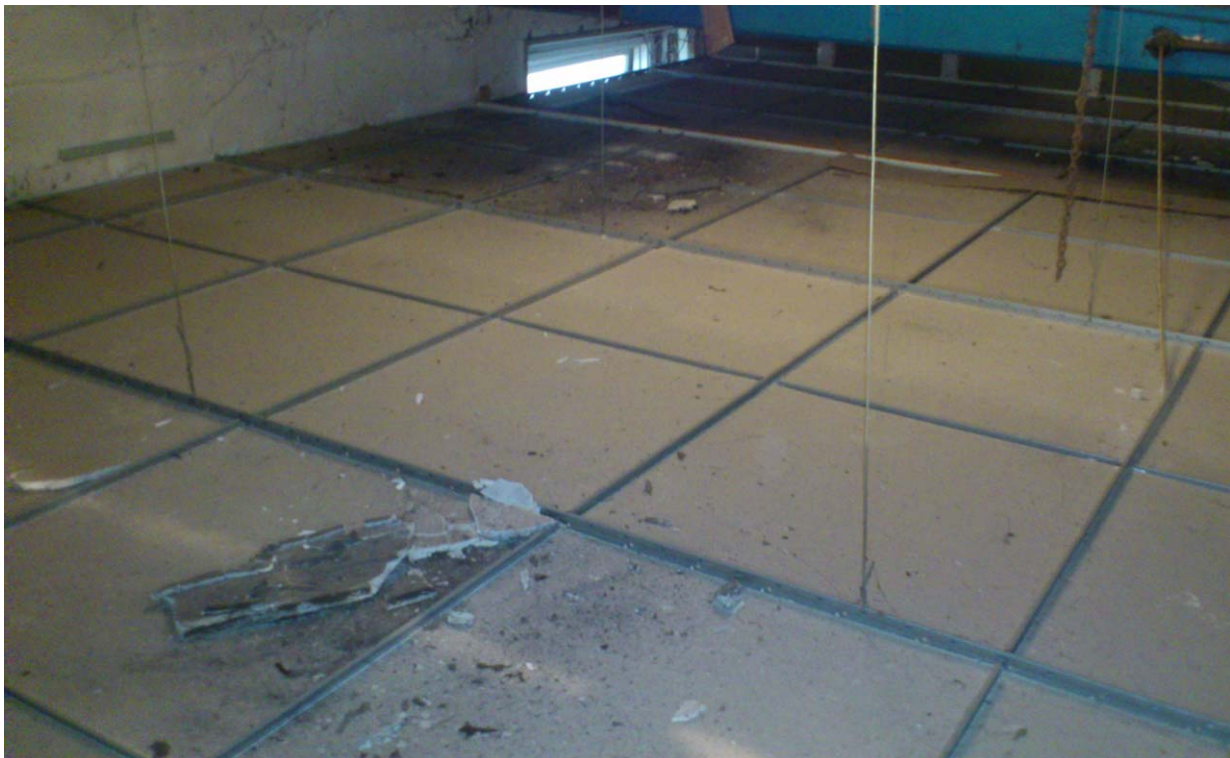
**Photograph No. 14 - Northern area of roof space to offices on the first floor. This area is clean and free of any evidence of bat occupation. There is good access to the main loft void and is unlikely to have been cleaned.**

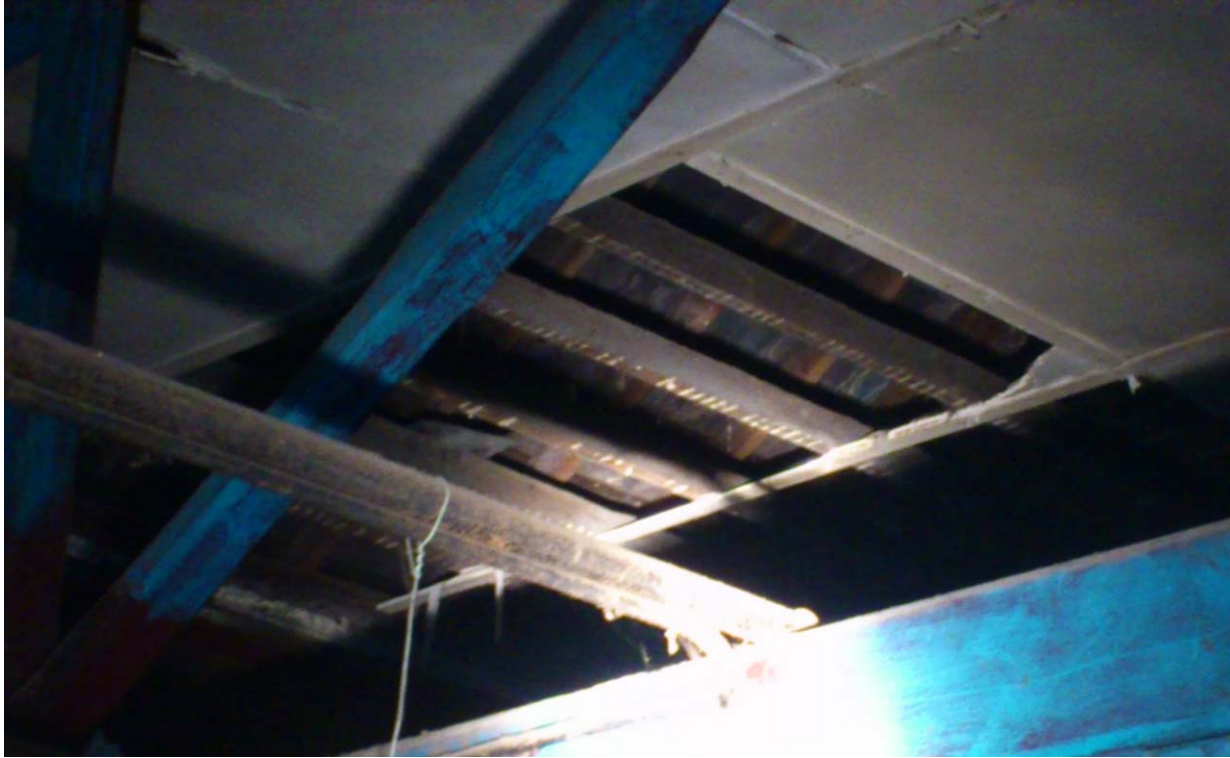
- 4.2.8 There is no roofing membrane in situ and the slate tiles lie directly above the rafters. This will reduce the potential for crevice dwelling bats such as common pipistrelle bats as the space between the roof tile and membrane is a favoured roost site for this species. Pipistrelle bats are furthermore the most common bat in urban scenarios.
- 4.2.9 There are areas that could not be viewed directly between the diagonal walls of the first floor and the eaves on the exterior. These areas are however suggested to be sub-optimal for roosting bats as they will not trap heat being open to the main loft void and oriented on a north to south axis.
- 4.2.10 In a habitat that was more amenable for bat foraging this loft space may have warranted a higher designation however it is believed that what is currently offered is '*negligible*' in terms of bat roost potential.

**Photograph No. 15 - Missing panels exposing roof void. It can be seen that there is no roof membrane that will reduce the potential for viable bat roost space within the loft void, and equates to 'Negligible' Bat Roost Potential.**

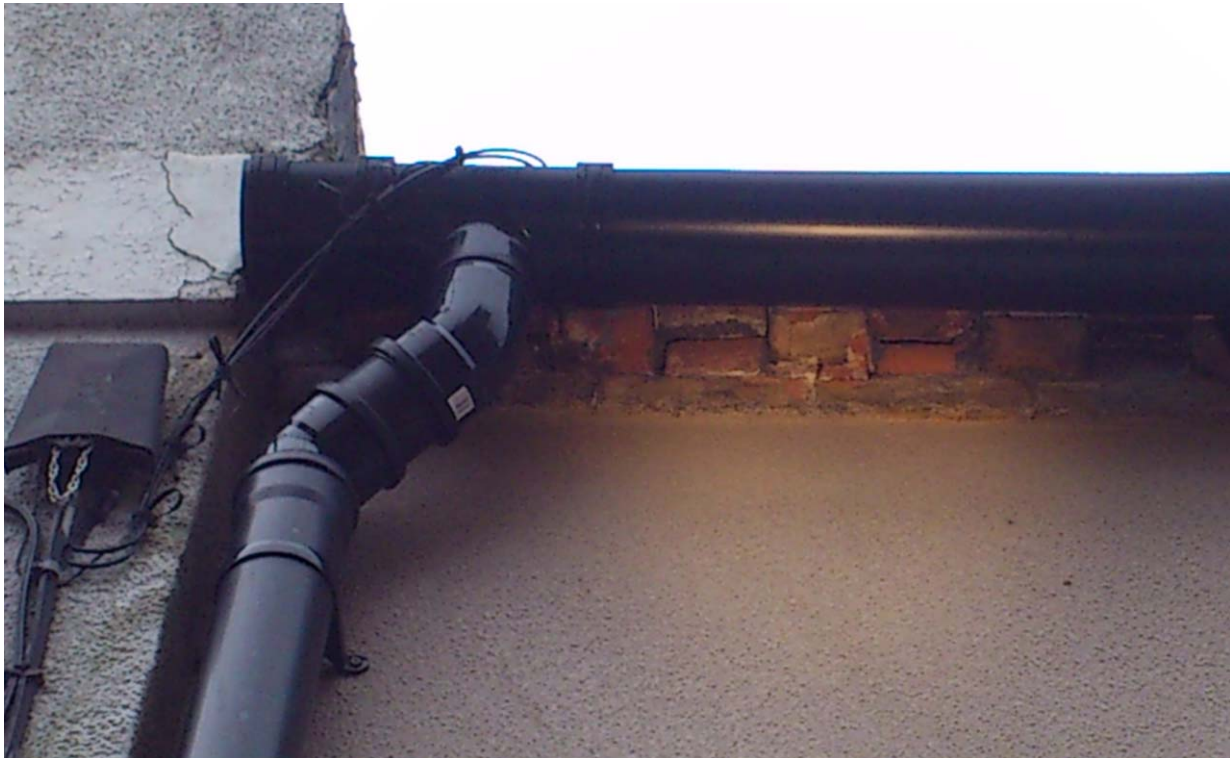
**Photograph No. 16 - Potential bat access point around the roof eaves on the eastern elevation. In the local context equates to 'Negligible' Bat Roost Potential.**

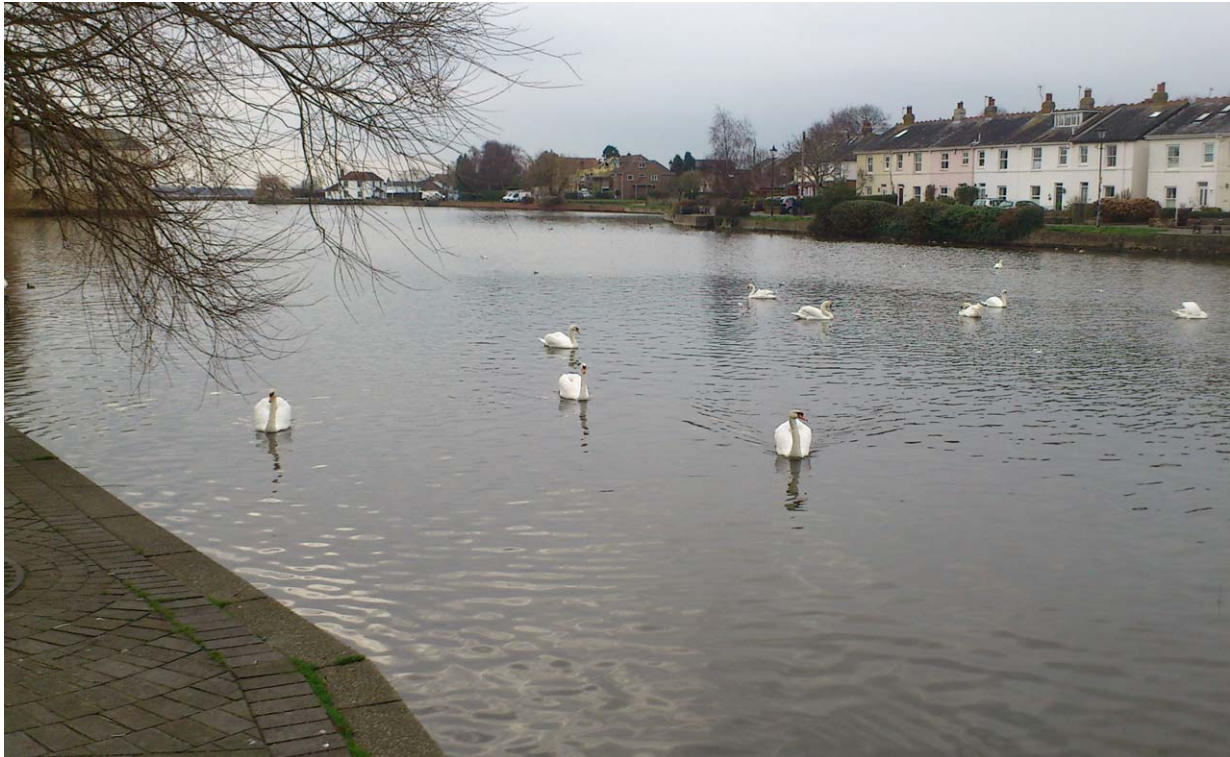
**Photograph No. 17 - Habitat found c. 35.00 metres west of the site. Hard standing habitat up to the edge of the water. Remaining habitat fairly uniform. Poor quality bat foraging habitat.**

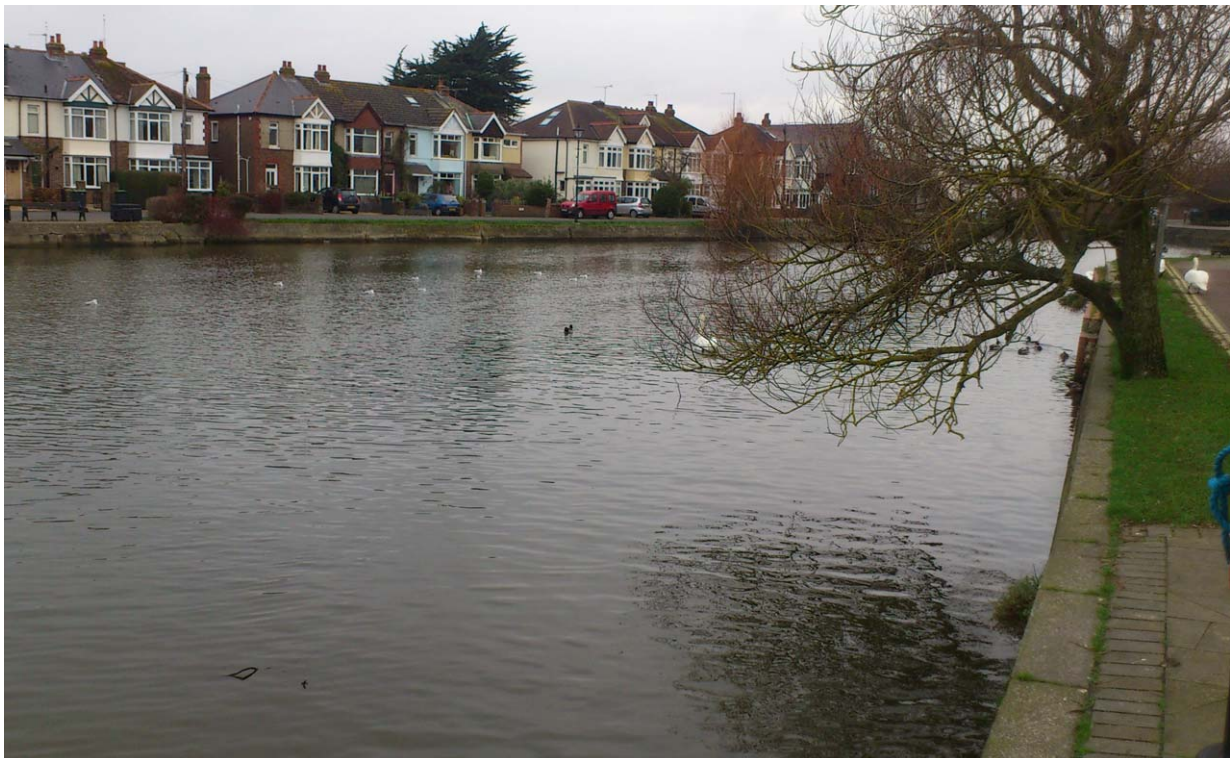
**Photograph No. 18 - Habitat found c. 35.00 metres west of the site. Hard standing habitat up to the edge of the water. Remaining habitat fairly uniform. Poor quality bat foraging habitat.**

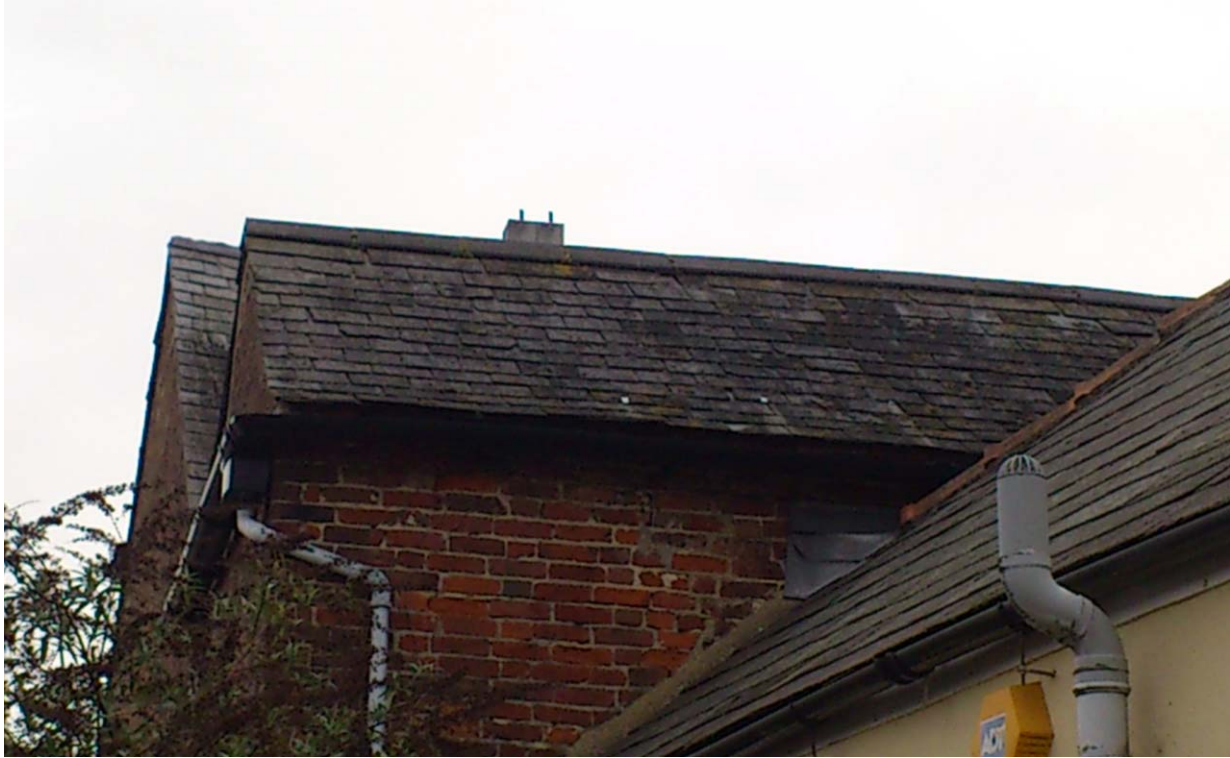
**Photograph No. 19 - Western elevation of the existing building. Tiles are tight-fitting slate with minimal potential access points exist under the eaves. In the local context this equates to 'Negligible' Bat Roost Potential.**

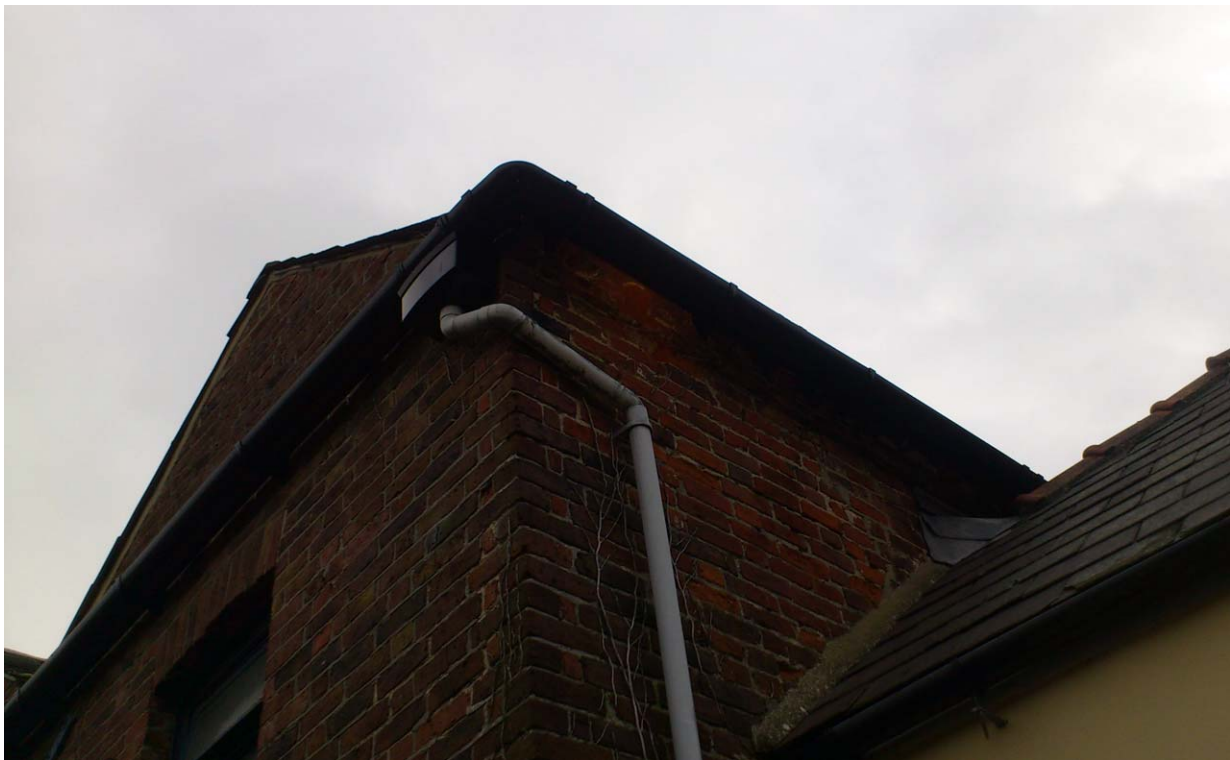
**Photograph No. 20 - Minimal potential bat access points under the eaves on the western elevation.**

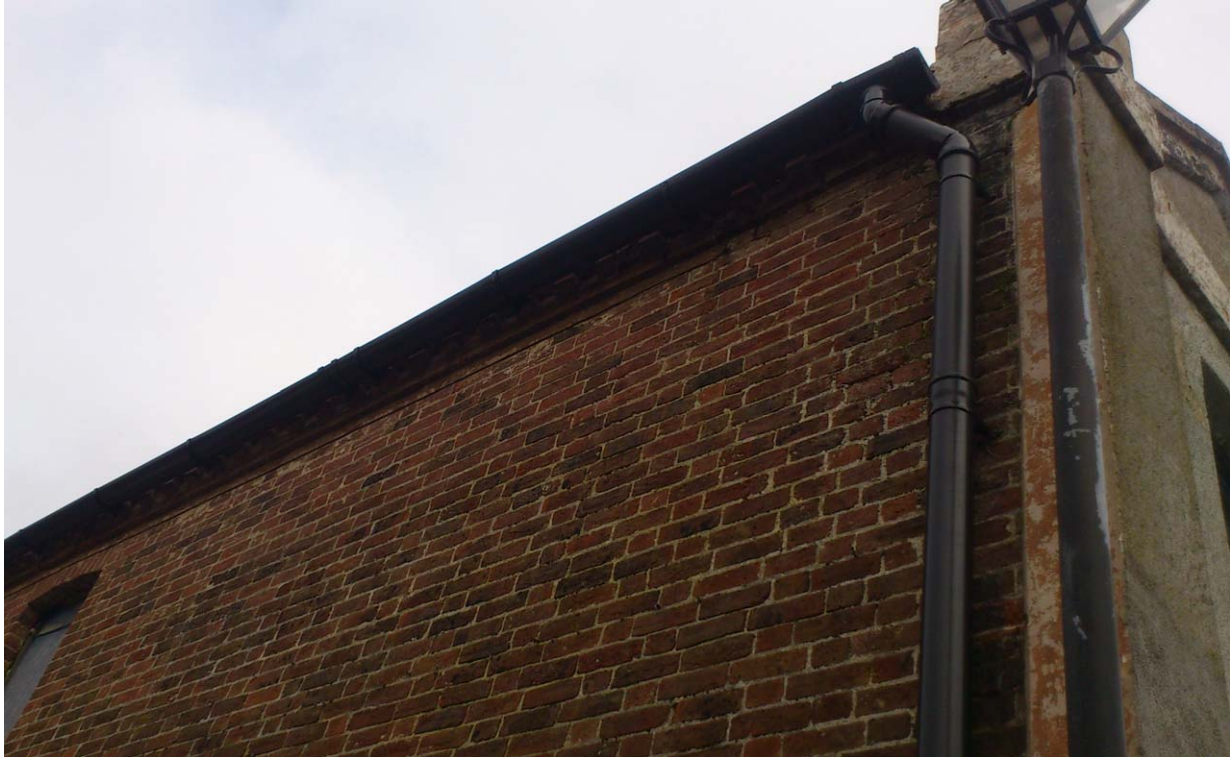
**Photograph No. 21 - Minimal potential bat access points under the eaves on the western elevation.**

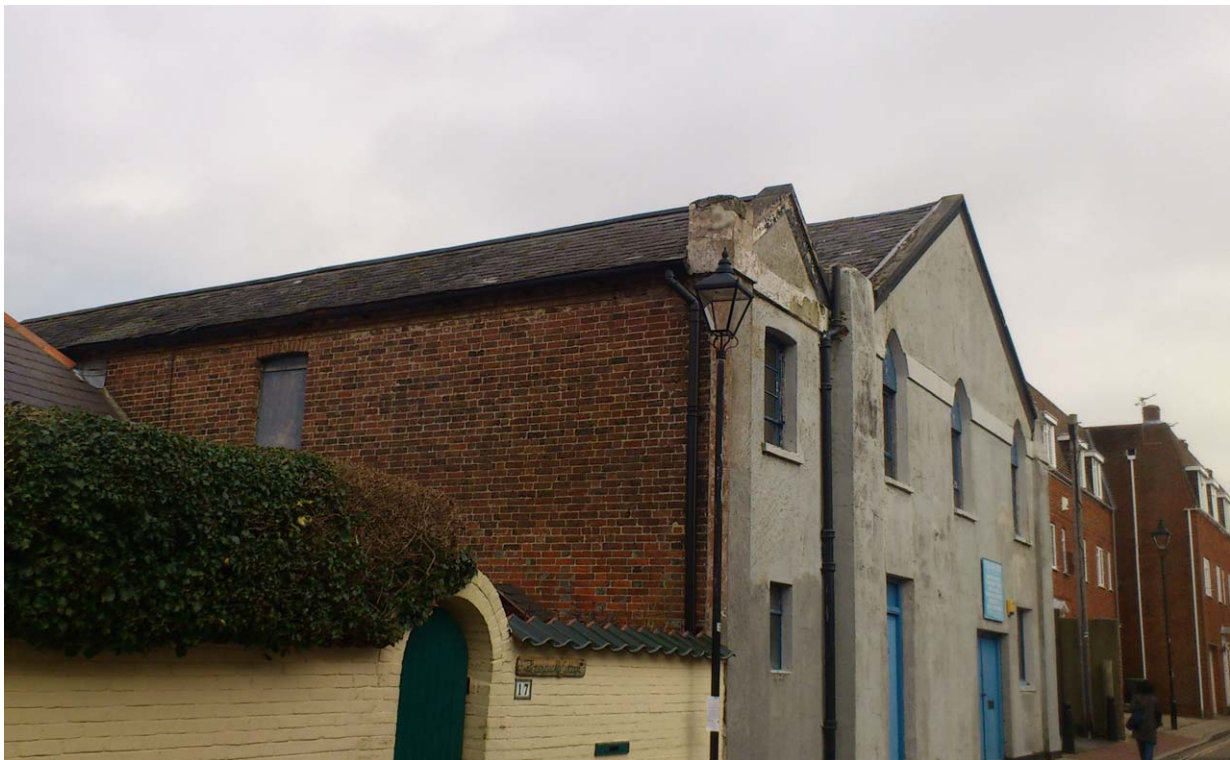
**Photograph No. 22 - Tight-fitting slate tiles over all visible areas of the roof, with minimal bats access points, and 'Negligible' Bat Roost Potential.**
