## Emsworth Primary School

Ground Investigation Report

Hampshire County Council

| Clients Brief | The investigation was undertaken to provide foundation guidance for the construction of a proposed single-storey extension to the existing school building. |

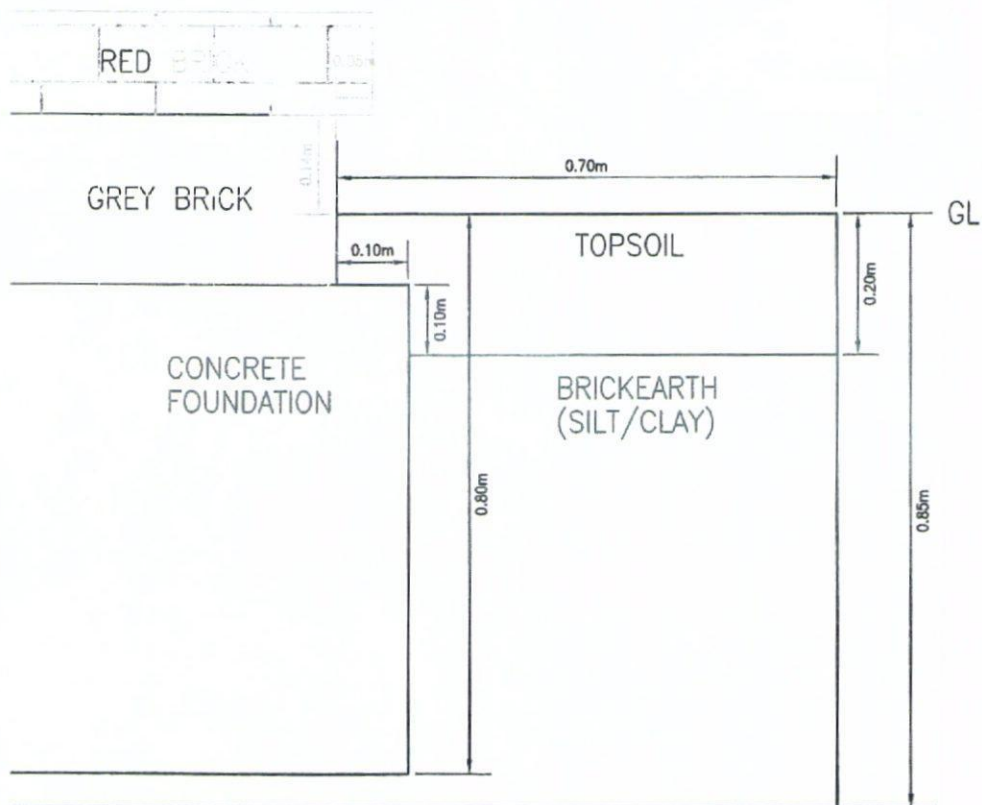
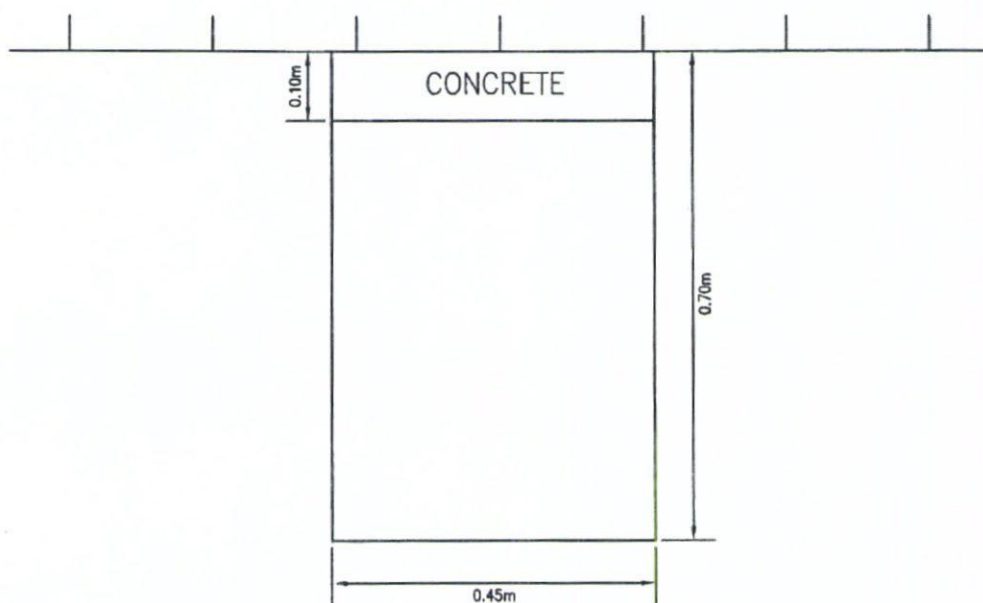
# SECTION

# PLAN

## BRICK WALL

Obstructions were not encountered during drilling of the window samples. Trial pits TP1 and TP2 indicate existing foundations to comprise shallow conventional spread-type bearing at between 0.8 and 0.9mbgl onto the firm Brickearth. This is consistent with the depth to the base of the school foundations indicated on the foundation and drainage layout plan provided by HCC (see Appendix H), which shows the school building to be founded upon strip footings 450mm wide with a founding depth of 900mm.

Sketch plans of conditions encountered within the trial pits are presented in Appendix B.

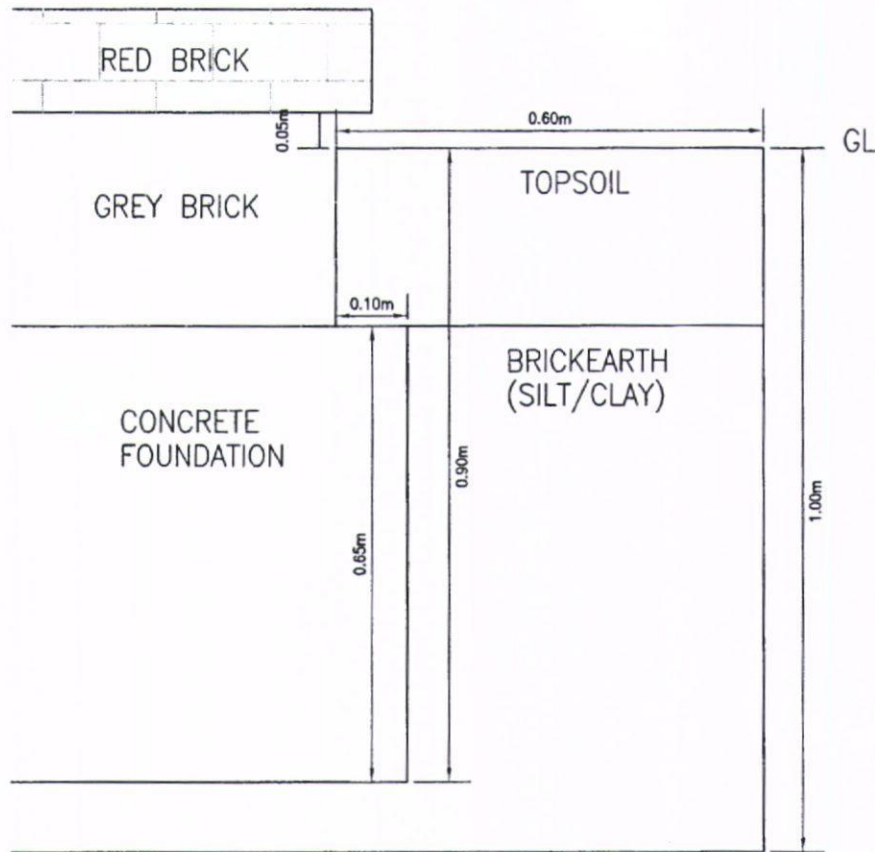
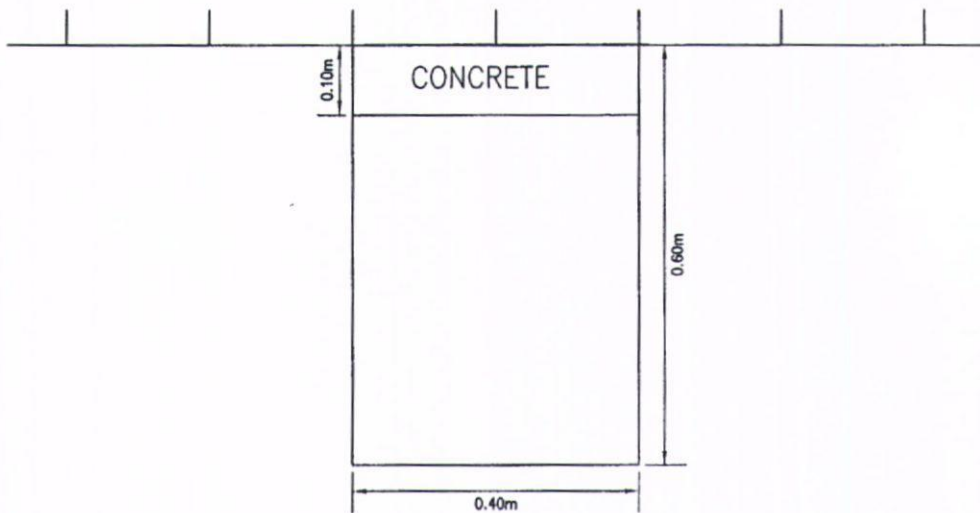
TP2

SECTION

PLAN

BRICK WALL

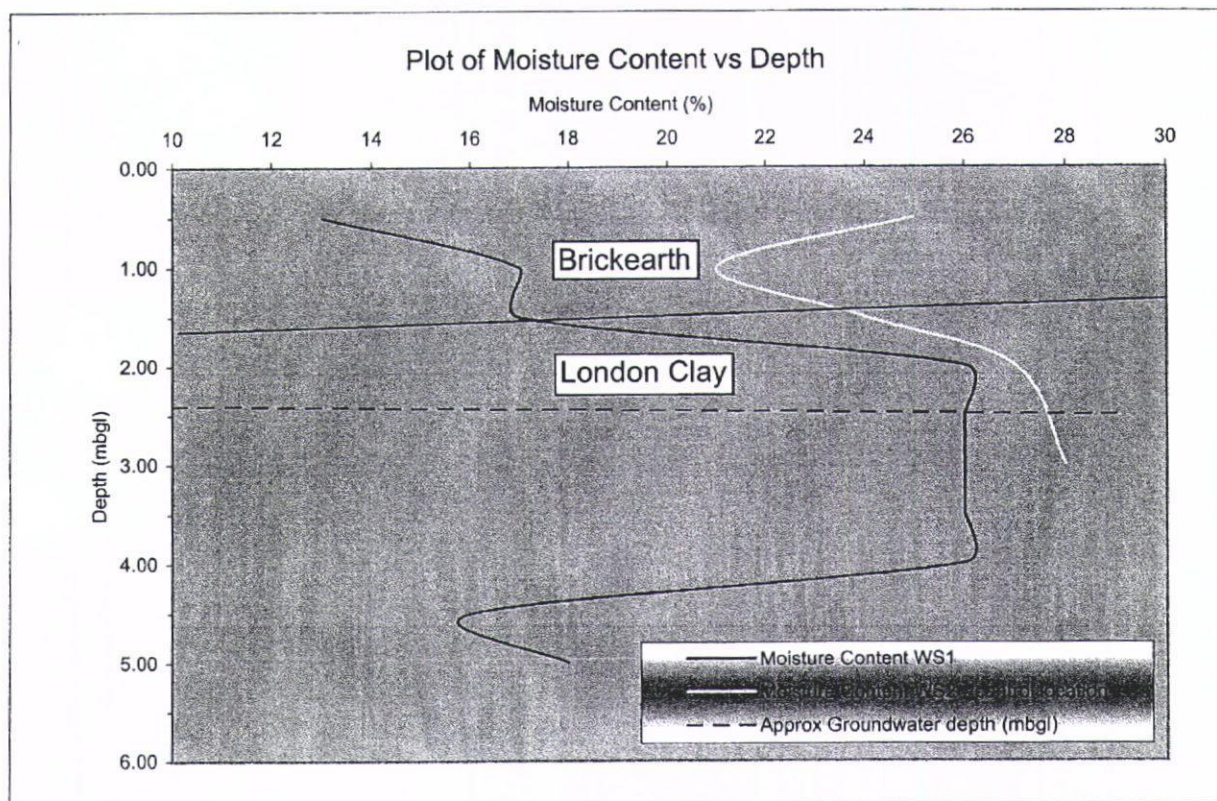
| Location | Depth (mbgl) | Stratum | Moisture Content (%) | Liquid Limit (%) | Plastic Limit (%) | Liquid Limit * 0.4 | Plasticity Index (%) | Liquidity Index |

Comparison of soil moisture content profiles at both locations confirms this assessment, with lower moisture contents in all samples of Brickearth in WS1 compared to WS2. Plots of the moisture content profiles are presented in Appendix C.

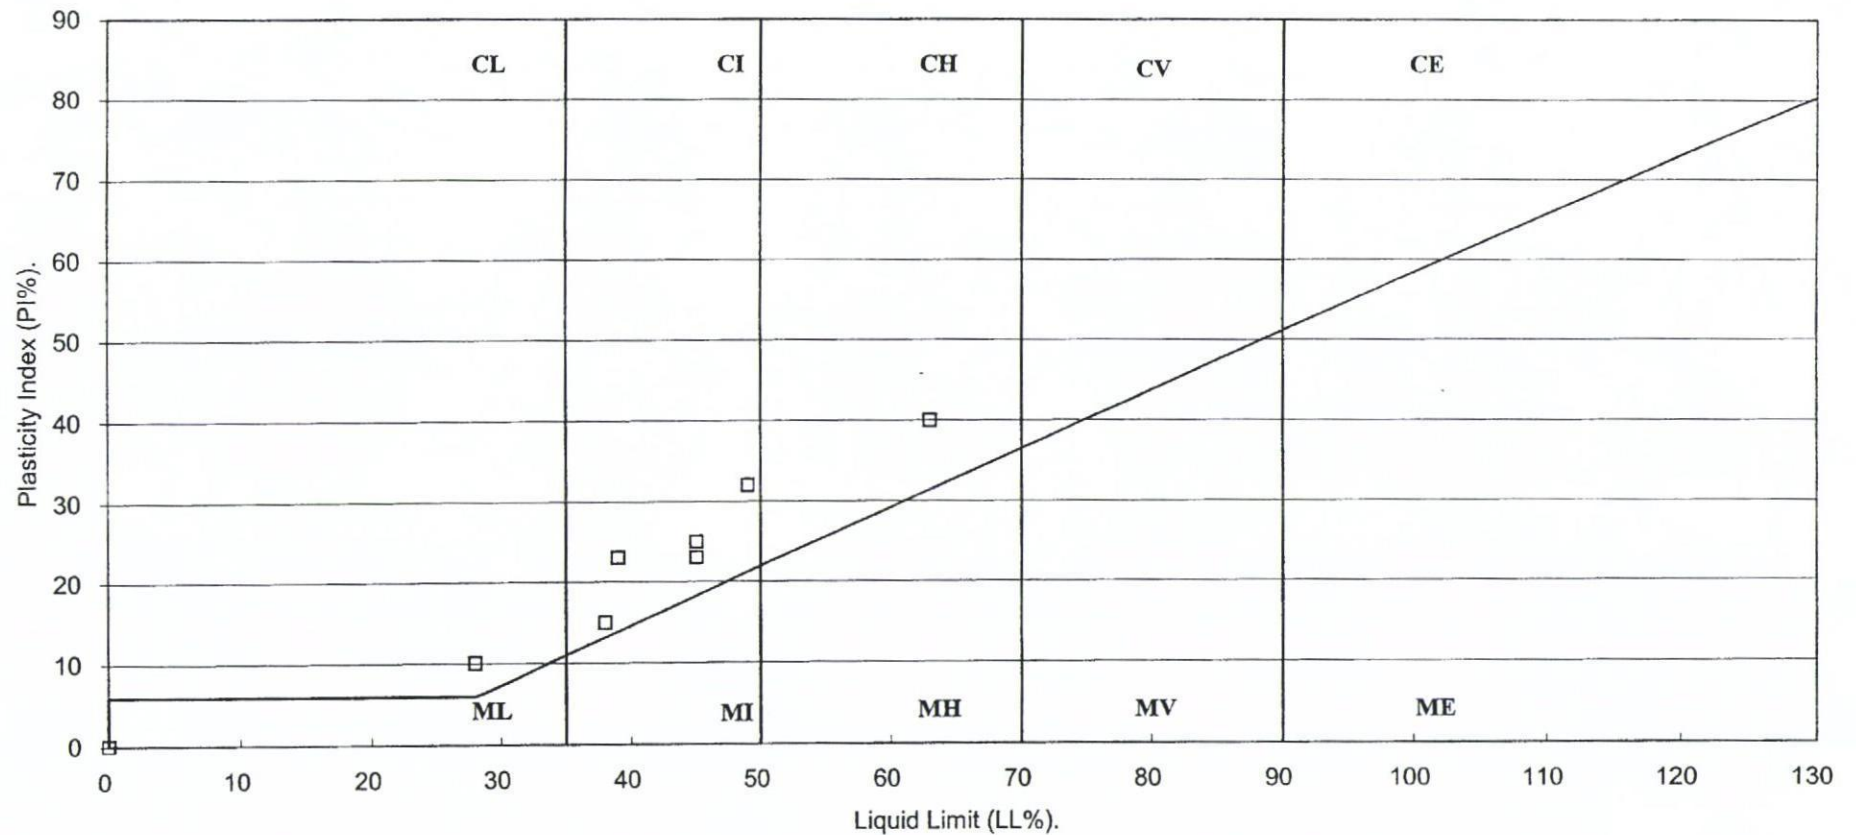
# PLASTICITY CHART FOR CASAGRANDE CLASSIFICATION.

(B.S.5930 : 1999)

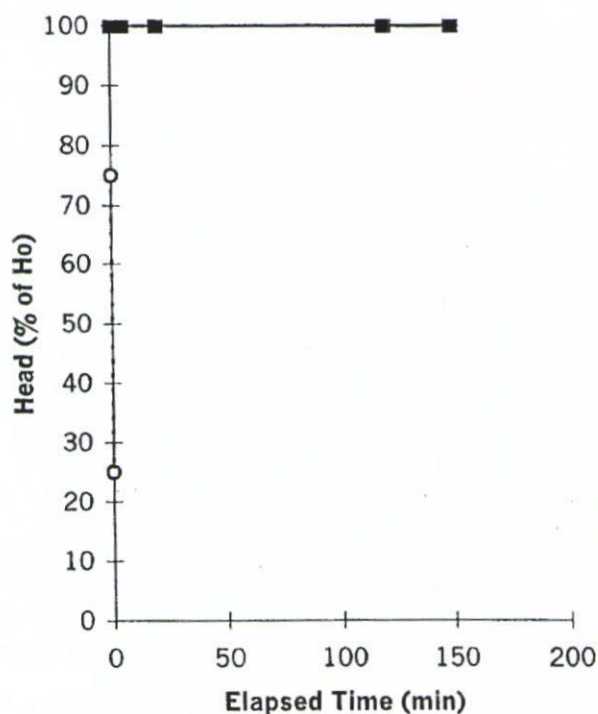
## Comments

Test terminated after 150 minutes. Water level unchanged.

A negligible soil infiltration rate was recorded for the London Clay Formation, and a rate of  $2.119 \times 10^{-6}$  was recorded within the Brickearth indicating the stratum to be of low permeability.

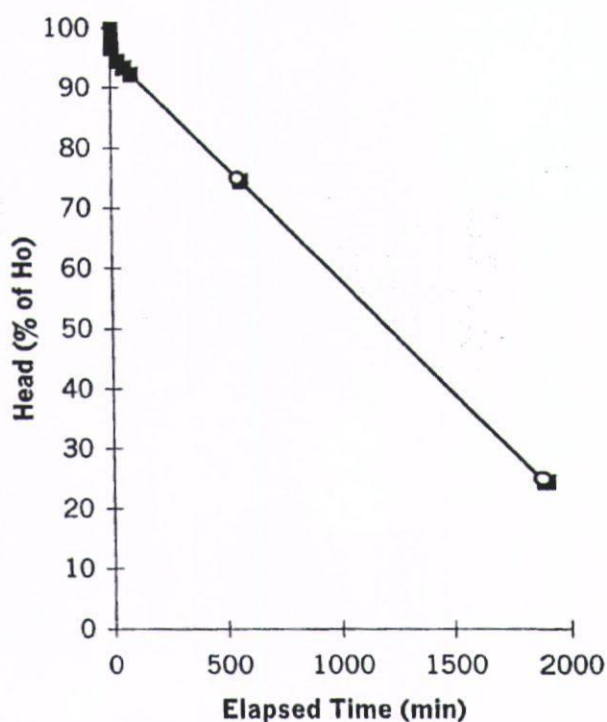
## Comments

Extrapolated data after 90 minutes.
