# Hermitage Stream and Park Lane Stream

Aquatic Macroinvertebrate and  
Habitat Investigation

Dunsbury Hill ES Technical

July 2011

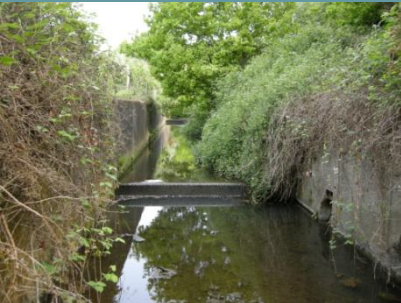
- Concrete channel section:
  - This 125m section of concrete lined channel to the south of the A3(M) culvert exhibits very low habitat diversity. The concrete channel contains a series of weirs designed, it is thought, to act as velocity breaks. These are currently ineffective as velocity breaks due to coarse and fine sediment accretion between the weir sections to weir invert level. Sediment accumulation within the concrete line channel indicates that the Hermitage Stream within, and adjacent to, the scheme boundary is in.

| Site | Image | Description |
|---|---|---|
| Hermitage Stream<br>HS01 | | Aquatic macroinvertebrate sampling site and center point of habitat assessment location. Viewed looking upstream. |

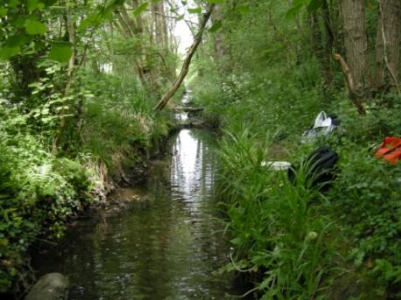
- Soft bank (straightened) section:
  - Immediately downstream of the concrete lined channel is soft banked, tree lined channel which has been realigned along a straight course for approximately 85m. The bed is composed predominantly of pebble sized substrate and there is little variation in bed level resulting in a homogenous channel form. Channel complexity increases where roots from mature riparian tree protrude into the channel. The channel is slightly incised and has low vertical clay banks indicating that they are subject to on-going erosion and sediment transport. Banks are, however, relatively stable as a result of the presence of riparian trees and associated root binding.

| Site | Image | Description |
|---|---|---|
| Hermitage Stream<br>HS02 | | Aquatic macroinvertebrate sampling site and center point of habitat assessment location. Viewed looking upstream. |

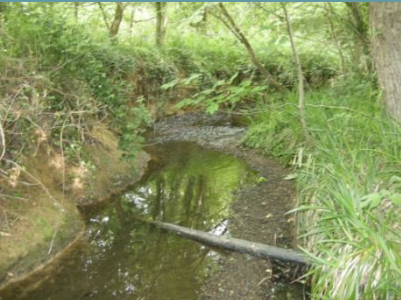
- Soft banked (natural) section:

- Downstream of the straighten channel the channel form becomes more characteristic of a low order wooded stream section with an occasional tortuous planform between mature tree stands. The clay banks are high and often vertical indicating that they are subject to on-going erosion with rapid removal of collapsed bank material occurring within bayed areas. Gravel bars and deep pools alternate within the channel and the bed sediment is dominated by pebble and gravel substrates.

| Site | Image | Description |
|---|---|---|
| Hermitage Stream<br>HS03 | | Aquatic macroinvertebrate sampling site and center point of habitat assessment location. Viewed looking upstream. |

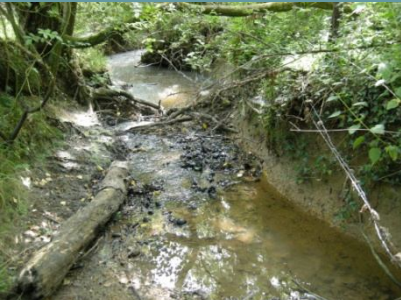
The habitat quality of the Park Lane Stream was investigated along its boundary with the Scheme. Park Lane Stream exhibits a tortuous planform with deep pools (up to 1.3m deep) and shallower gravel sections. Of particular note is the presence of numerous large woody debris jams which act to provide a diverse set hydromorphological features. Bed substrates in faster flowing sections are dominated by pebble and gravel although within the bed interstices a high proportion of fine sediment was evident.

| Site | Image | Description |
|---|---|---|
| Park Lane Stream<br>PL01 | | Aquatic macroinvertebrate sampling site and center point of habitat assessment location. Viewed looking downstream. |
