# APPENDIX 15.9

## Otter and Water Vole Survey Report

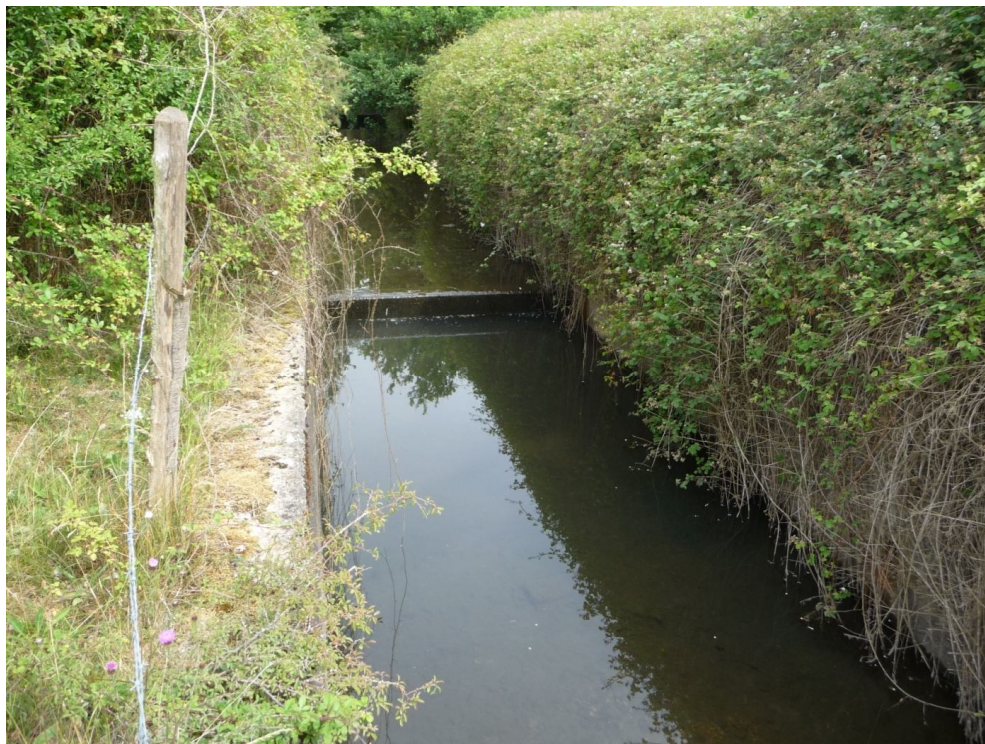
Photograph 1 - Northern canalised section of the Hermitage Stream showing concrete sides of culvert with overhanging bramble

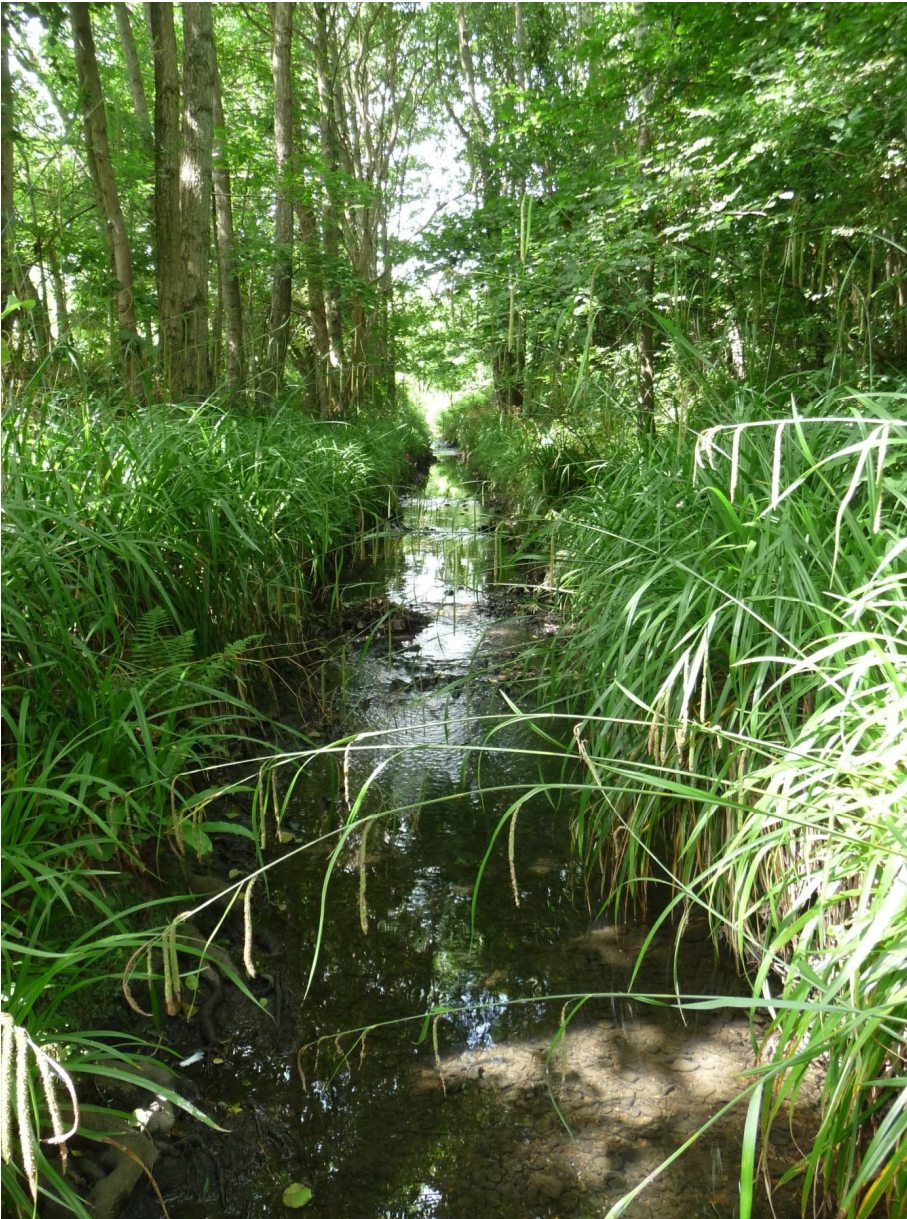
Photograph 2 - Southern section of the Hermitage Stream showing dominant bankside vegetation of pendulous sedge leading to woodland edge of Cherry Tree Row SINC (right side of photograph)
