# St Michael's Convent, 354 London Road, Waterlooville, PO7 7TF

## Ecological Assessment Report

**Ecological Appraisal Report**  
**St Michael's Convent, 354 London Road, Waterlooville, PO7 7TF**  
**for**  
**Linden Homes**

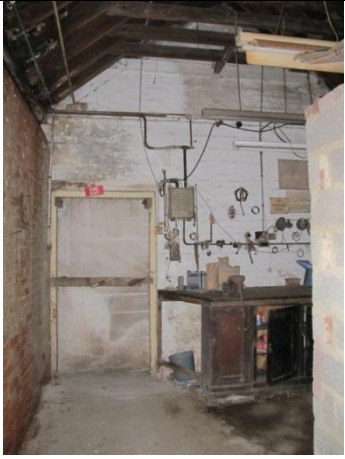
| Building | Photograph | Bat Roost Potential |
|---|---|---|
| A | | <p>Building A is a one-storey brick and breezeblock building with a pitched asbestos sheet roof. There is no internal lining or insulation. A small area of wooden cladding is present on the western elevation. There is an annex on the eastern end, which is constructed from bricks and breezeblocks, with a pitched, tiled roof on timber beams. The roof within the annex is lined with wooden boards. Bargeboards are present around the exterior of the building, and there are several gaps into the interior. A lifted tile on the annex provides entry to the interior of the roof void, whilst the asbestos roof of the main part of the building is raised. There are several loose or missing tiles on the annex (front and side). The interior of the main building is well lit to the roof (approximately 10m high). Mouse droppings are scattered throughout. This building has <b>high bat roost potential</b> which was confirmed by the presence of bat droppings on the floor of the annex. Therefore, <b>this building is a bat roost.</b></p> |

Three areas have been identified as being a bat roost (as a result of bat droppings observed within them). These are Building A and the roof voids G and H within the convent buildings. Therefore, it will be necessary to carry out a minimum of three emergence surveys during the bat active season between May and September in order to watch for bats leaving the building at dusk. This would gather enough information about bat populations (including species, numbers and status of roost sites) to support a bat EPS licence application.

Bat roosts are present on site in Building A and in the roof voids G and H within the convent buildings. Therefore, an EPS licence for bats from Natural England is required prior to any works commencing on these buildings. The licence would permit activities that may otherwise be offences under the *Conservation Habitats & Species Regulations 2010*, such as destruction of bat roost sites. If bats are found in other buildings on site during the emergence surveys they can be incorporated into the EPS licence. Should bats be found during works on any other buildings then work must stop on the relevant building and an amendment to the EPS licence should be applied for.

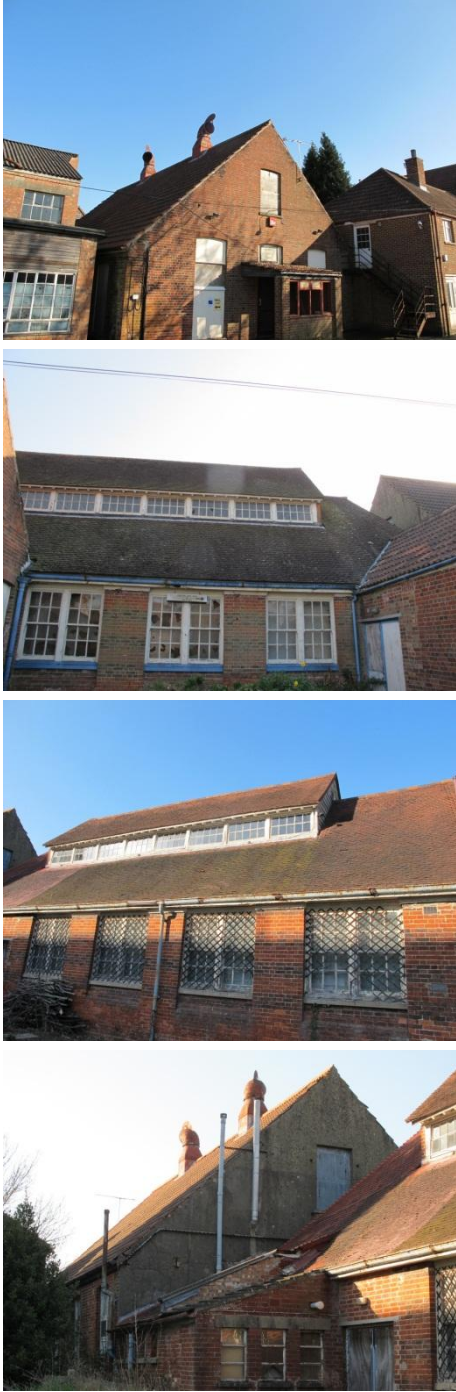
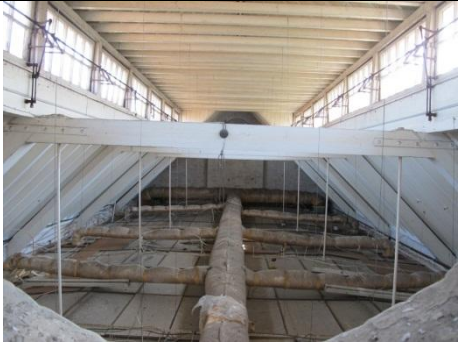
| <p><b>B</b></p> | | <p>A large two-storey brick outbuilding with a pitched tiled roof. There are two voids both of which are lined with wooden boards. The interior has a suspended ceiling. The main void above the suspended ceiling has a row of windows running along the north and south elevations making the interior void very well lit. The frame within the voids is wood with ridge beams present at the apex. There were very few cobwebs within the voids, although no evidence of bats was found. Mouse and rat droppings were scattered throughout the voids and the ground floor of the building. It has several loose or missing tiles that could provide access to bats, as well as a hole in the brickwork on the western elevation. However, the high levels of light in the roof voids means that bats may be disturbed. Therefore, it has <b>moderate bat roost potential</b>.</p> |

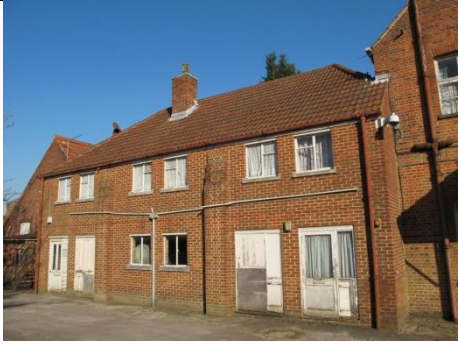
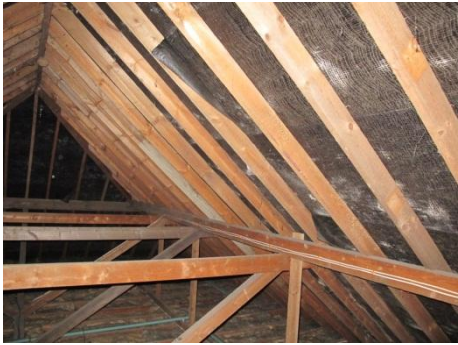
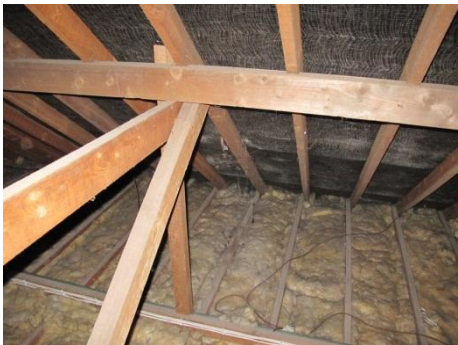
| C | | <p>Building C is a two-storey brick house with a hipped, pitched tiled roof. The roof void is lined with roofing felt and is insulated with fiberglass. The frame is wooden with a wooden ridge beam. The void has a maximum height of approximately 3m. Light enters the void through four large tears in the felt lining. Rodent droppings were found throughout. There were few cobwebs within the void, but no evidence of bats.</p> <p>Bargeboards and a chimney with lead-flashing present on the exterior of the building. There are several lifted tiles on the roof, and an area of lifted lead-flashing on the southern elevation of the chimney. This building has <b>moderate bat roost potential</b>.</p> |

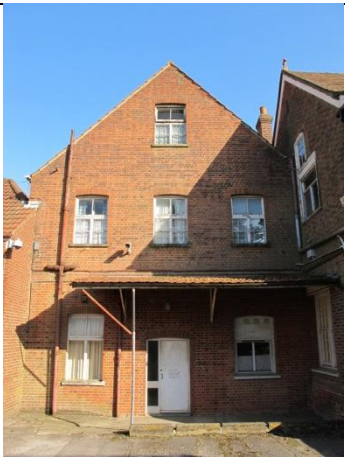
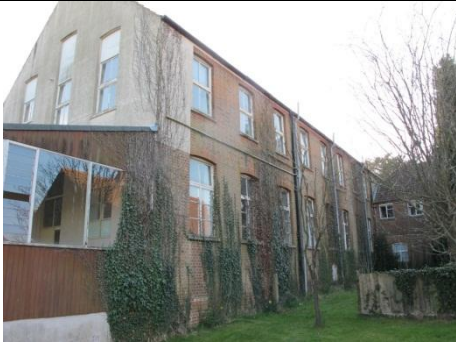
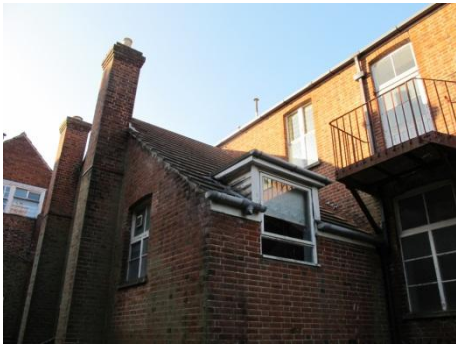
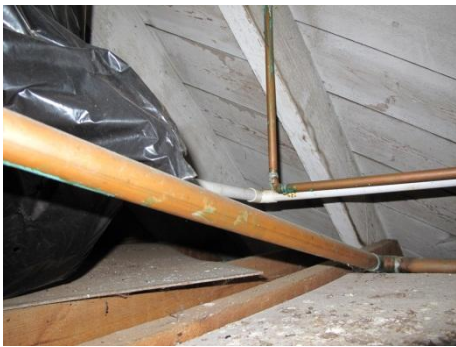
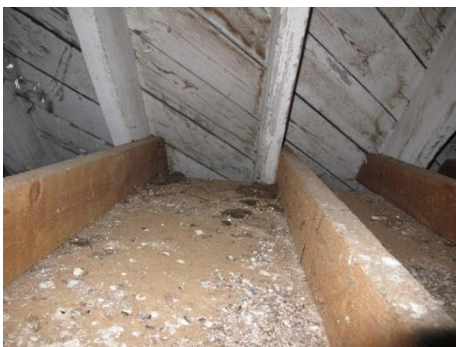
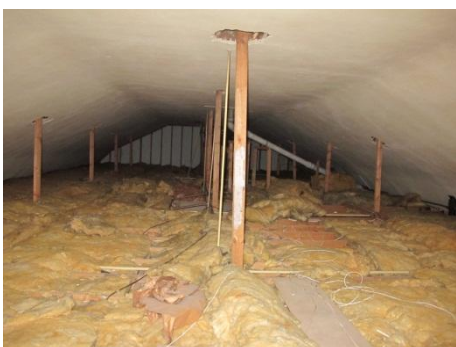
| D | | <p>A three-storey brick building with a pitched tiled roof. There is an extension with wooden cladding on the east side. Two roof voids are present, one small void containing a water tank on the east and a larger void on the west. The smaller of the two voids is lined with wooden boards. It contains few cobwebs and is well-sealed. The void is filled with pigeon droppings. The larger of the voids has wooden beams, contains fiberglass insulation, and is lined with plasterboard. No evidence of bats was visible at the time of survey, although some rodent droppings were present.</p> |

| | <p>There are gaps into the roof void via a hole to the right of the red drain pipe on the west side and via several slipped tiles. Lead-flashing and a porch are present on the exterior of the structure. There are climbing plants including <i>Hedera helix</i> (Ivy) on the northern elevation. This building has <b>moderate bat roost potential</b>.</p> |

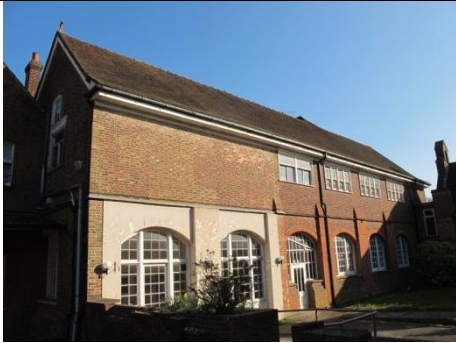
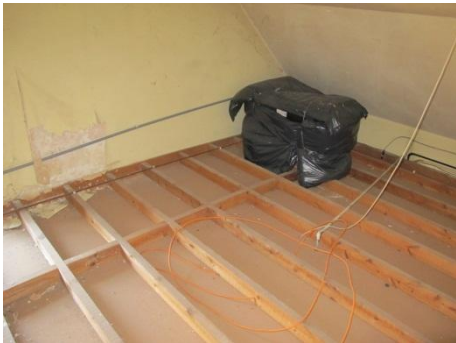
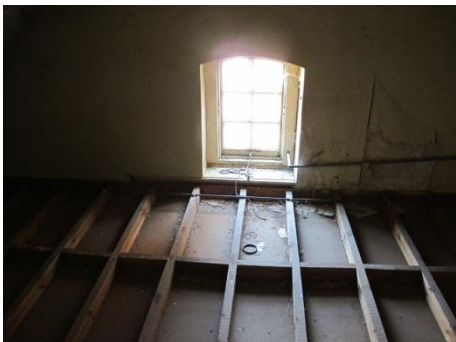
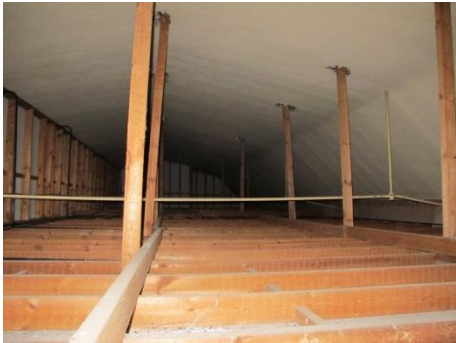
| <p><b>E</b></p> | | <p>A two-storey brick building with a pitched tiled roof. The interior of the void is lined with plaster and devoid of cobwebs. A small area of the north end of the roof void is partitioned off, with an access hole into the main part of the roof void. It has a large window, ensuring much of this area is well lit. Rodent droppings were scattered throughout the void, but no evidence of bats was found. There are several raised tiles on the roof and a gap in the soffits in which birds were nesting at the time of survey. There are bargeboards and soffit boxes around the exterior of the roof, and a chimney with lifted lead-flashing. This building has <b>moderate bat roost potential</b>.</p> |

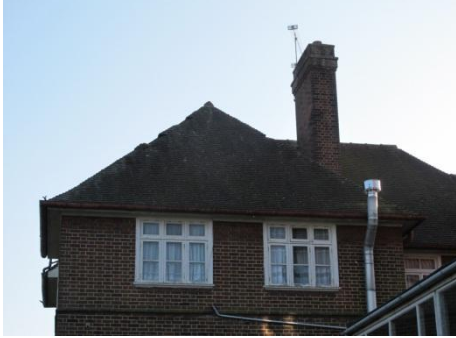
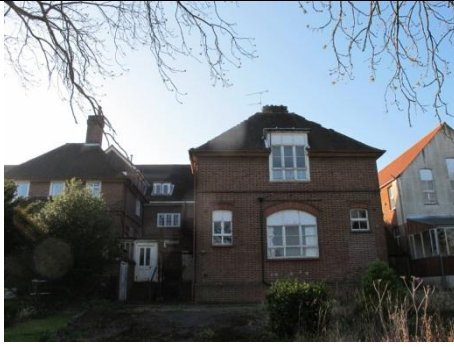
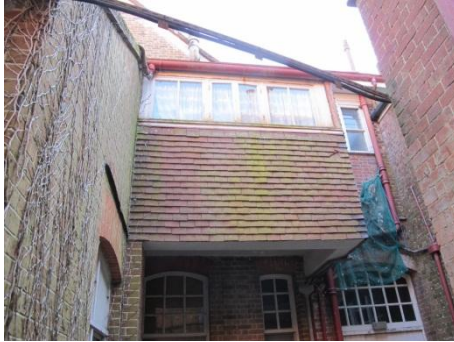
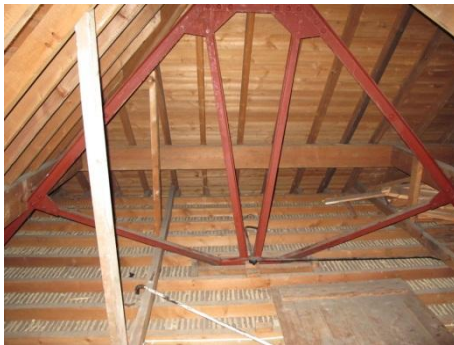
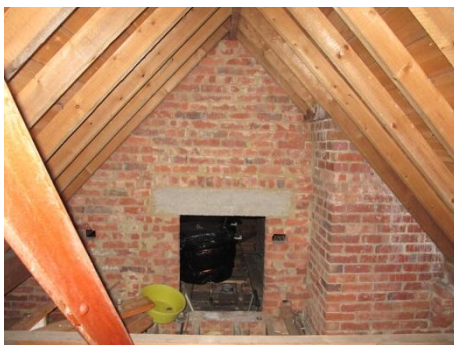
| <p><b>F</b></p> | | <p>Building F is an extension to the east of Building E. It is a brick building with a pitched, hipped, tiled roof. The roof void is lined with wooden boards and has a wooden and metal frame. There were few cobwebs within the void. Rodent droppings were scattered throughout but no evidence of bats was found. On the eastern end of the building several hip tiles have and missing and slipped. In addition, there are missing and lifted tiles on the roof and lifted lead-flashing and gaps either side of dormer windows. There is a</p> |

small area of hanging tiles on the northern side. Bargeboards, soffit boxes, dormers windows, a chimney and lead-flashing are present on the exterior of the building. This building has **moderate bat roost potential**.

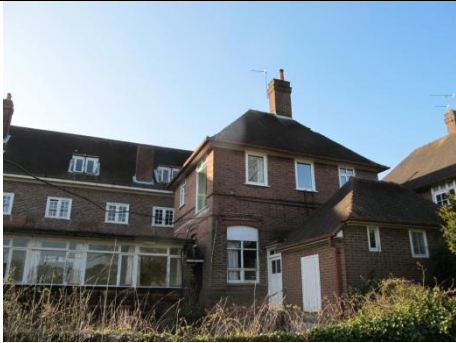
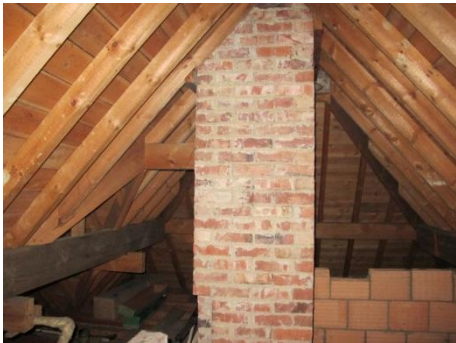
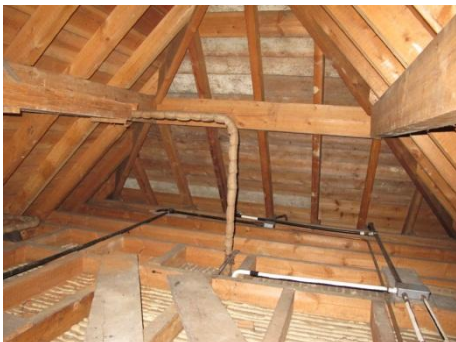
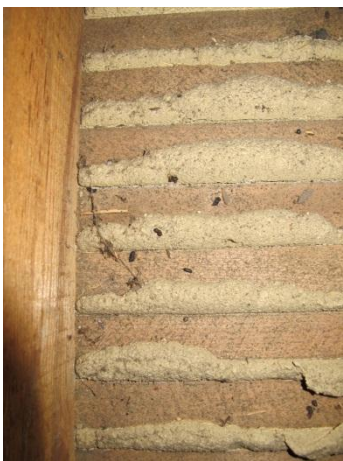
| <p><b>G</b></p> | | <p>A brick built two-storey building with a pitched, hipped, tiled roof. The roof void is open and lined with wooden boards. There are very few cobwebs. Rodent droppings from rodents were scattered throughout. There are missing and slipped hip tiles on the north and south elevations, slipped and missing tiles on the main slope of the roof and lifted lead-flashing. Bargeboards, soffit boxes and a chimney with lead-flashing are present on the exterior. This building has <b>high bat roost potential</b>. This was confirmed by the presence of bat droppings. Therefore, <b>this building is a bat roost</b>.</p> |

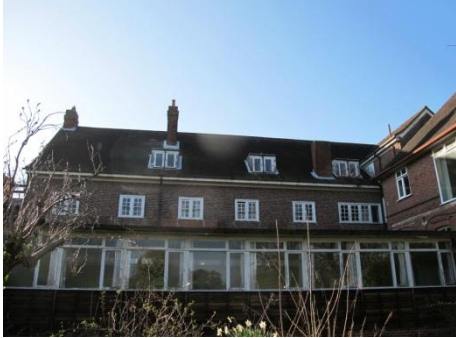
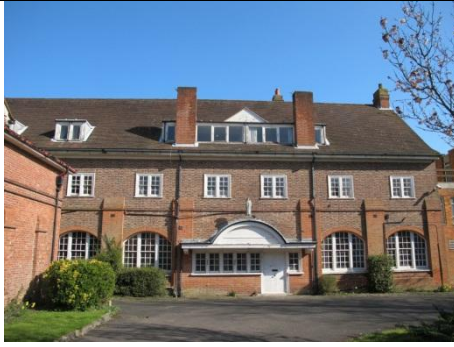
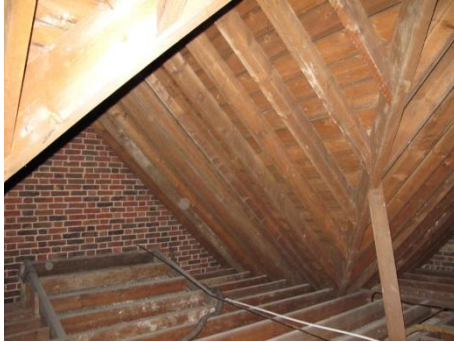
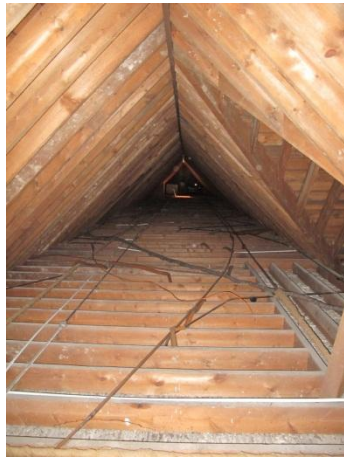
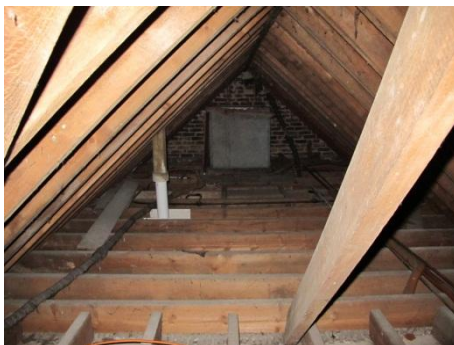
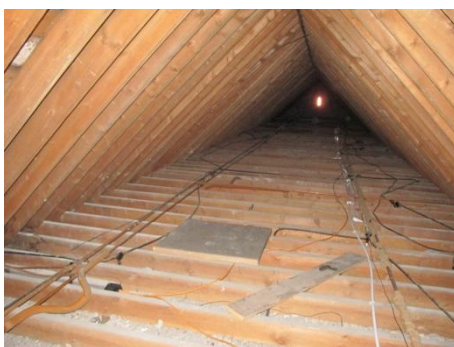
| <p><b>H</b></p> | | <p>A brick built two-storey building with a pitched tiled roof. Its roof is constructed from wooden beams with a wooden ridge and is lined with wooden boards. It has an open roof void with no insulation between the joists. Light is visible at the northern end of the void, through a large gap in the bricks (covered in wire). There are few cobwebs within the void. Rodent droppings were scattered throughout. There are several lifted and missing tiles that</p> |

could provide bat access into the roof void. Also, there are two raised ridge tiles on the southern apex of the building. In addition, there is lifted lead-flashing around the northern dormer on the western elevation and a raised tile on the inner valley of the connection between buildings H and I. There are gaps into the soffits either side of the southern gable end. This building has **high bat roost potential**. This was confirmed by the presence of bat droppings. Therefore, **this building is a bat roost**.

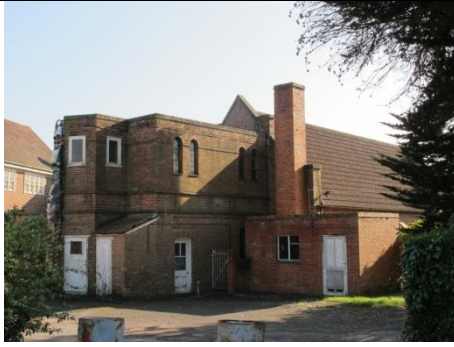
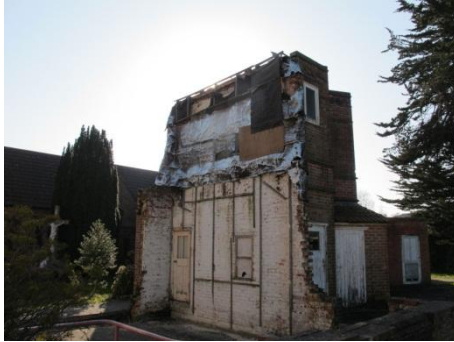
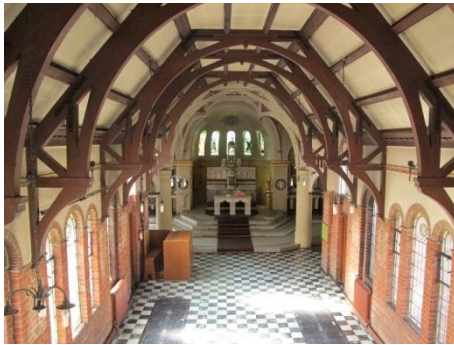
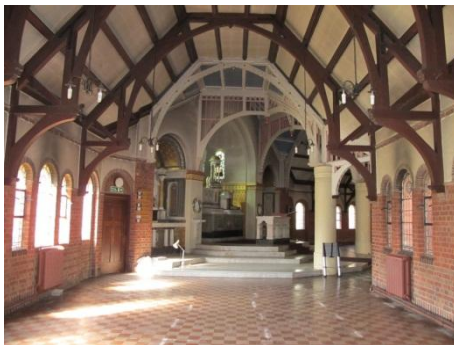
| <p><b>I</b></p> | | <p>Building I is a brick-built Victorian chapel with a pitched, tiled roof. It was not possible to access the roof void between the roof and the interior plaster of the chapel's ceiling. The exterior is well-sealed, with the exception of gaps under lead-flashing on the gable ends on the north, south and west elevations; and where a connection to the convent has been demolished (northern elevation) and there are multiple gaps into the structure (partially covered by roofing felt). There are also raised tiles on a small lean-to building attached to the chapel. This building has <b>moderate bat roost potential</b>.</p> |

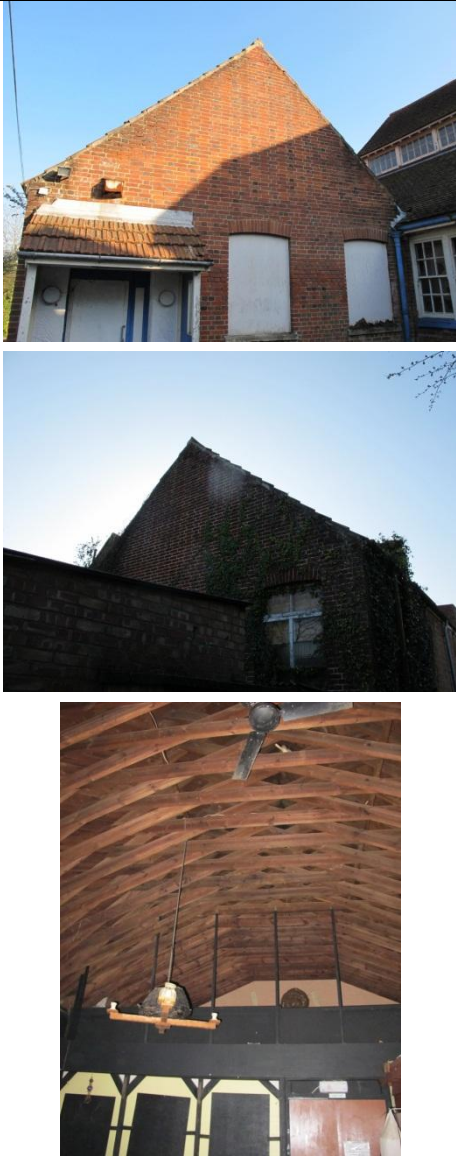
| <p><b>J</b></p> | | <p>Building J is brick-built with a pitched, tiled roof. The interior is open to the ceiling, which has a wooden ridge and is paneled with wood. Rodent droppings were scattered throughout. There are several raised tiles including ones at both gable ends where the mortar is missing beneath them. There is a small tiled porch on the western elevation with raised tiles; and bargeboards on the northern and southern elevations. This building has <b>moderate bat roost potential</b>.</p> |

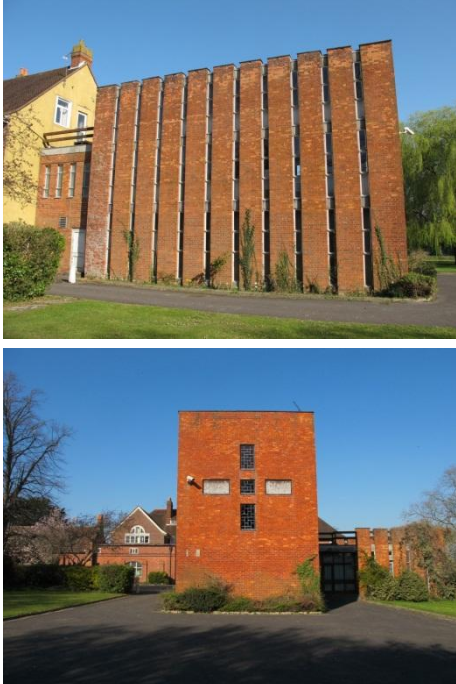
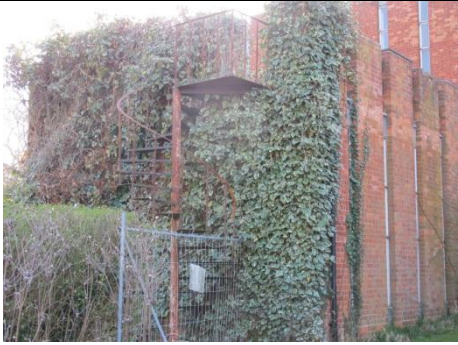
| <p><b>K</b></p> | | <p>Building K is a three-storey extension built circa 1960. The building is made from brick, with a flat roof and lead-flashing. The climber <i>Hedera helix</i> (Ivy) covers the eastern elevation on the ground floor. Some of the brickwork on the western elevation has crumbled and created a gap behind the lead-flashing. This building has <b>low to moderate bat roost potential</b>.</p> |

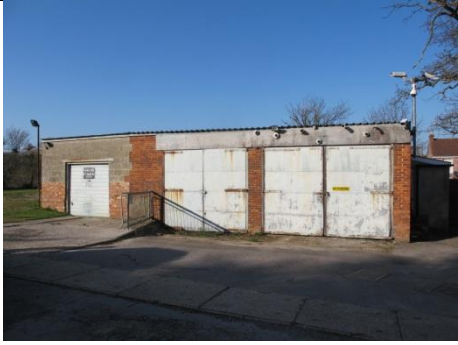
| <b>L</b> | | Building L is a single-storey, flat roofed garage. It is brick-built with a sheet metal roof. It appears well-sealed. It has <b>low bat roost potential</b> . |

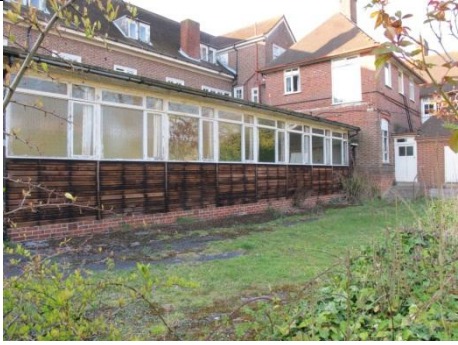
| <b>M</b> | | Building M is a single-storey, flat roofed extension to building H. It is constructed of wood and glass, with a felt roof. The exterior is wooden cladded, although this appears to be well-sealed. It has <b>low bat roost potential</b> . |

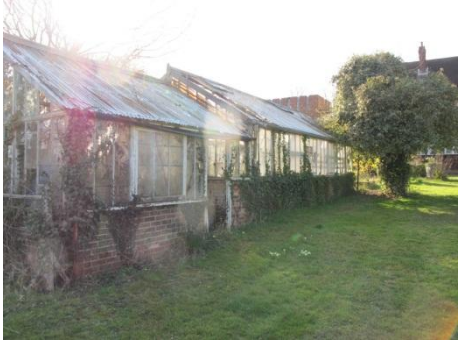
| <b>N</b> | | Building N is a single-storey disused greenhouse. Several of the glass panes are broken, and the interior is filled with <i>Rubus fruticosus</i> agg. (Bramble). It has <b>negligable bat roost potential</b> . |

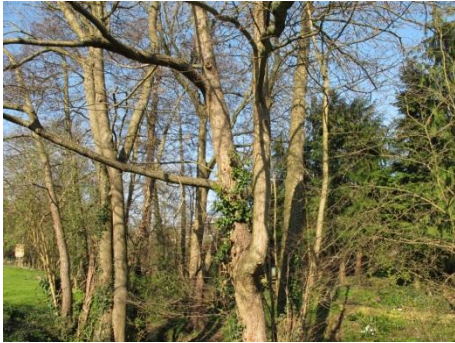
*Photo 17. A Fraxinus excelsior (Ash) tree with a hole on the southern elevation by the Hermitage Stream.*

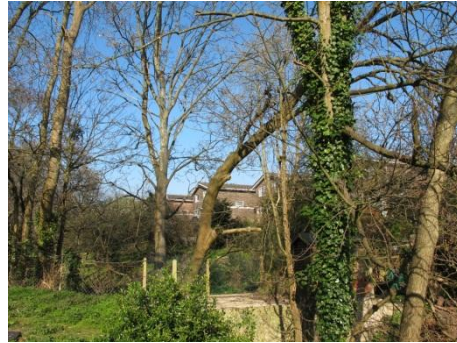
*Photo 18. Hole in the southern elevation of a Fraxinus excelsior (Ash) tree in the north-east corner of the site, by the Hermitage Stream.*
