**Cunningham Lindsey**

52, Hulbert Road

**INSURANCE CLAIM****CONCERNING SUBSIDENCE DAMAGE****ENGINEERING APPRAISAL REPORT**

# **FACTUAL REPORT OF INVESTIGATION**

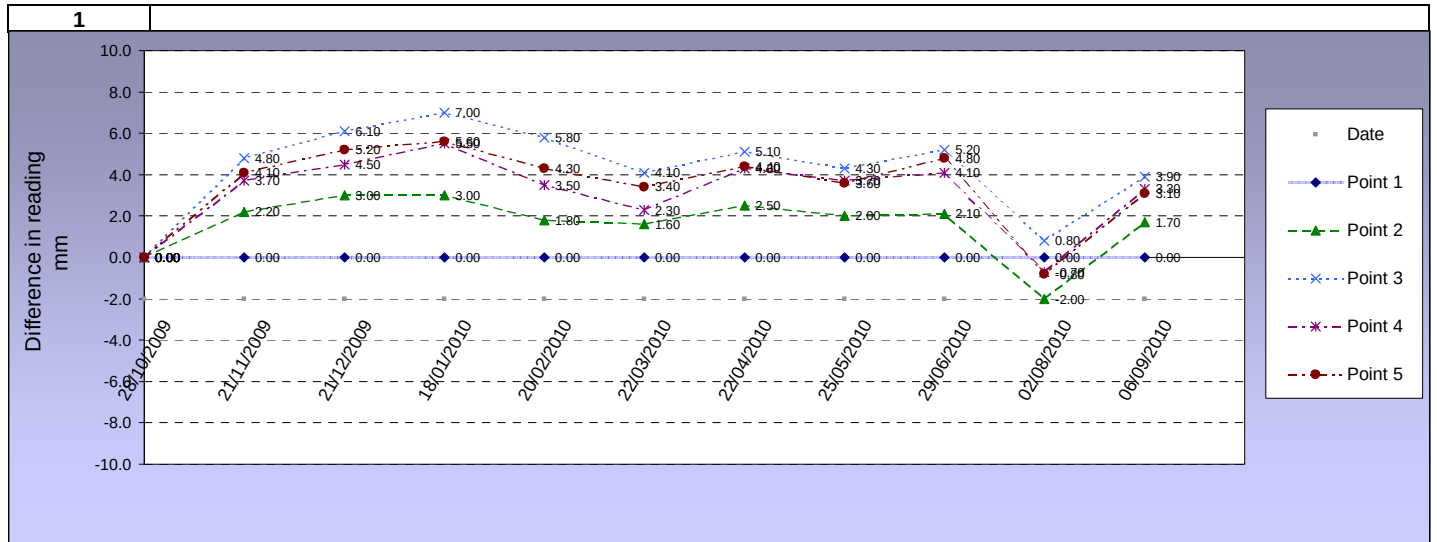
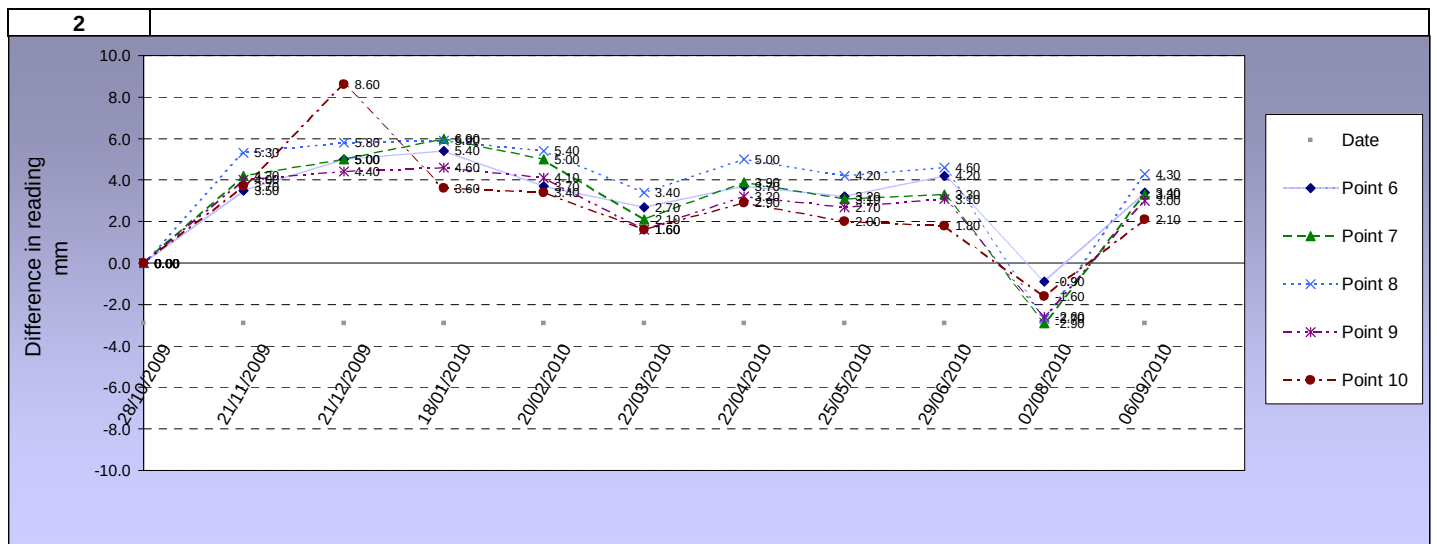
In summary, the results to date show soil recovery following the commencement of the levelling with a period of general stability until subsidence from June to August. The latest monitoring shows some degree of recovery again corresponding with the recent rain. The degree of both subsidence and recovery is quite consistent across the rear.

Chart is displaying Subsidence

Point labels give level difference of last reading from original datum in mm.
