# Langstone Flood & Coastal Erosion Management Scheme

## Factual Report on Ground Investigation

Project No: 736036

Client: Havant Borough Council

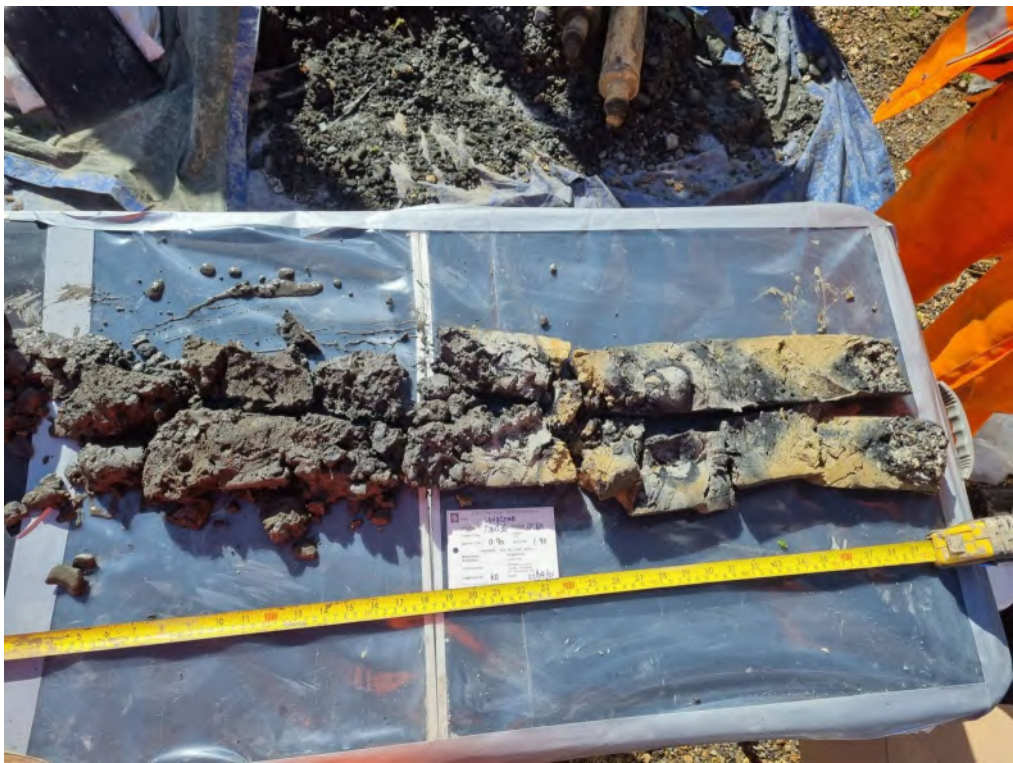
Run 1: 0.90 - 1.90 m.

Run 2: 1.90 -2.90 m.
