**Road Safety Audit Stage 1**

**Section 278 Works**

**North Street**

**Emsworth**

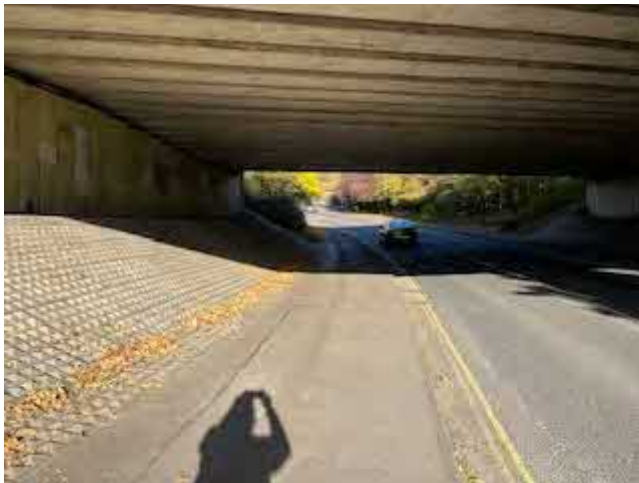
Figure 1: Crossing point after underpass.

**Location:** Proposed western crossing point.

**Summary:** Pedestrians crossing from a dark area could lead to sudden braking and rear end shunt collisions, or vehicle to pedestrian collisions.

North Street curves as it goes through the underpass, where road users could be emerging from dark to light conditions, in addition the underpass lighting is only on the eastern side. Road users may suddenly encounter a pedestrian crossing from a dark area – see figure 1 below. This could lead to sudden braking and rear end shunt collisions, or vehicle to pedestrian collisions.

It is recommended that a suitable lighting should be provided to illuminate pedestrians.

| Item No. | RSA Problem | RSA Recommendation | Design Organisation Response | Auditors Response | Overseeing Organisation Response | Agreed RSA Action |
|---|---|---|---|---|---|---|
| 3.4.2 | Pedestrians crossing from a dark area could lead to sudden braking and rear end shunt collisions, or vehicle to pedestrian collisions. | It is recommended that a suitable lighting should be provided to illuminate pedestrians. | <b>AGREE.</b><br>Lighting is currently provided on the underside of the bridge. A review of its suitability will be undertaken at the detailed design stage. | Noted and accepted. | | |

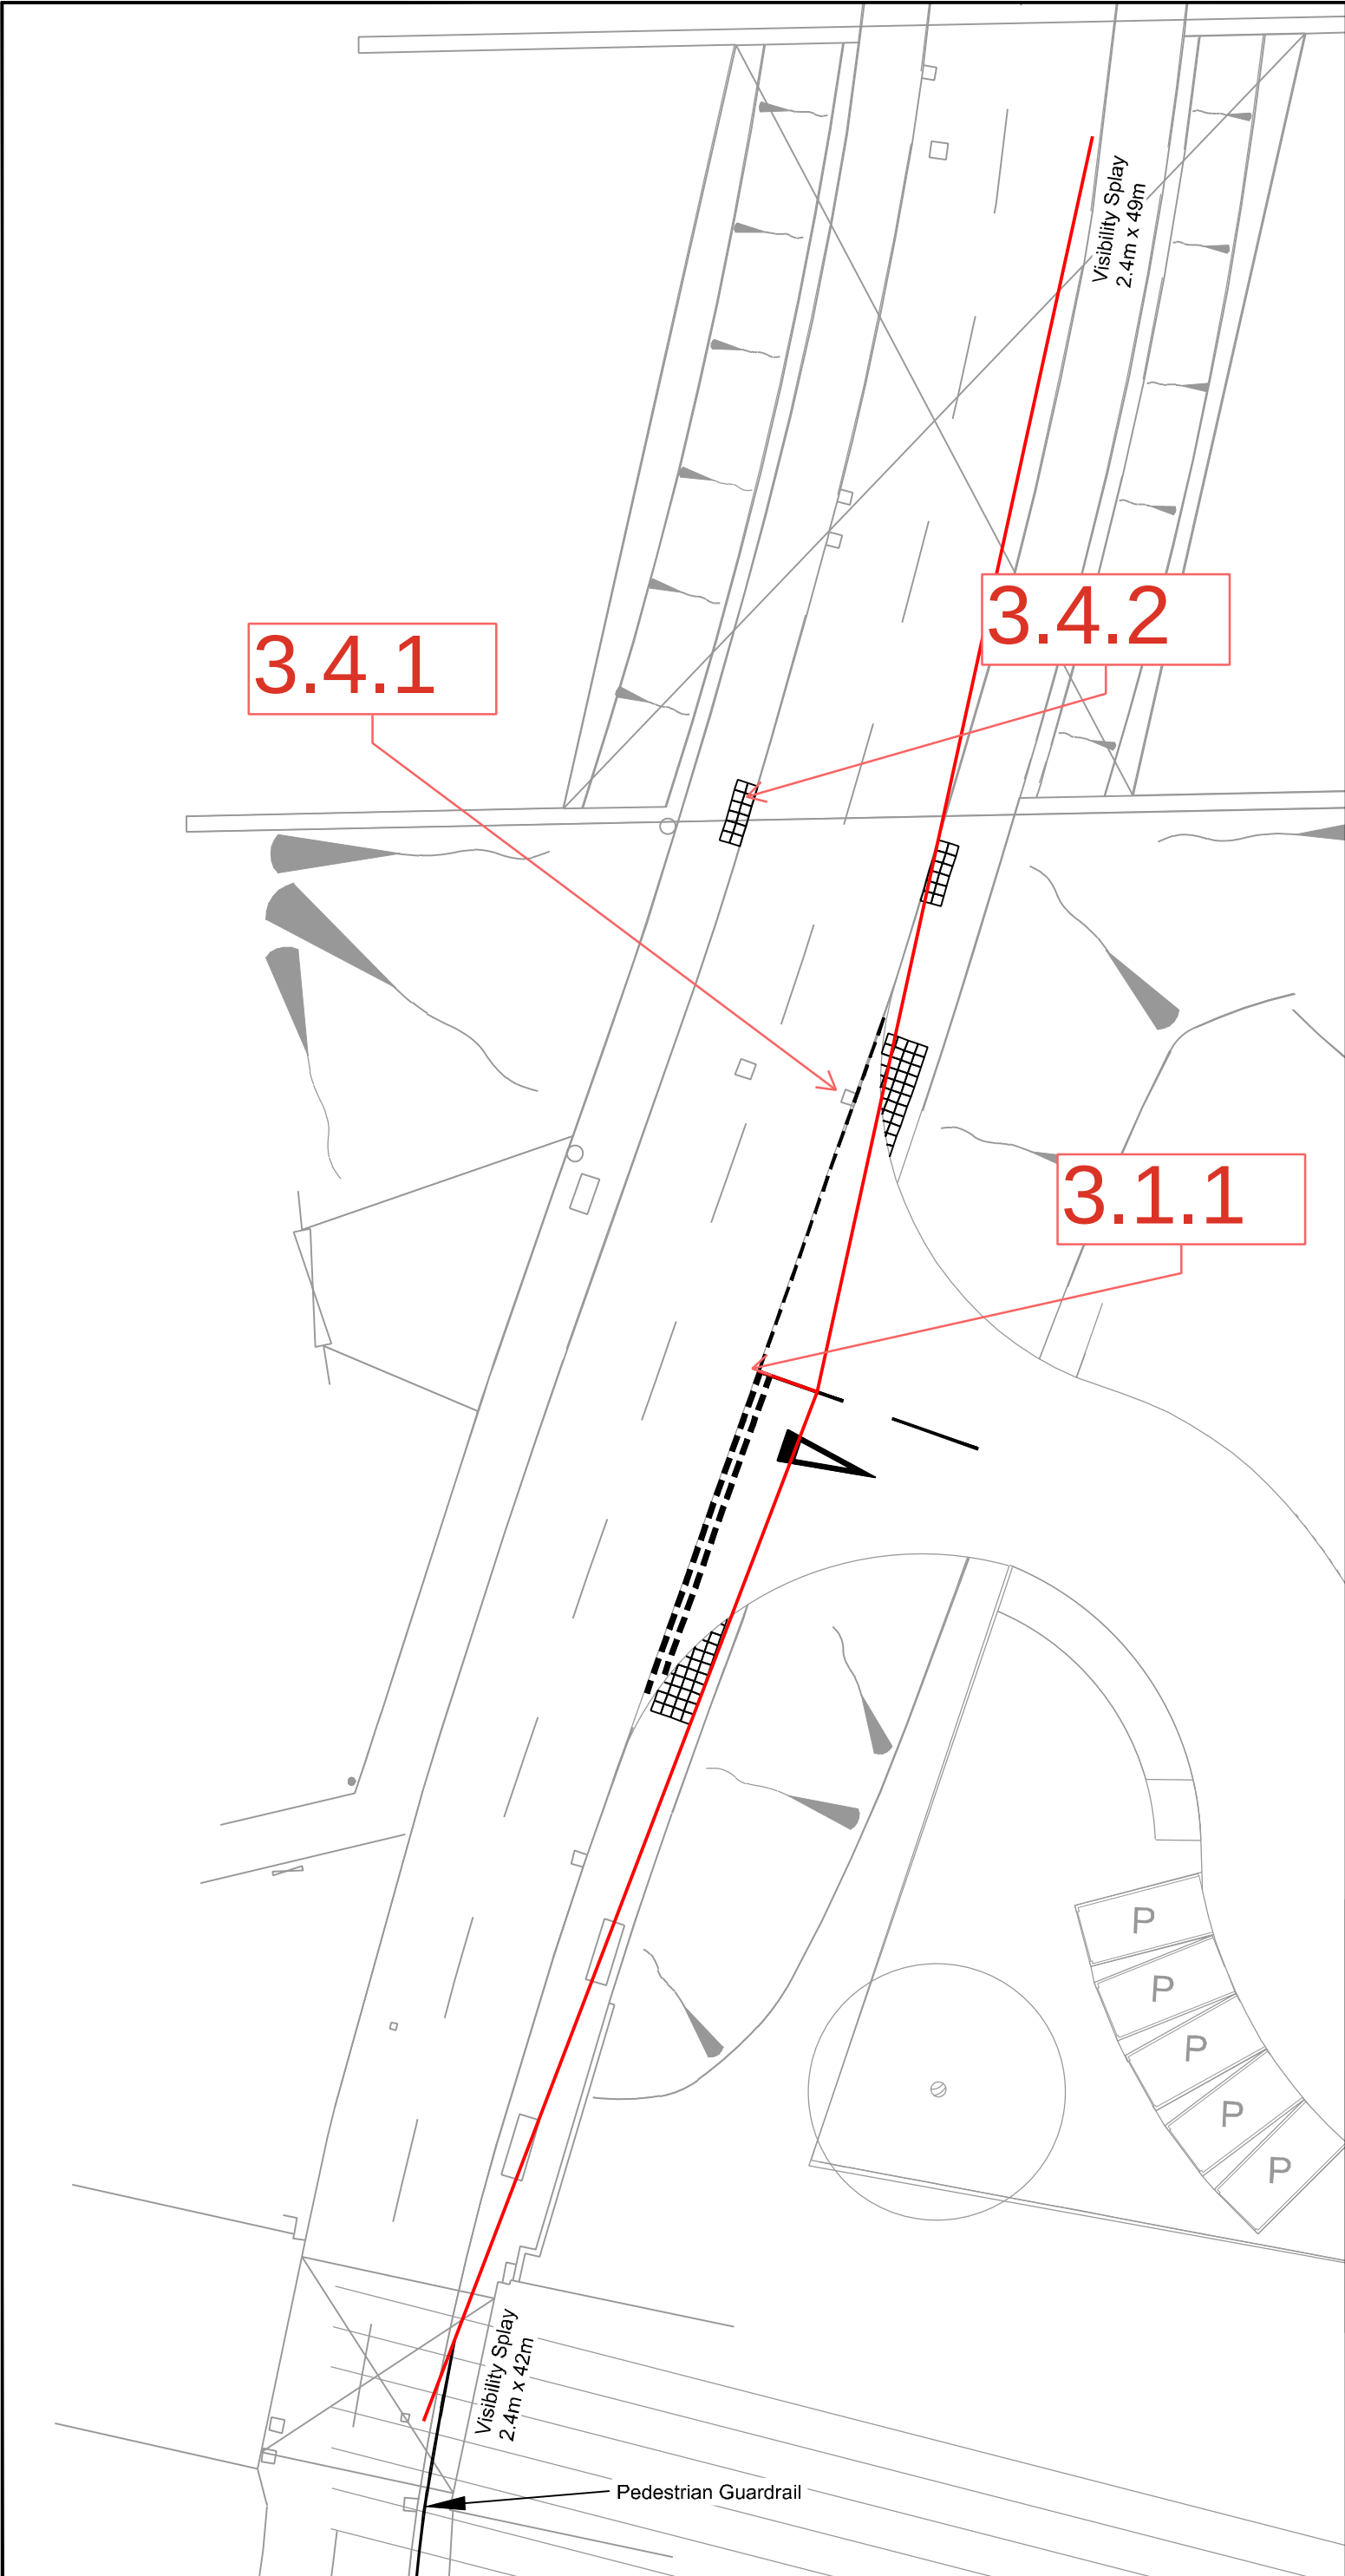
Access Visibility

Plan attached showing the locations of the problems identified as part of this audit (location numbers refer to paragraph numbers in the report).

Visibility taken to 300mm from kerbs as per HCC TG3

Speeds -  
Northbound: 29.5mph  
Southbound: 33mph

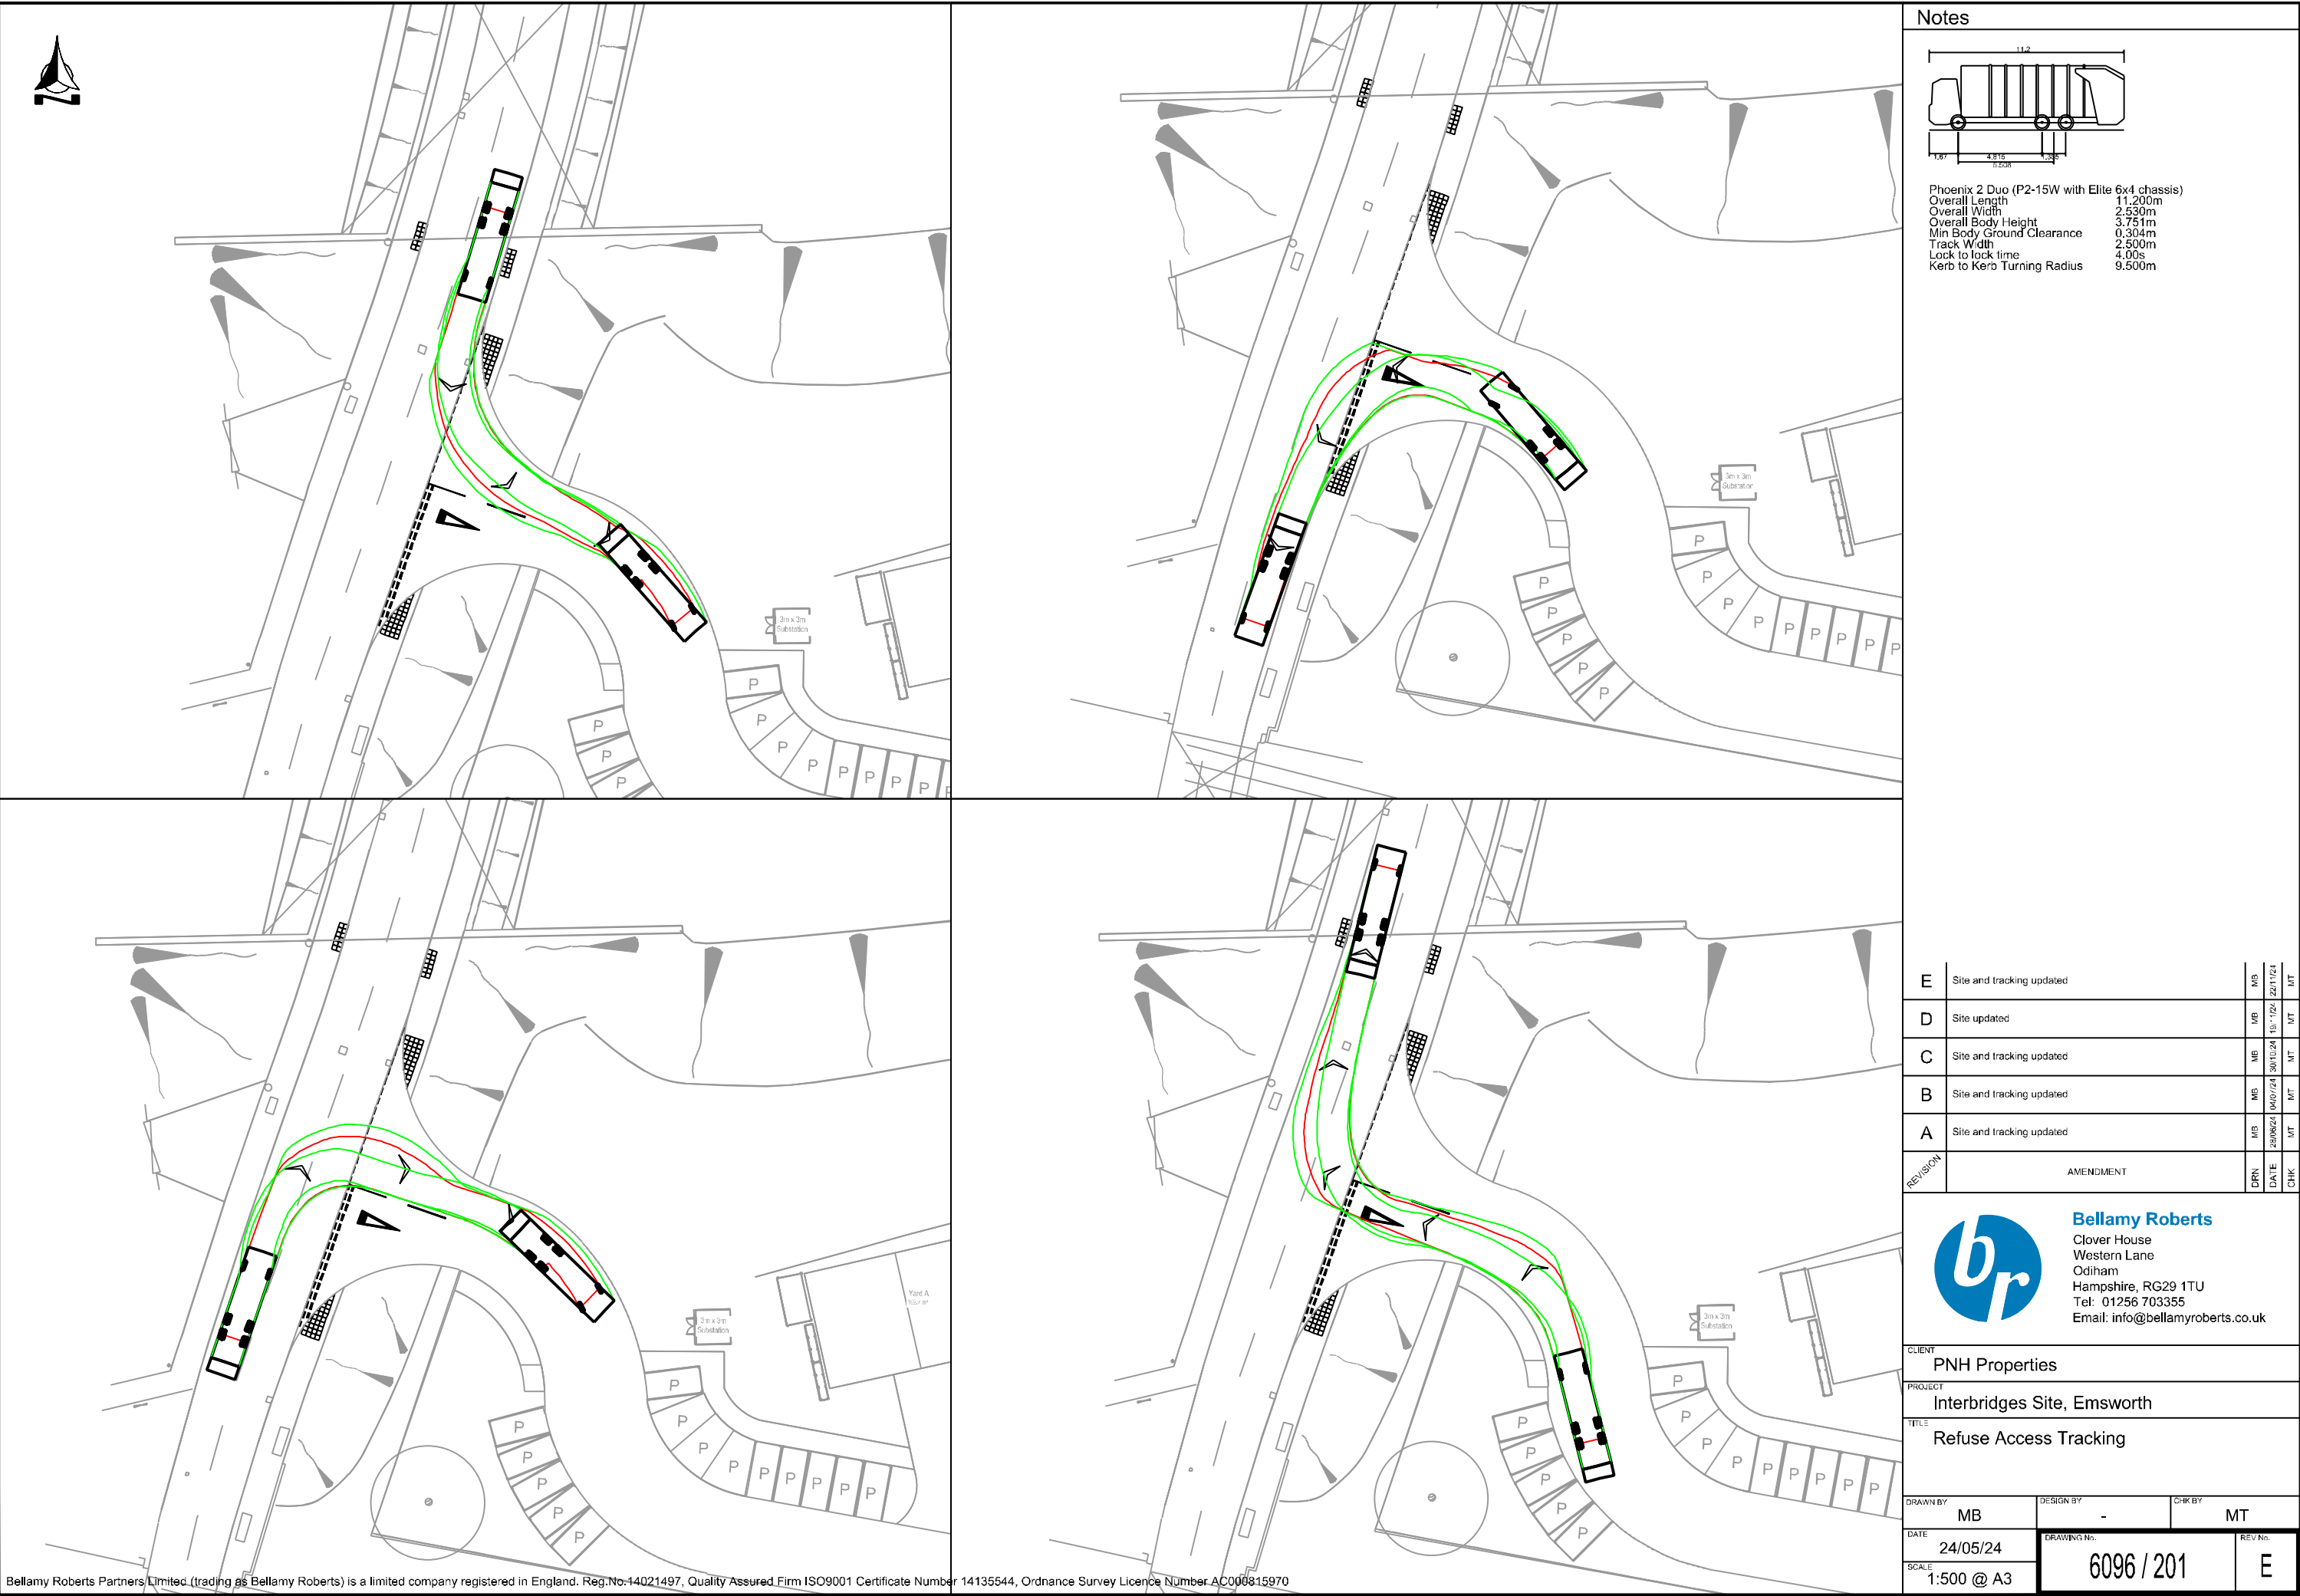
| TITLE | Refuse Access Tracking | | |

Phoenix 2 Duo (P2-15W with Elite 6x4 chassis)  
Overall Length 11.200m  
Overall Width 2.530m  
Overall Body Height 3.751m  
Min Body Ground Clearance 0.304m  
Track Width 2.500m  
Lock to lock time 4.00s  
Kerb to Kerb Turning Radius 9.500m

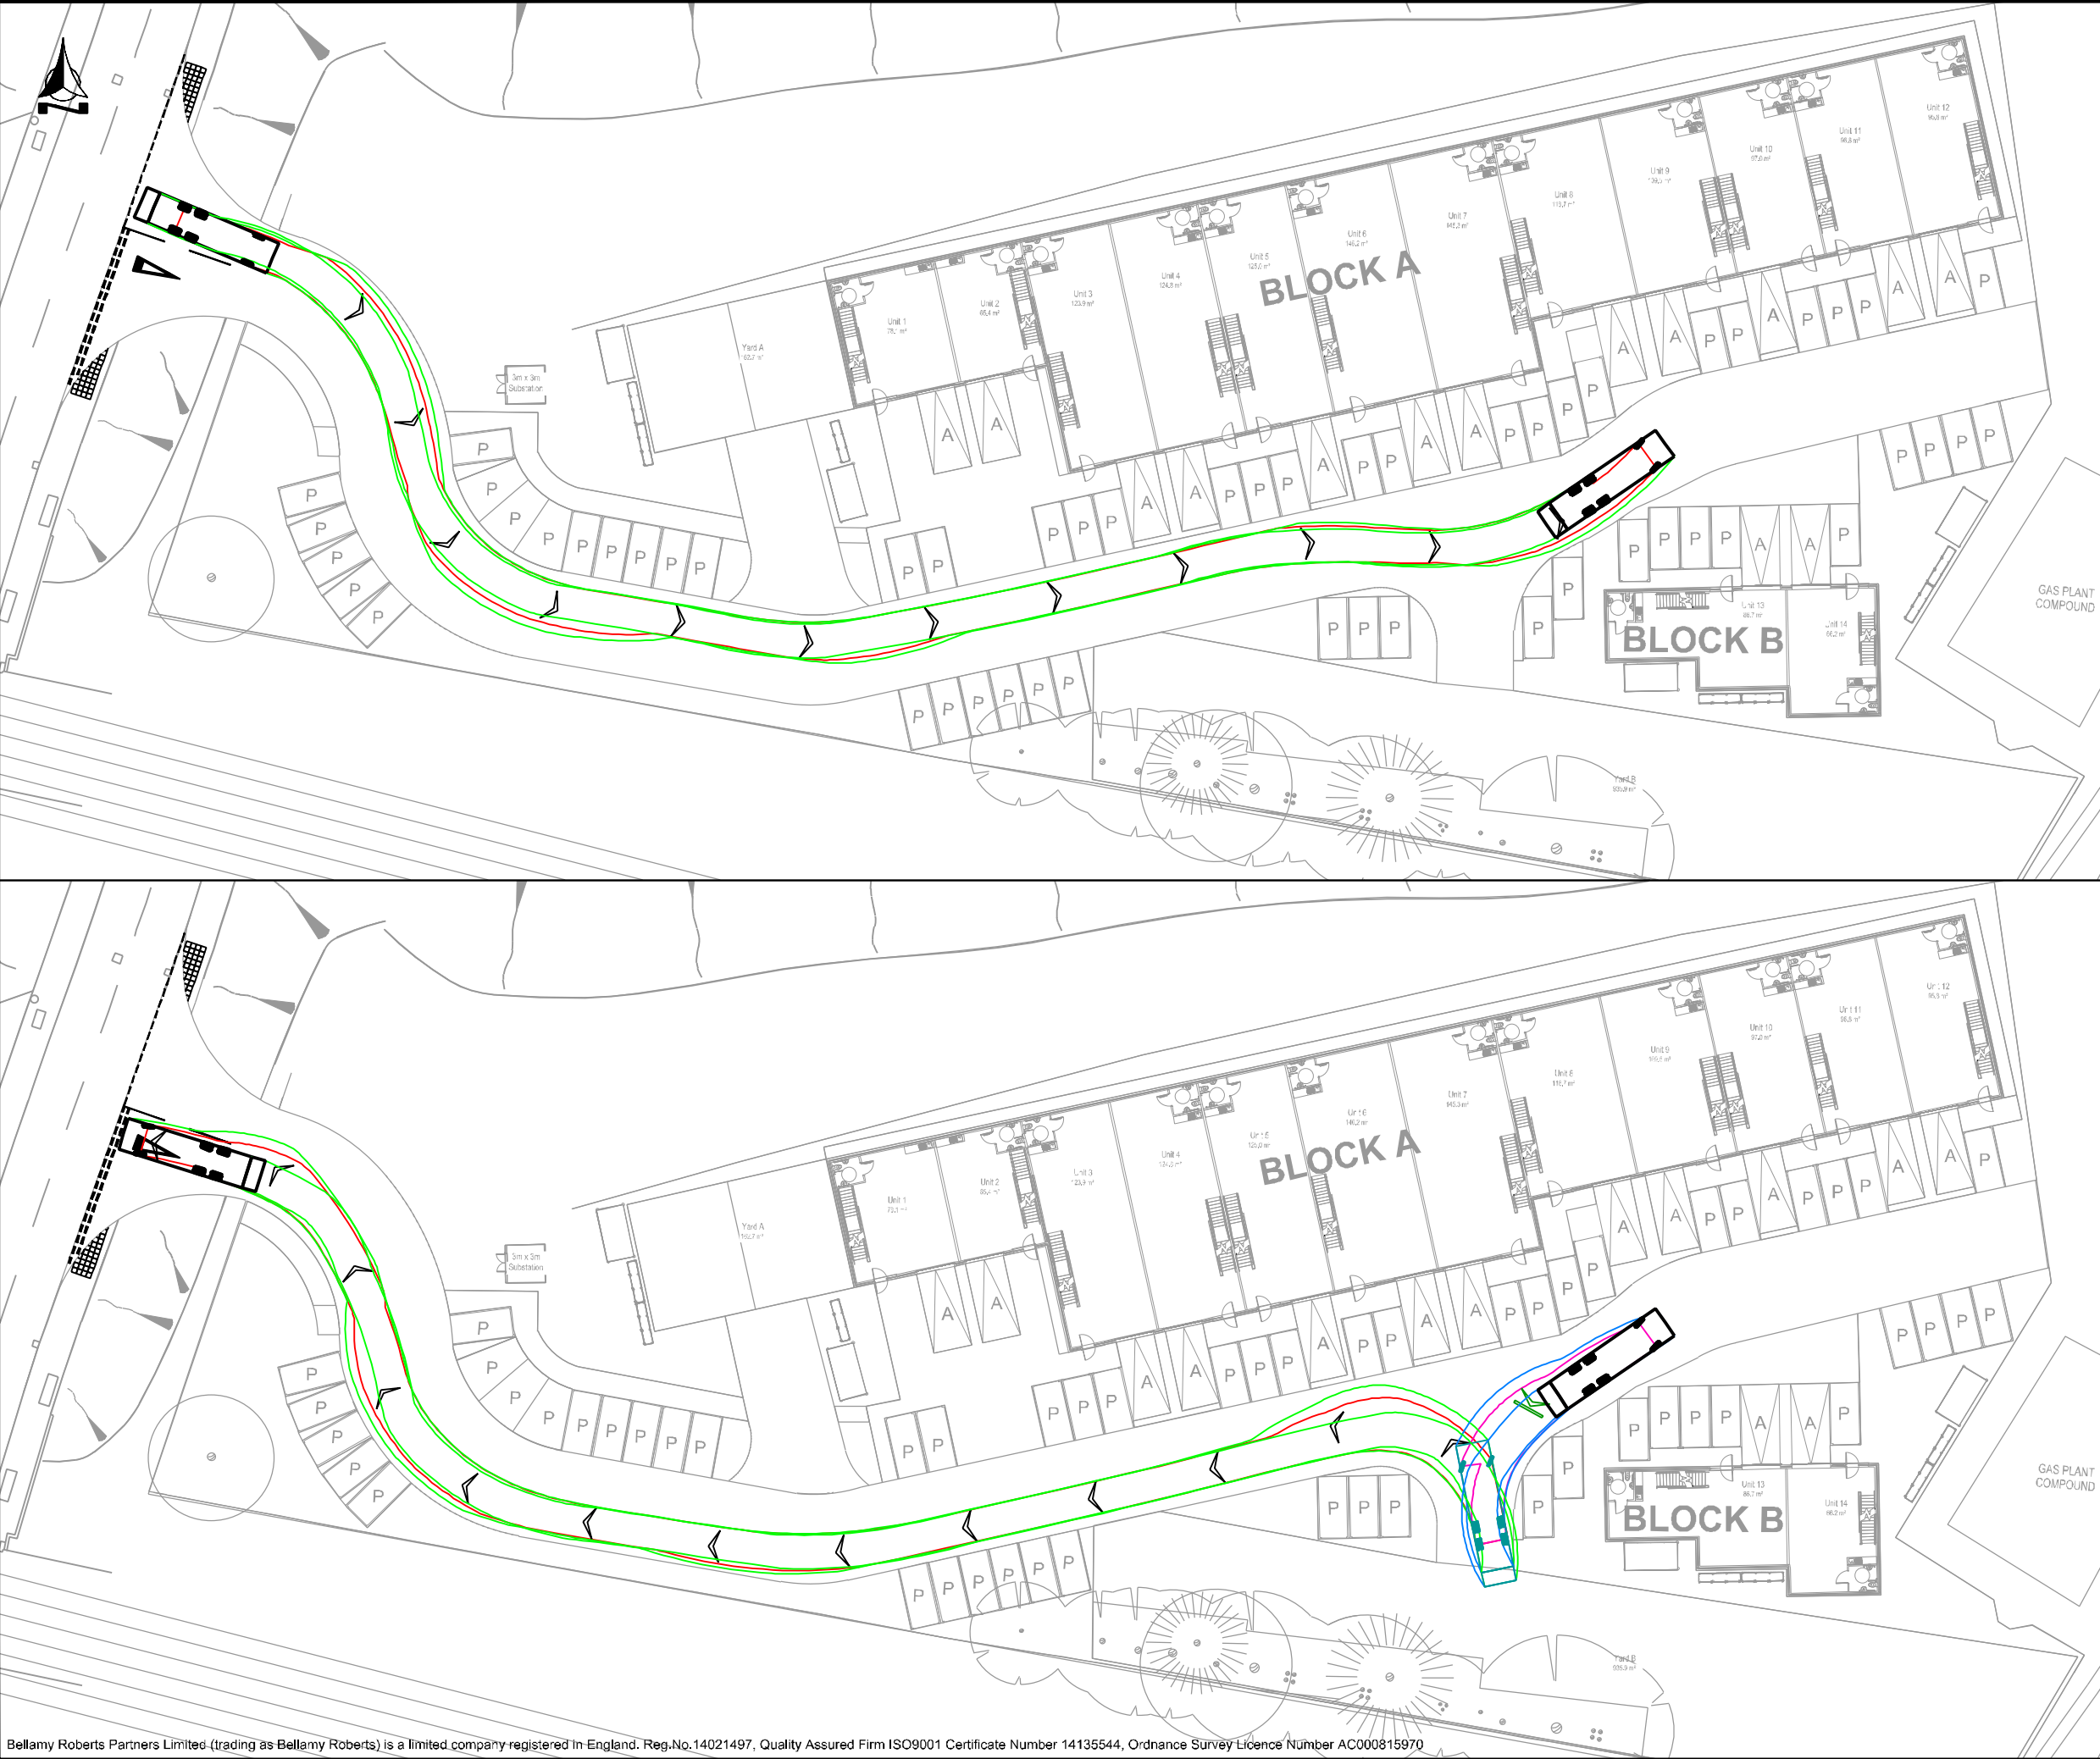
| TITLE | Refuse Internal Tracking |

Phoenix 2 Duo (P2-15W with Elite 6x4 chassis)  
Overall Length 11.200m  
Overall Width 4.800m  
Overall Body Height 2.530m  
Min Body Ground Clearance 0.304m  
Track Width 2.500m  
Lock to lock time 4.00s  
Kerb to Kerb Turning Radius 9.500m

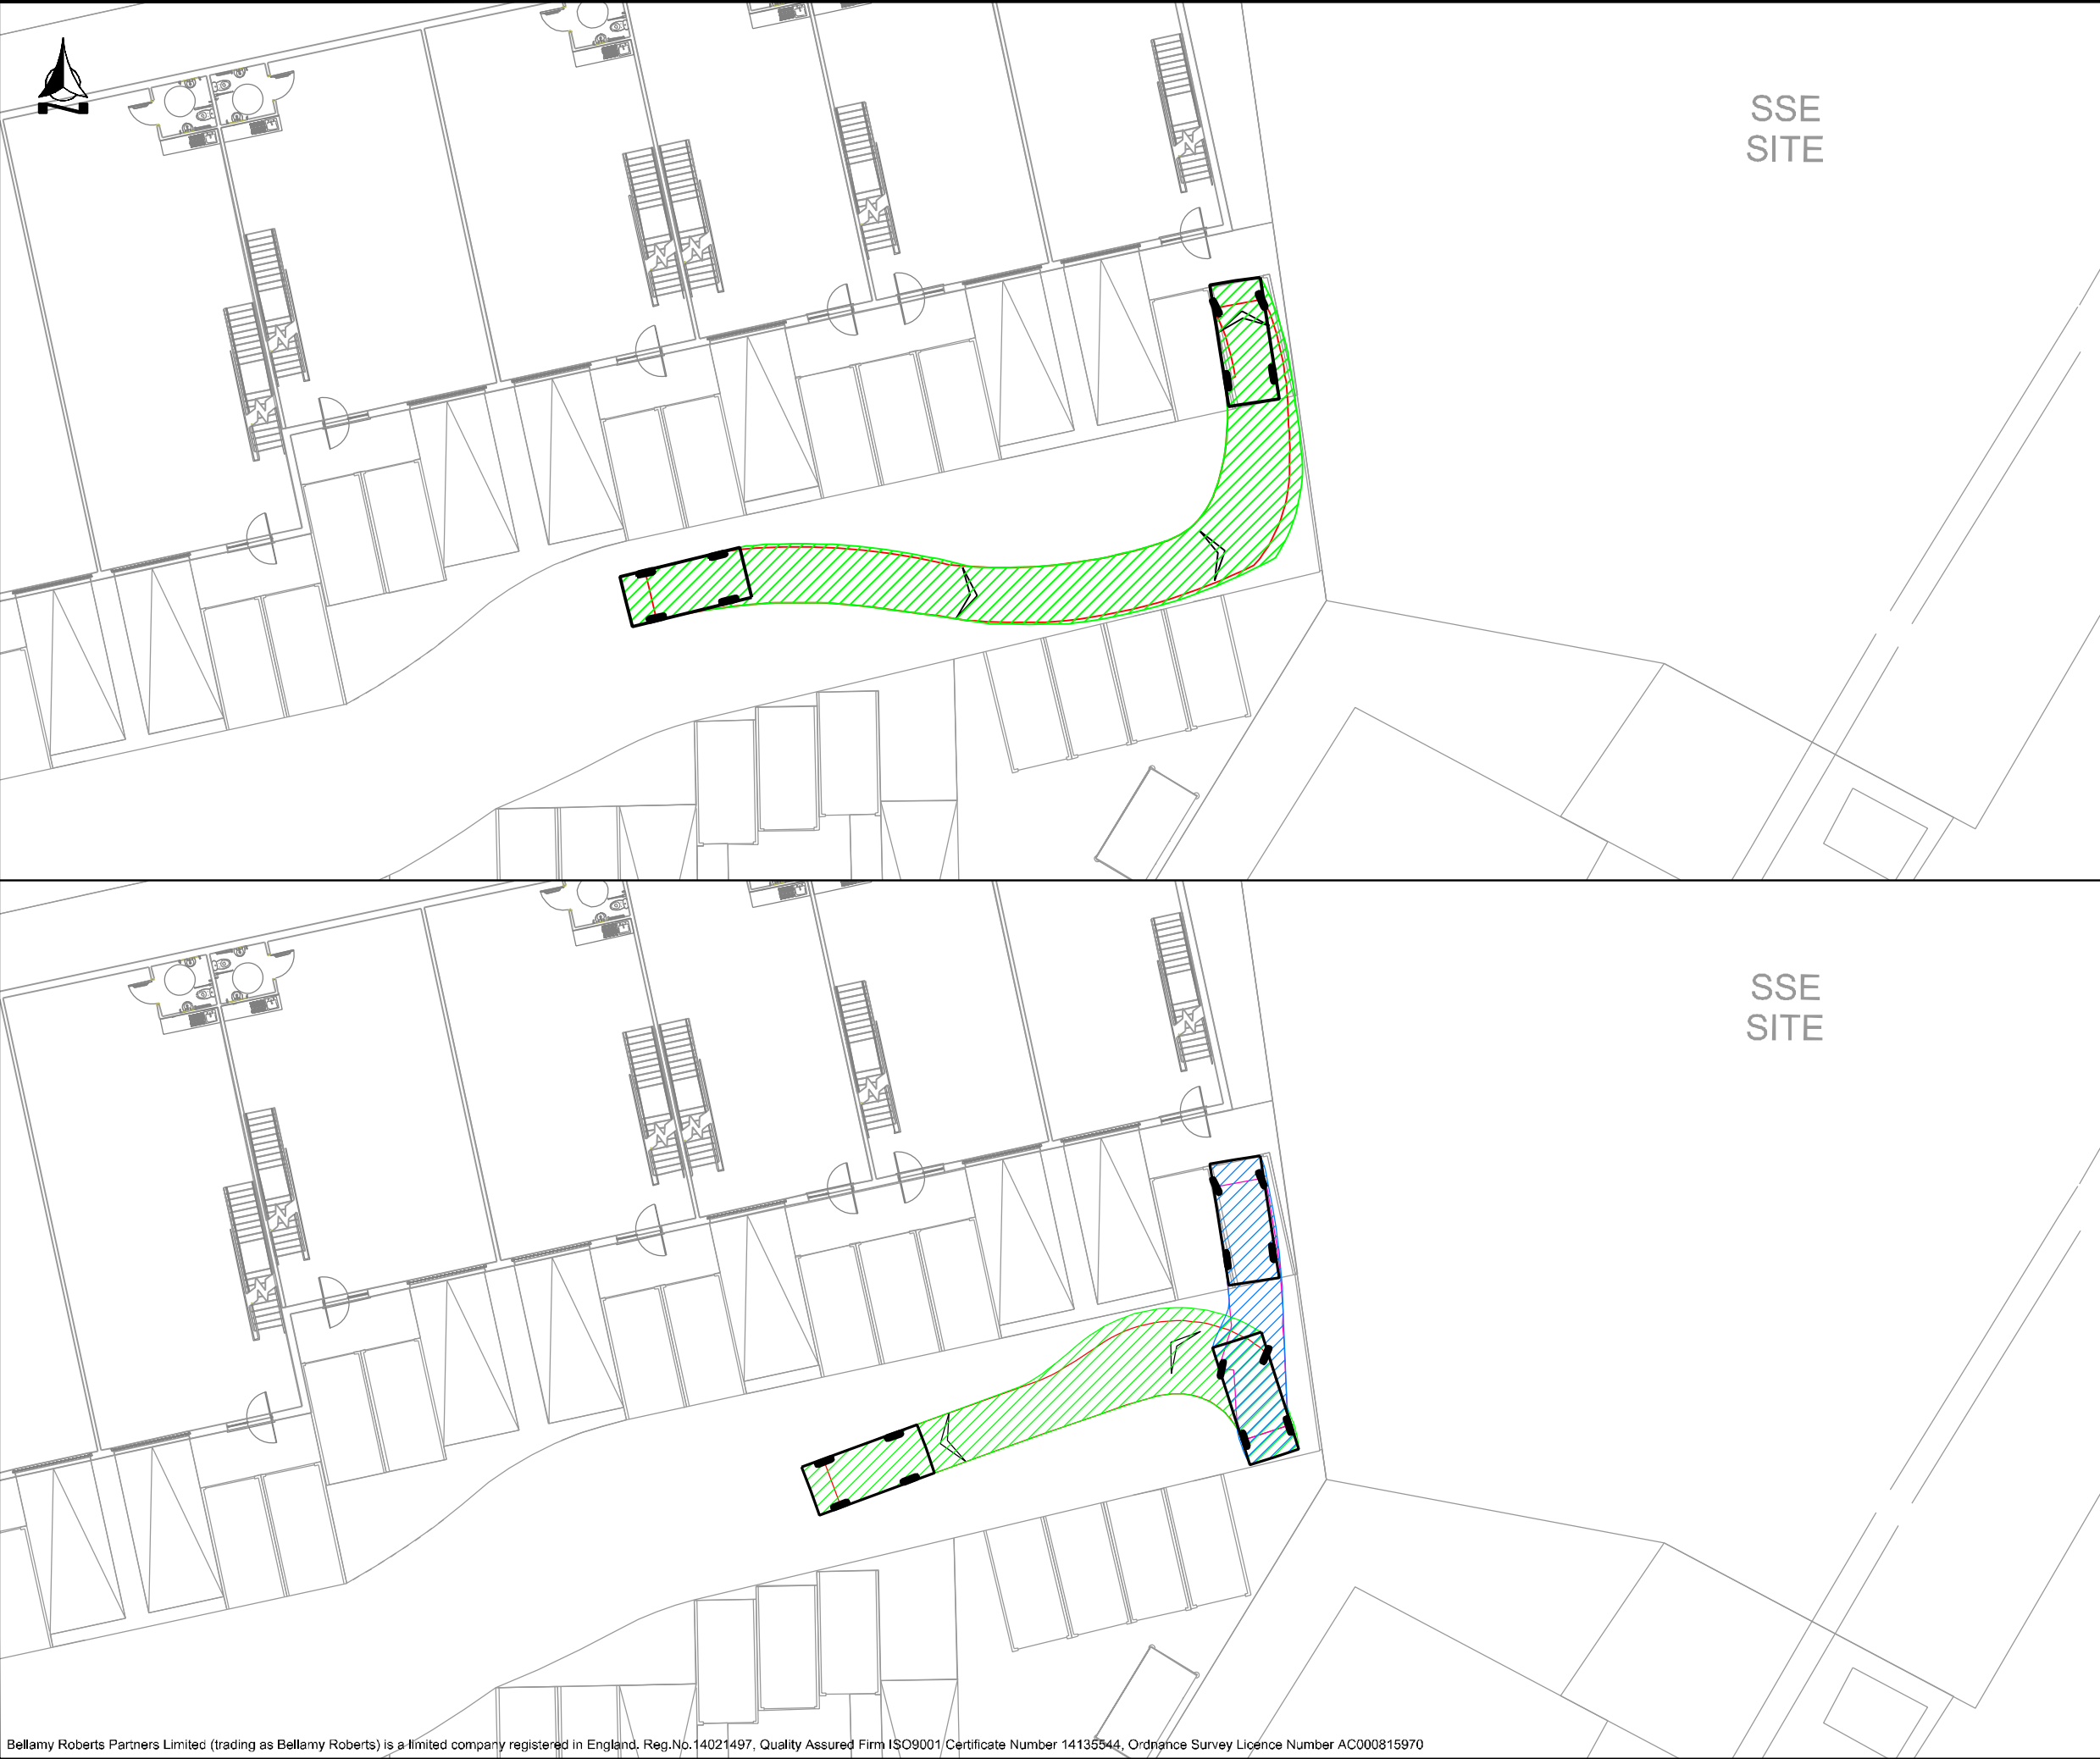
| TITLE<br>Car Parking Tracking | | |

Standard Design Vehicle (SDV)  
Overall Length 4.800m  
Overall Width 2.000m  
Overall Body Height 1.950m  
Min Body Ground Clearance 0.100m  
Track Width 2.300m  
Lock to lock time 4.00s  
Wall to Wall Turning Radius 6.000m
