## Preliminary Ecological Appraisal

Southfield House, 366, London Road, Waterlooville, Hampshire PO7 7SY

The split of existing flat no.7 and development of existing conservatory into a single storey extension.

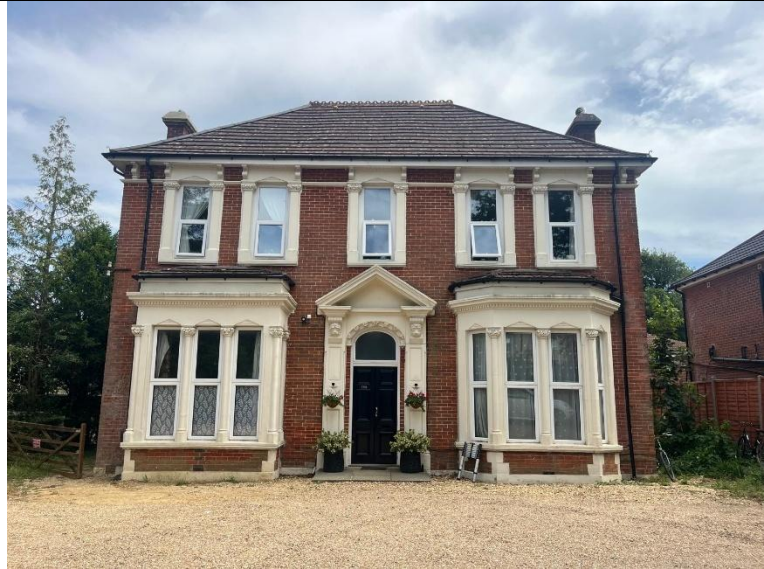
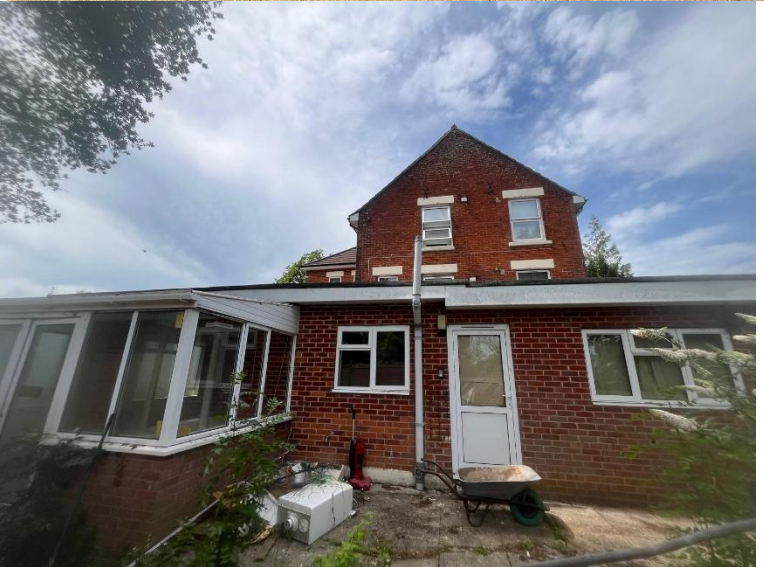
| <i><b>B1 Building description</b></i> | <i><b>Photographs</b></i> |
|---|---|
| <p><i><b>Summary</b></i></p> <p>B1 is a two storey brick-built building, with hipped and gabled tile roof. The roof appears in excellent condition throughout. A single storey flat roof section is located to the rear of the building with a brick based conservatory.</p> <p>Only the single storey section on the south-eastern elevation will be impacted by the proposed works.</p> <p>No evidence of bats was found externally during the survey.</p> <p>The building has <b>negligible habitat value</b> for roosting bats.</p> | |

| Foreseen Impacts | <p><b>Roosting habitat [Buildings]</b><br/>Bats are very unlikely to be roosting within this building and as such, there are not anticipated to be any impacts on bats in this location as a result of the proposed development.</p> <p><b>Roosting habitat [Trees]</b><br/>None foreseen.</p> <p><b>Foraging and commuting habitat</b><br/>The proposed development will not result in the removal of any habitats which could be used by foraging or commuting bats. However, the proposed development will include the use of lighting which could spill on to bat roosting, foraging or commuting habitat and deter bats from using these areas.</p> <p><b>Artificial lighting</b><br/>The proposed development may lead to an increase in the amount of current lighting of surrounding habitats or the retained building without mitigation. This may disturb commuting bats.</p> | | |

| <i>Recommendations</i> | <p><b>Roosting habitat [Trees]</b><br/>In the unlikely event that a bat or evidence of bats is discovered during the development all work must stop and a bat licensed ecologist contacted for further advice.</p> <p><b>Foraging and commuting habitat</b><br/>No further surveys are required.</p> <p><b>Artificial lighting</b><br/>A low impact lighting strategy will be adopted for the site during post-development which outlines the areas of the site that will be retained as dark corridors. Parameters can be found on the Bat Conservation Trust website: <a href="https://www.bats.org.uk/our-work/buildings-planning-and-development/lighting-2">https://www.bats.org.uk/our-work/buildings-planning-and-development/lighting-2</a></p> <p><b>Suggested biodiversity enhancements</b><br/>The installation of one bat box at the site will provide additional roosting habitat for bats.<br/>The bat boxes will be incorporated onto the existing dwelling. They will be suitable for pipistrelles (which have been identified locally through EPSL data). Suitable bat boxes include Habitat Bat Box, Ibstock Enclosed Bat Box or similar alternative brand.<br/>Bat boxes should be positioned 3-5m above ground level facing in a south or south-westerly direction with a clear flight path to and from the entrance, away from artificial light.</p> |

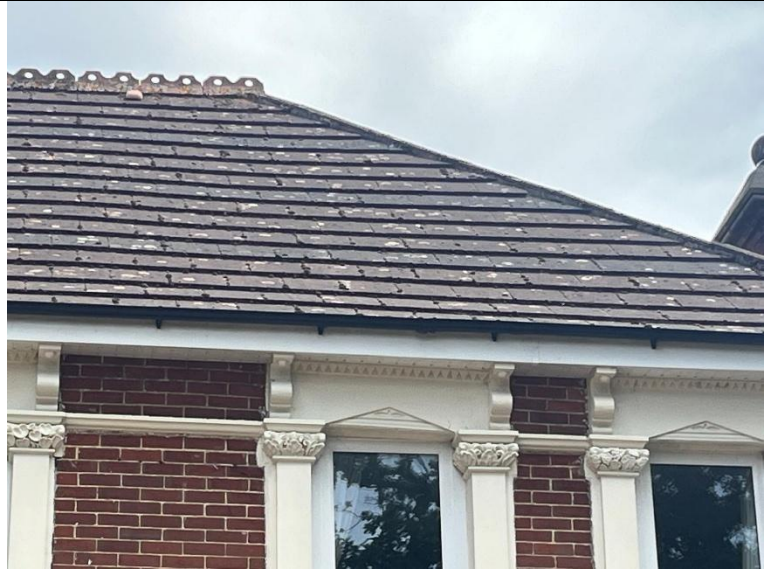
| Feature | Materials | Condition/description/suitability | Photographs |
|---|---|---|---|
| Roof | Clay | <p><b>Condition/description</b><br/>Roof tiles appear in good condition, fitting flush to one another with no gaps identified underneath.</p> <p><b>Suitability/access/evidence of bats</b><br/>No gaps that could provide roosting opportunities for crevice dwelling bats, or access into the roof structure.</p> | |

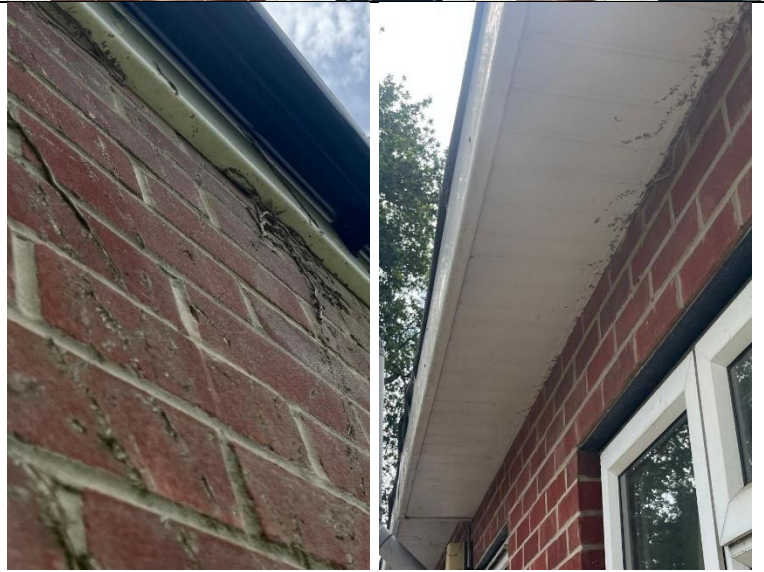
| Feature | Materials | Condition/description/suitability | Photographs |
|---|---|---|---|
| Barge boards/fascia boards | uPVC | <p><b>Condition/description</b><br/>uPVC soffit boards are present under the eaves, and these appeared in good condition and were tight fitting against the brickwork with no gaps.</p> <p><b>Suitability/access/evidence of bats</b><br/>No gaps that could provide roosting opportunities for crevice dwelling bats, or access into the roof structure.</p> | |

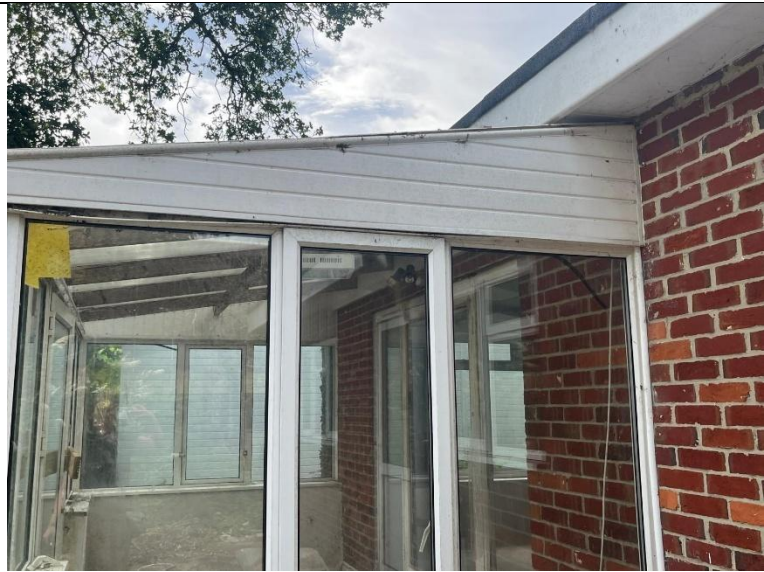
| Conservatory | Brick, uPVC | <p><b>Condition/description</b><br/>The conservatory is well sealed and appears in excellent condition.</p> <p><b>Suitability/access/evidence of bats</b><br/>No gaps that could provide roosting opportunities for crevice dwelling bats.</p> | |

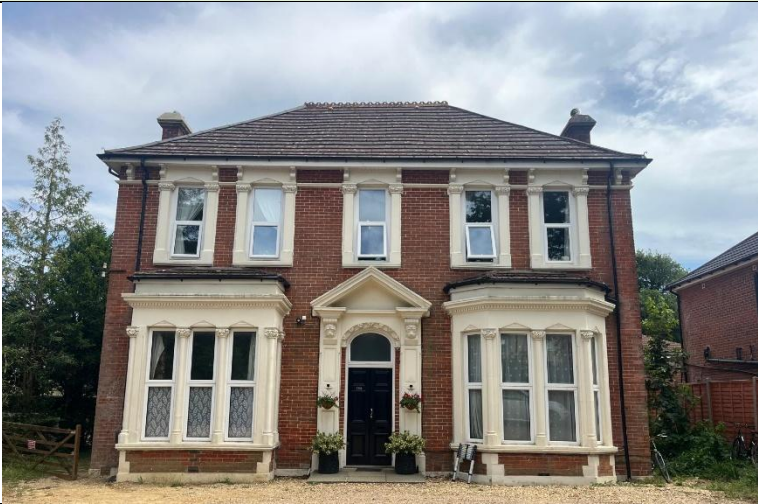
| Buildings | |
|---|---|
| | Figure 1: Main dwelling (B1) on site |

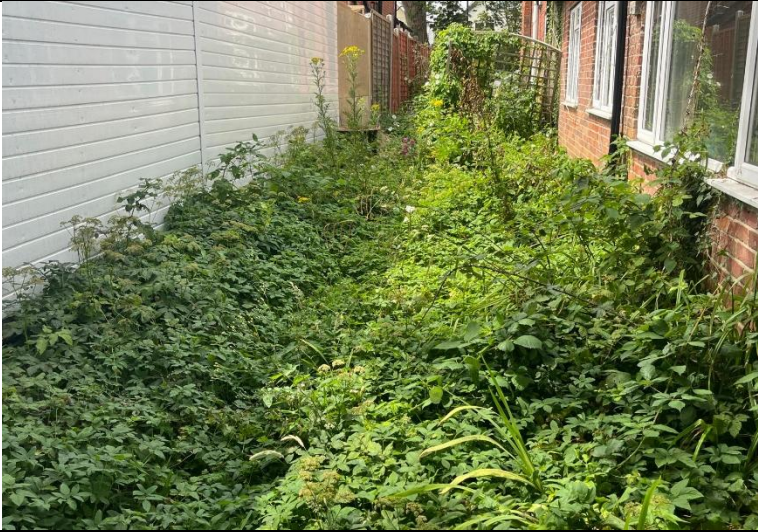
| Buildings | |
|---|---|
| | Figure 2: Unmanaged ruderals on site |

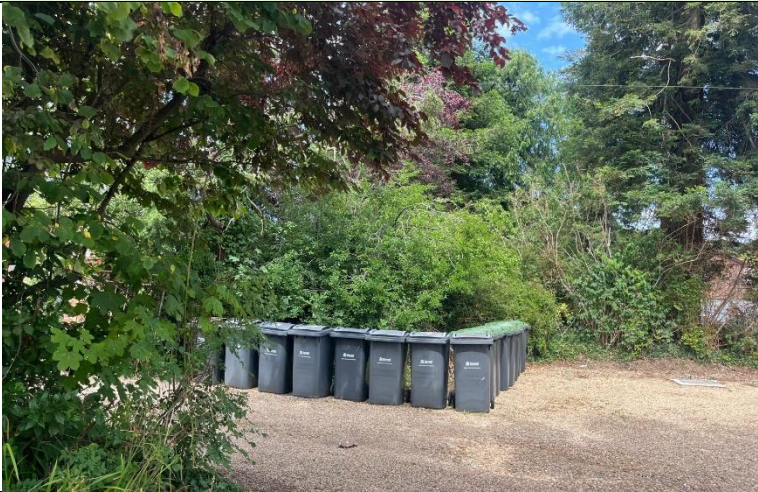
| Scattered trees | |
|---|---|
| | <p>Figure 3: Scattered trees present on site</p> |

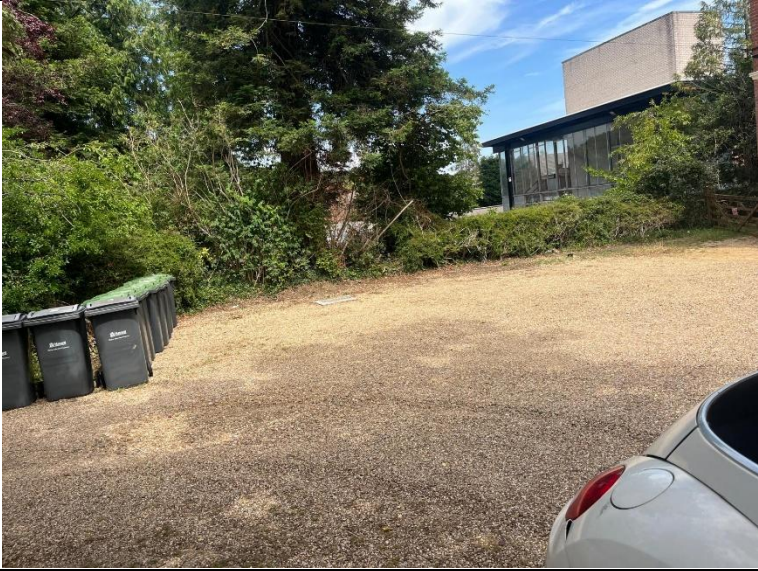
| Scattered trees | |
|---|---|
| | <p>Figure 4: Hedgerow along northern site boundary</p> |
