**41 North Shore,  
Hayling Island,  
PO11 0HN**

**PHASE 1 BAT SURVEY  
(Provisional roost assessment)**

**April 2025**

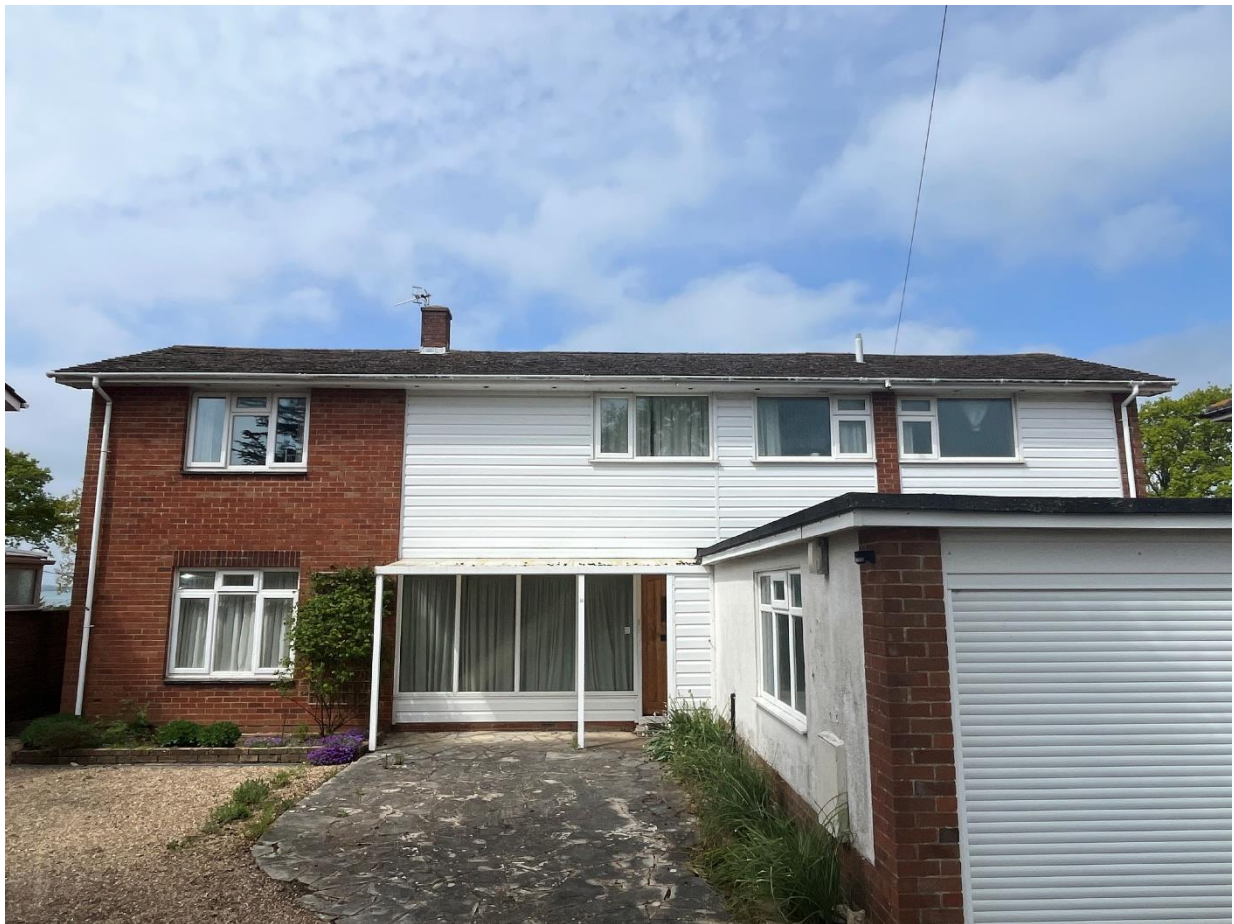
**Figure 3. Front elevations looking northwest.**

The property is a detached two-storey house dating to late 20<sup>th</sup> Century. It has a low, single pitched roof of close-fitting cement tiles (see figures 3-4). The walls are of plain

brick and the soffits and fascias and large sections of the walls are faced with modern uPVC cladding (See figures 3-4 and 6).

There is a flat roofed garage off the front (See figure 3) which has no internal voids and a permanently illuminated interior (see figure 8).

There was no evidence of historic bat activity in the property, and the roof, soffits and walls have no potential access points. Therefore, the property has negligible potential, and a Phase 2 bat survey is not recommended.

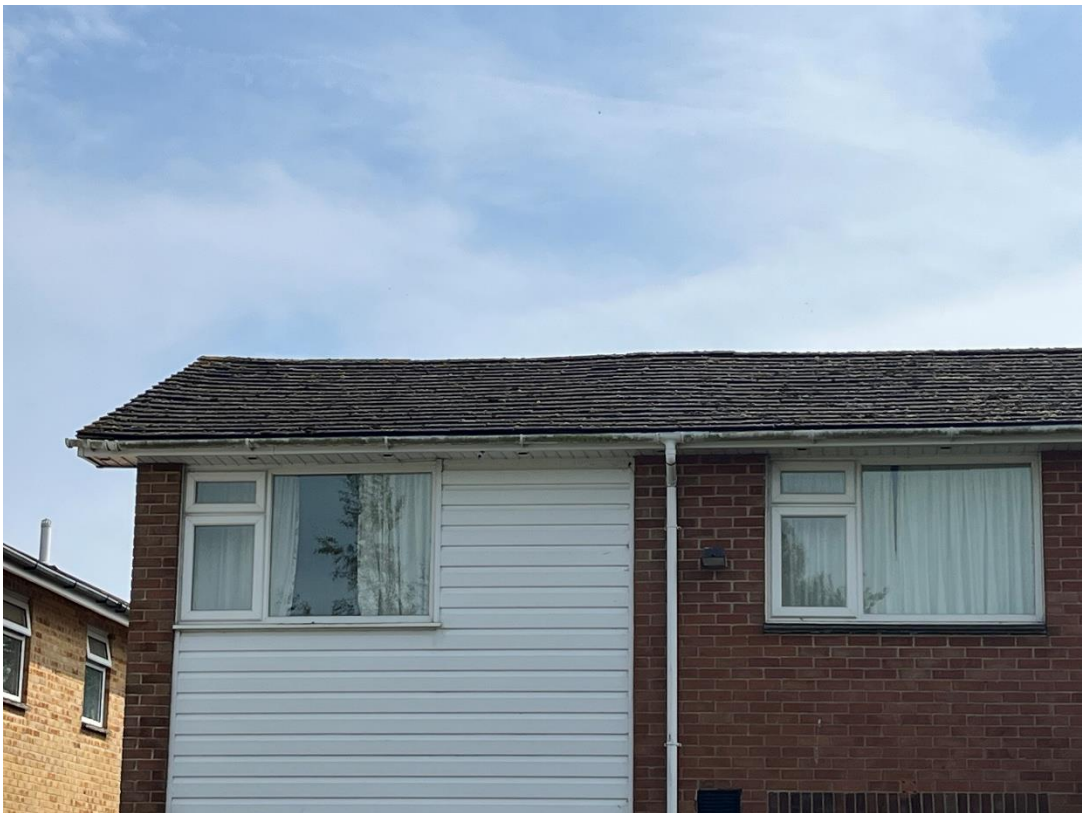
**Figure 5. Rear elevations (eastern half) looking southeast.**

There is a large single-storey ground floor extension off the rear which has no enclosed voids and no potential for bats.

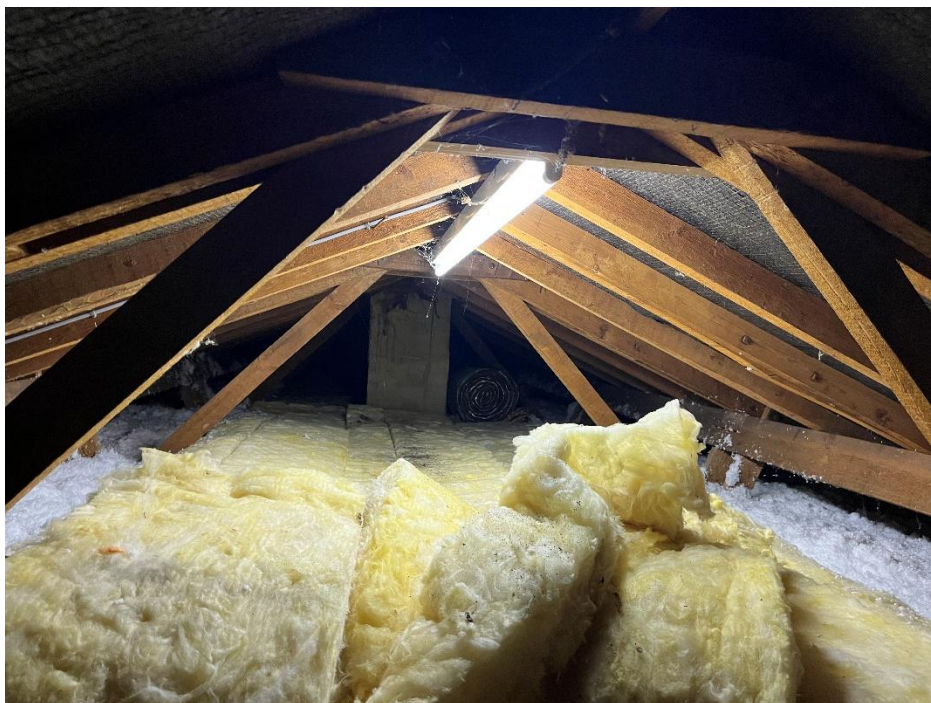
**Figure 7. Main loft looking southwest**

The original loft space was accessed via a hatch on the landing. The roof is lined with felting (see figure 7) and there was no sign of any bat activity within. The extension off the east end has a separate loft hatch and is also lined with felting and devoid of any signs of bat activity.
