# Road Safety Audit Report

**Stage 1/2 Completion of Detail Design;** and

## **Proposed Highway Works to form a Continuous Footway at the northern access to Havant & South Downs College Barncroft Way Havant**

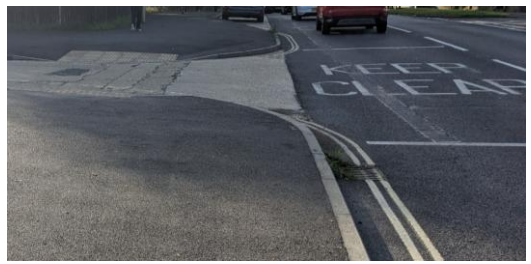
| <b>B.2.1</b> | <b>PROBLEM</b> |
| <b>Location:</b> | Barncroft Way |
| <b>Summary:</b> | Edge of carriageway may not generate a smooth alignment |
| <b>Acc Type:</b> | Vehicle loss of control type collision |
| <p>The existing northern access to HSDC Havant is just circa 3.5 metres wide and taken off Barncroft Way at a bellmouth that accommodates 6 metre radii. The access is formed in a concrete surface that meets the tangent of each radii and allows for a smooth edge of carriageway. The proposals include highway works to remove the existing bellmouth and provide a vehicular crossover to allow access to a 7 metre carriageway that allows for two-way traffic. The continuous footway and access road are to be provided at existing levels and therefore a ramp is to be provided to the east, immediately adjacent to give-way markings that highlight the need for motorists to slow and give priority to pedestrians. The scheme drawings illustrate the area of the 3.7 metre wide continuous footway and identifies that the western edge, along Barncroft Way, will not meet the tangent of the southern radius. The Audit Team have concerns that this does not generate a smooth edge of carriageway which could lead to loss of control type collisions should a motorist suddenly become aware of the and swerve.</p> | |

| <b>RECOMMENDATION:</b> | |
| It is recommended that the proposed works allow for a smooth edge of carriageway. | |

| Stage 1/2 Road Safety Audit (RSA) Decision Log | | | | | |
|---|---|---|---|---|---|
| B.2.1 | Edge of carriageway may not generate a smooth alignment | It is recommended that the proposed works allow for a smooth edge of carriageway. | Accept – The scheme references that the proposed continuous footway is to be provided in accordance with the example on page 18 of TG10 published by Hampshire County Council. The standard detail identifies that PC3 kerbs are to be provided along the edge of the carriageway. These will replace the corner radii and meet the existing kerblines generating a smooth alignment along the edge of carriageway. | | |

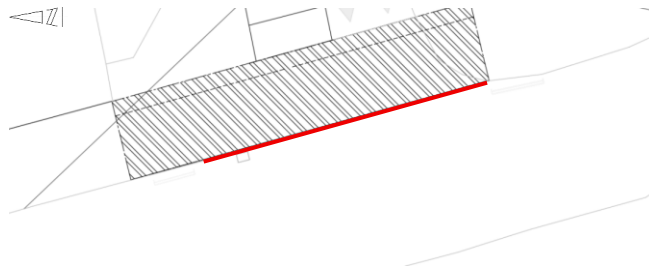
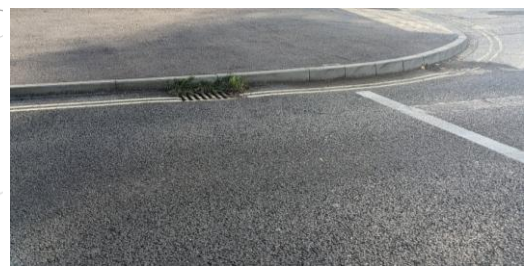
#### Location Plan:

| <b>B.2.2</b> | <b>PROBLEM</b> |
| <b>Location:</b> | Barncroft Way |
| <b>Summary:</b> | Proposed ACO drain is likely to become blocked by debris |
| <b>Acc Type:</b> | Vehicle sideswipe type collision |
| <p>Barncroft Way is mostly cambered which forces surface water to fall towards the channels where it drains through a network of road gullies. The proposals include the removal of an existing road gully that is situated immediately to the north of the existing northern access to HSDC Havant and</p> | |

replacement with an ACO channel drain. Whilst the surface area of a linear drains will generally exceed that of a road gully and therefore could drain an excess amount of surface water, the Audit Team have concerns that the debris that collects within a channel could block a linear drains due to the narrow nature of the grills which could have an impact on the drainage of surface water resulting in ponding and loss of control type collisions.

#### RECOMMENDATION:

It is recommended that the linear drain is replaced with strategically located road gullies

| Stage 1/2 Road Safety Audit (RSA) Decision Log | | | | | |
|---|---|---|---|---|---|
| B.2.2 | Proposed ACO drain is likely to become blocked by debris | It is recommended that the linear drain is replaced with strategically located road gullies. | Accept – The proposals will not adjust the existing levels of Barncroft Way and therefore the existing road gully will be retained. This existing road gully is situated outside of the proposed vehicular crossover, adjacent to the transition kerbs, according to the topographical survey. The grate should therefore not be situated along the desire line of a cyclist turning left onto the proposed vehicular crossover, however, if considered necessary the grate can be exchanged for a cyclist friendly type. | | |

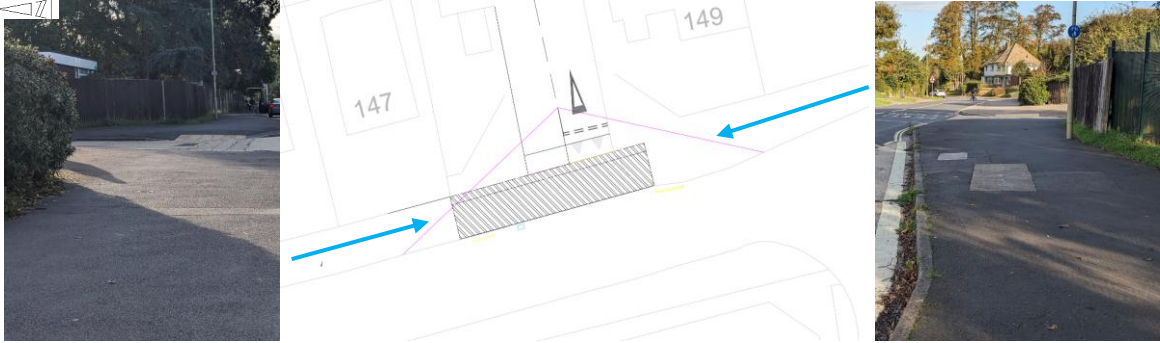
| <b>Location Plan:</b> | |

| <b>B.4.1</b> | <b>PROBLEM</b> |
| <b>Location:</b> | Barncroft Way |
| <b>Summary:</b> | Intervisibility is limited |
| <b>Acc Type:</b> | Cyclist to vehicle type collision |
| <p>Barncroft Way benefits from a shared footway cycleway along the northern side of the carriageway and allows access to the northern parking and servicing facility associated with HSDC Havant. The existing access takes the form of a bellmouth that accommodates an uncontrolled crossing. The proposals include works at the existing access to form a vehicular crossover, creating a continuous shared footway cycleway and providing priority for pedestrians and cyclists. The proposed vehicular crossover is to be accessed from the HSDC Havant parking and servicing facility via a ramp that accommodates give-way markings at the bottom. The scheme drawing illustrates the visibility splays that are achievable and identifies that an exiting motorist will be able to see cyclists and pedestrians at a distance of 17 metres. It is noted, however, that this splay extends to the channel line and not the back edge of the shared footway cycleway. The achievable intervisibility splay between the driver of a vehicle exiting and the back edge of the shared footway cycleway is limited to circa 10 metres. Whilst a pedestrian can stop almost instantly, the stopping sight distance of a cyclist approaching the proposed vehicular crossover at a speed of 20kph equates to 17 metres. The Audit Team have concerns that the achievable level of intervisibility is limited which may result in a motorist not becoming aware of an approaching cyclist and lead to cyclist to vehicle type collisions.</p> | |

| <b>RECOMMENDATION:</b> | |
| It is recommended that the give-way line is brought forward to maximise intervisibility. | |

| Stage 1/2 Road Safety Audit (RSA) Decision Log | | | | | |
|---|---|---|---|---|---|
| B.4.1 | Intervisibility is limited | It is recommended that the give-way line is brought forward to maximise intervisibility. | Accept – The give-way line has been relocated to the foot of the proposed ramp where an intervisibility envelope extending 12 metres is achievable between a driver at an offset of 2 metres and an approaching cyclist. This is extended to 17 metres at an offset of 2 metres from the top | | |

| Stage 1/2 Road Safety Audit (RSA) Decision Log | | | | | |
|---|---|---|---|---|---|
| | | | of the ramp to an offset 0.75 metres to the south and 1.2 metres to the north. It must be noted that the shared footway cycleway is straight in alignment forward visibility to the vehicular crossover, for a cyclist, significantly exceeds the 17 metres. A cyclist will therefore become aware of a vehicle exiting the vehicular crossover at a safe distance to slow accordingly. | | |
