# Site Investigation Letter Report for Langstone Technology Park, Havant

## Prepared for AG Langstone B.V

**10/1425/001 Rev. 000**

## Foundation Inspection Trial Pitting Letter Report Langstone Technology Park, Havant

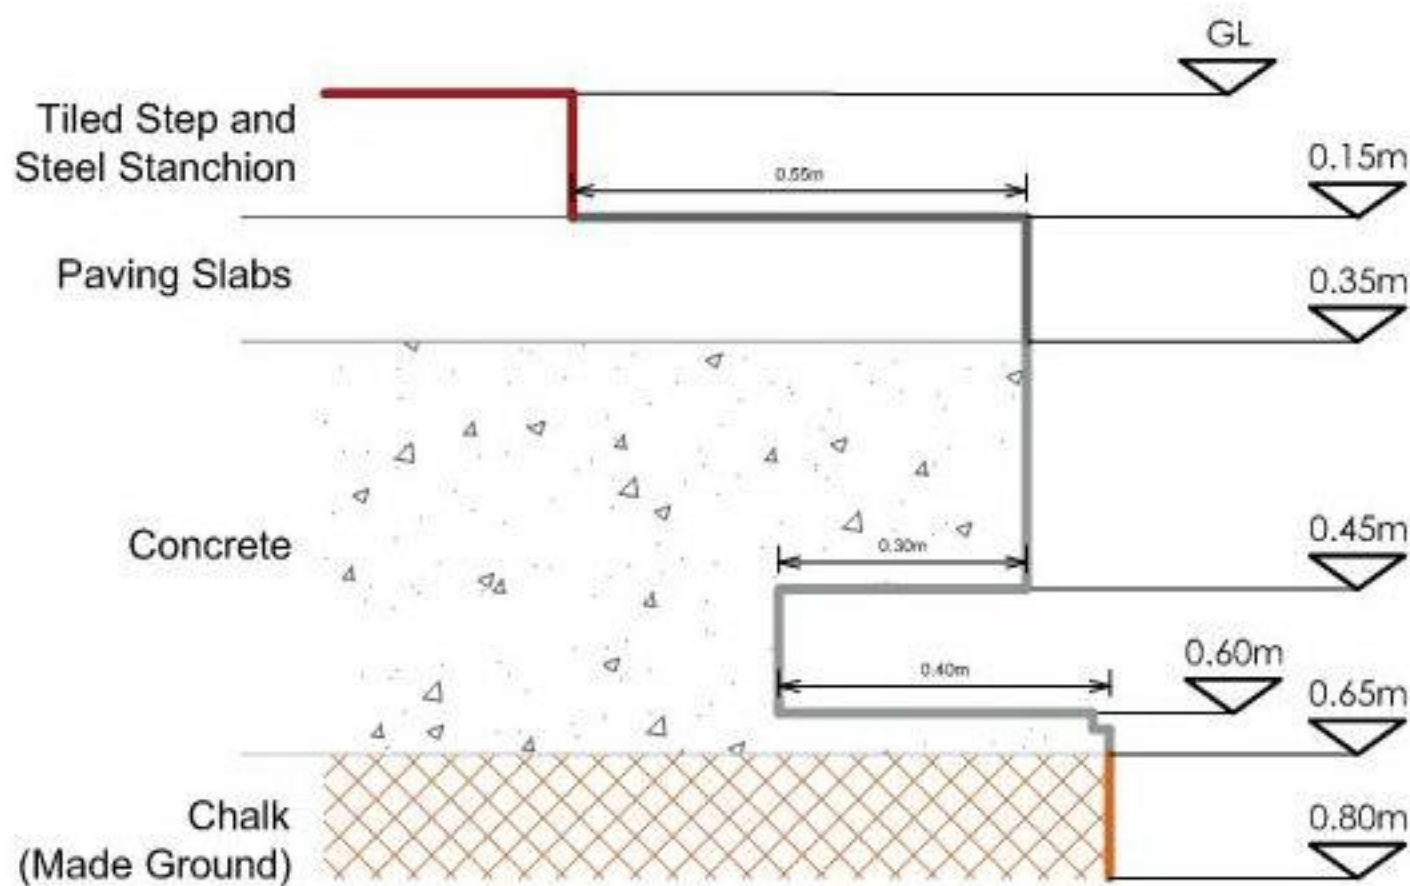
## TP01

| Trial Pit ID | Location | Foundation Construction | Step Out from Wall of Structure (m) | Depth to Underside of Foundation (m bgl) | Notes |
|---|---|---|---|---|---|
| TP01 | Northern side of 'building 7000' | Concrete | 0.65 | 0.65 | Foundation appeared to bear upon chalk assessed as being Made Ground. |

Trial pit excavated to investigate existing foundations. Trial pit terminated in chalk interpreted to potentially be Made Ground / reworked natural strata. Trial pit backfilled with arisings.

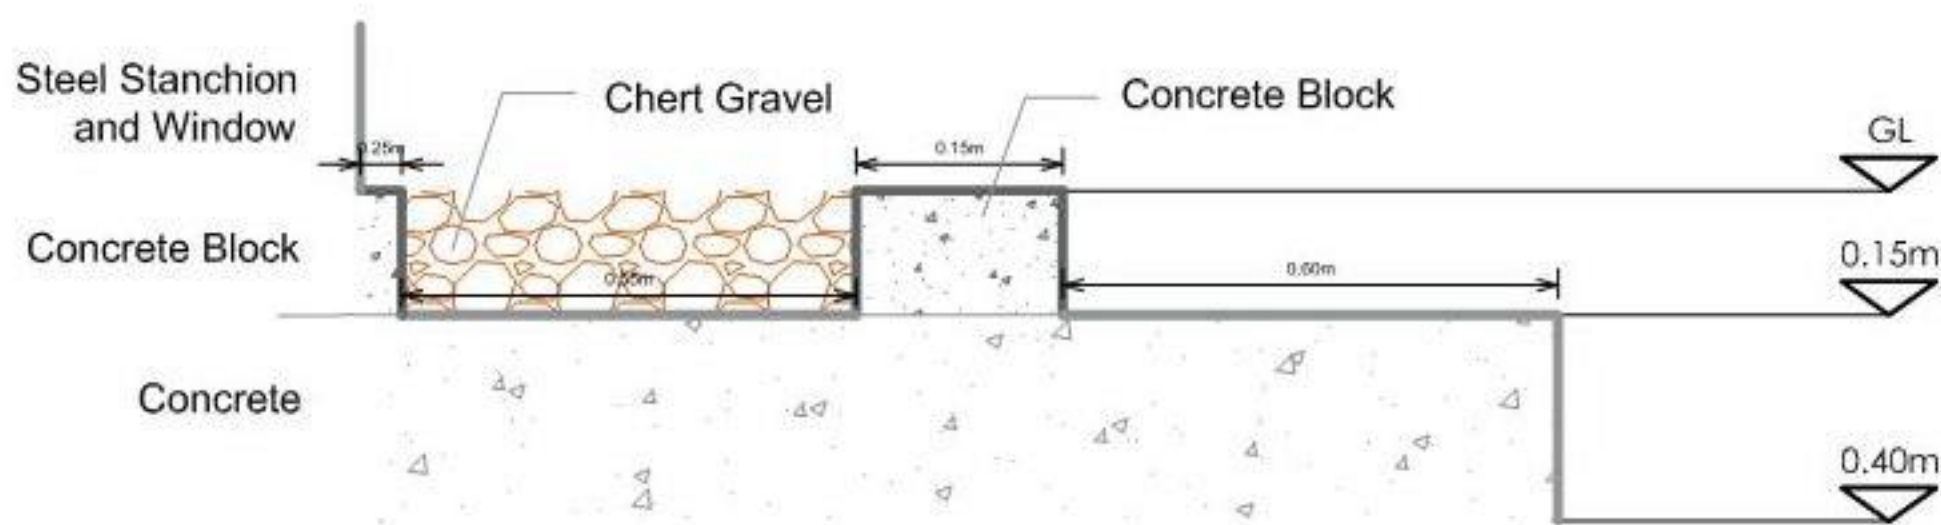
## TP02

| Trial Pit ID | Location | Foundation Construction | Step Out from Wall of Structure (m) | Depth to Underside of Foundation (m bgl) | Notes |
|---|---|---|---|---|---|
| TP02 | Eastern side of 'building 4000' | Concrete | 1.55 | >0.40 | The underside of the foundation could not be identified due to the presence of buried services. |

Trial pit excavated to investigate existing foundations. Trial pit terminated due to service. Trial pit backfilled with arisings.

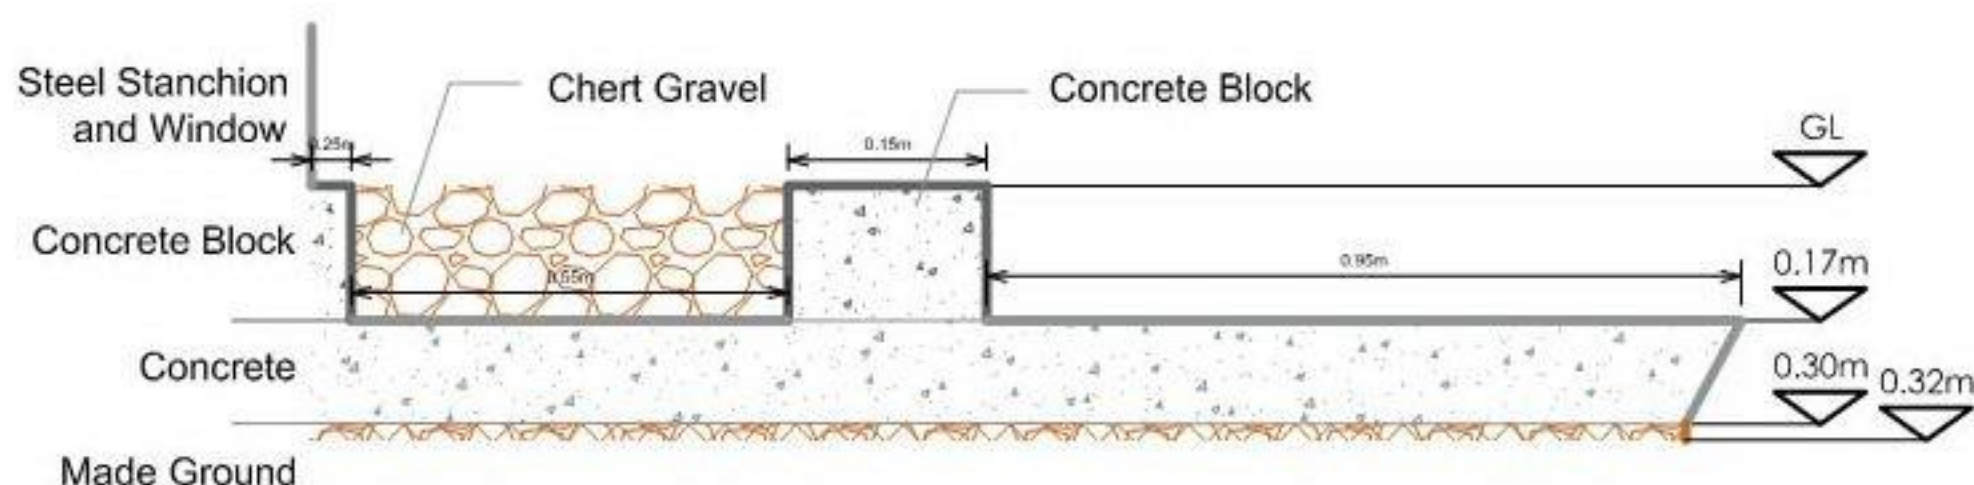
## TP03

| Trial Pit ID | Location | Foundation Construction | Step Out from Wall of Structure (m) | Depth to Underside of Foundation (m bgl) | Notes |
|---|---|---|---|---|---|
| TP03 | Eastern side of 'building 4000' | Concrete | 1.90 | 0.30 | Foundation appeared to bear upon sand and gravel strata assessed as being Made Ground. |

Trial pit excavated to investigate existing foundations. Trial pit terminated in Made Ground.  
Trial pit backfilled with arisings.

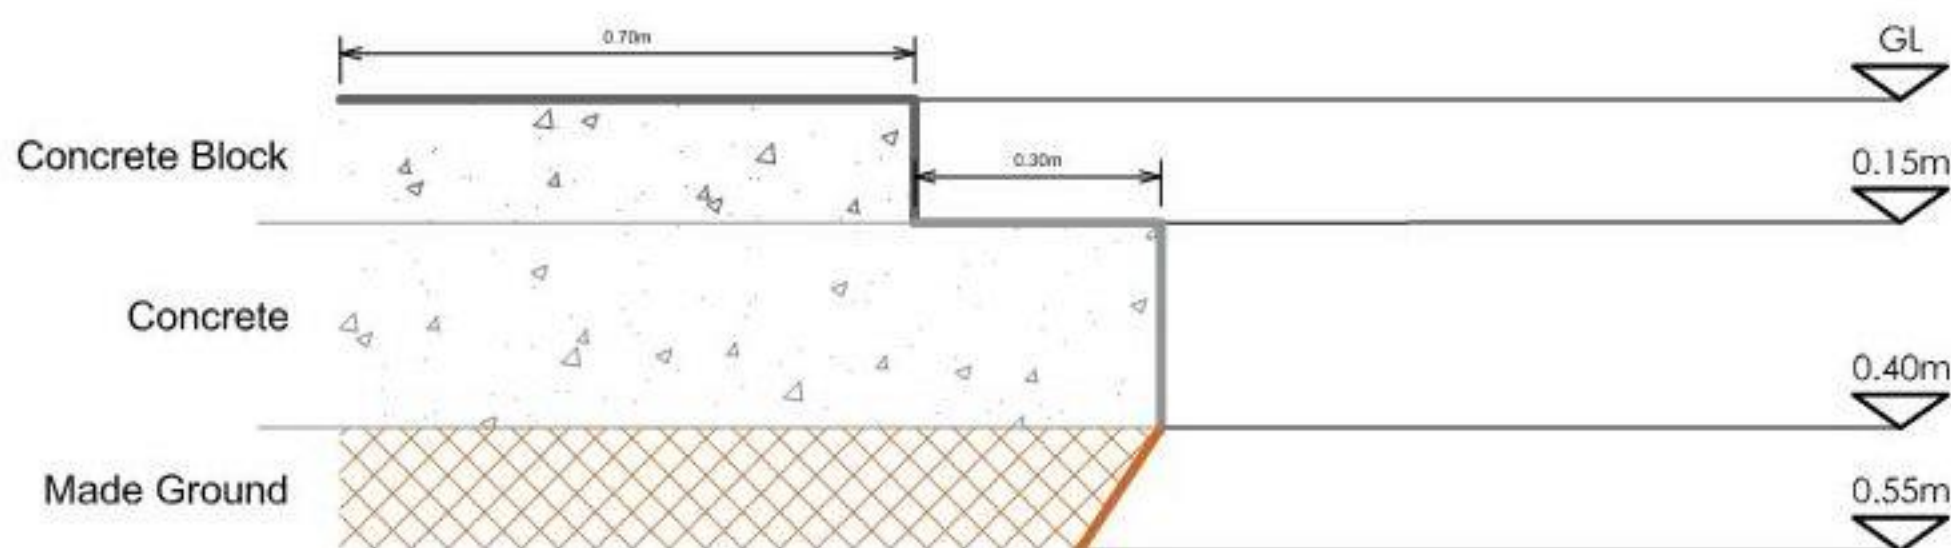
## TP04

| Trial Pit ID | Location | Foundation Construction | Step Out from Wall of Structure (m) | Depth to Underside of Foundation (m bgl) | Notes |
|---|---|---|---|---|---|
| TP04 | Eastern side of 'building 1000' | Concrete | 1.00 | 0.40 | Foundation appeared to bear upon Made Ground. |

Trial pit excavated to investigate existing foundations. Trial pit terminated in Made Ground.  
Trial pit backfilled with arisings.

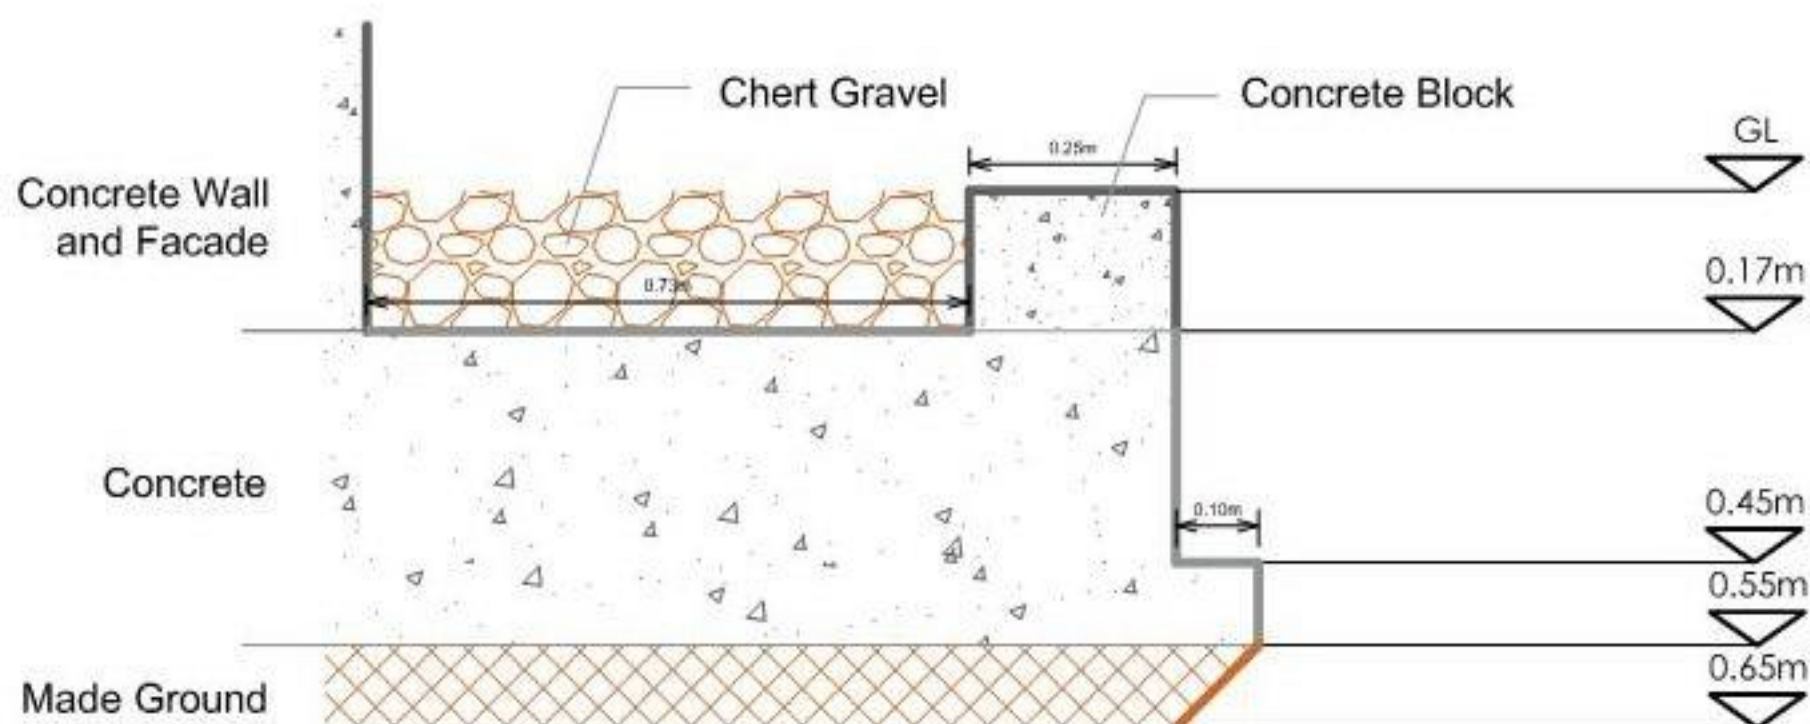
## TP05

| Trial Pit ID | Location | Foundation Construction | Step Out from Wall of Structure (m) | Depth to Underside of Foundation (m bgl) | Notes |
|---|---|---|---|---|---|
| TP05 | Eastern side of 'building 1000' | Concrete | 1.08 | 0.55 | Foundation appeared to bear upon Made Ground. |

Trial pit excavated to investigate existing foundations. Trial pit terminated in Made Ground.  
Trial pit backfilled with arisings.
