## **Main Investigation Report**

**Newtown Hotel, Manor Road, Hayling Island,  
Hampshire PO11 0DA**

**Marblesea Ltd**

**Reference: I8966/MIR\_R27  
March 2021**

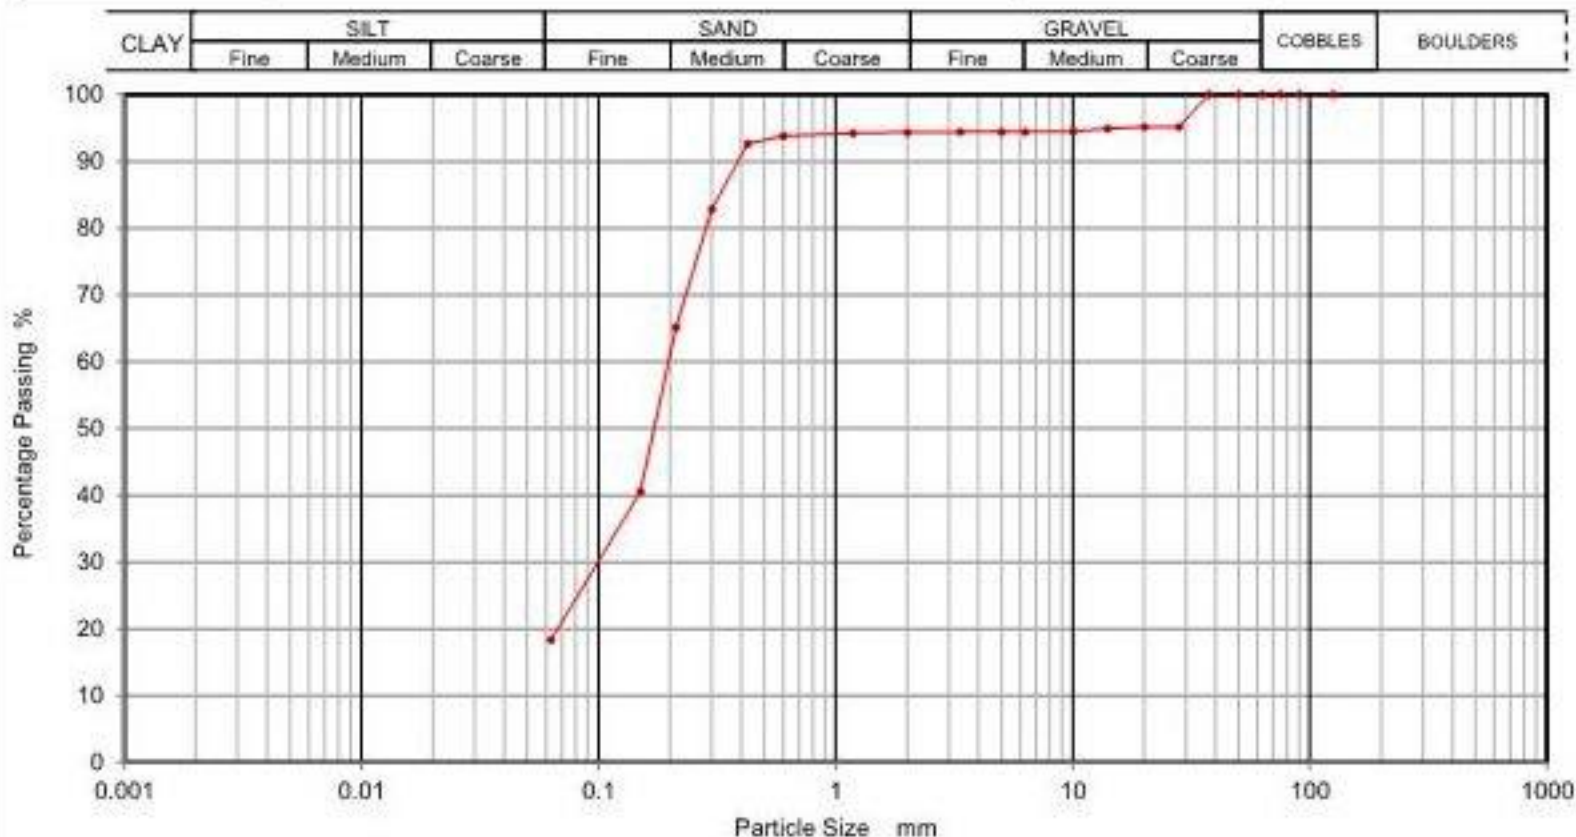
| Sieving | | Sedimentation | |

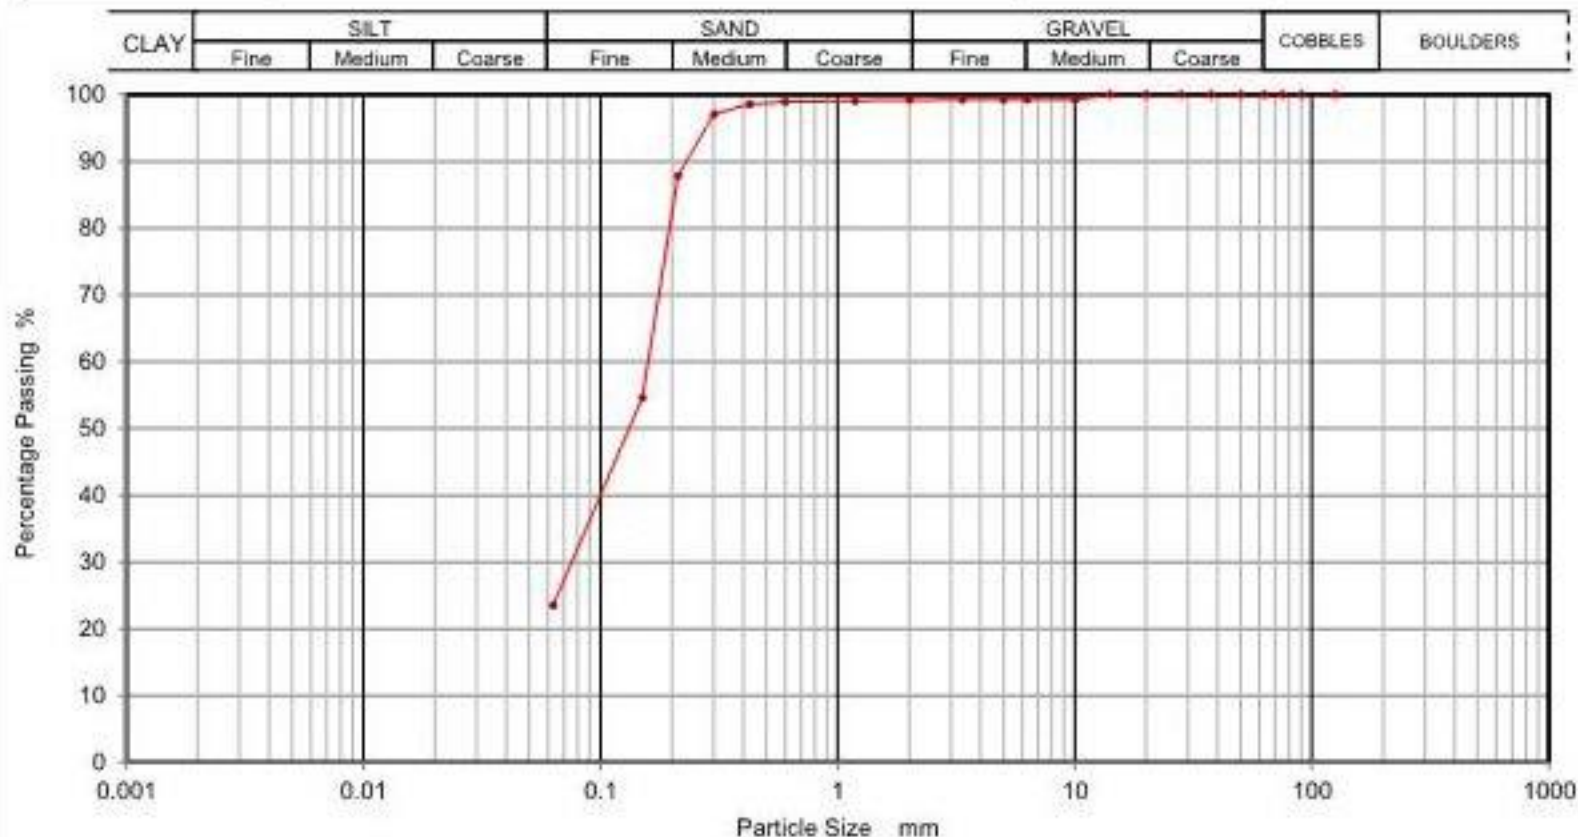
| Sieving | | Sedimentation | |

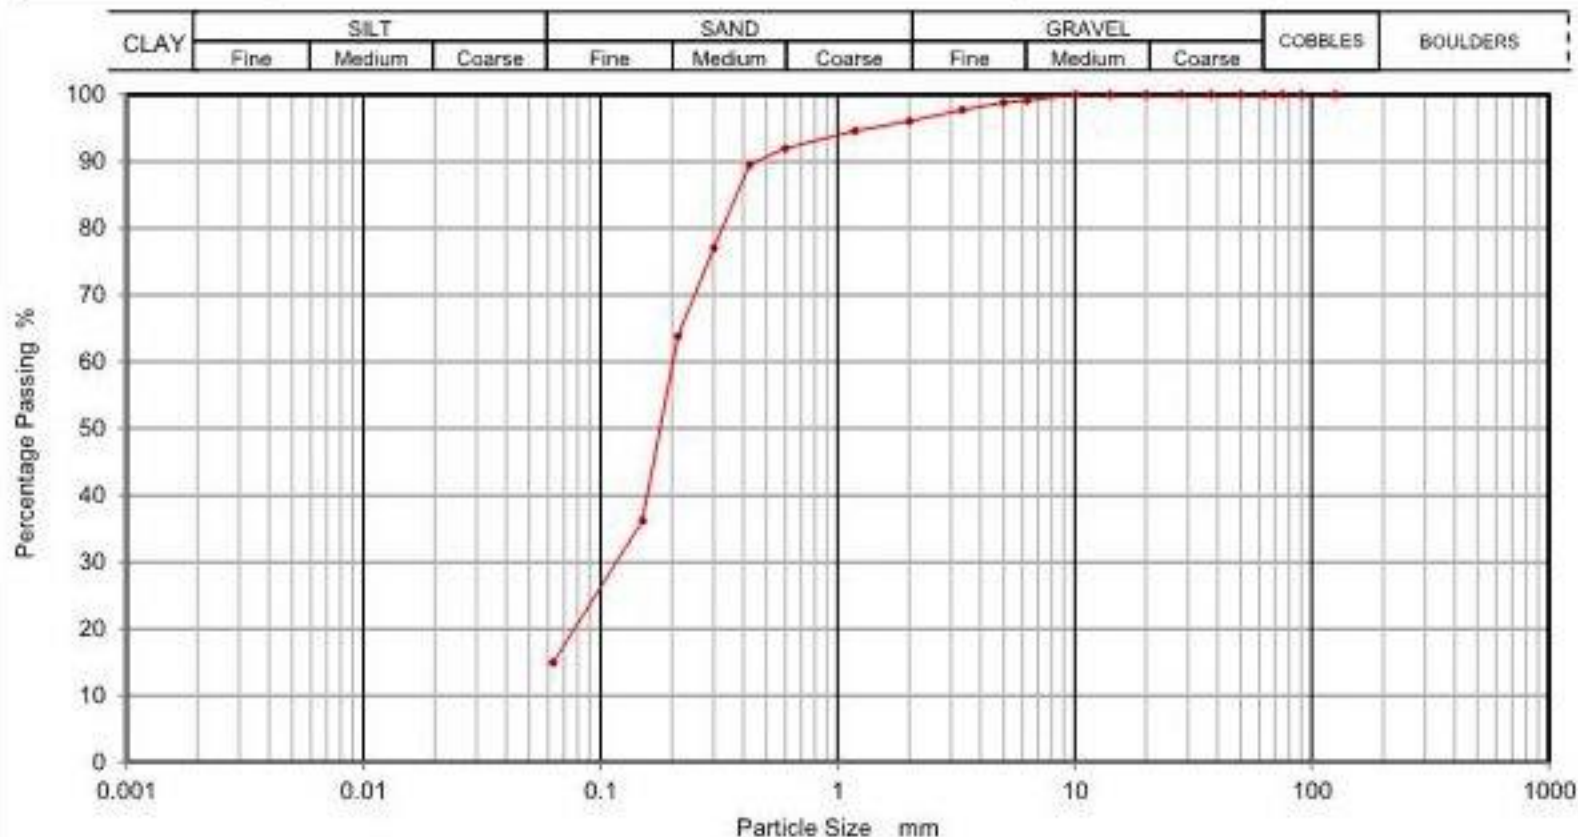
| Sieving | | Sedimentation | |
