**Preliminary Minerals Resource Assessment**

at  
**Kingscroft Farm, Meyrick Road, Havant, Hampshire PO9 1FJ**

for  
**Foreman Homes**

**Reference: 21117/PMRA**  
**October 2023**

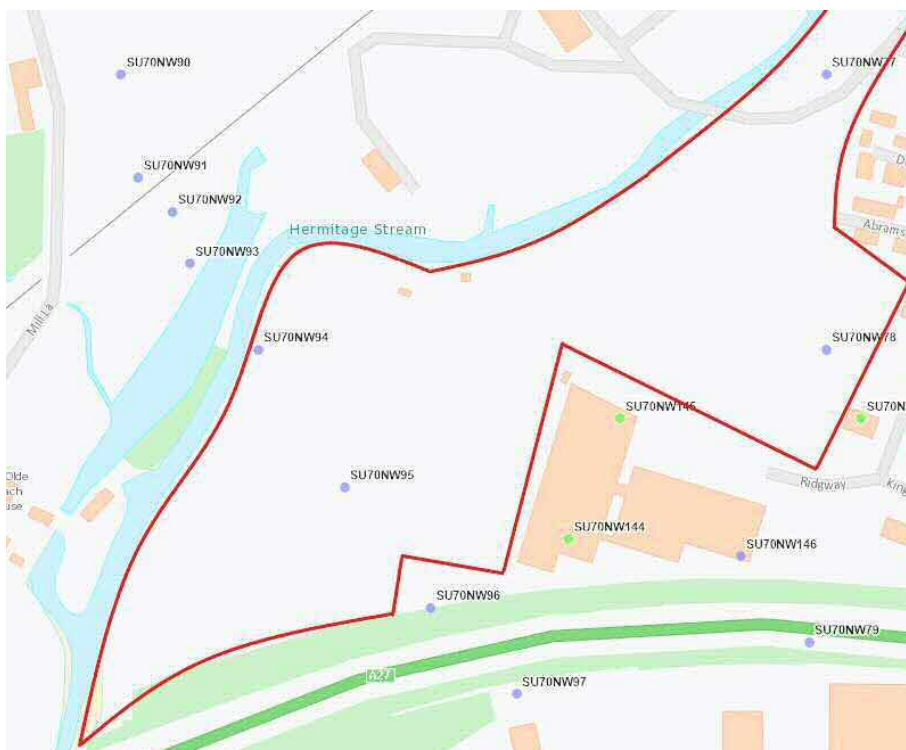
**Figure A Historical Borehole Locations**

A location map for the boreholes identified on site is presented in Figure A:

It must be noted that the bedrock of Lewes Nodular Chalk Formation was only encountered within the boreholes BH106 and BH110 located close to the northern and eastern site boundaries respectively, being broadly in accordance with the findings of the former investigation undertaken on site (ref: 17877/MIR, dated November 2019, by Soils Limited), where the Lewes Nodular Chalk Formation bedrock had been mainly encountered close to the northern and north-eastern site boundaries.
