**GEOTECHNICAL INTERPRETATIVE REPORT**

**PHASE 2 AREA, WOODCROFT FARM,**

**GRAINGER PLC**

| <b>Reference:</b> | GE16942-GIR-AUG18 |

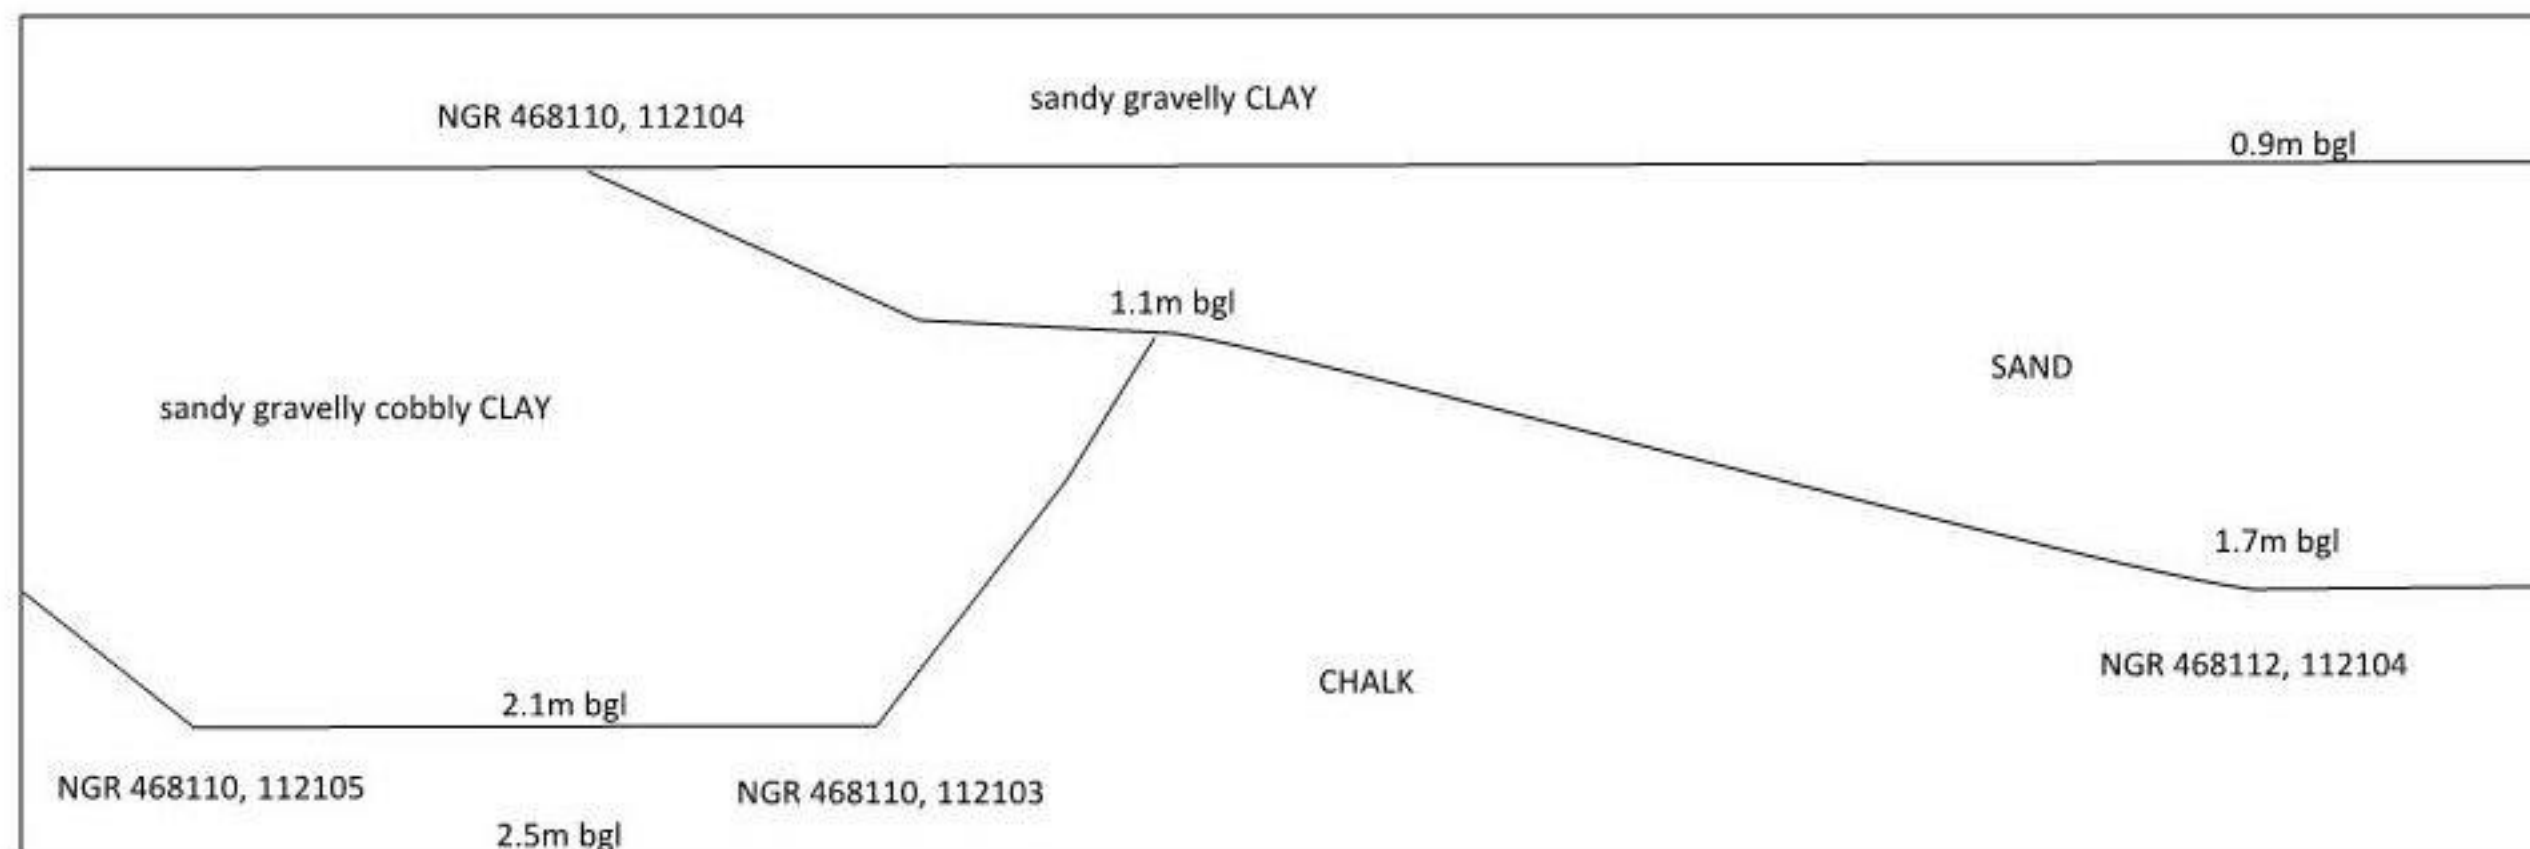
Trench start NGR 468109, 112107

Trench end NGR 468113, 112104

Refer to TP709 log for detailed descriptions of strata

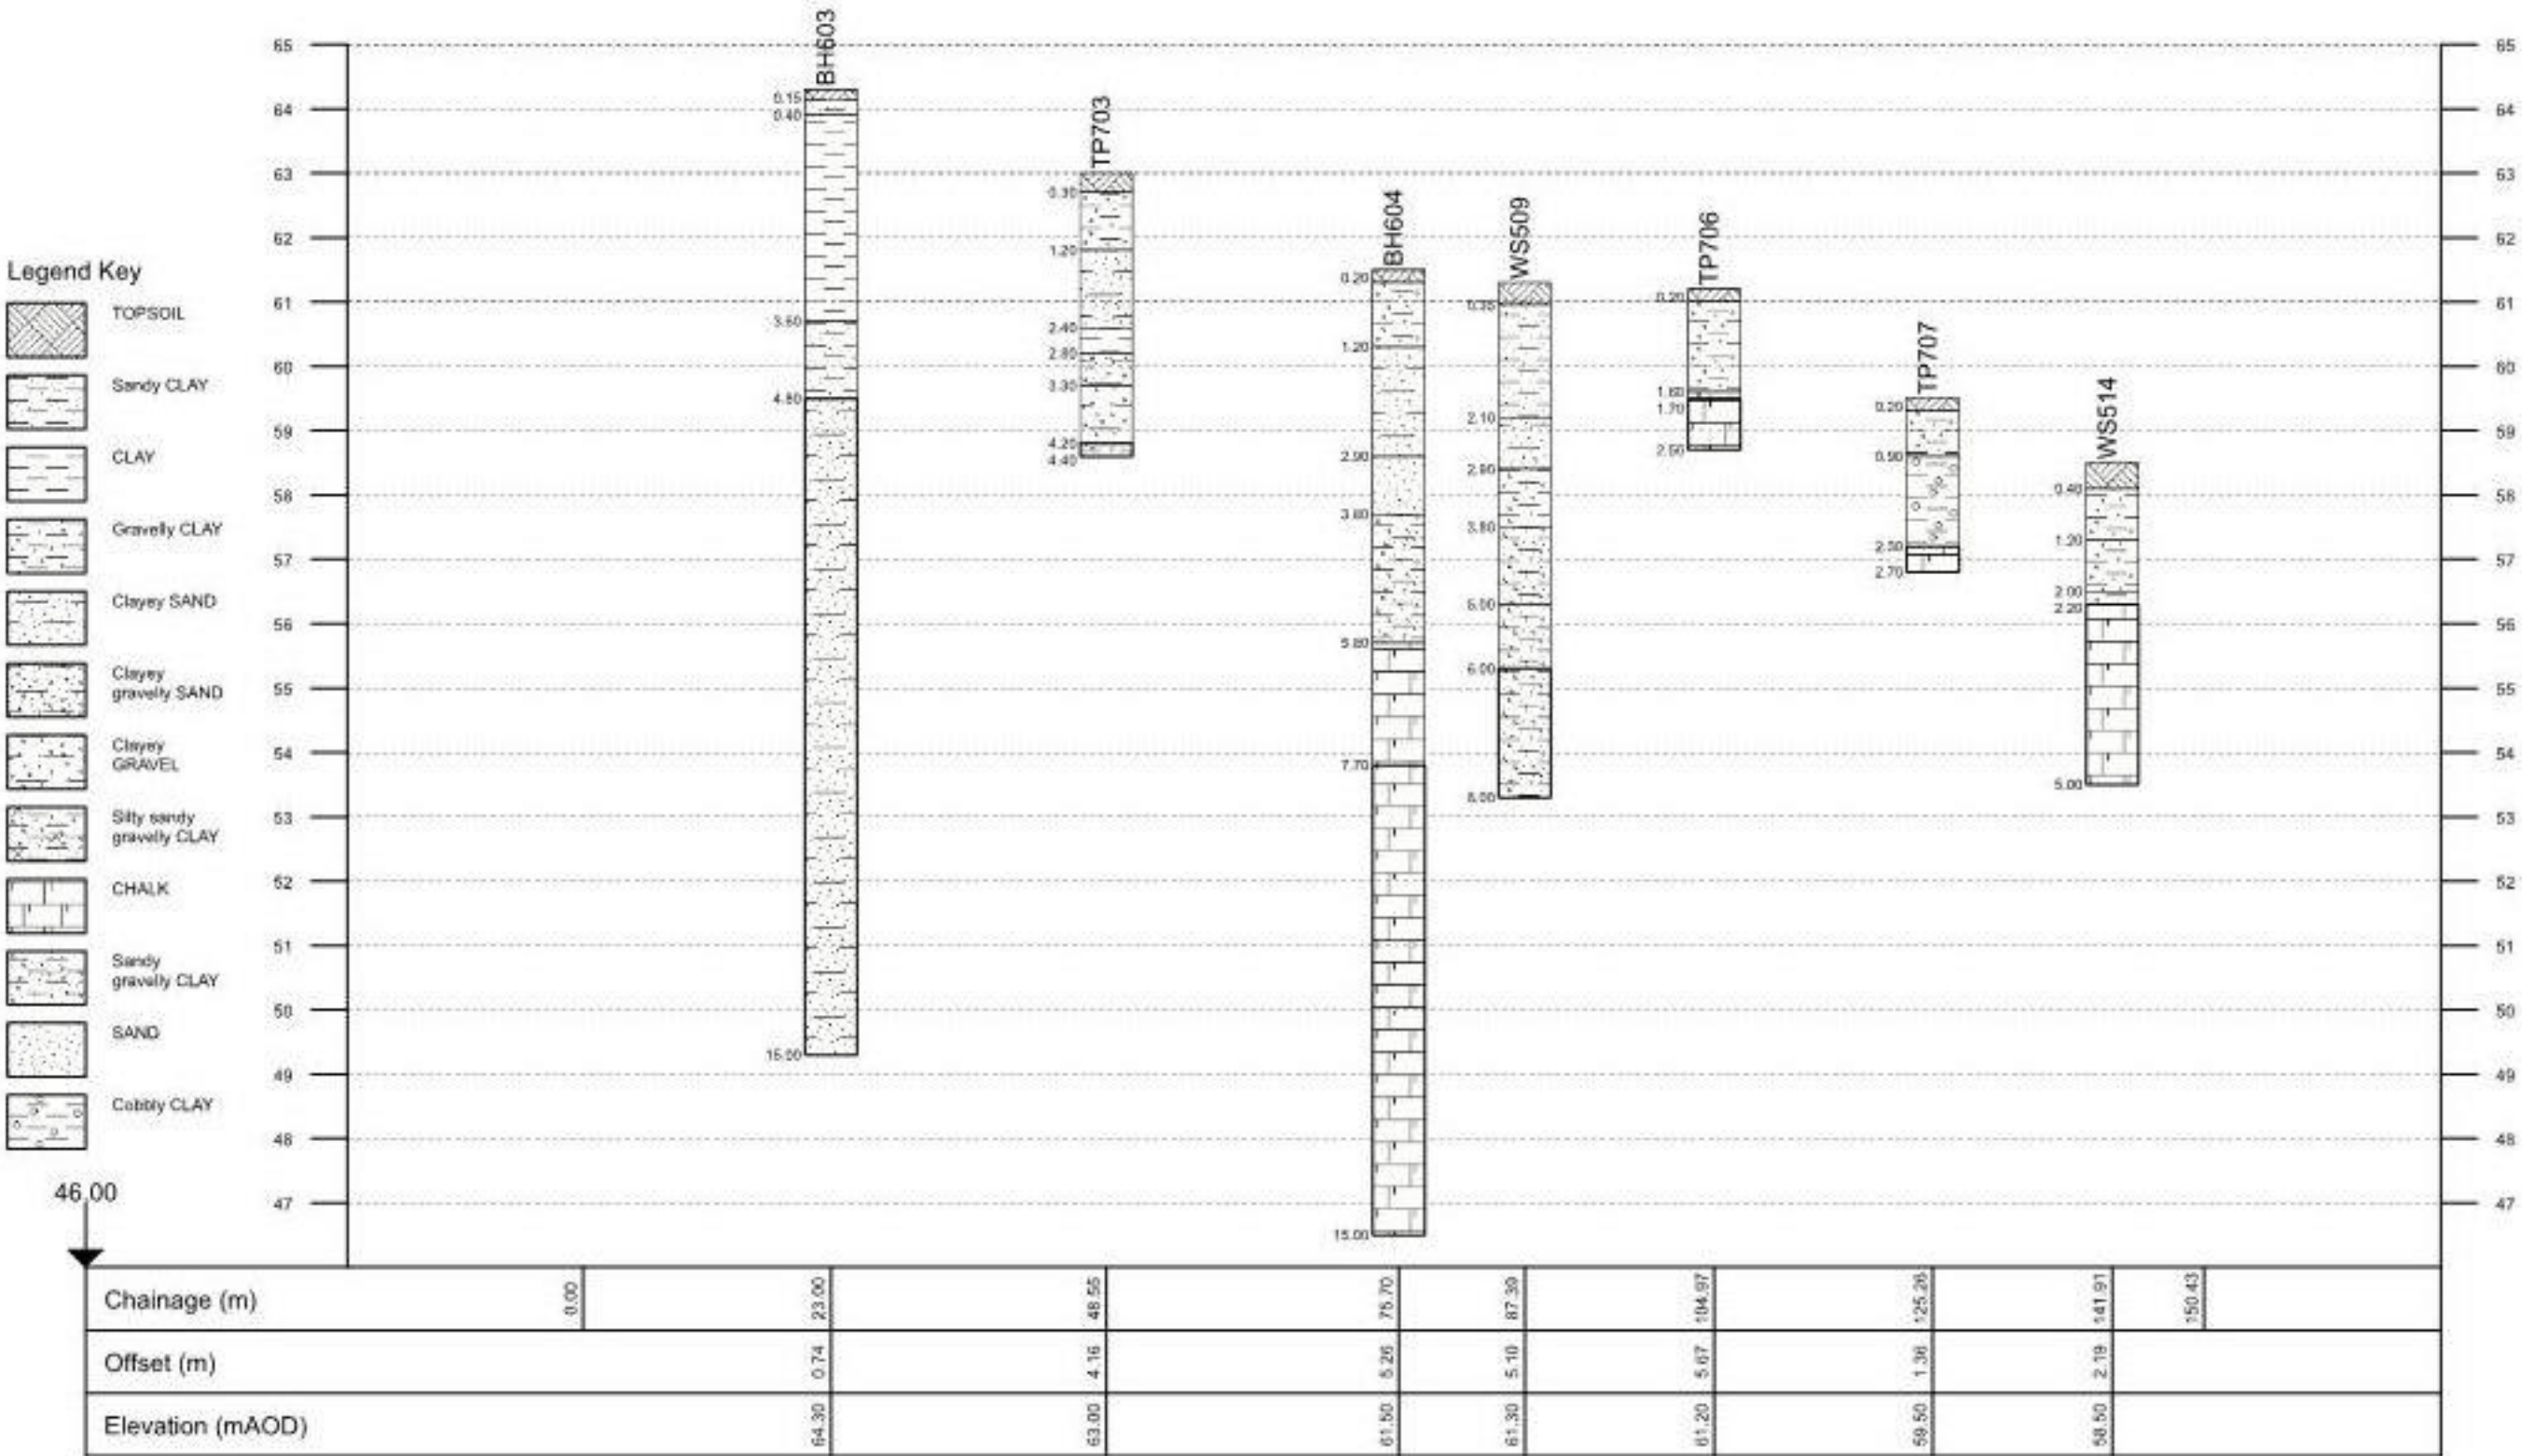
Figure 10 Section WS201 to TP237

Title: WS201 to TP237  
Vertical Scale: 1:146  
Horizontal Scale: Not to scale  
Engineer: GR

For further details of the ground conditions encountered, reference should be made to Figures 5 to 14 and the exploratory hole logs presented in Appendix A.

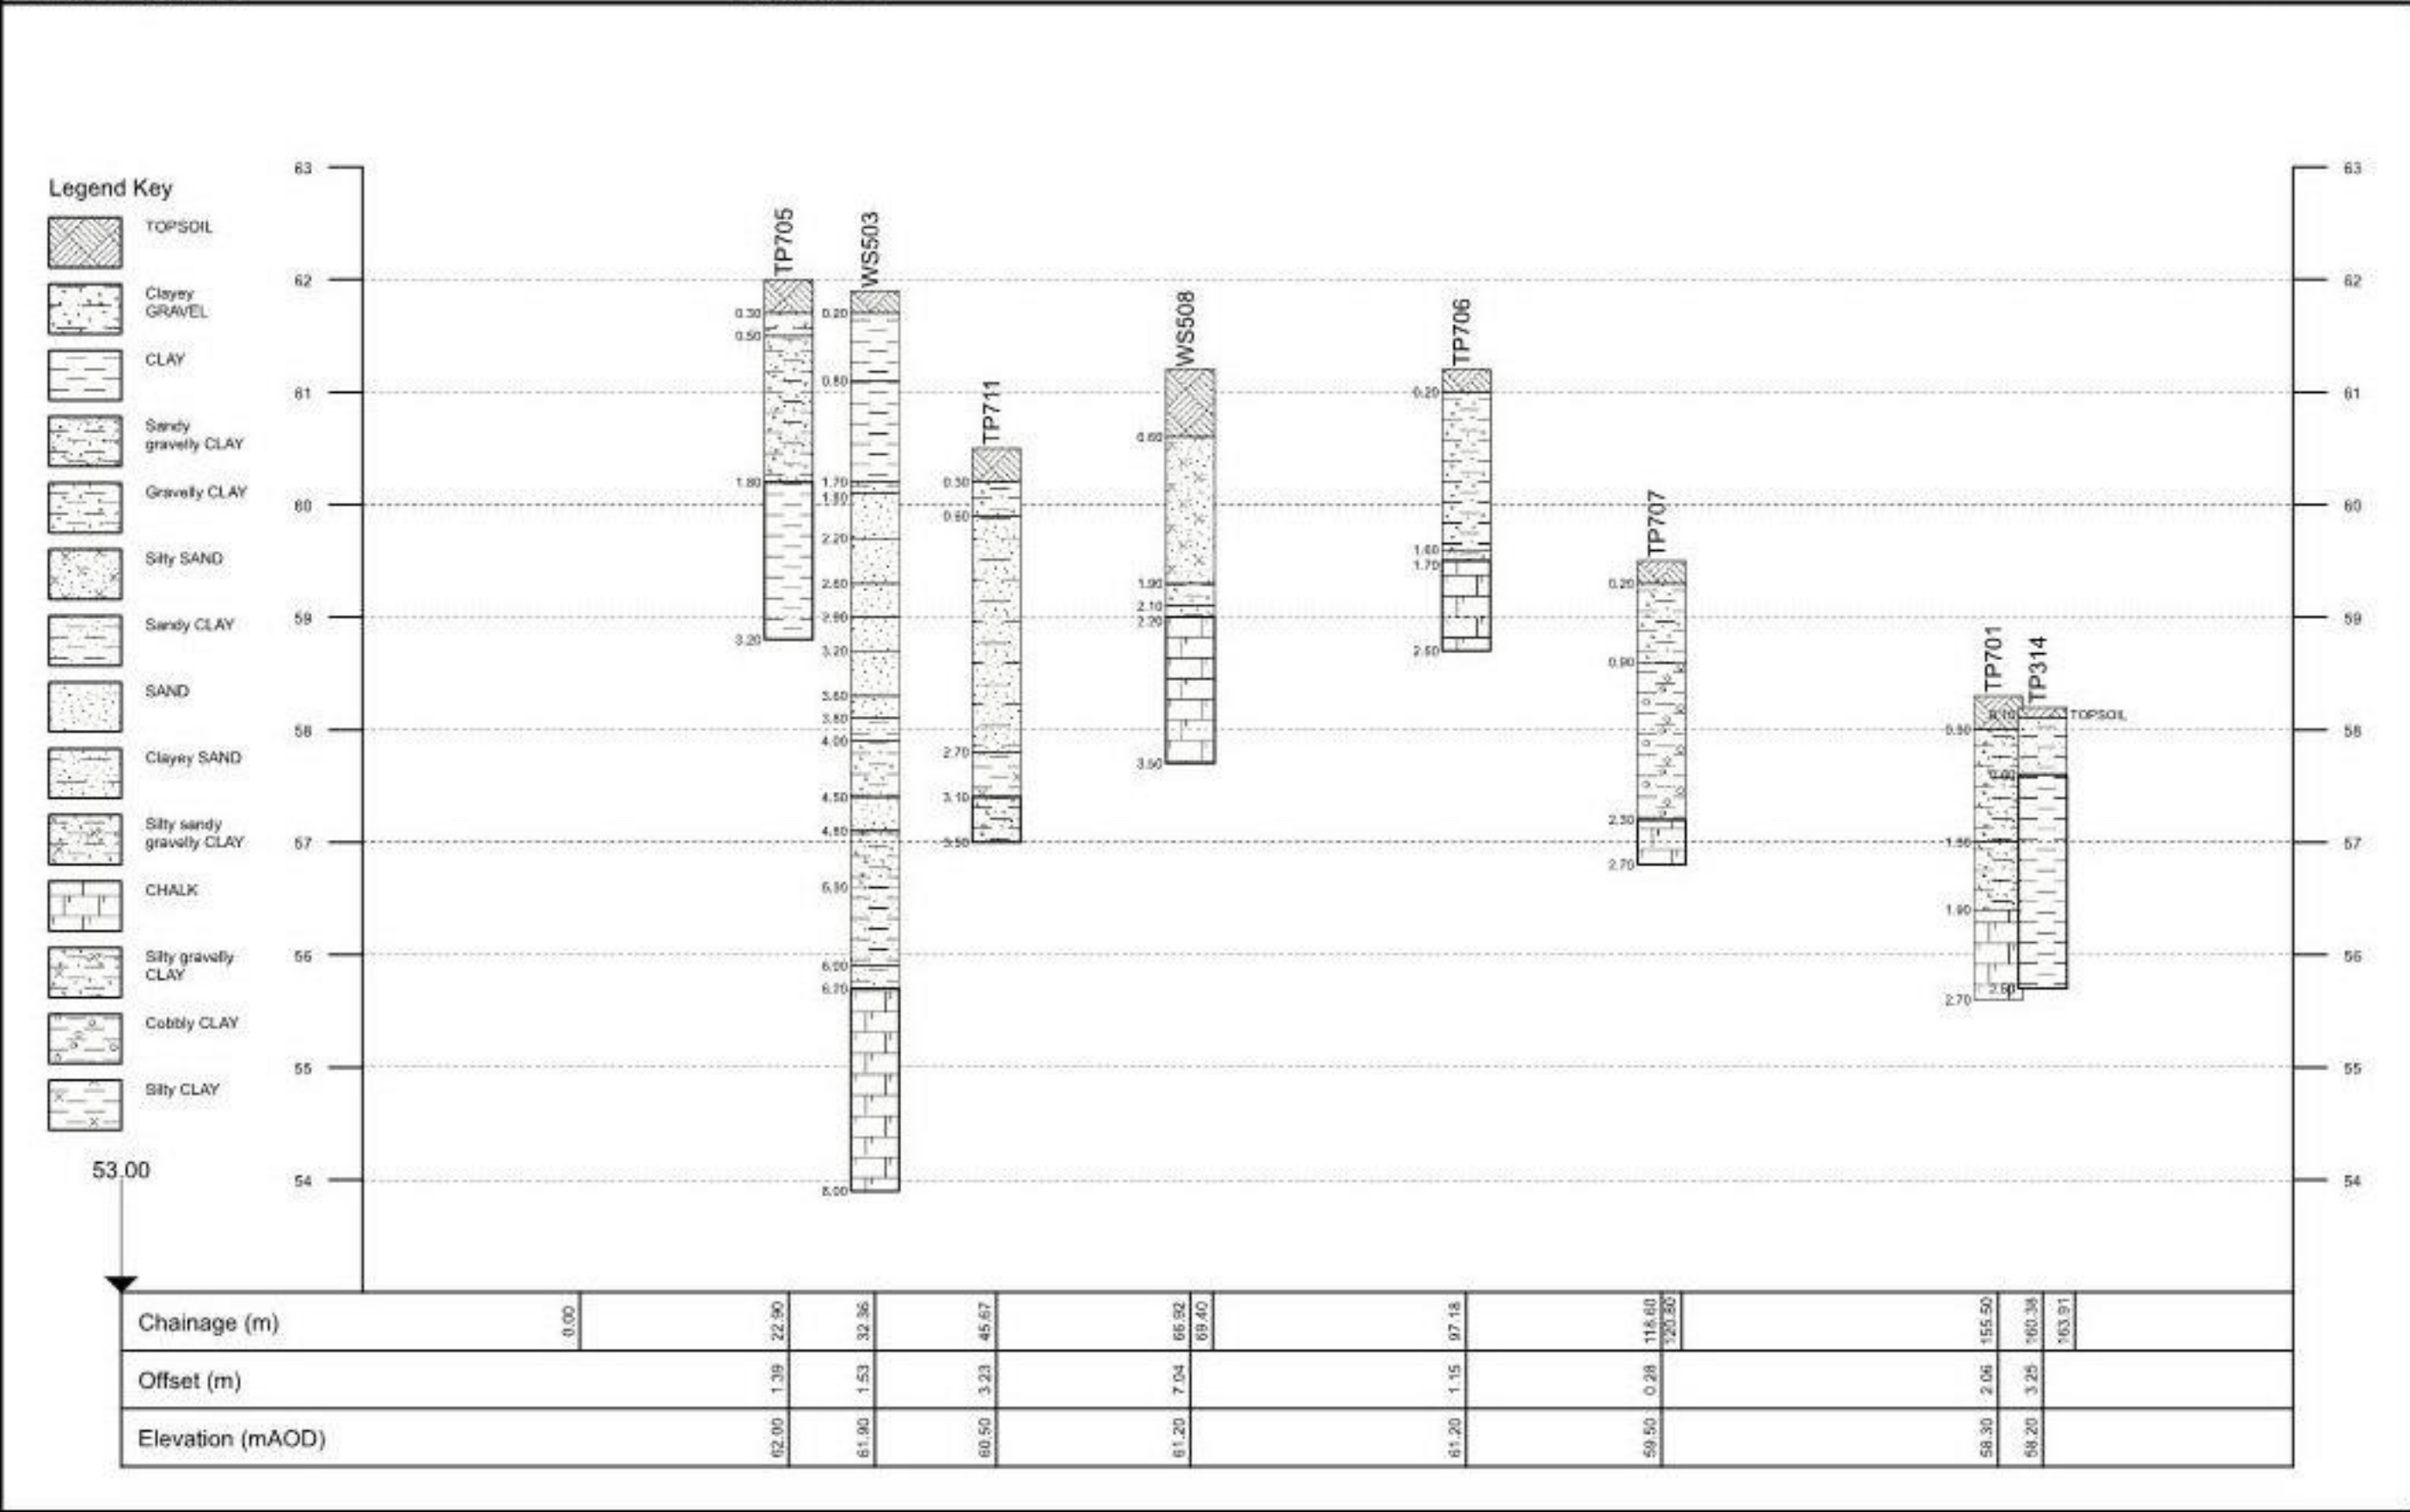
| <b>Project:</b> | Woodcroft Farm, Lovedean, Hampshire | | | <b>Title</b> | 3D Ground surface model | |

The aerial survey incorporated photogrammetry and LiDAR surveys to develop a Digital Terrain Model (DTM) of the site in its current condition, as shown in Figures 16 and 17. The DTM showed the ground levels to vary across the site and correlate with observed conditions, i.e. with a shallow and relatively broad valley feature crossing through the site from the northern boundary to the western boundary and extending into a more extensive dry valley feature located to the west and calling towards the west and south-west. Whilst the valley feature within the site was relatively broad, i.e. extend across much of the site, the extension upgradient across the northern boundary was much narrower and appeared to tie-in with ground level undulations and depressions observed on the land to the north.

Figures 16-17 show the 3D DTM developed from the aerial survey and these clearly identify Sinkholes 1 to 4 and the valley feature described in Section 3.1. Figures 18 and 19 show the variation in depth to Chalk across this portion of the site and the chalk level 3D model, respectively. Figure 19 shows that there are sudden changes in the level of the upper surface of the Chalk around Sinkholes 1, 2 and 3, but no clear evidence around Sinkhole 4 despite the DTM indicating the presence of Sinkhole 4 and corroborating previous phases of investigation. It is possible that the variation in level of the Chalk is less pronounced around Sinkhole 4. Figure 19 also indicates the presence of a sharp change (lowering) in level to the upper surface of the Chalk along the northern boundary between Sinkholes 1 and 2, as postulated in a previous third party report, and appears to extend off-site to the north. The boundary of this additional feature may differ from that predicted in the model as there was no ground investigation information on the land to the north (outside of the site), but the portion of the feature within the site was modelled based on a combination of the DTM and ground investigation information.

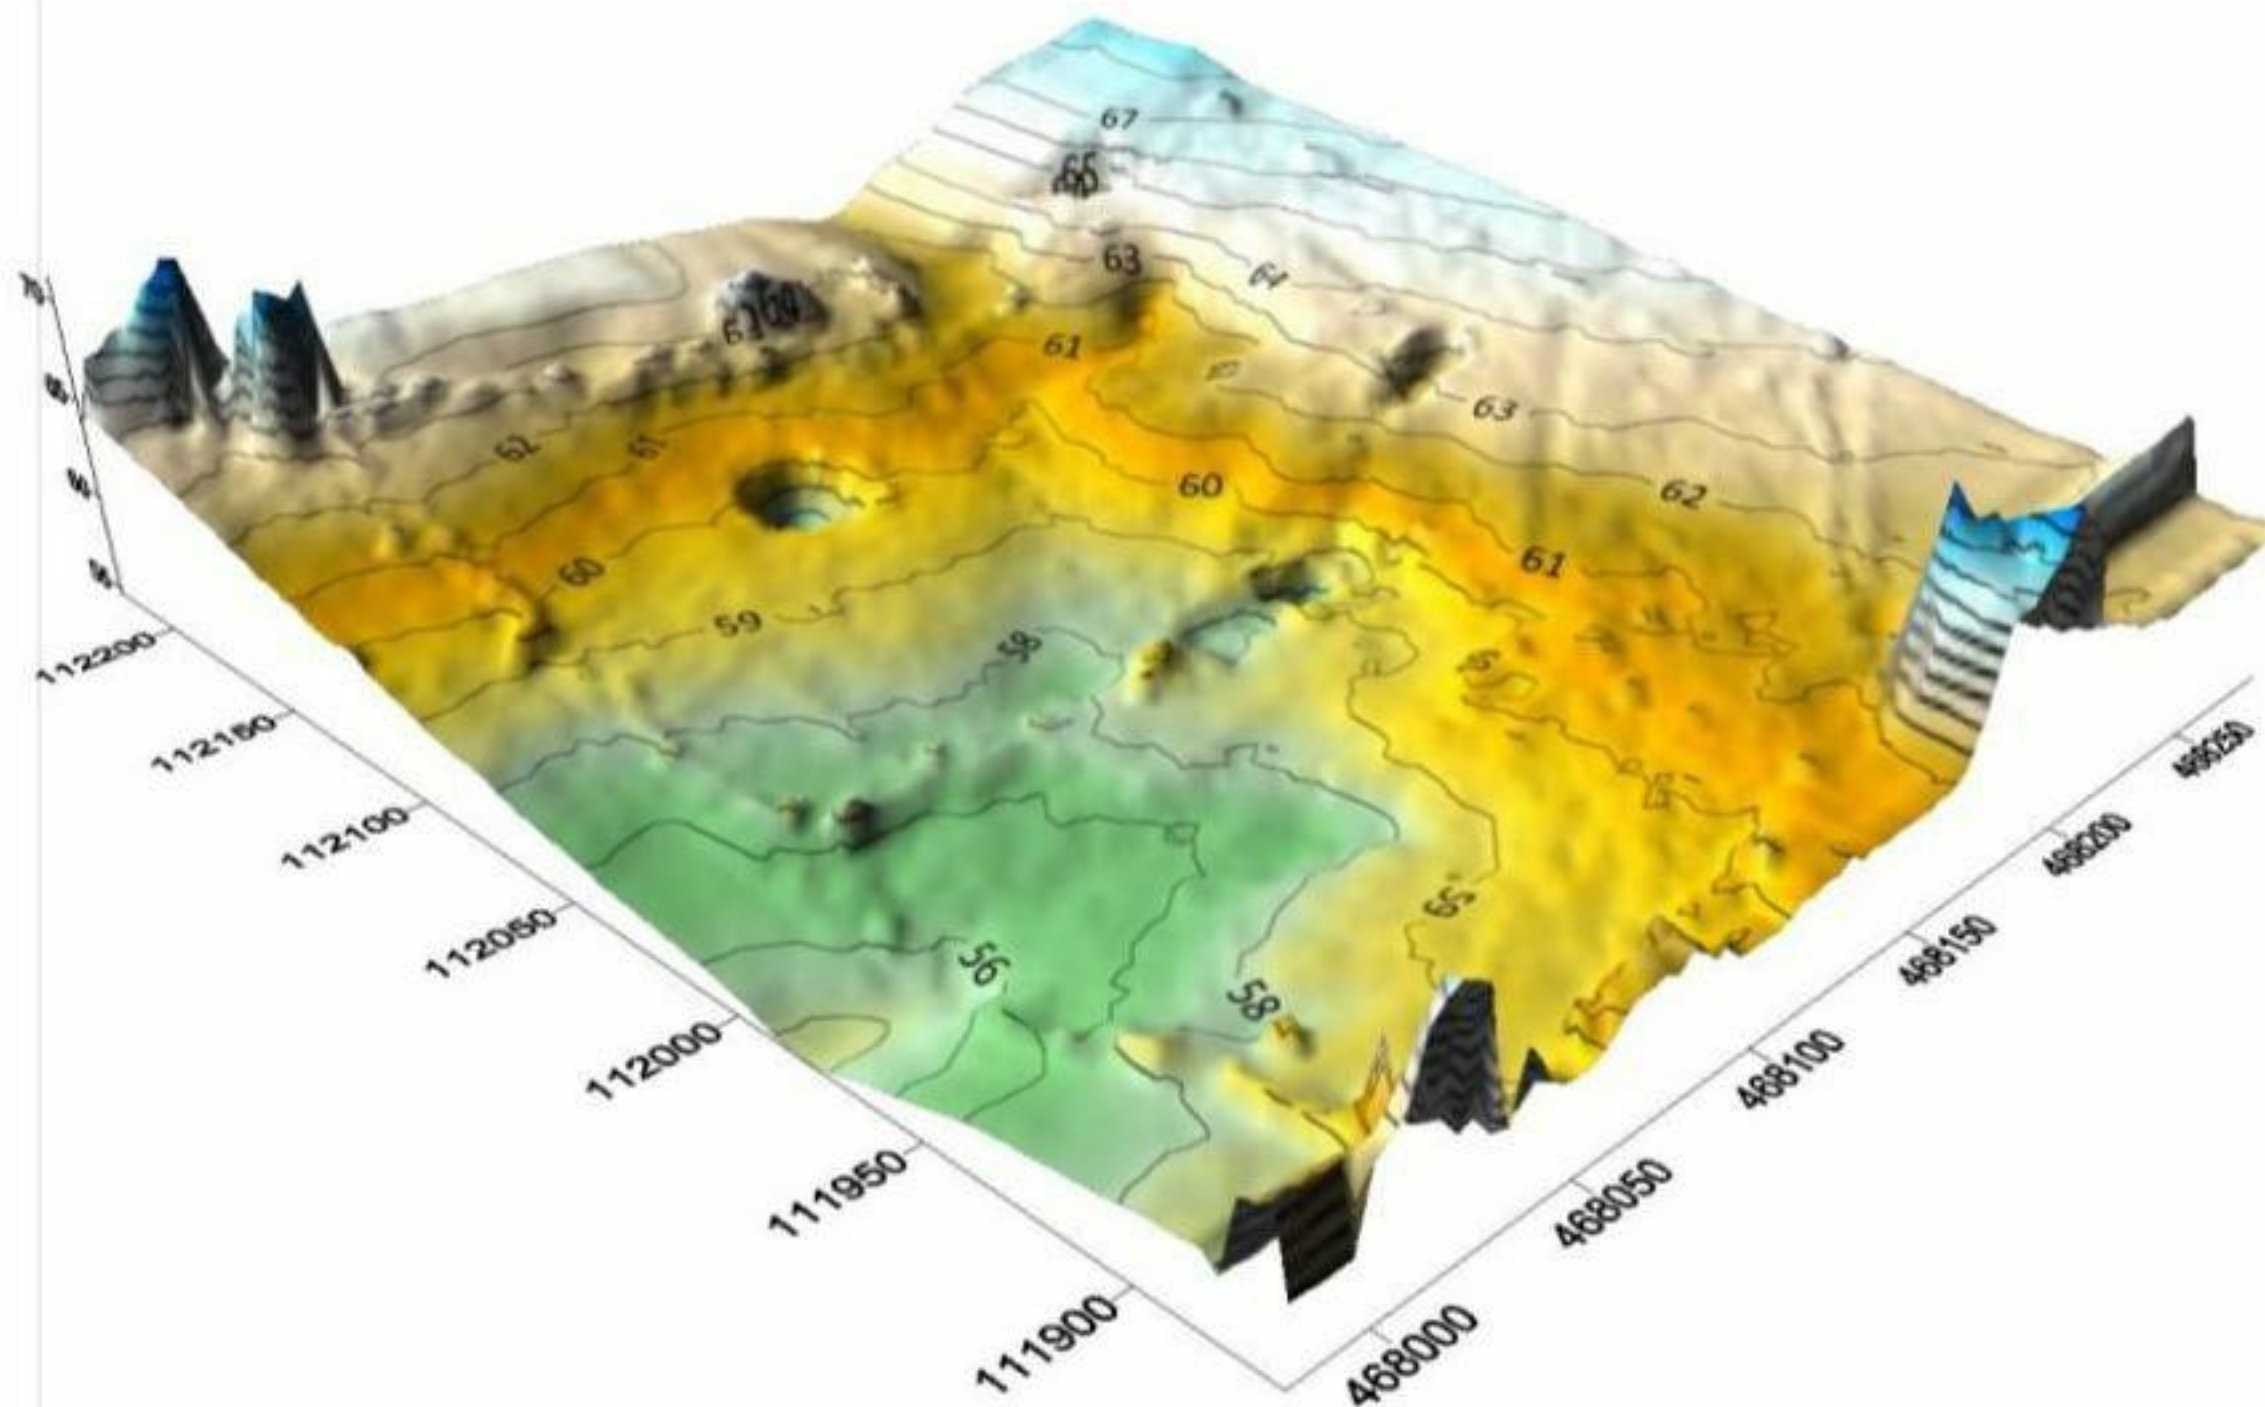
| <b>Project:</b> | Woodcroft Farm, Lovedean, Hampshire | | | <b>Title</b> | 3D ground surface contour model | |

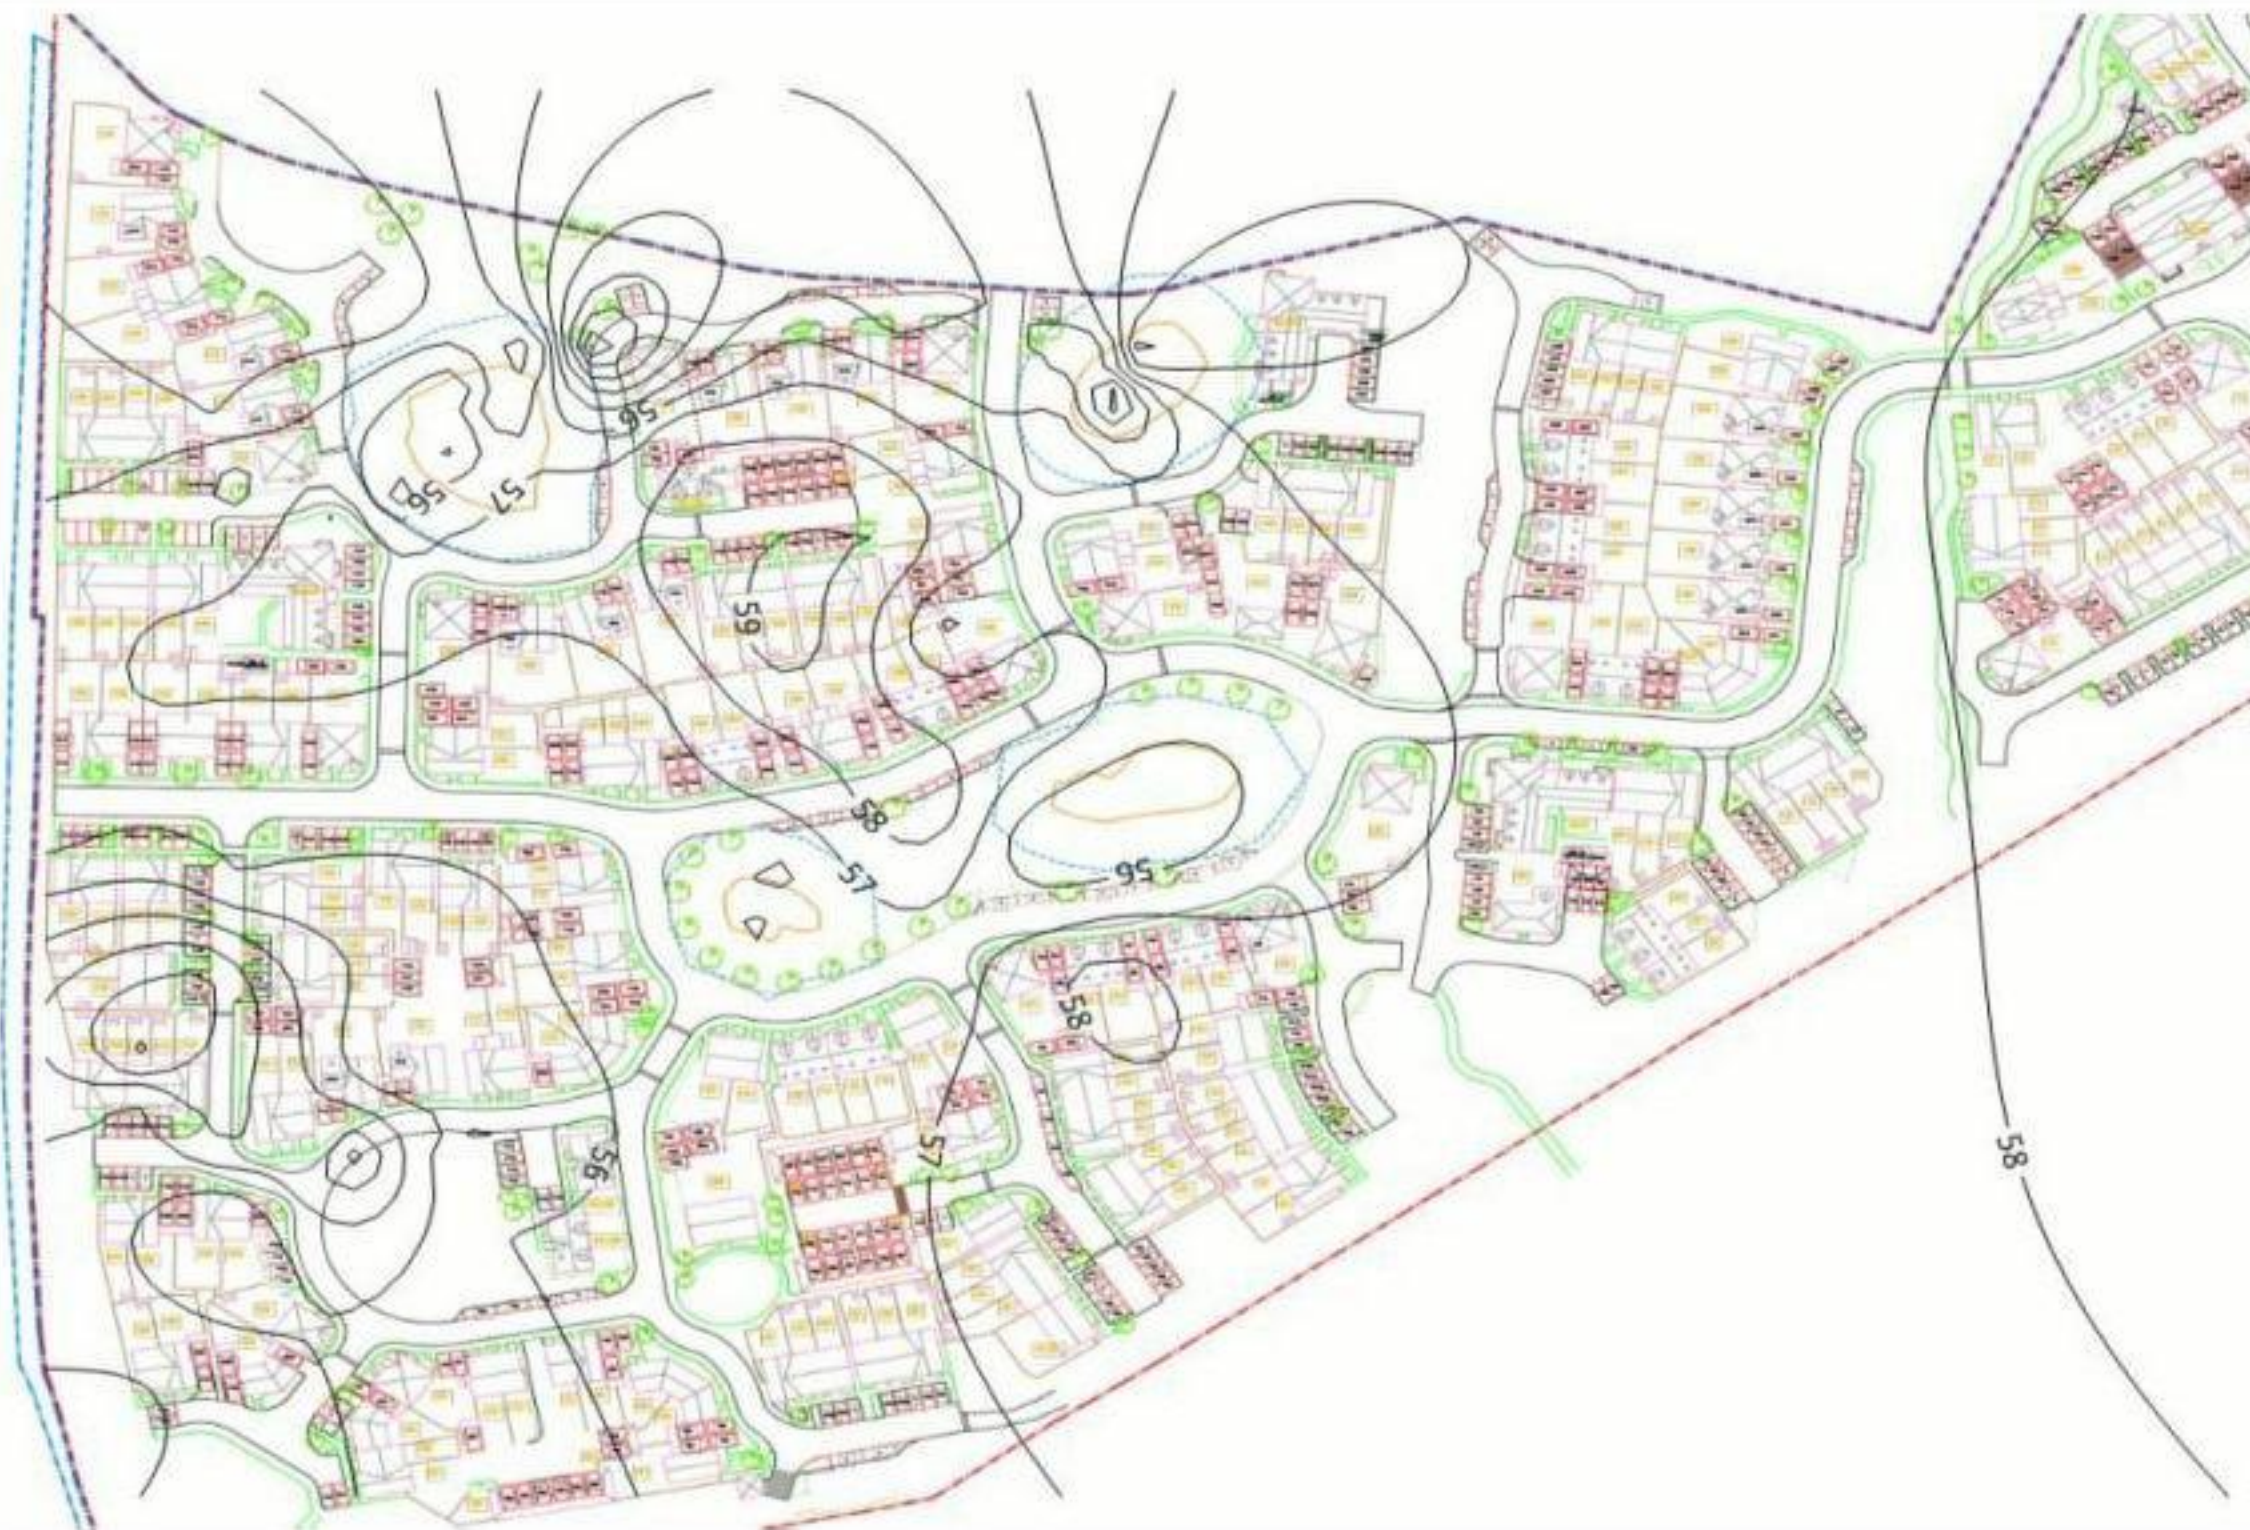
| <b>Project:</b> | Woodcroft Farm, Lovedean, Hampshire | | | <b>Title</b> | Chalk level contours on development layout | |
