**GEOTECHNICAL INTERPRETATIVE REPORT**  
**for the site at**  
**PHASE 2 AREA, WOODCROFT FARM,**  
**LOVEDEAN, HAMPSHIRE PO8 9QA**  
**on behalf of**  
**GRAINGER PLC**

| <b>Site:</b> | PHASE 2 AREA, WOODCROFT FARM, LOVEDEAN, HAMPSHIRE PO8 9QA |
| <b>Reference:</b> | GE16942-GIR-AUG18 |

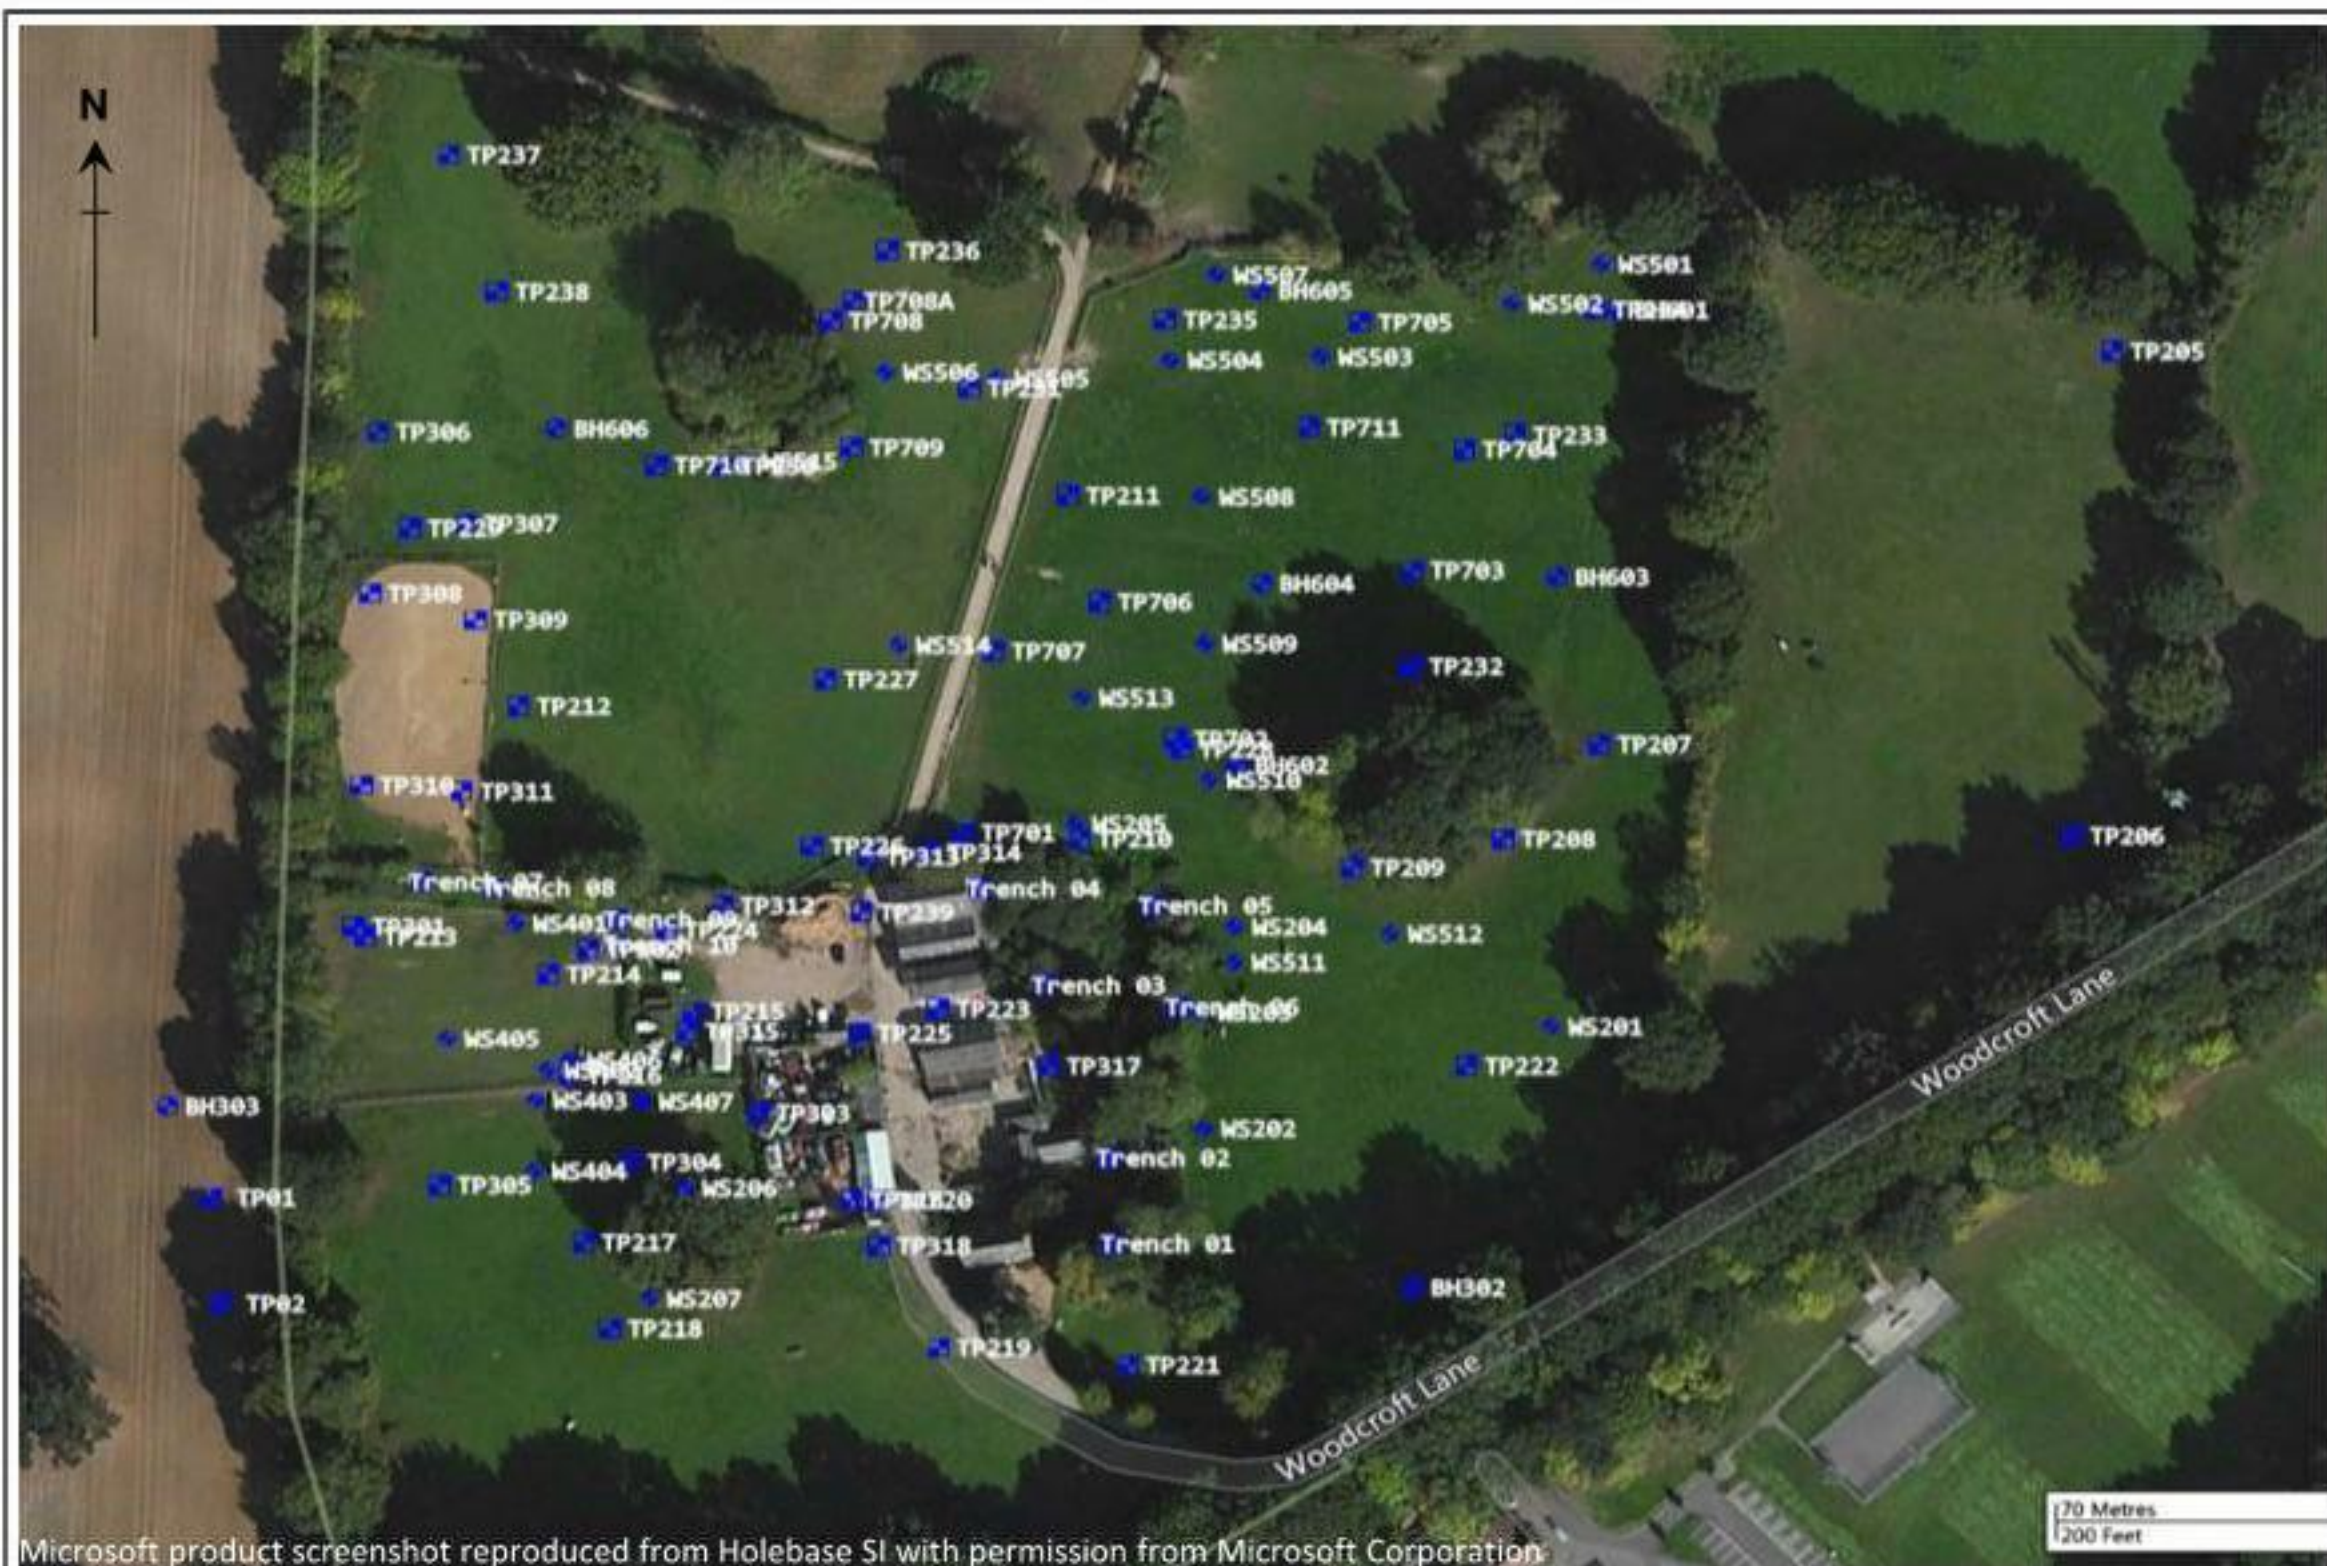
Cable percussion boreholes BH601 to BH606 were positioned to provide information to depth where development is proposed in proximity to Sinkholes 1-4 and other surface features as well as providing general coverage. Window sampler boreholes WS501 to WS515 were positioned along three survey lines crossing between the main sinkholes to clarify the ground conditions through the area of undulating and hummocky ground and target areas of proposed development. Trial pits and trenches TP701 to TP711 were located to provide further information on the ground conditions around specific sinkholes and also to target areas of hummocky/undulating ground surface, e.g. TP703 and TP704 targeted smaller scale surface depressions between Sinkholes 2 and 3, and TP711 targeted an elongated depression to the west of Sinkhole 2.

| <b>Project:</b> | Woodcroft Farm, Lovedean, Hampshire | | | <b>Title</b> | Exploratory Hole Location Plan | |

A factual record of the conditions encountered during the physical investigation of the subject site is presented in the following sections. Exploratory hole locations are shown in Figure 3.

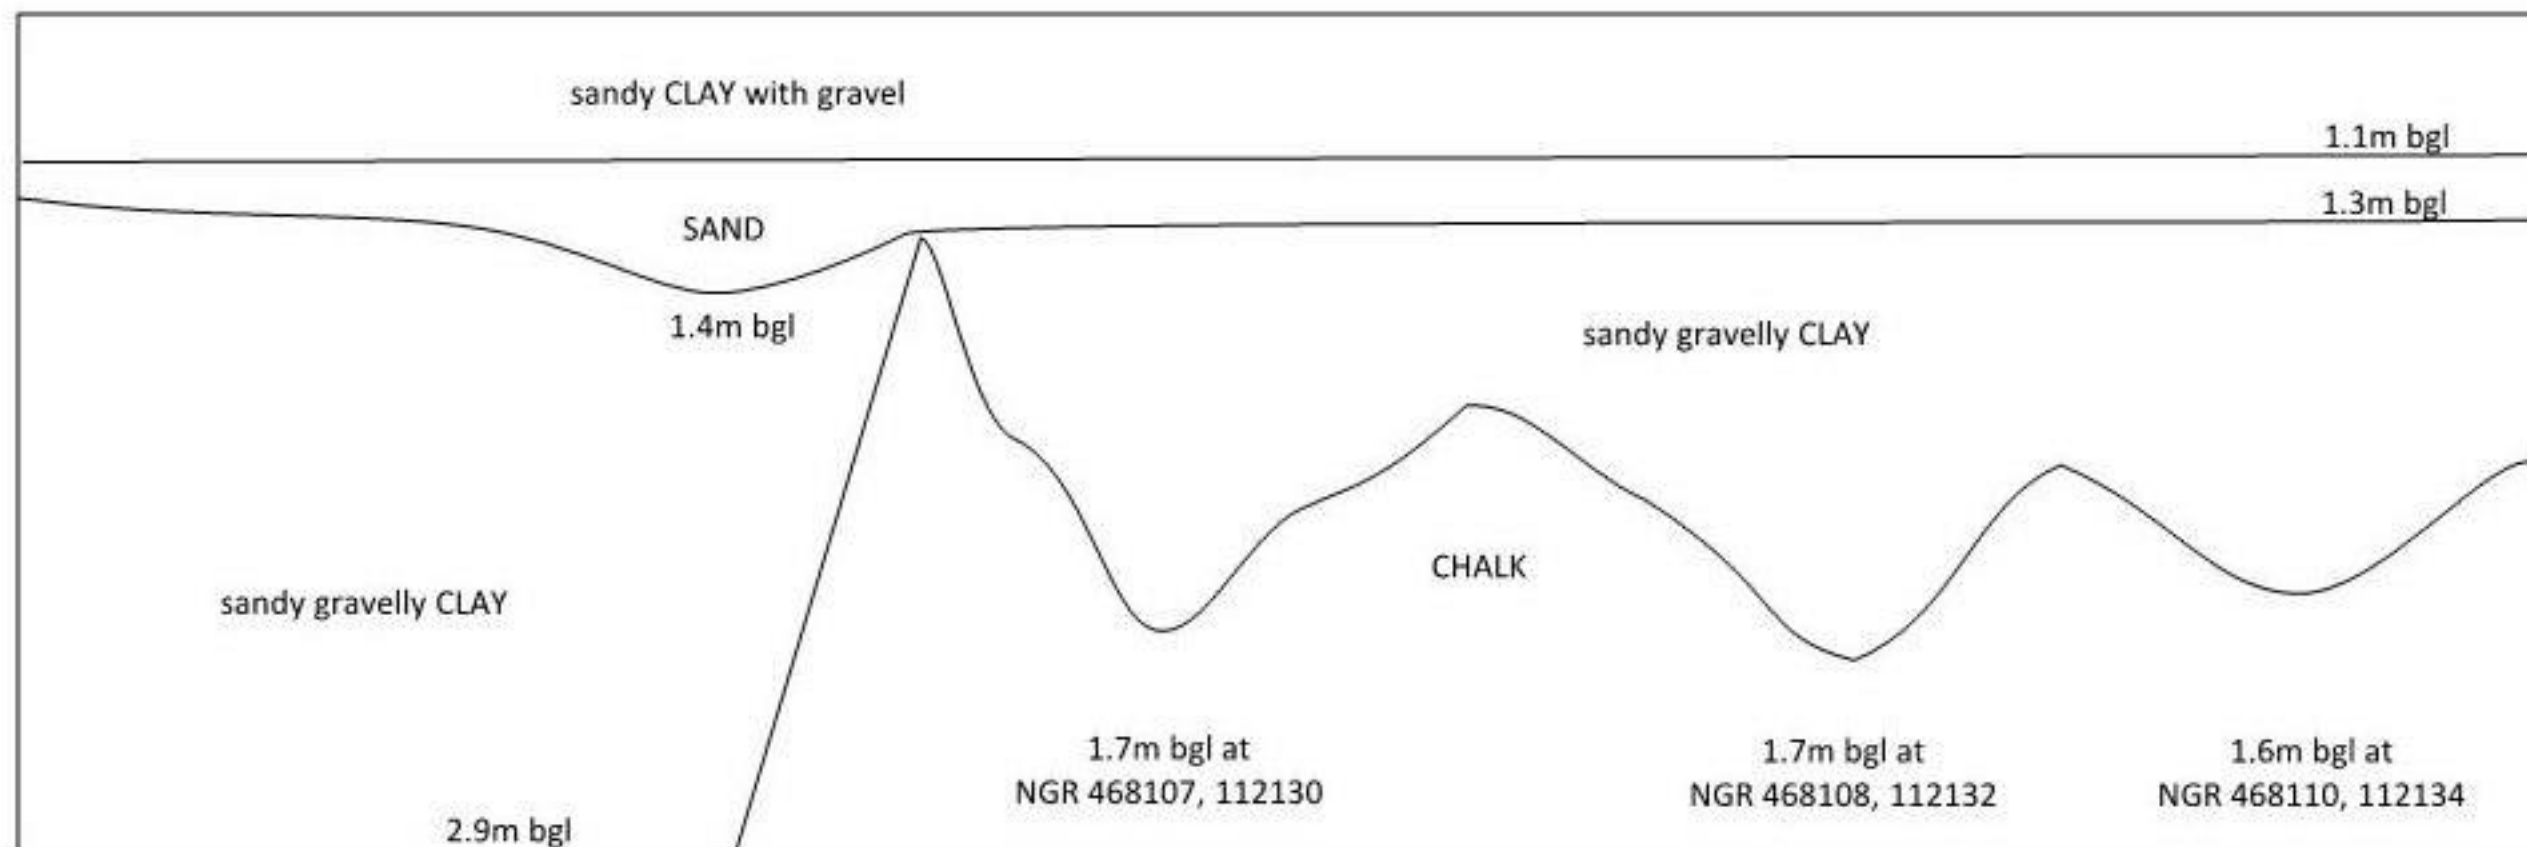
Chalk interface with sandy gravelly  
CLAY plunging WSW at c.70-80° at  
NGR468109, 112136

Refer to TP708 and TP708A logs for detailed descriptions of strata

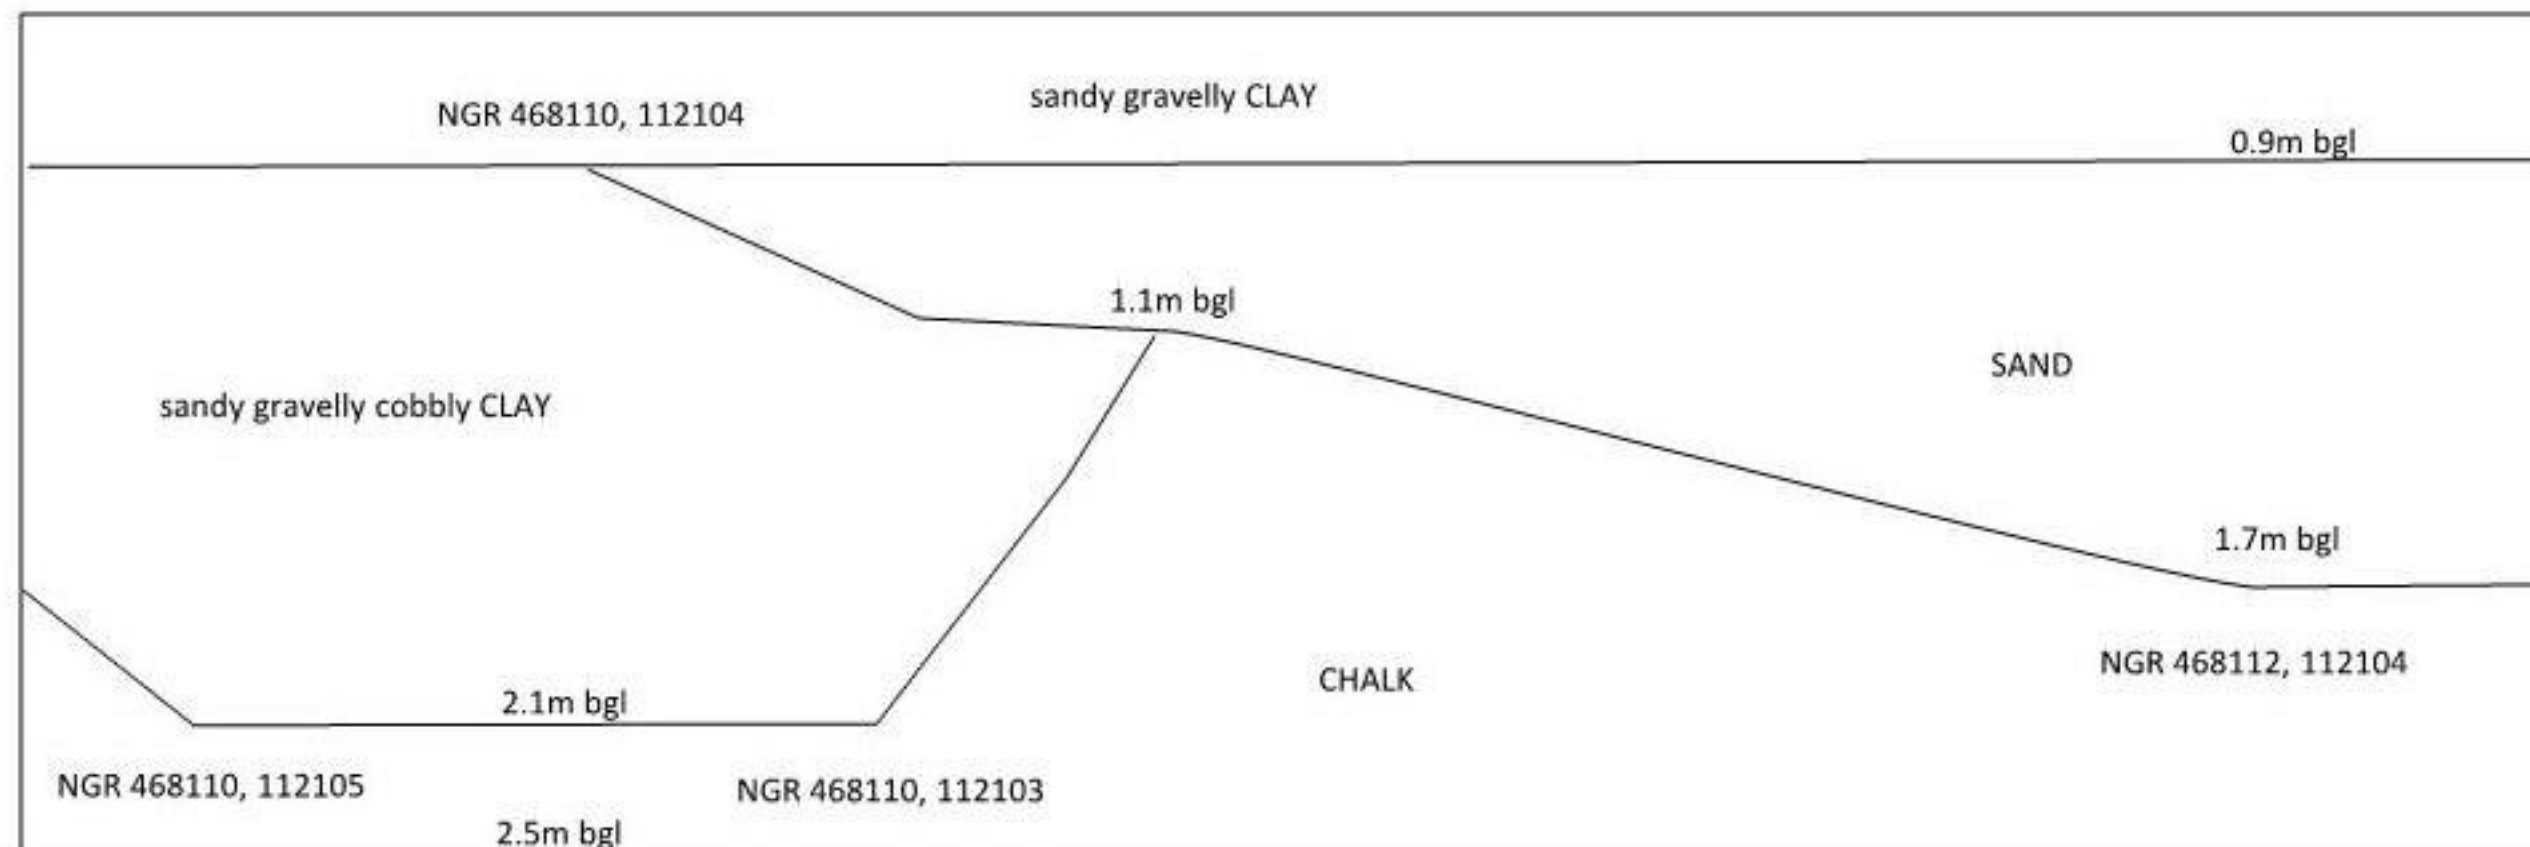
Refer to TP709 log for detailed descriptions of strata

| <b>Project:</b> | Woodcroft Farm, Lovedean | | | <b>Title</b> | TP709 Section sketch | |

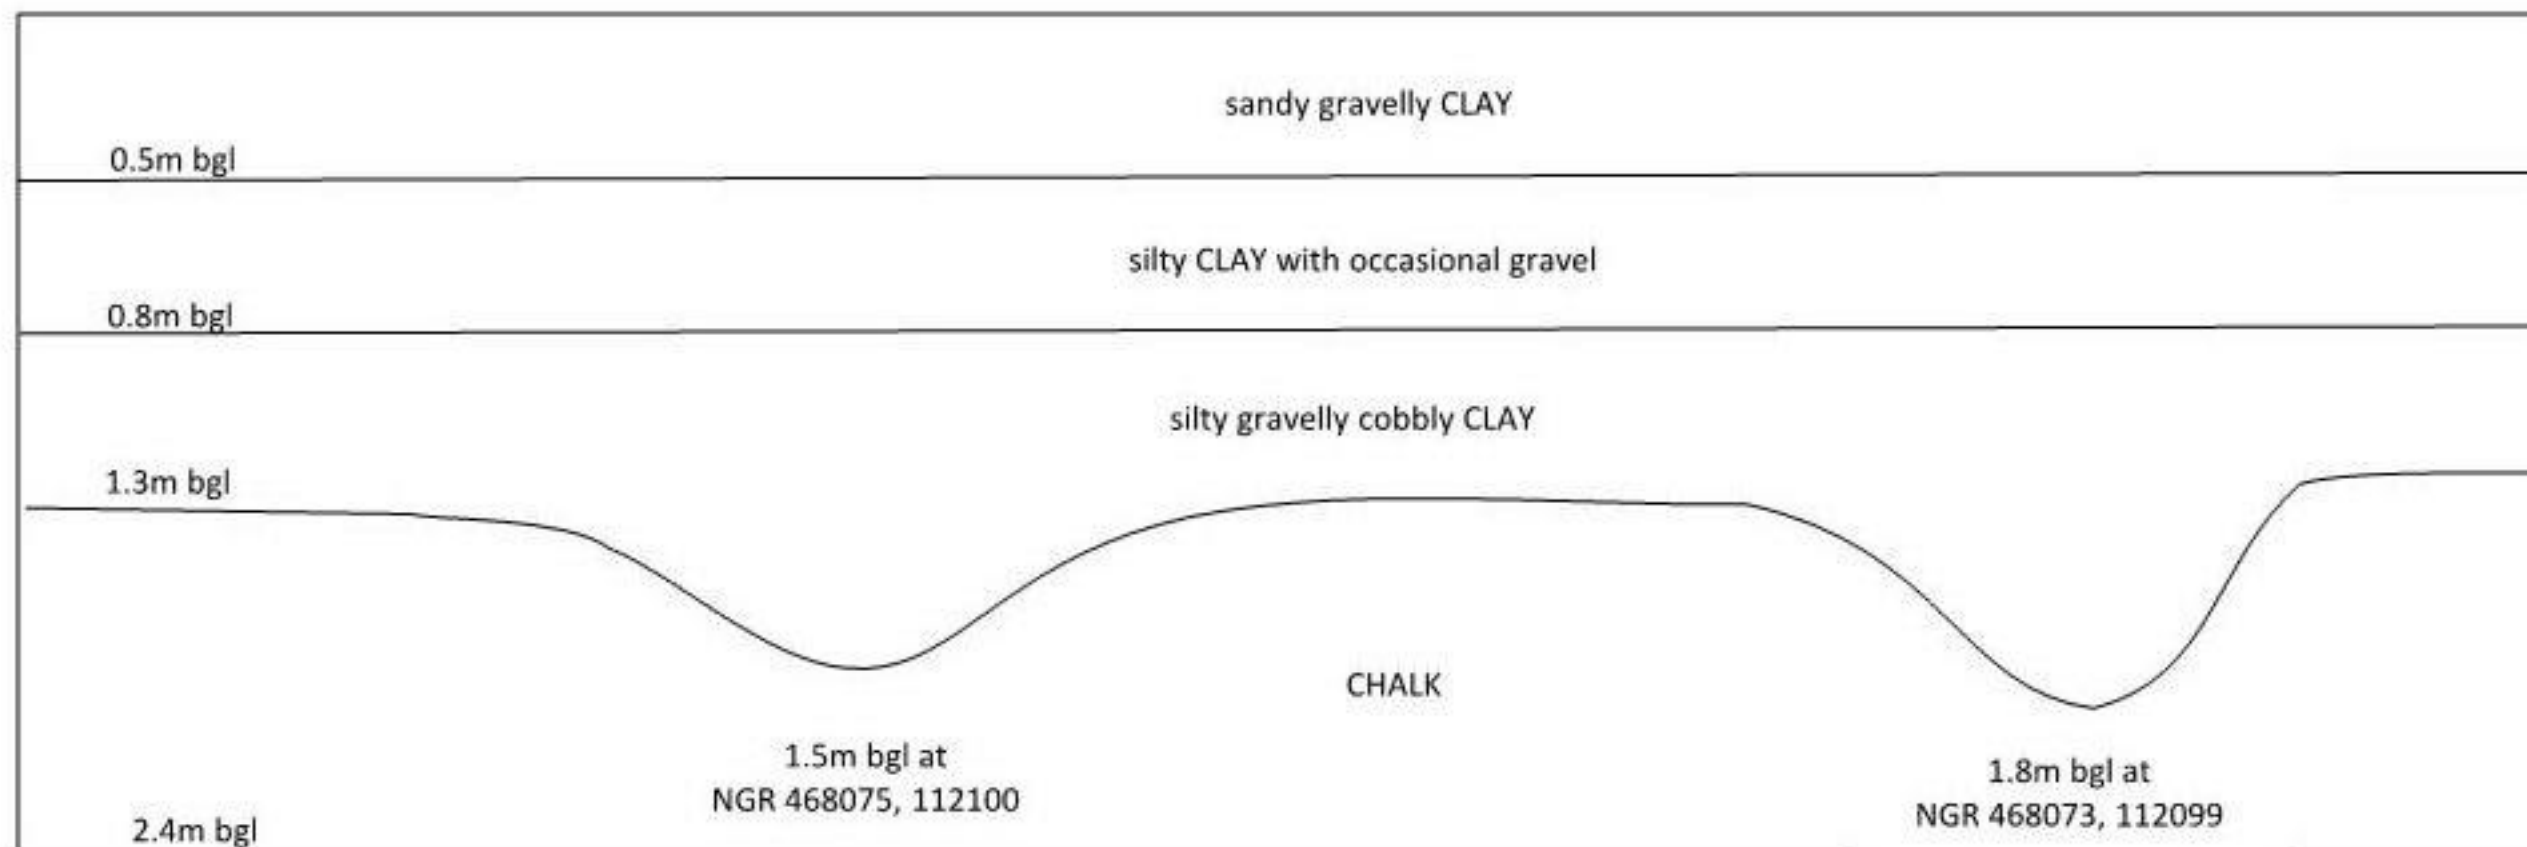
Refer to TP710 log for detailed descriptions of strata

| <b>Project:</b> | Woodcroft Farm, Lovedean | | | <b>Title</b> | TP710 Section sketch | |

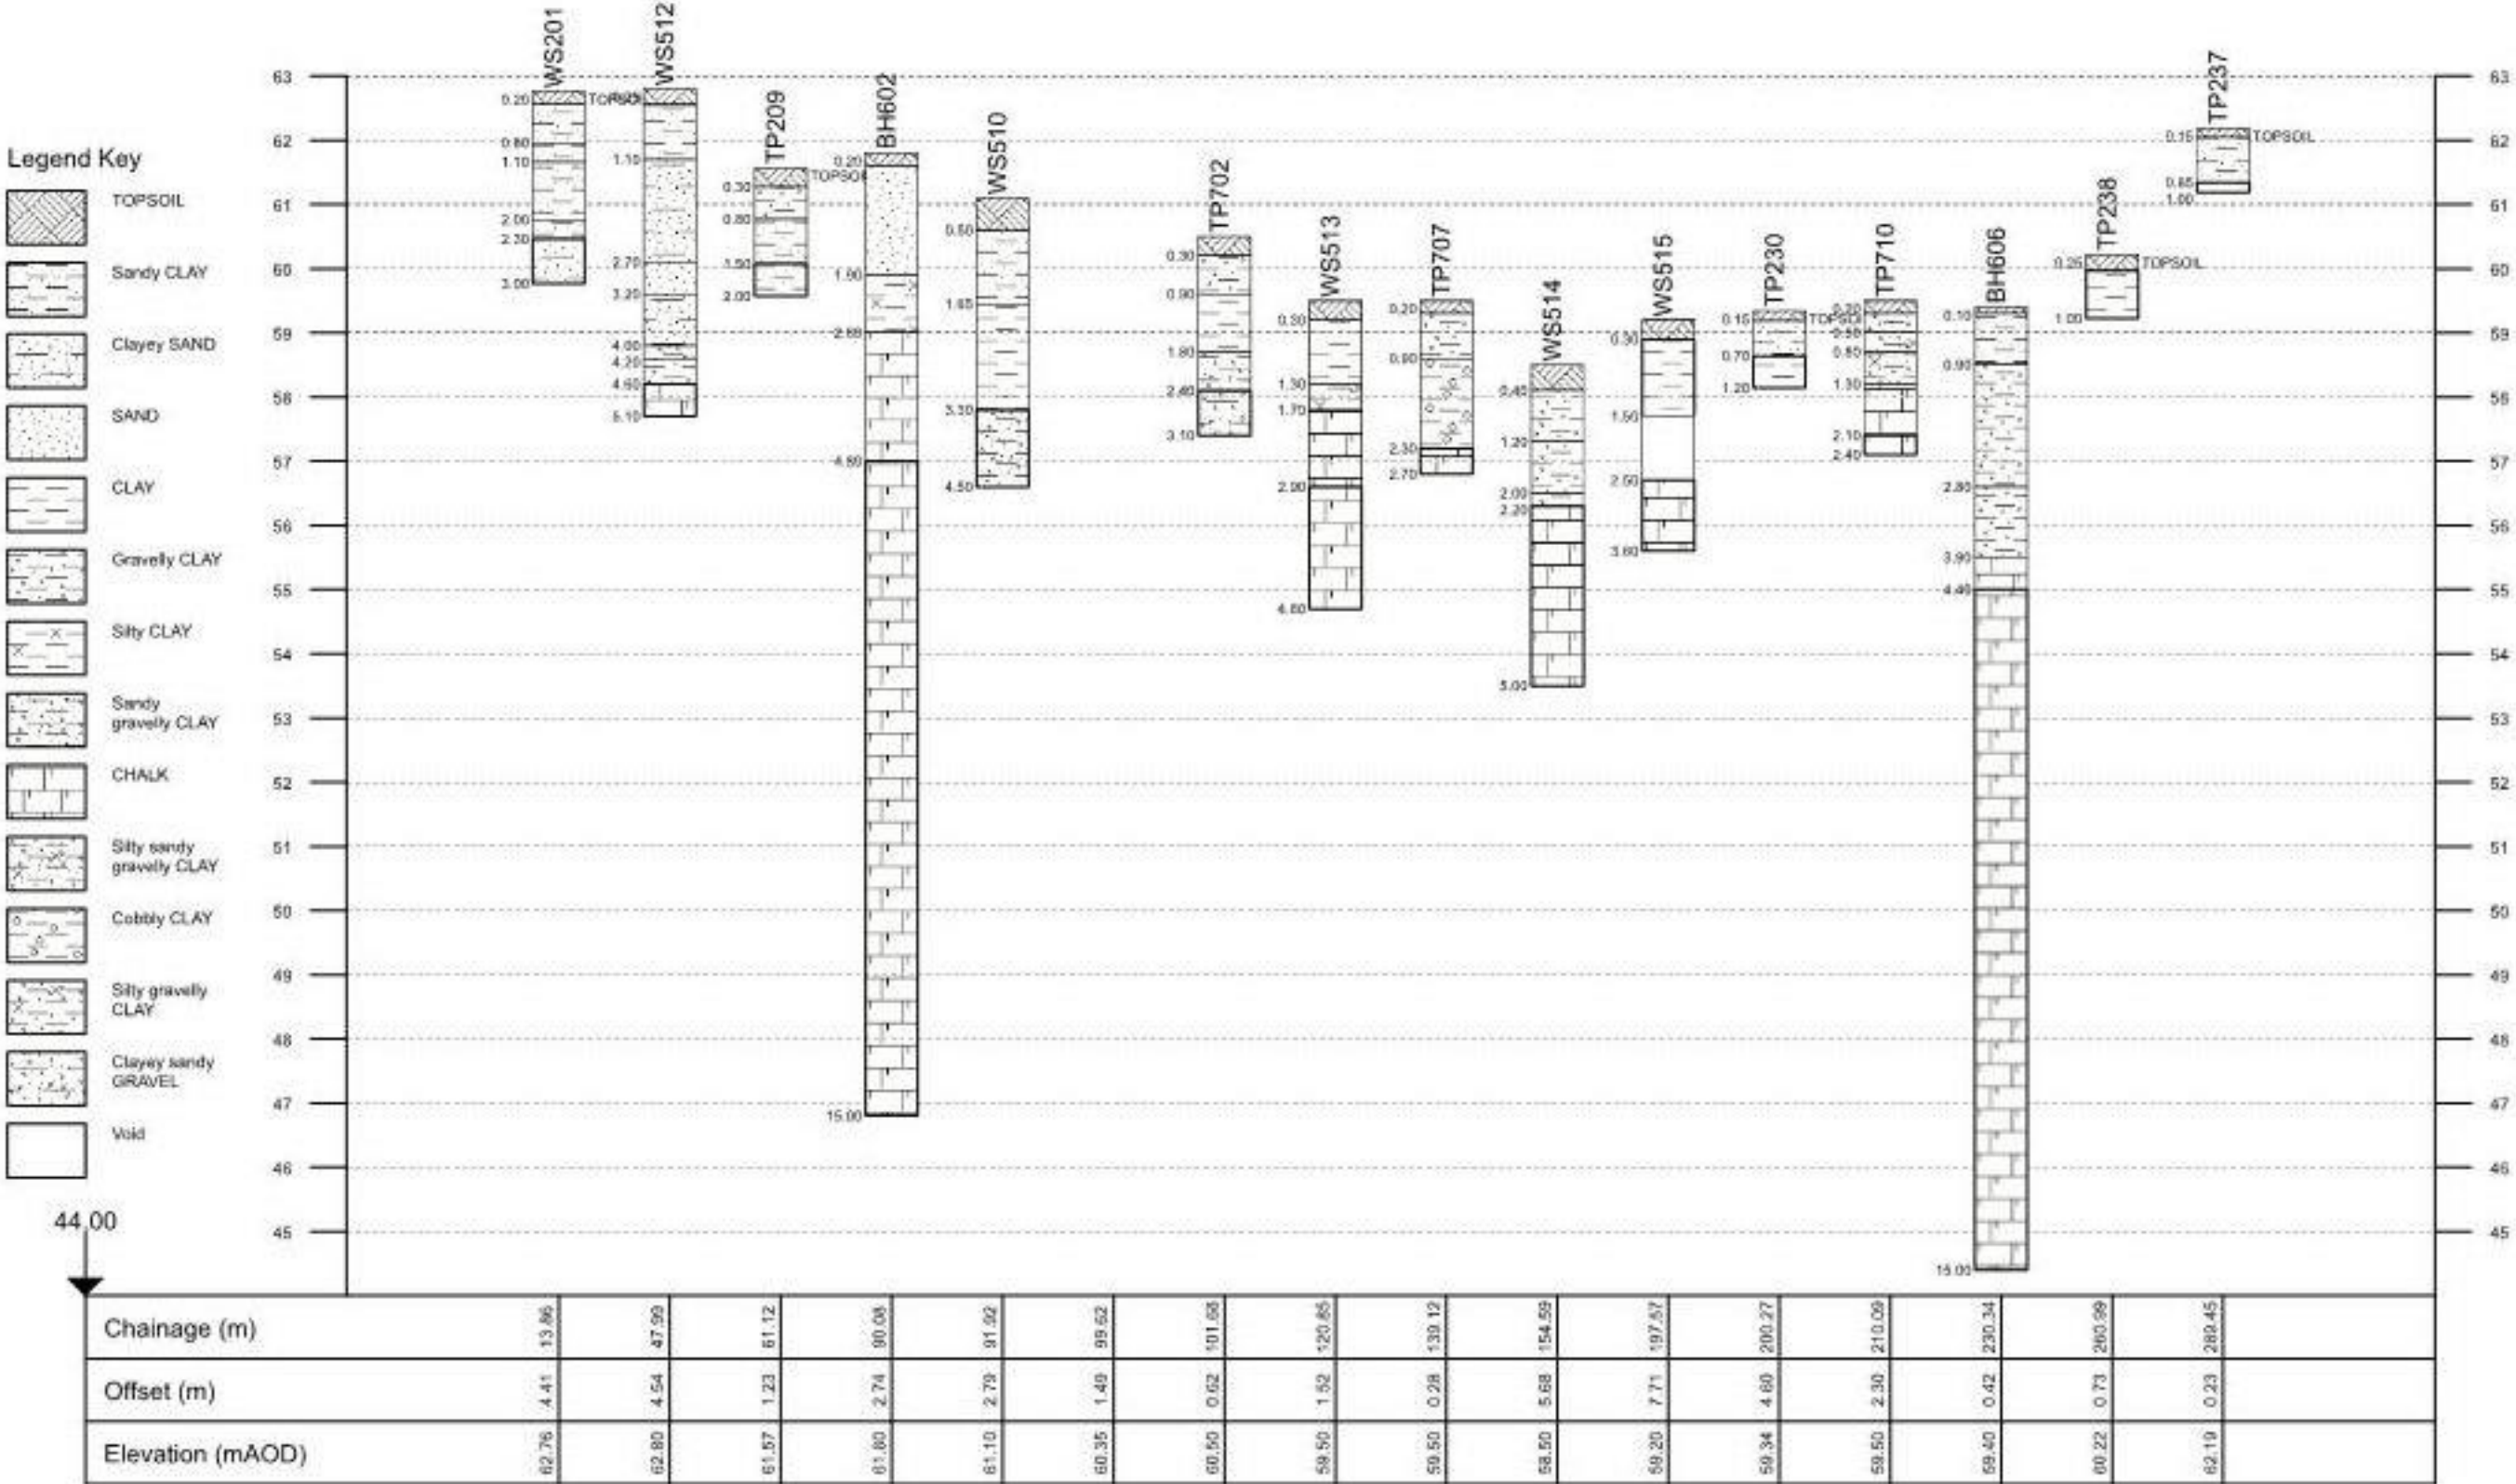
Figure 10 Section WS201 to TP237

Title: WS201 to TP237  
Vertical Scale: 1:146  
Horizontal Scale: Not to scale  
Engineer: GR

For further details of the ground conditions encountered, reference should be made to Figures 5 to 14 and the exploratory hole logs presented in Appendix A.

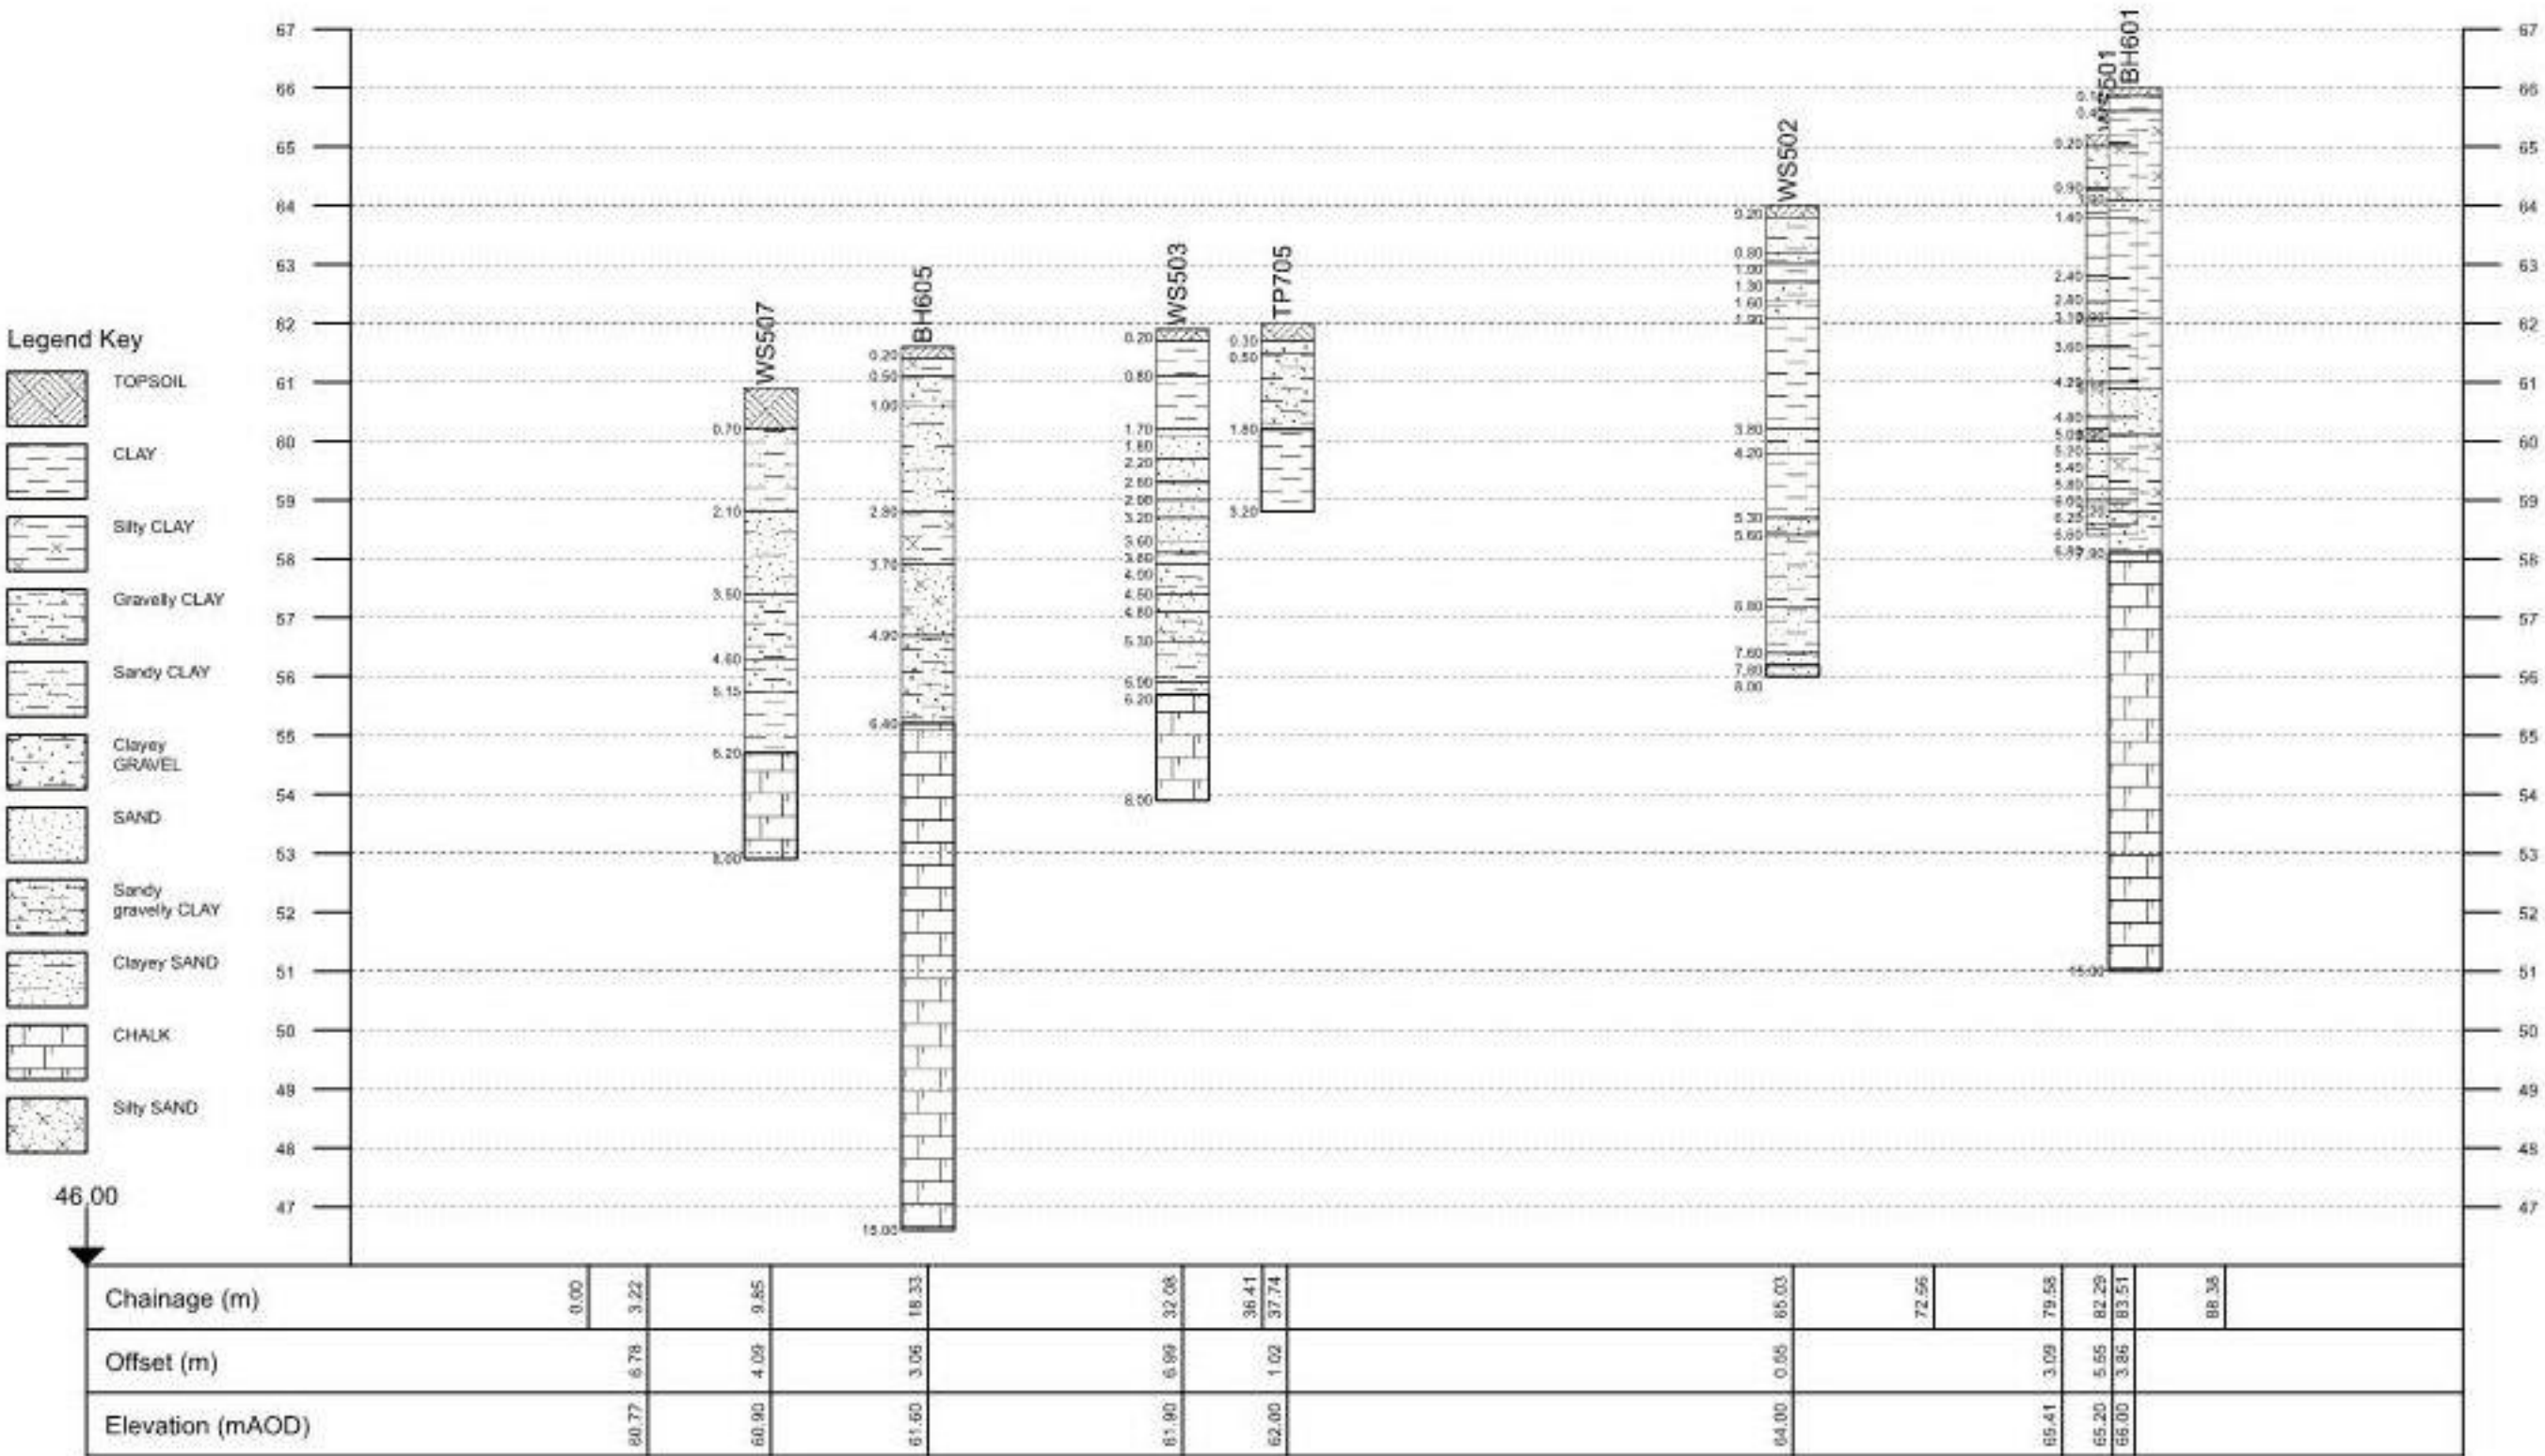
Figure 11 Section WS501 to WS507

Title: WS501 to BH606  
Vertical Scale: 1:176  
Horizontal Scale: Not to scale  
Engineer: GR

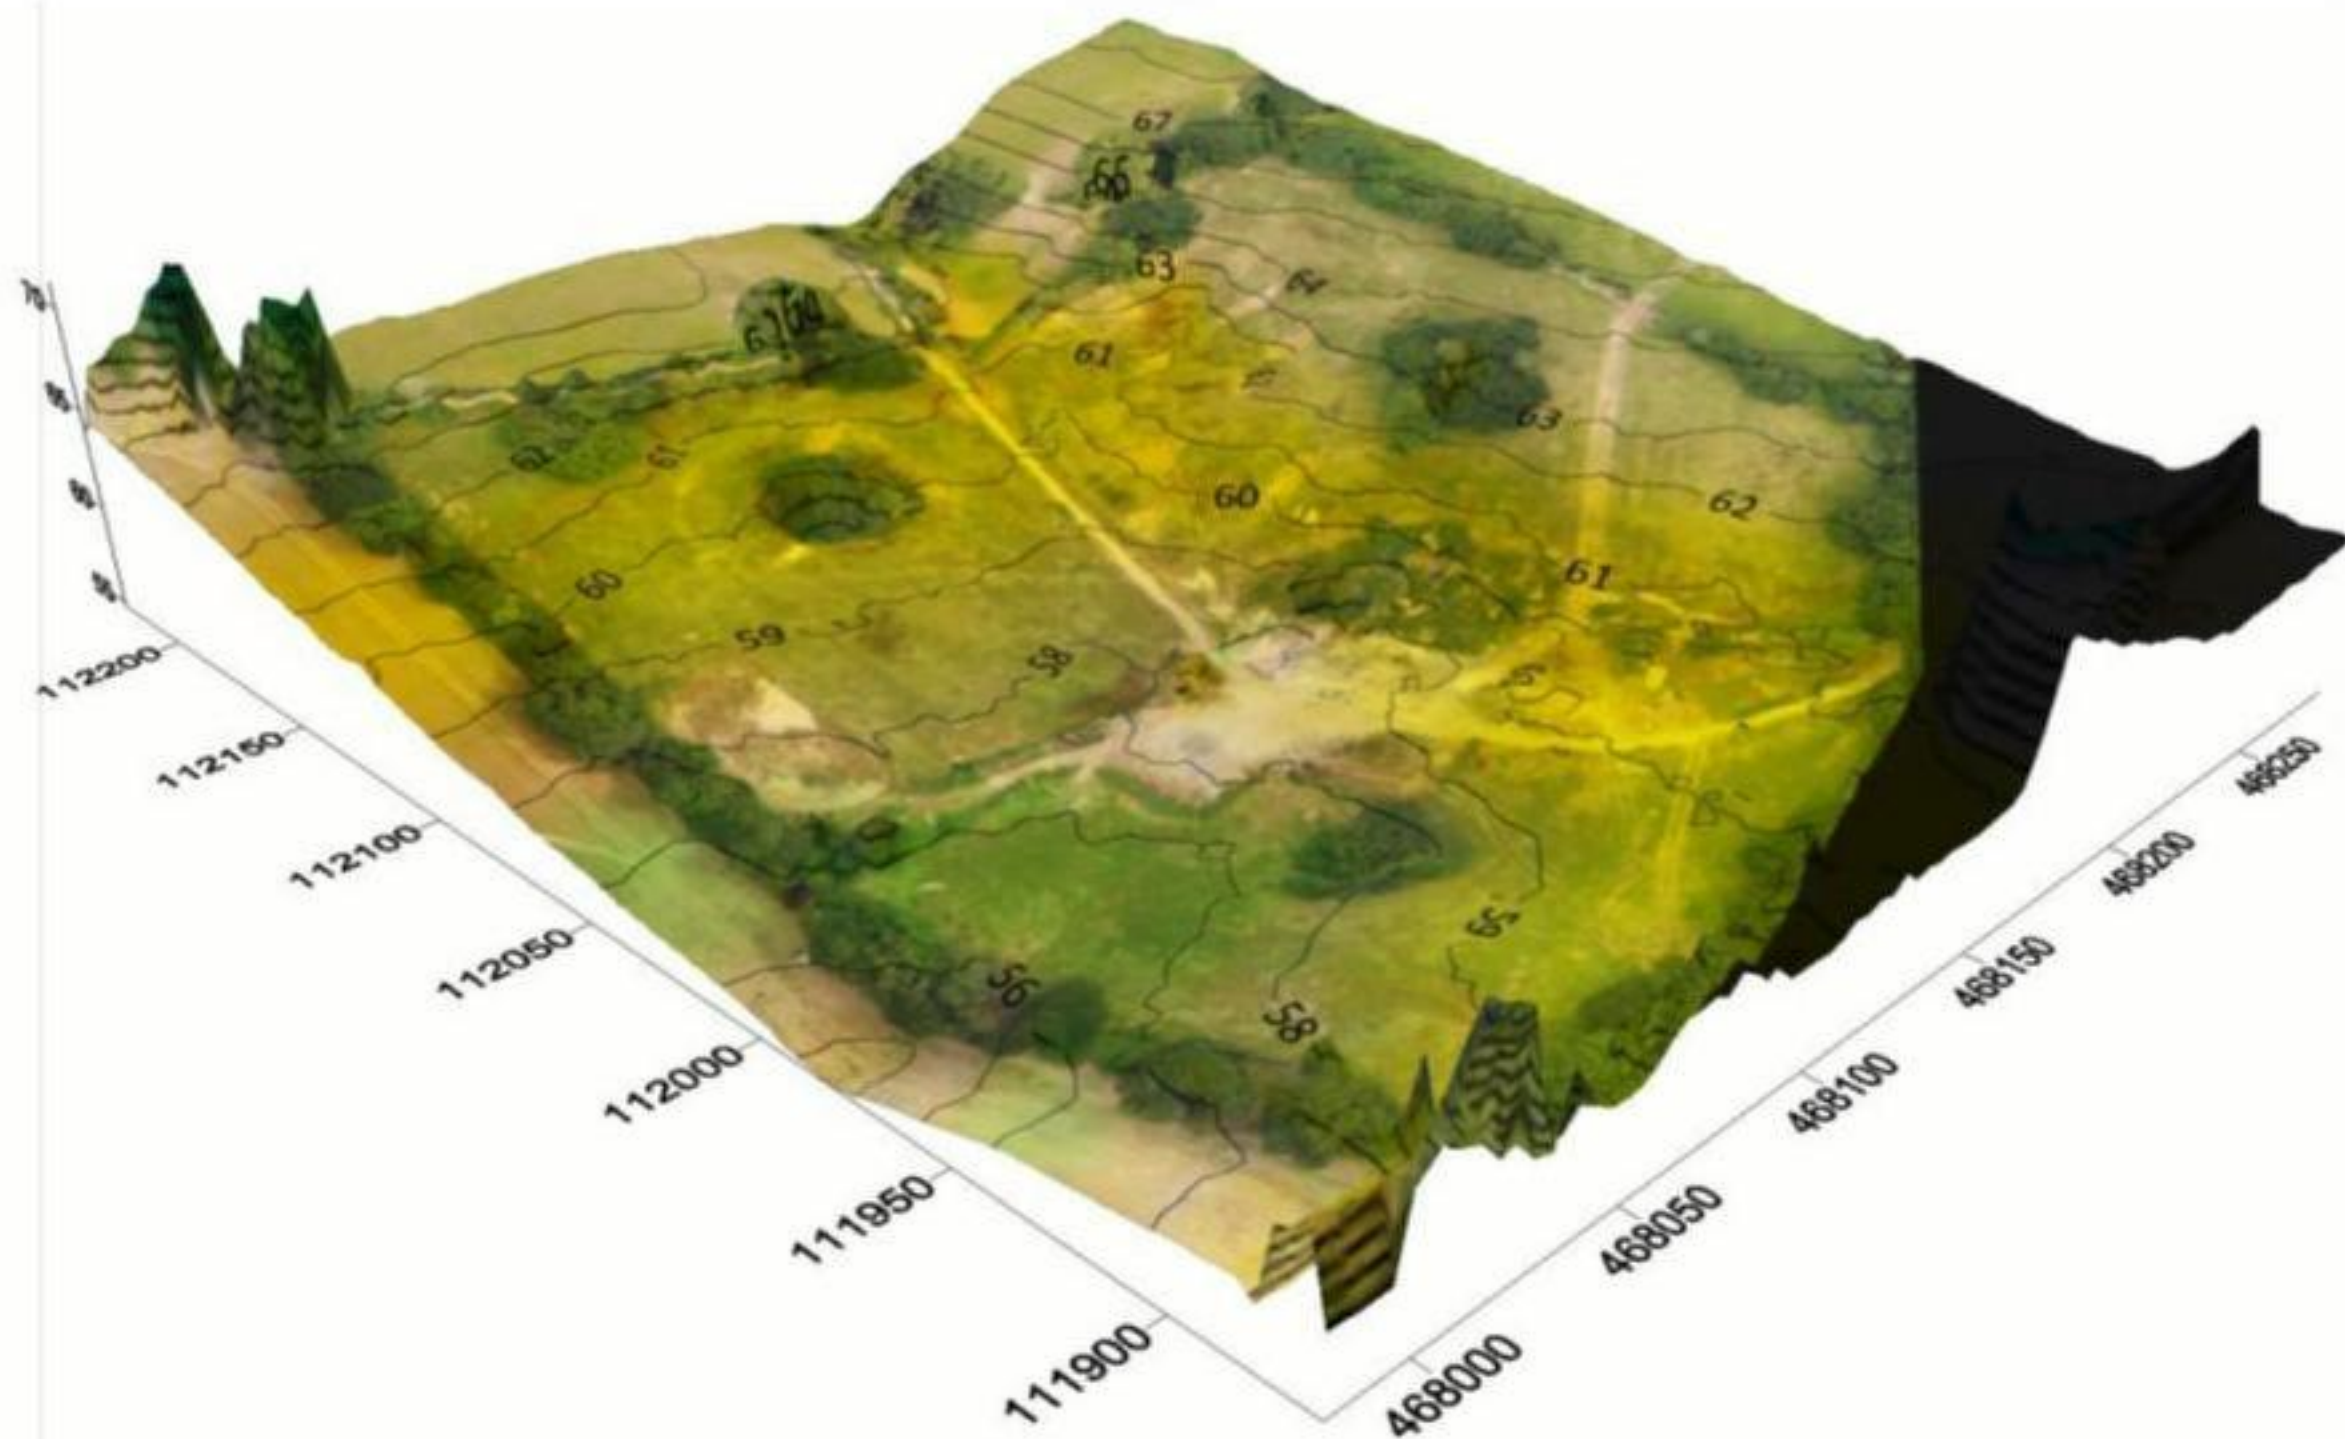
The aerial survey incorporated photogrammetry and LiDAR surveys to develop a Digital Terrain Model (DTM) of the site in its current condition, as shown in Figures 16 and 17. The DTM showed the ground levels to vary across the site and correlate with observed conditions, i.e. with a shallow and relatively broad valley feature crossing through the site from the northern boundary to the western boundary and extending into a more extensive dry valley feature located to the west and calling towards the west and south-west. Whilst the valley feature within the site was relatively broad, i.e. extend across much of the site, the extension upgradient across the northern boundary was much narrower and appeared to tie-in with ground level undulations and depressions observed on the land to the north.

| <b>Project:</b> | Woodcroft Farm, Lovedean, Hampshire | | | <b>Title</b> | 3D Ground surface model | |

Figures 16-17 show the 3D DTM developed from the aerial survey and these clearly identify Sinkholes 1 to 4 and the valley feature described in Section 3.1. Figures 18 and 19 show the variation in depth to Chalk across this portion of the site and the chalk level 3D model, respectively. Figure 19 shows that there are sudden changes in the level of the upper surface of the Chalk around Sinkholes 1, 2 and 3, but no clear evidence around Sinkhole 4 despite the DTM indicating the presence of Sinkhole 4 and corroborating previous phases of investigation. It is possible that the variation in level of the Chalk is less pronounced around Sinkhole 4. Figure 19 also indicates the presence of a sharp change (lowering) in level to the upper surface of the Chalk along the northern boundary between Sinkholes 1 and 2, as postulated in a previous third party report, and appears to extend off-site to the north. The boundary of this additional feature may differ from that predicted in the model as there was no ground investigation information on the land to the north (outside of the site), but the portion of the feature within the site was modelled based on a combination of the DTM and ground investigation information.
