**GEOTECHNICAL INTERPRETATIVE REPORT**  
**for the site at**  
**PHASE 2 AREA, WOODCROFT FARM,**  
**LOVEDEAN, HAMPSHIRE PO8 9QA**  
**on behalf of**  
**GRAINGER PLC**

| <b>Site:</b> | PHASE 2 AREA, WOODCROFT FARM, LOVEDEAN, HAMPSHIRE PO8 9QA |
| <b>Reference:</b> | GE16942-GIR-AUG18 |

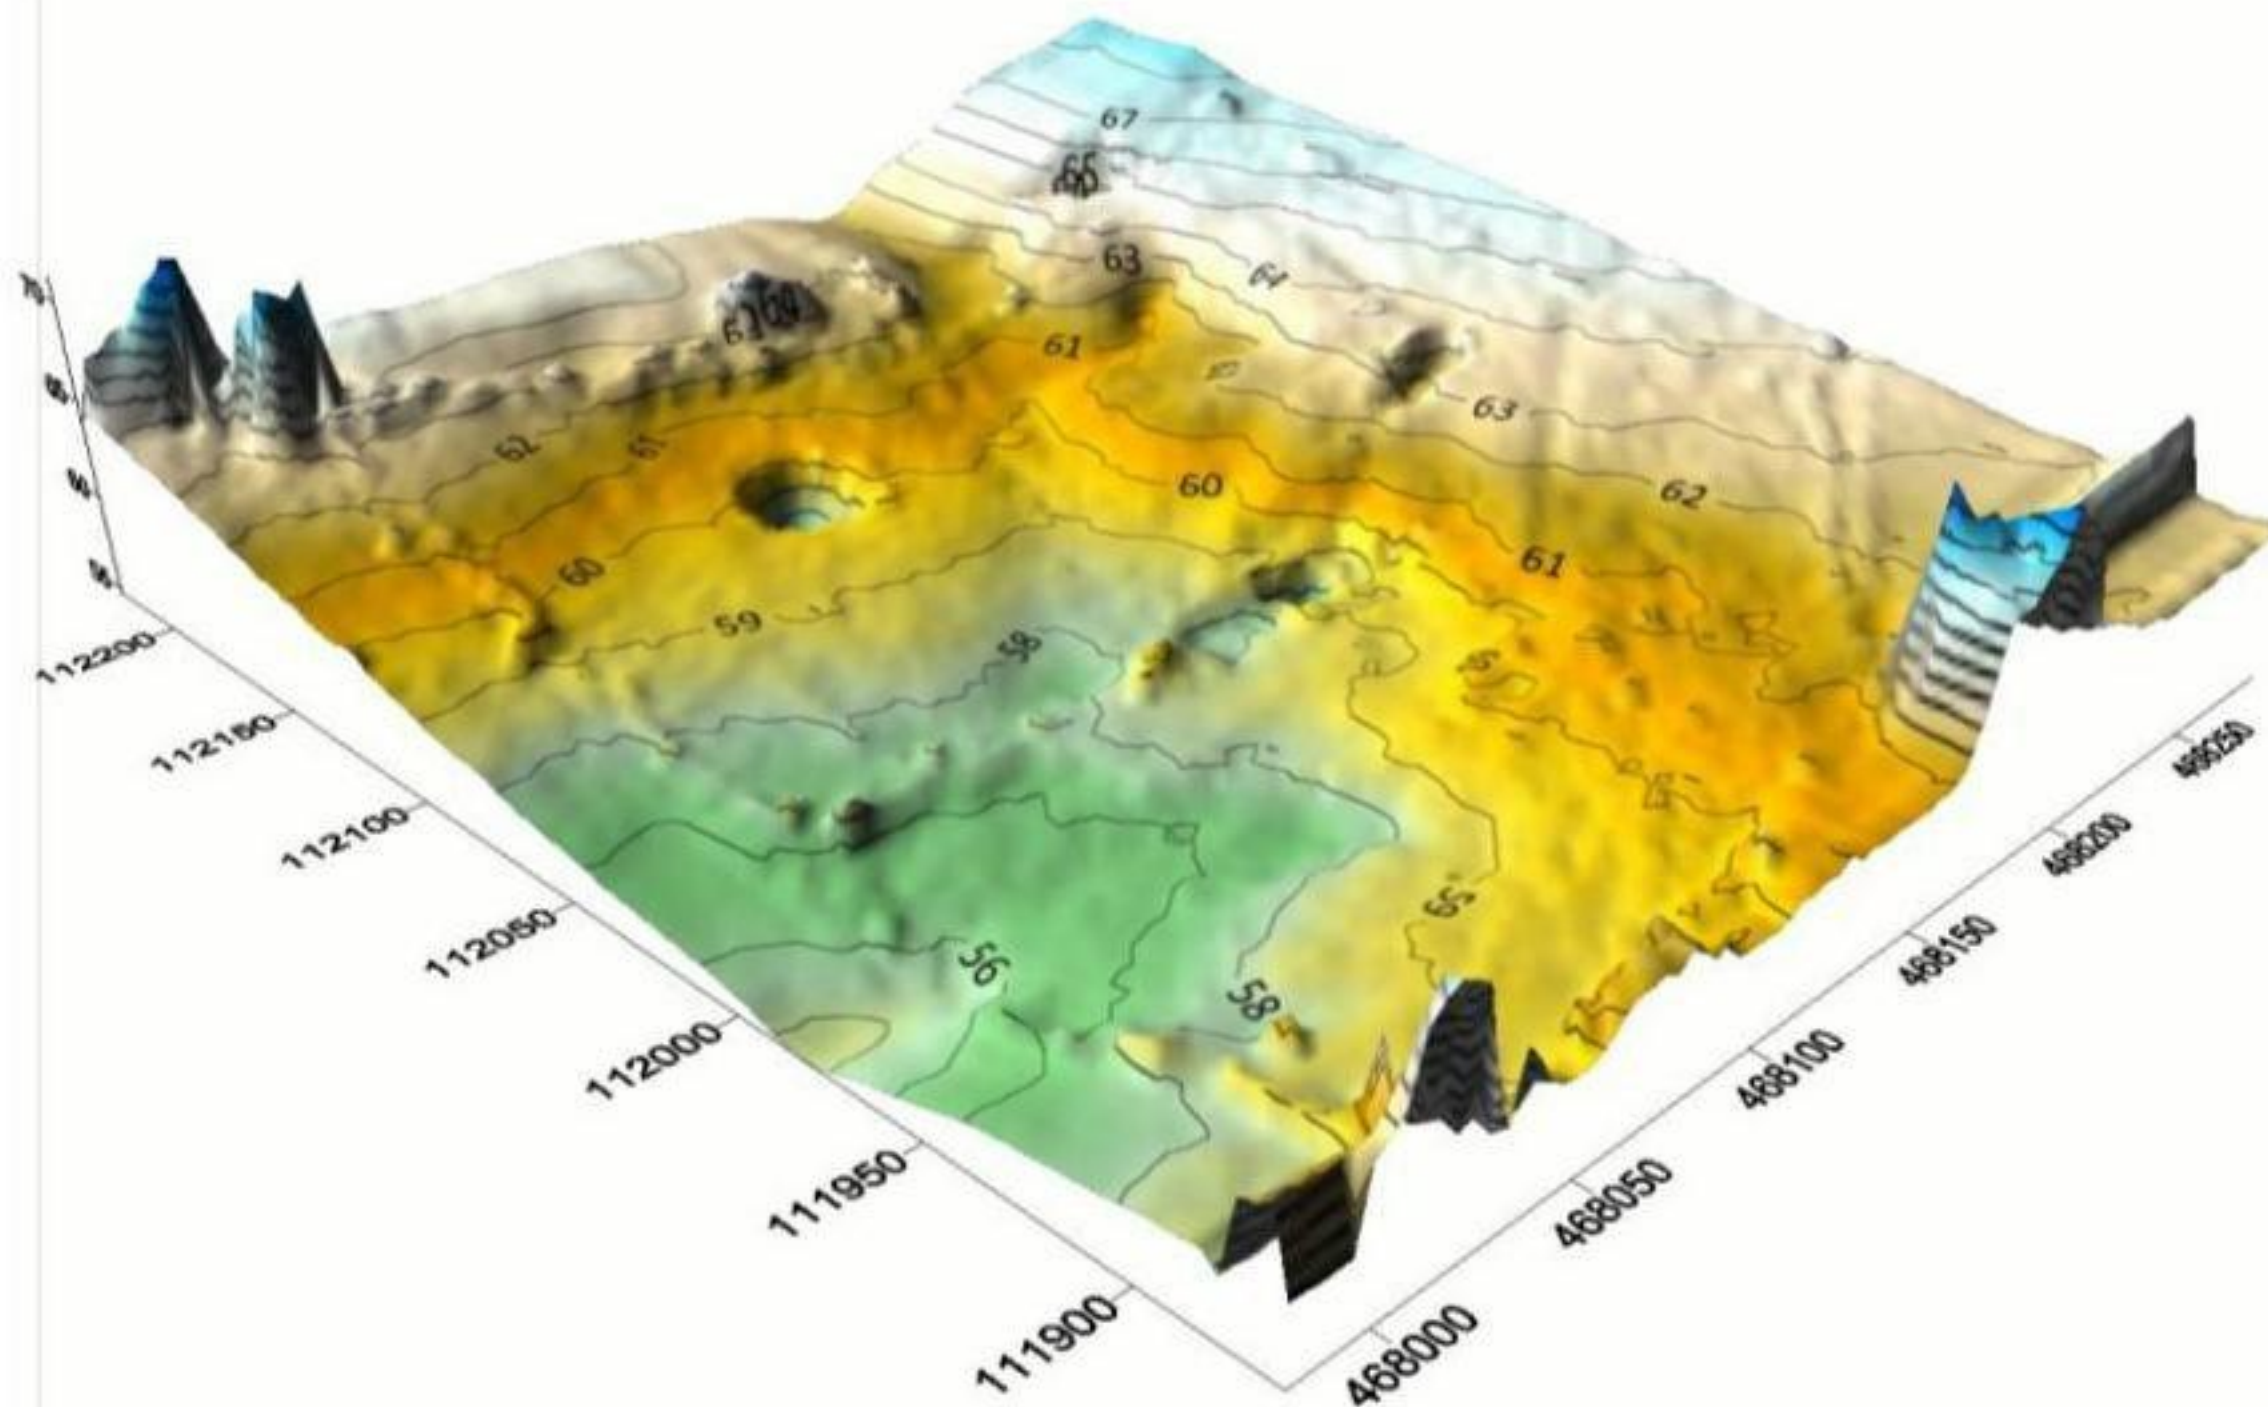
The aerial survey incorporated photogrammetry and LiDAR surveys to develop a Digital Terrain Model (DTM) of the site in its current condition, as shown in Figures 16 and 17. The DTM showed the ground levels to vary across the site and correlate with observed conditions, i.e. with a shallow and relatively broad valley feature crossing through the site from the northern boundary to the western boundary and extending into a more extensive dry valley feature located to the west and calling towards the west and south-west. Whilst the valley feature within the site was relatively broad, i.e. extend across much of the site, the extension upgradient across the northern boundary was much narrower and appeared to tie-in with ground level undulations and depressions observed on the land to the north.

| <b>Project:</b> | Woodcroft Farm, Lovedean, Hampshire | | | <b>Title</b> | 3D ground surface contour model | |

Figures 16-17 show the 3D DTM developed from the aerial survey and these clearly identify Sinkholes 1 to 4 and the valley feature described in Section 3.1. Figures 18 and 19 show the variation in depth to Chalk across this portion of the site and the chalk level 3D model, respectively. Figure 19 shows that there are sudden changes in the level of the upper surface of the Chalk around Sinkholes 1, 2 and 3, but no clear evidence around Sinkhole 4 despite the DTM indicating the presence of Sinkhole 4 and corroborating previous phases of investigation. It is possible that the variation in level of the Chalk is less pronounced around Sinkhole 4. Figure 19 also indicates the presence of a sharp change (lowering) in level to the upper surface of the Chalk along the northern boundary between Sinkholes 1 and 2, as postulated in a previous third party report, and appears to extend off-site to the north. The boundary of this additional feature may differ from that predicted in the model as there was no ground investigation information on the land to the north (outside of the site), but the portion of the feature within the site was modelled based on a combination of the DTM and ground investigation information.

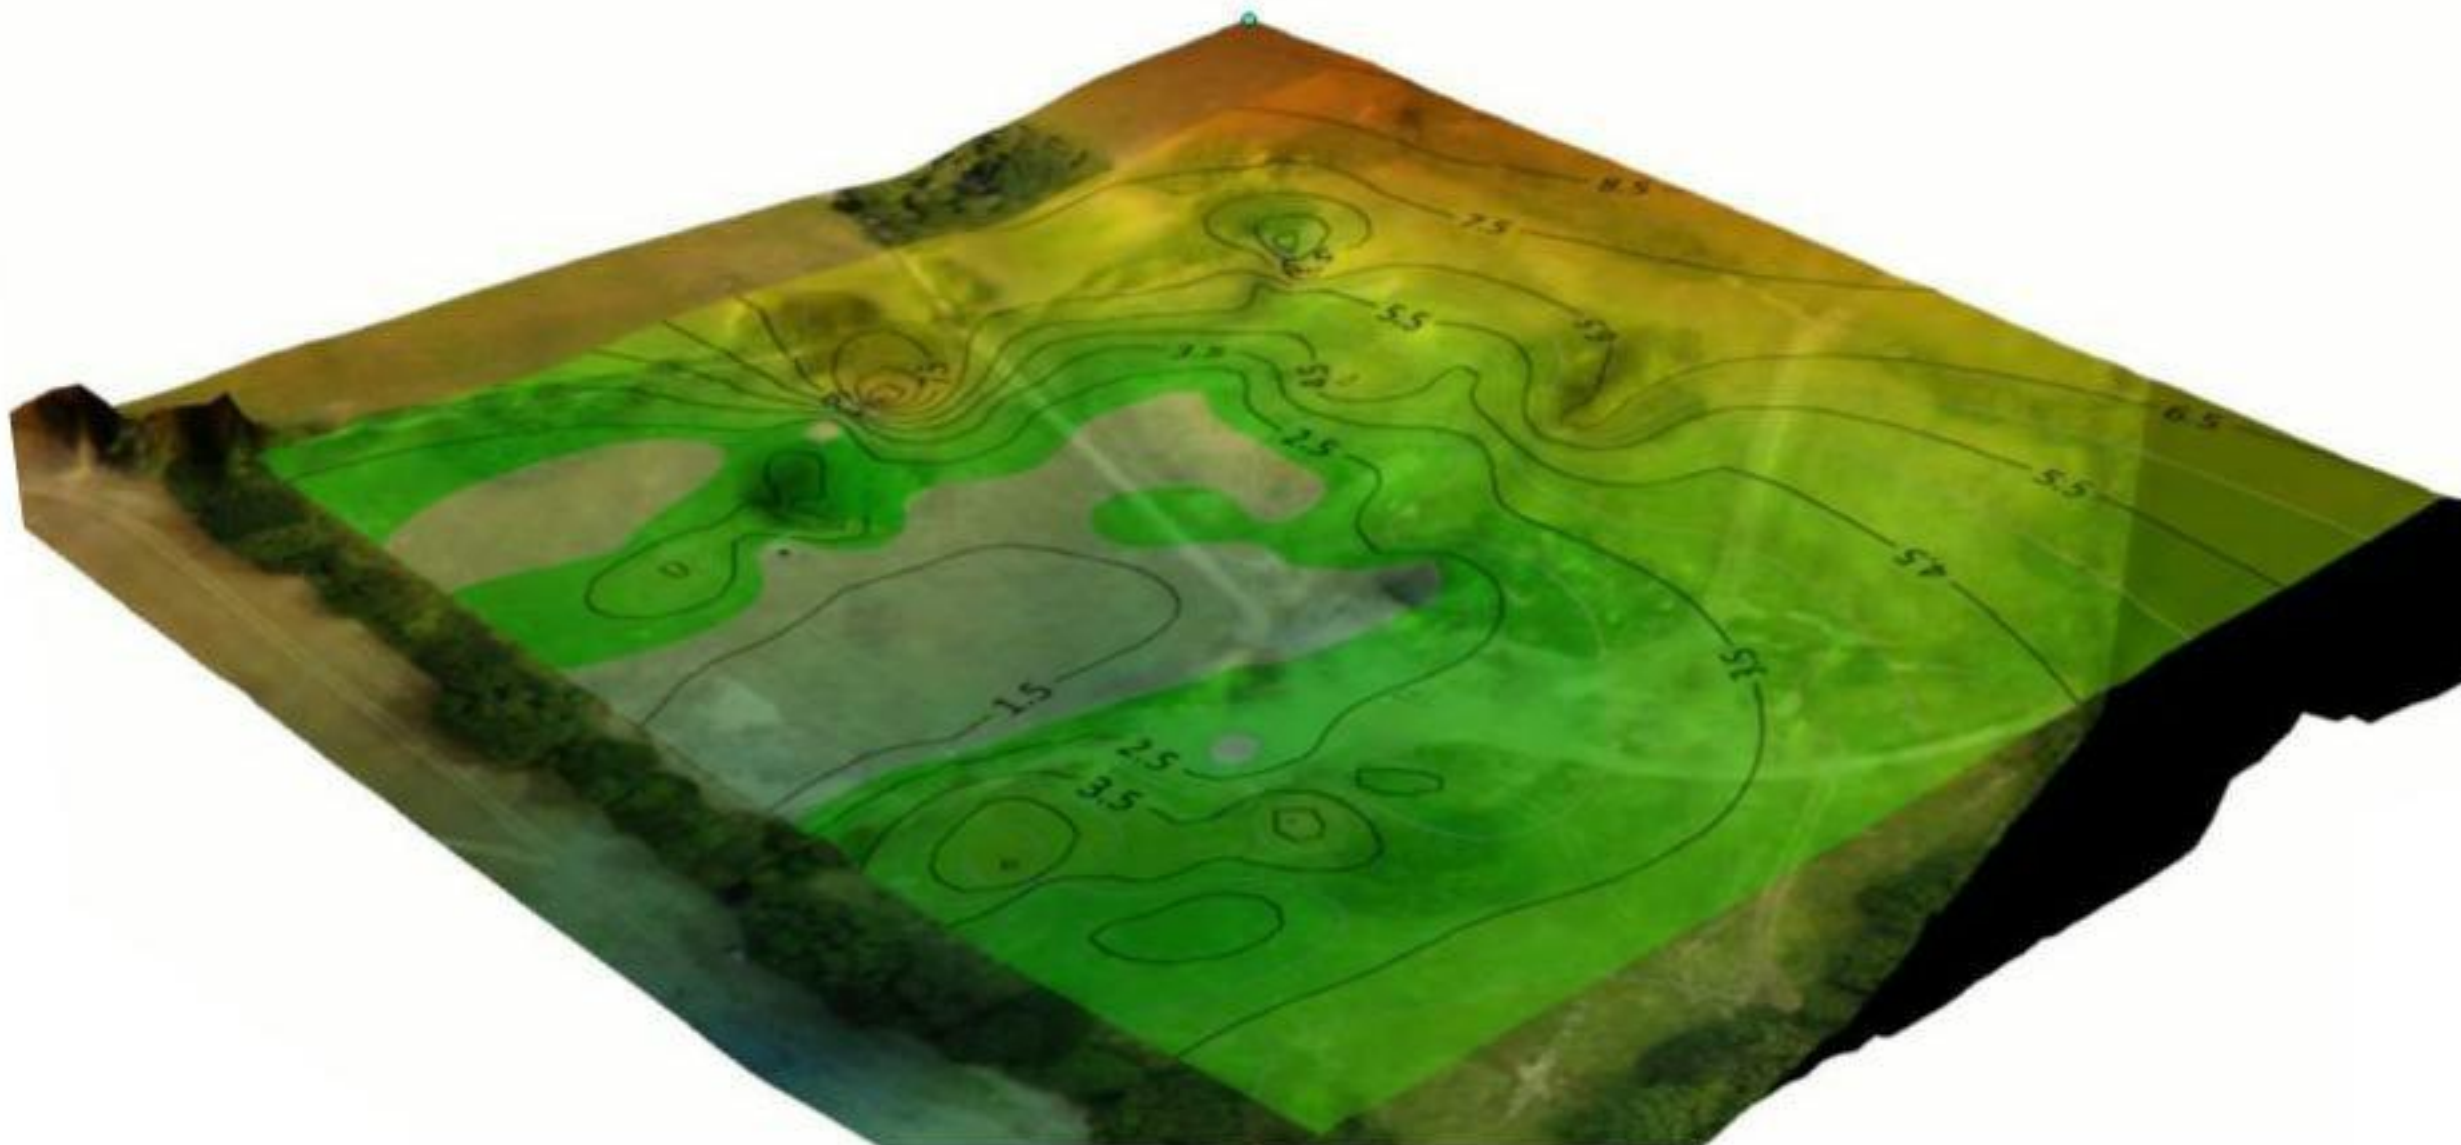
| <b>Project:</b> | Woodcroft Farm, Lovedean, Hampshire | | | <b>Title</b> | Aerial photograph with depth to chalk overlay | |

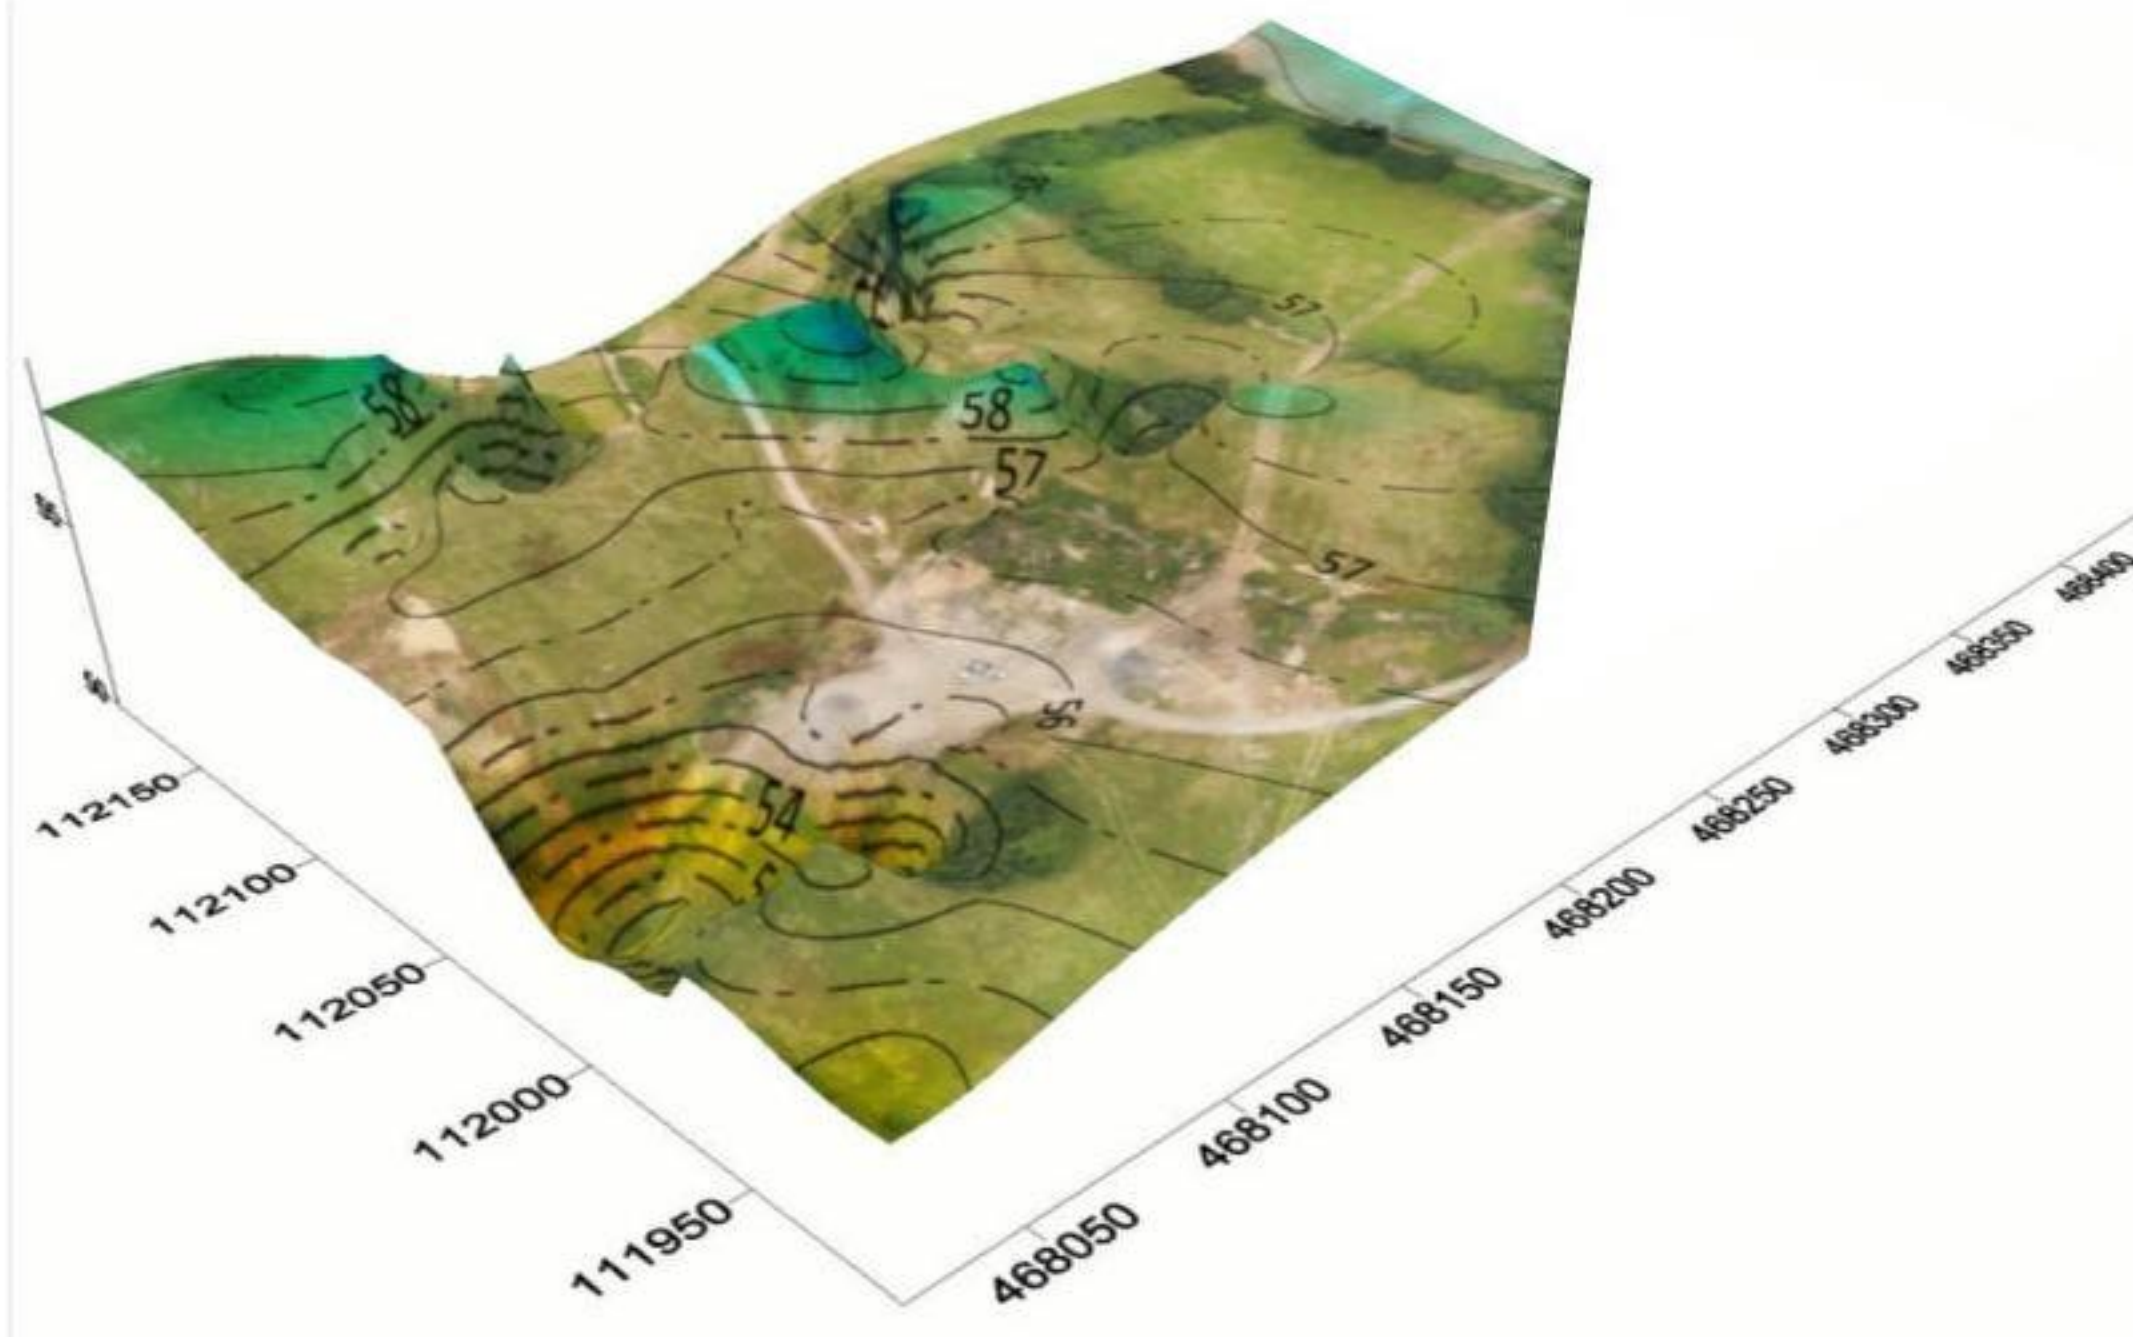
| <b>Project:</b> | Woodcroft Farm, Lovedean, Hampshire | | | <b>Title</b> | Chalk level 3D model on aerial overlay | |

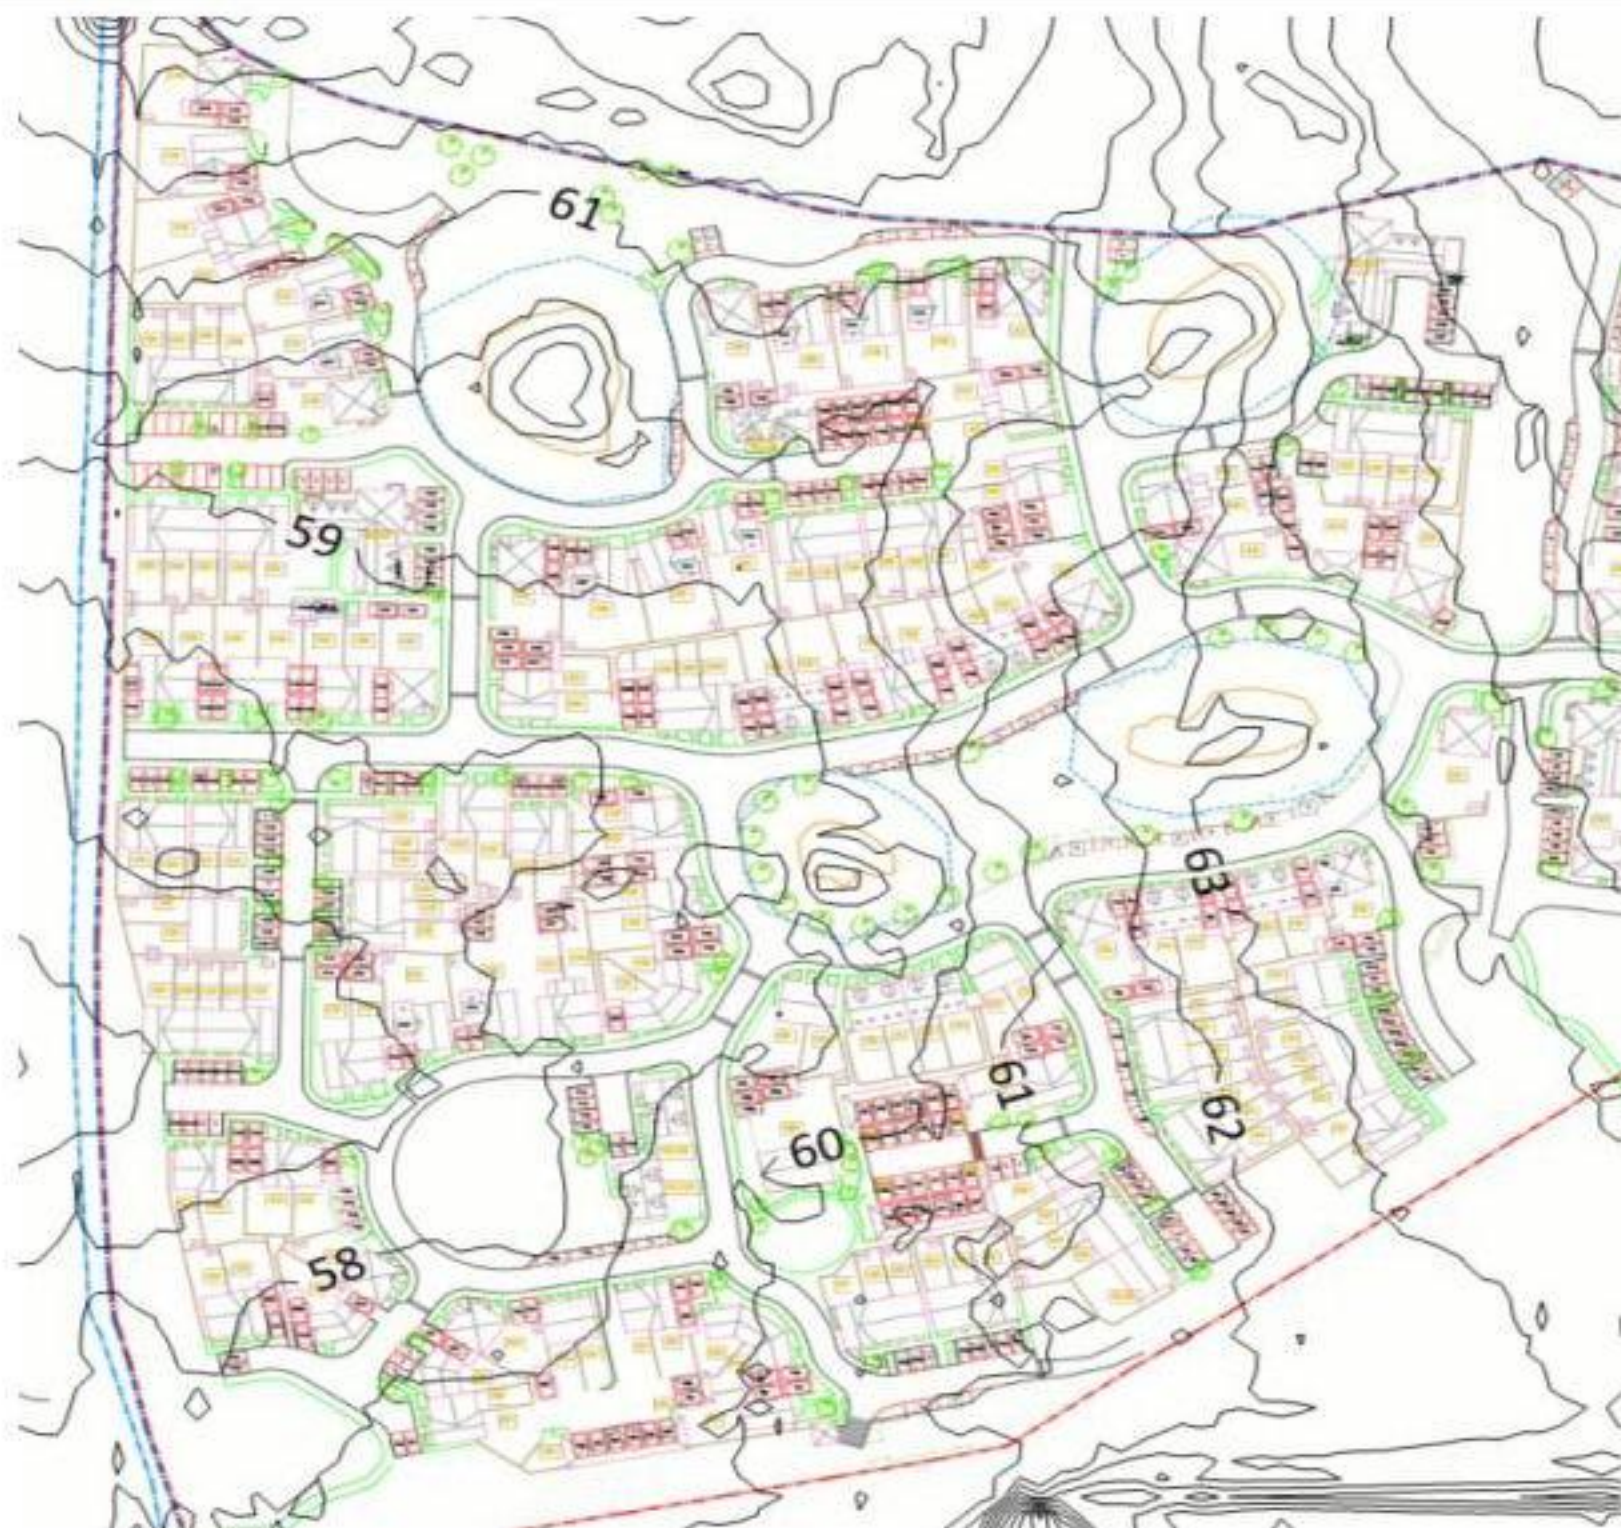
| <b>Project:</b> | Woodcroft Farm, Lovedean, Hampshire | | | <b>Title</b> | Pre-development ground level contours on development layout | |

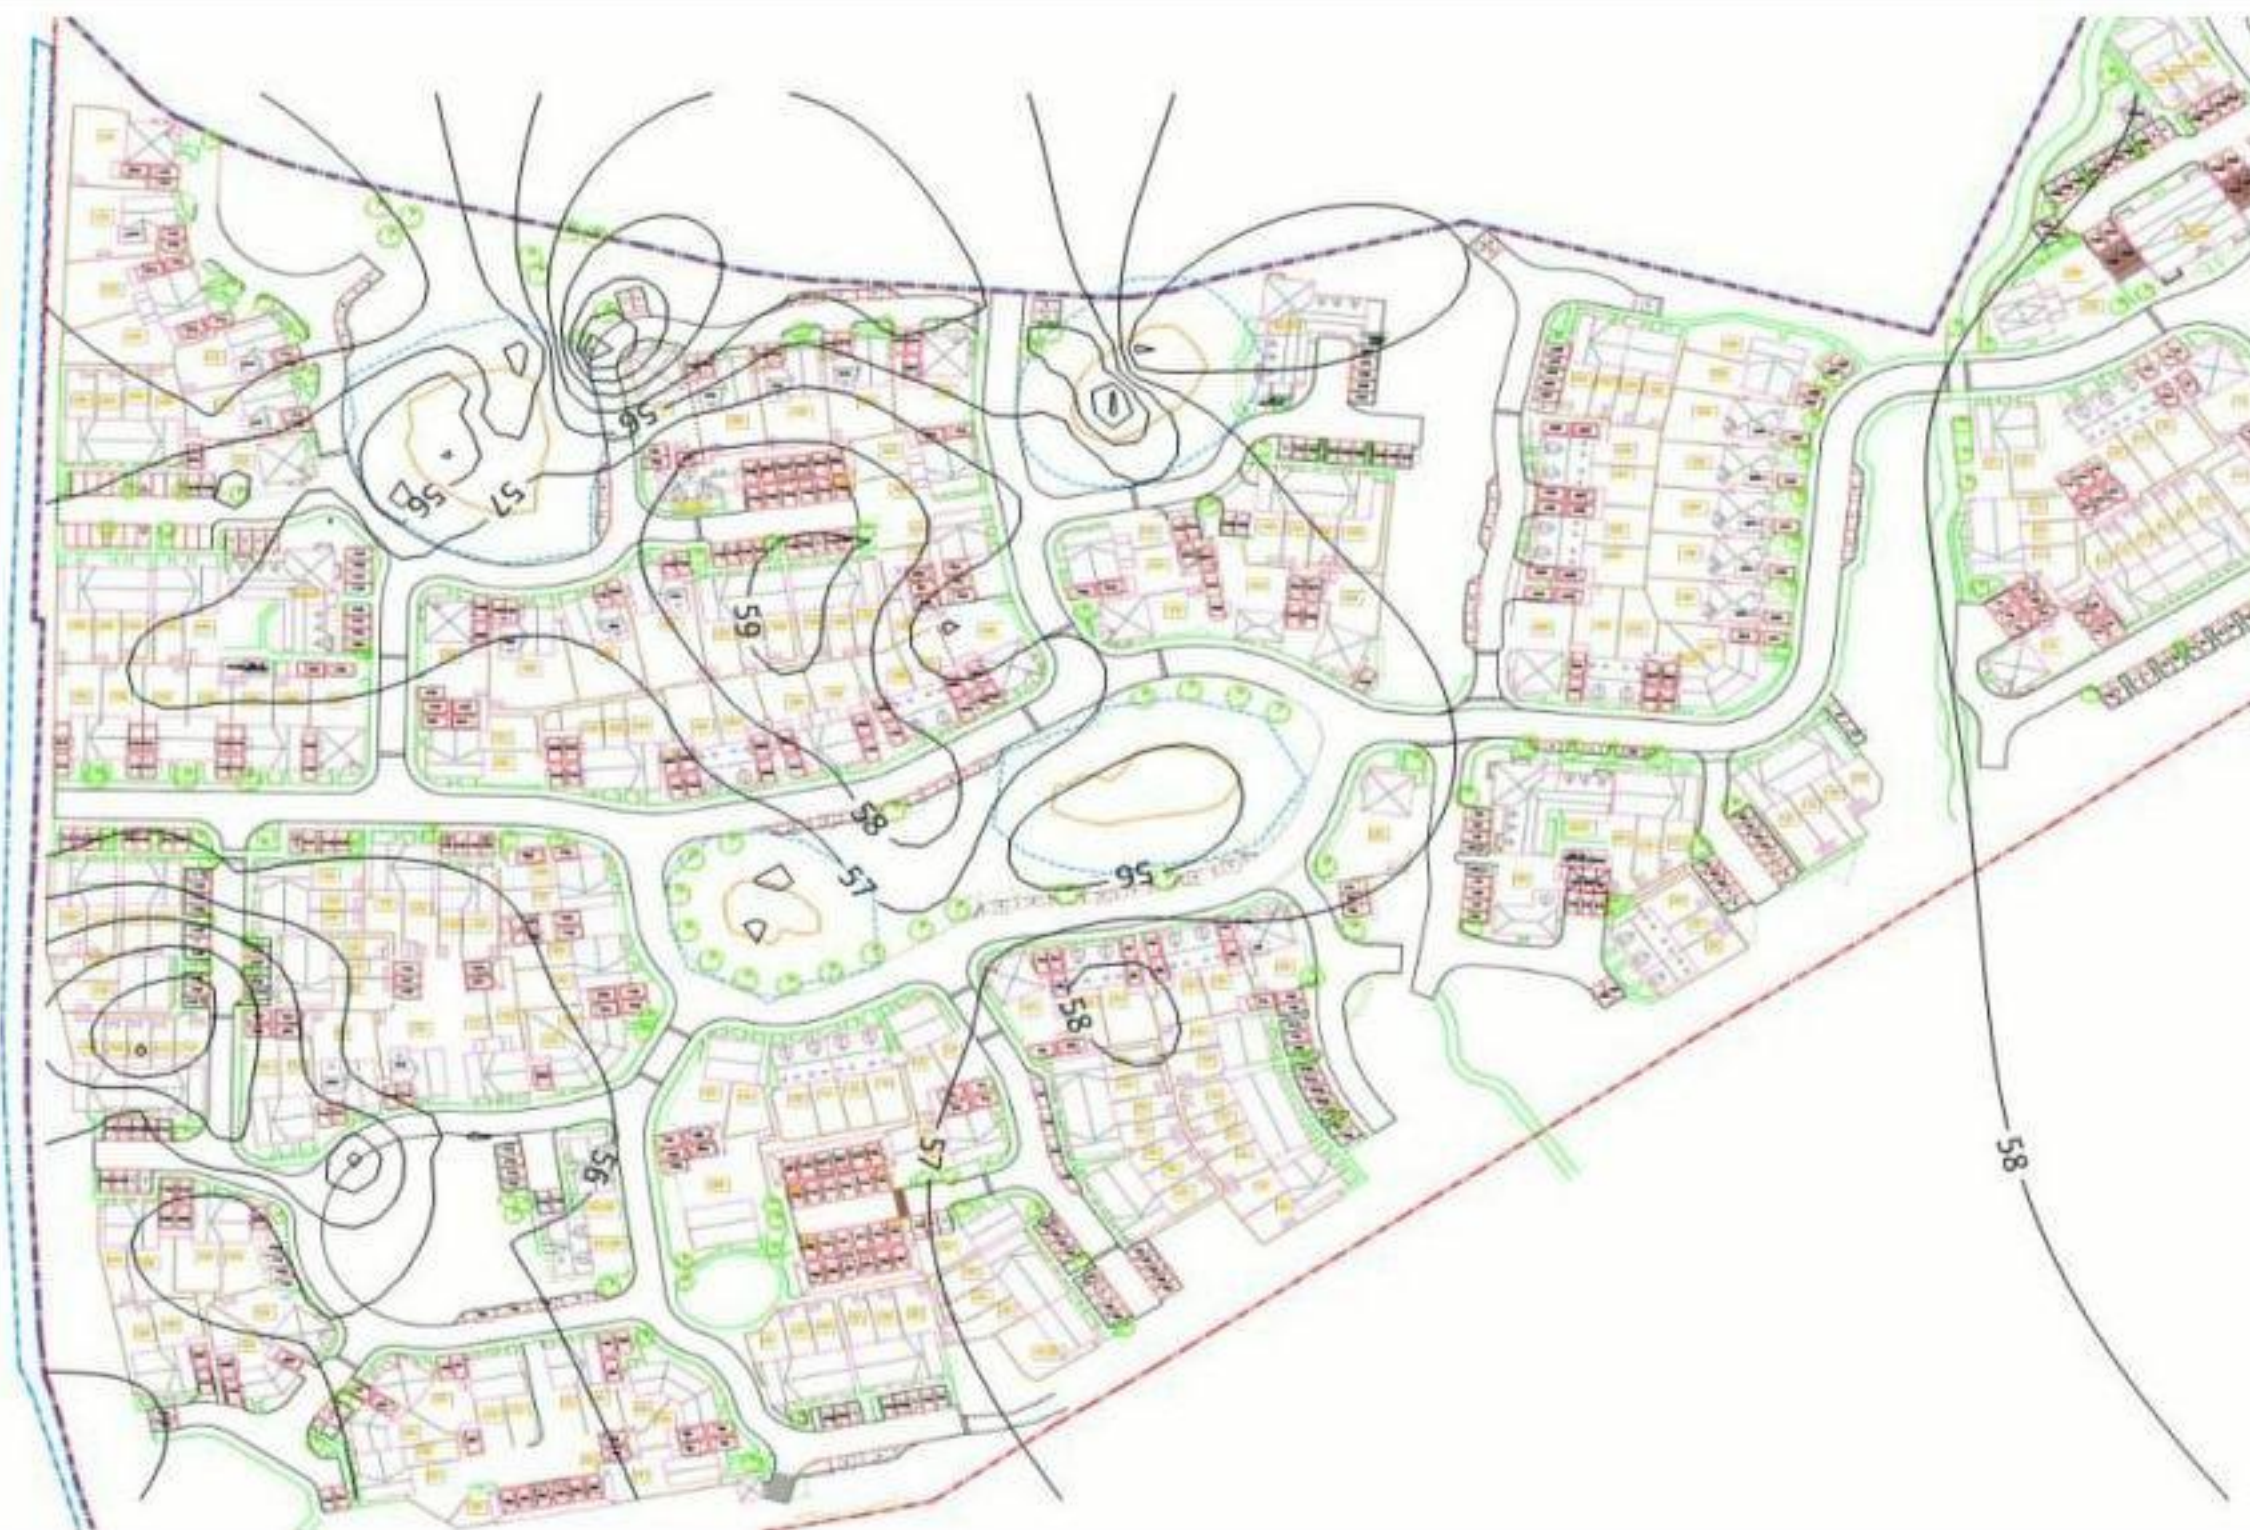
| <b>Project:</b> | Woodcroft Farm, Lovedean, Hampshire | | | <b>Title</b> | Chalk level contours on development layout | |

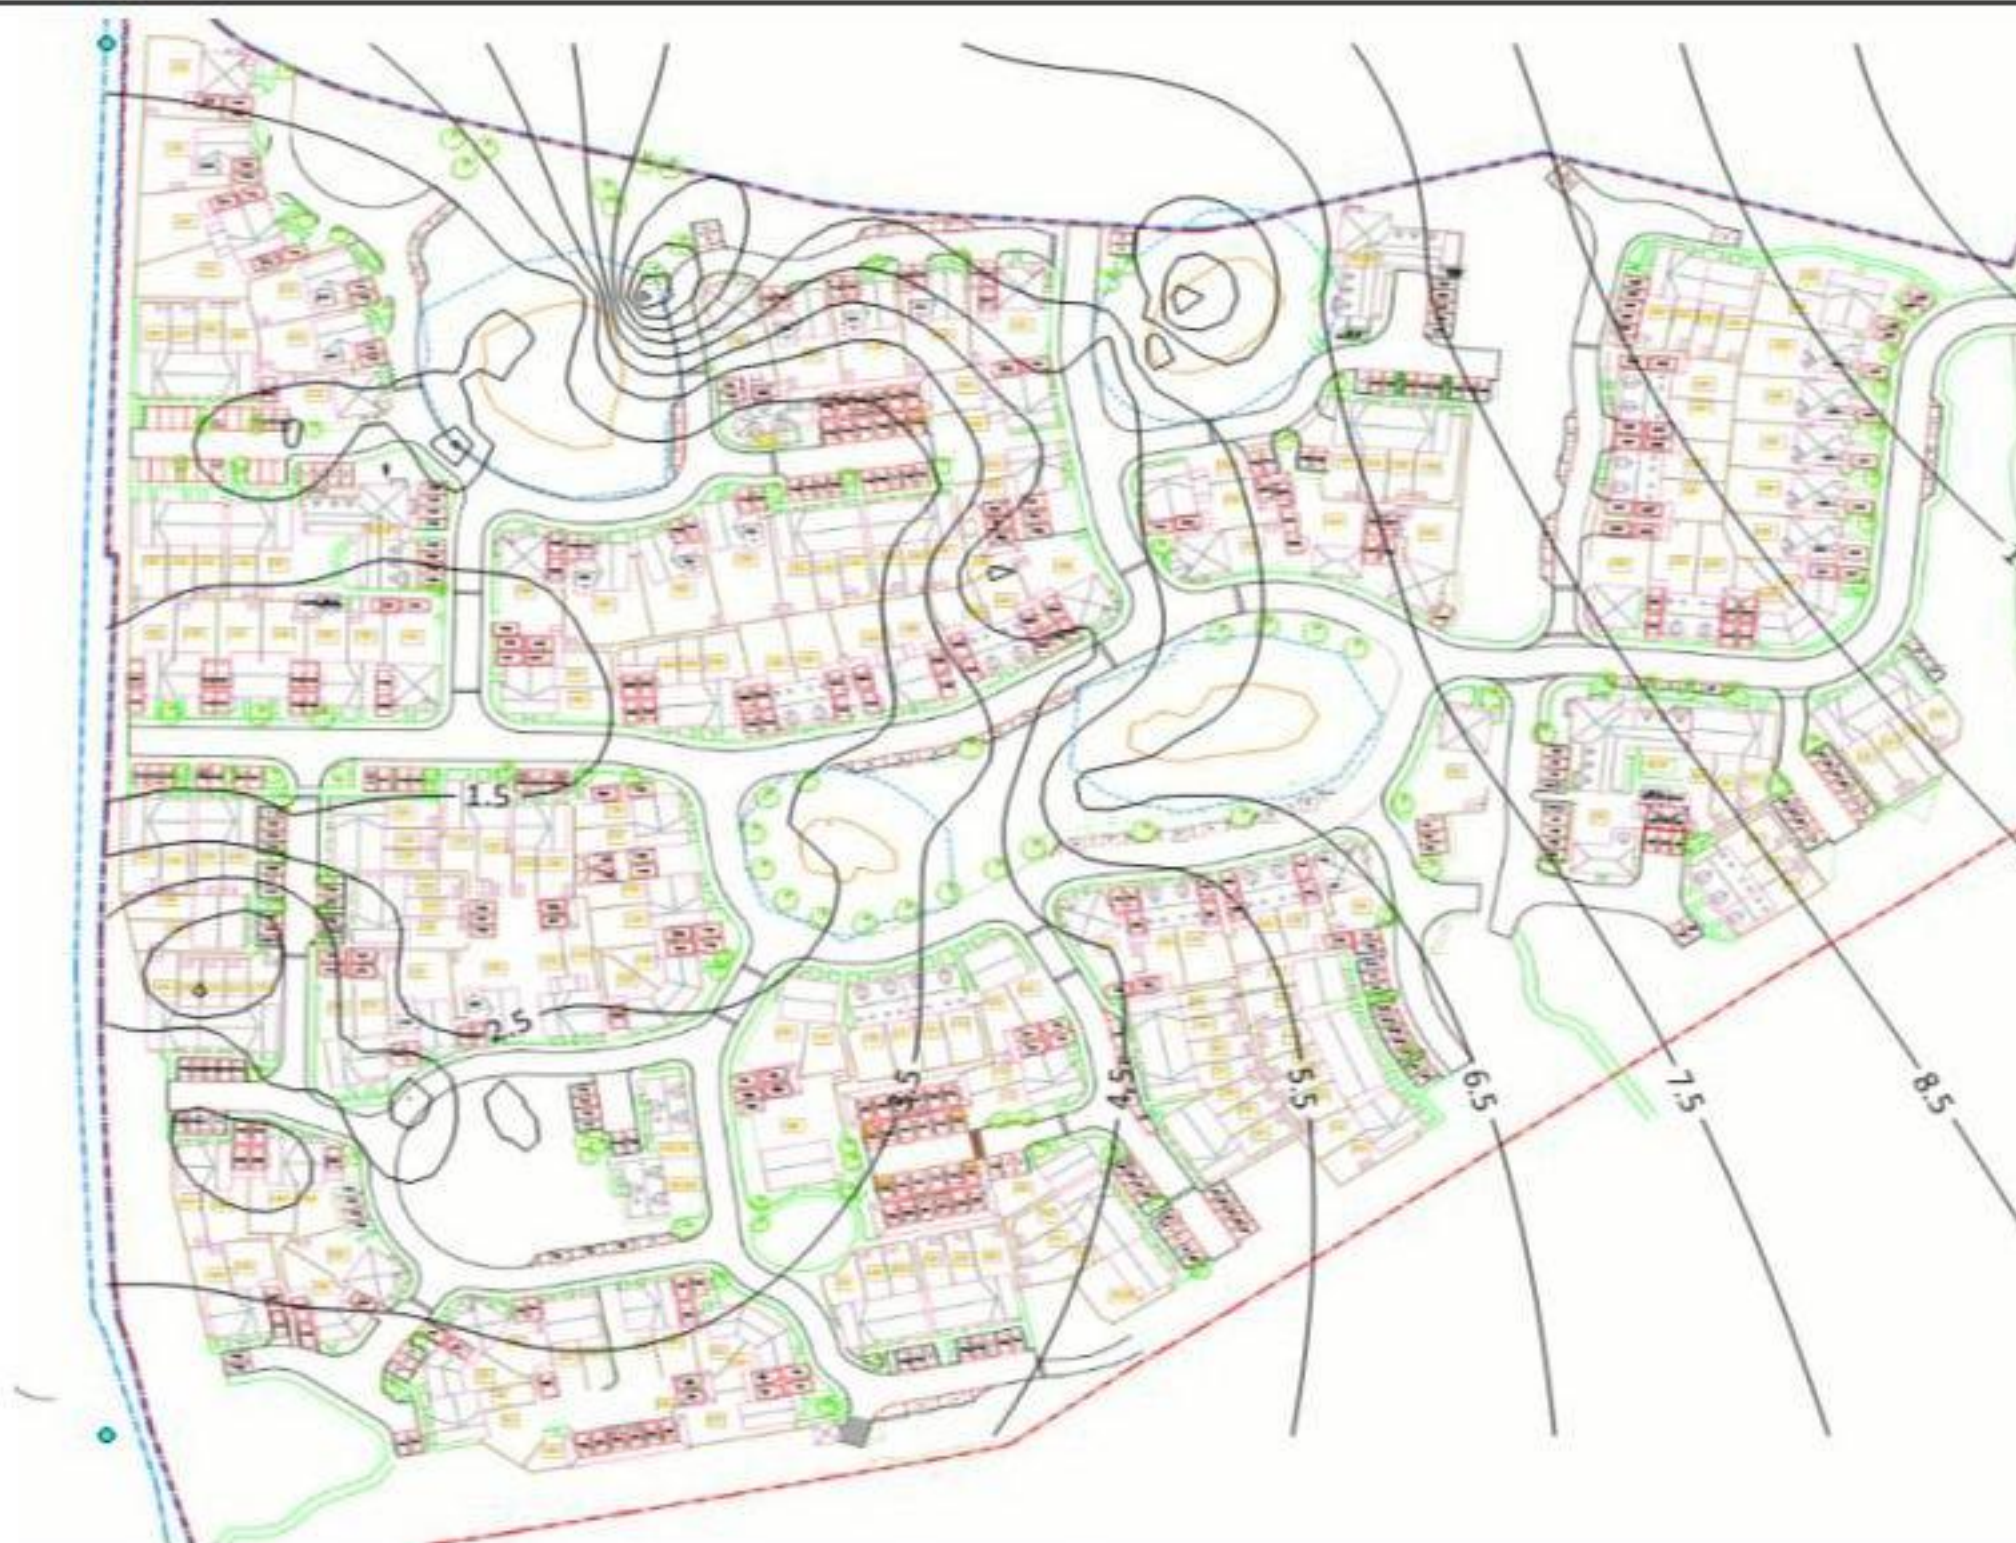
| <b>Project:</b> | Woodcroft Farm, Lovedean, Hampshire | | | <b>Title</b> | Depth to chalk on development layout | |
