FORMER LANGSTONE TECHNOLOGY PARK,  
LANGSTONE ROAD, HAVANT -  
INTERIM REMEDIATION VERIFICATION REPORT

## Interim Remediation Verification Report

## Proposed Remediation Method Statement – Langstone Technology Park, Havant

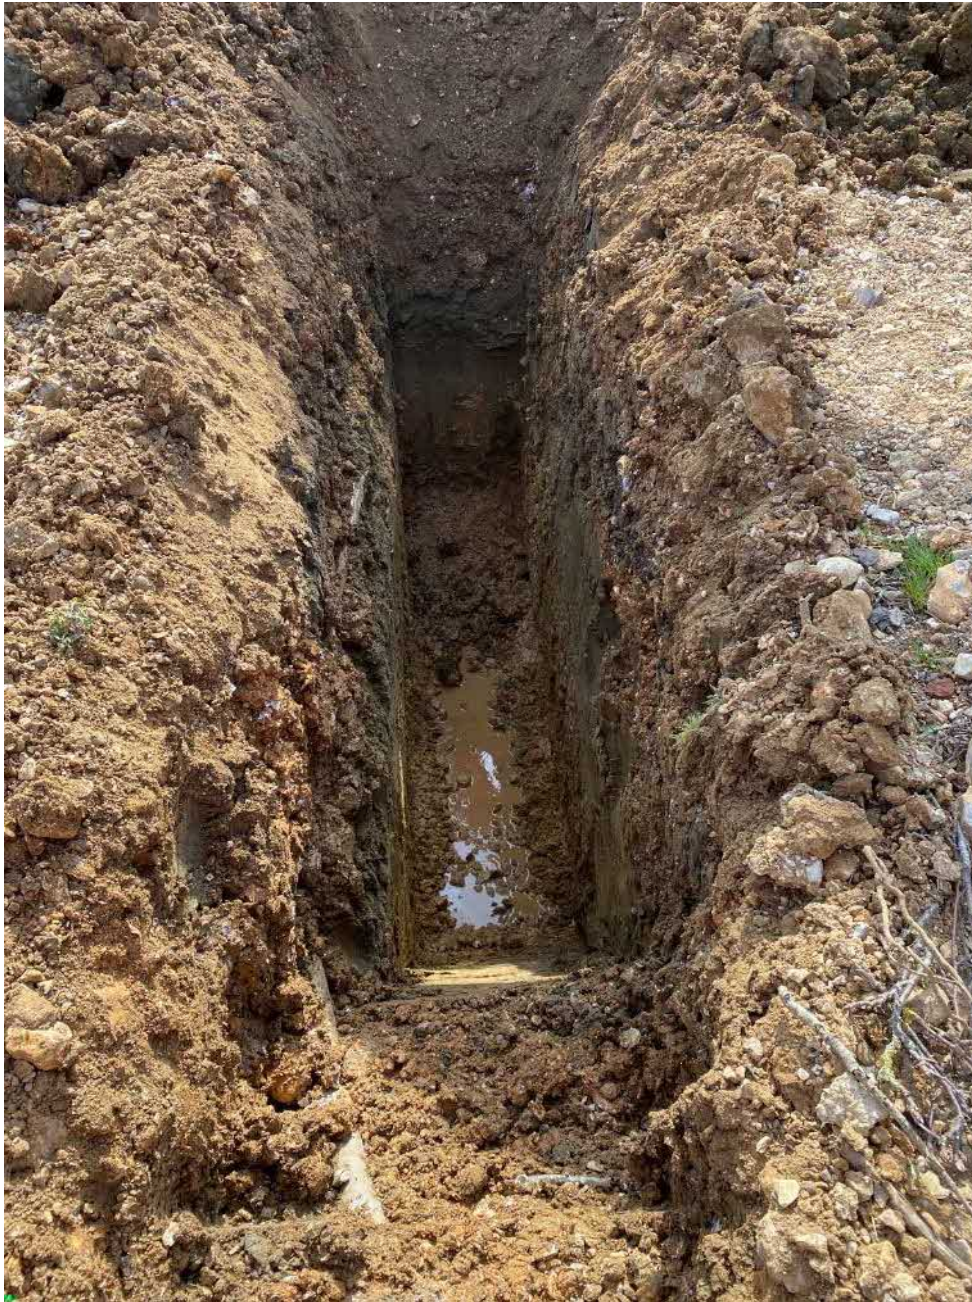
Figure 7 – Trial Pit Delineation (ESL101)

Note presence of GW at 2.8m bgl

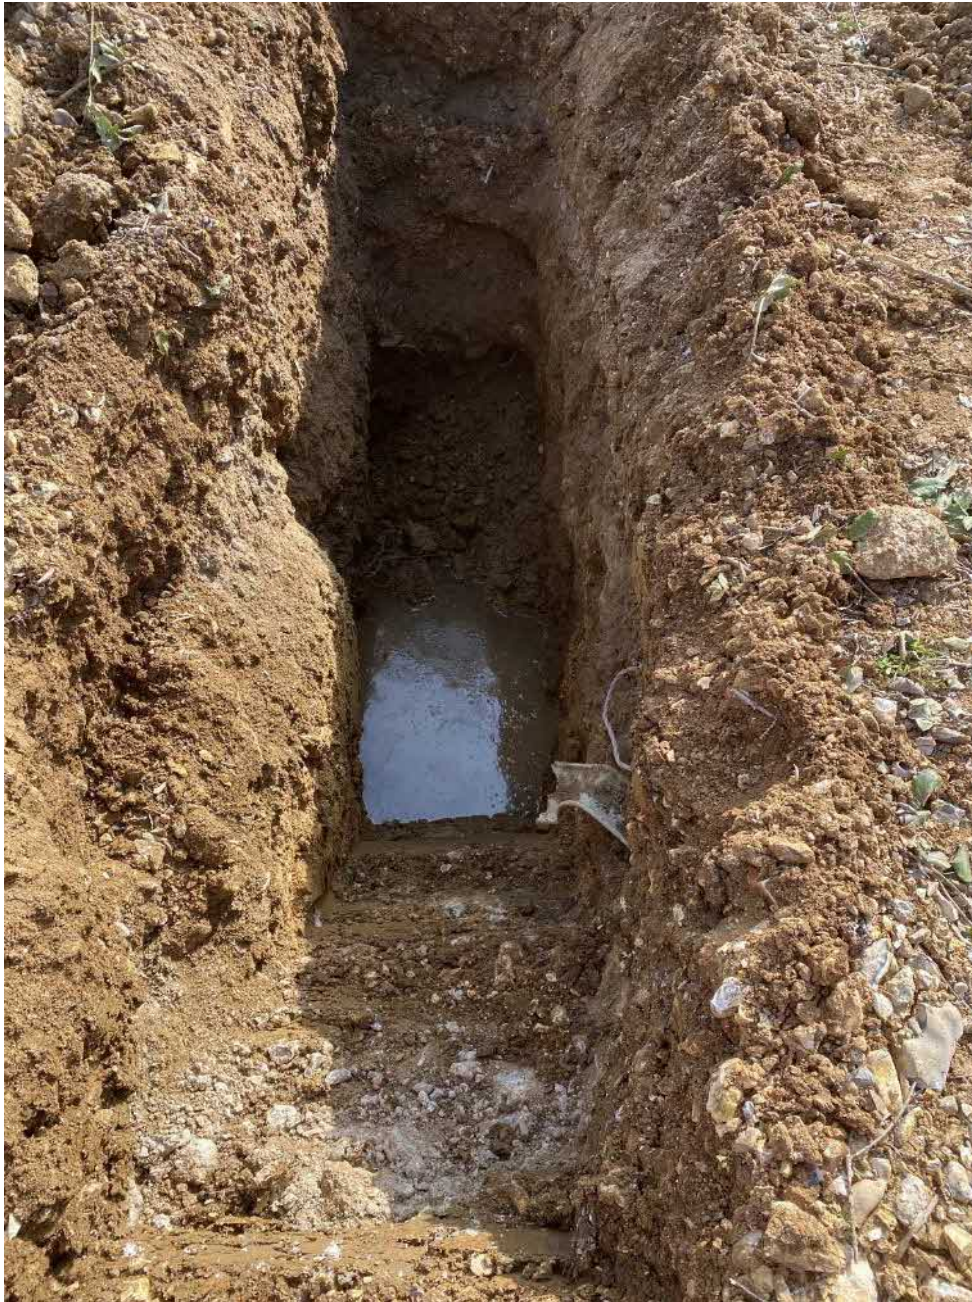
Figure 8 – Trial Pit Delineation (ESL107)

Note presence of GW at 2.8m bgl – hydrocarbon odour, possible iridescence of GW surface.

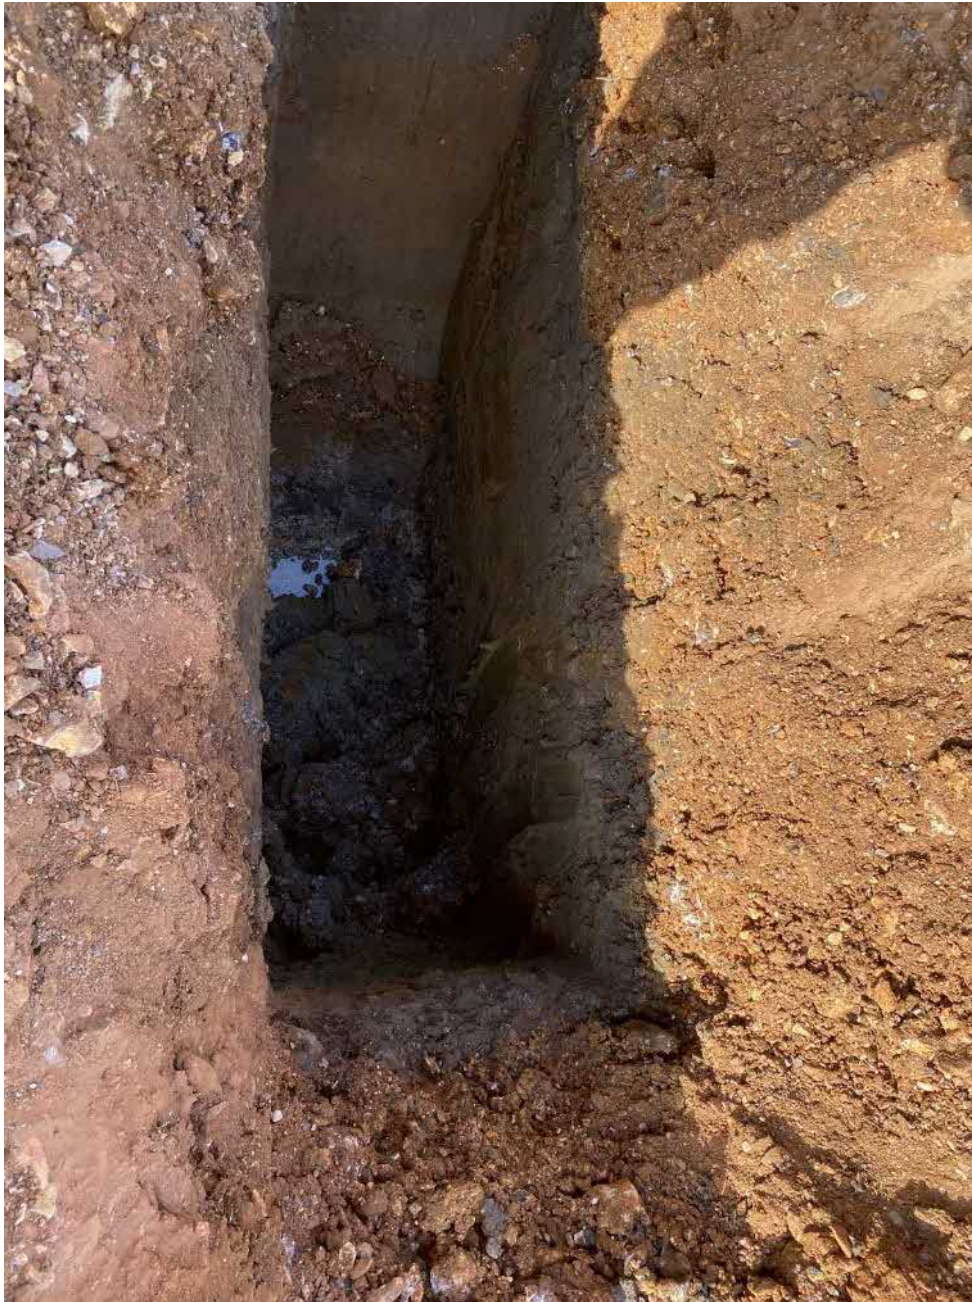
Figure 9 – Trial Pit Delineation (ESL109)

Note presence of GW at 2.8m bgl and slight discolouration of soil at / near groundwater (possible smear zone)

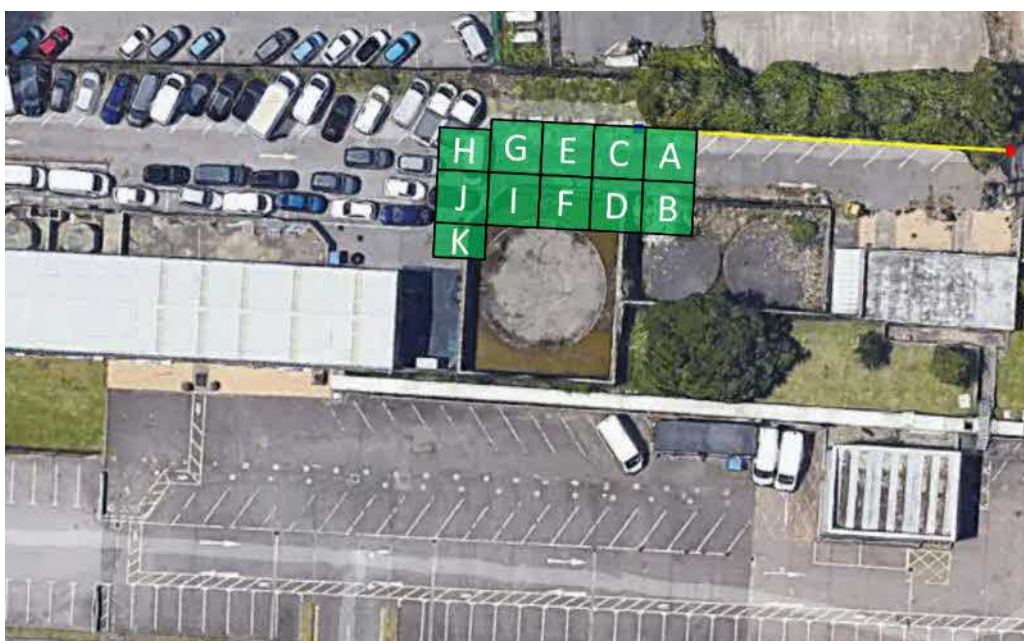
Figure 15 – Schematic Showing “Gridding” of Treatment Area

Each Treatment Grid was 5m by 5m (unless amended by the Project manager).

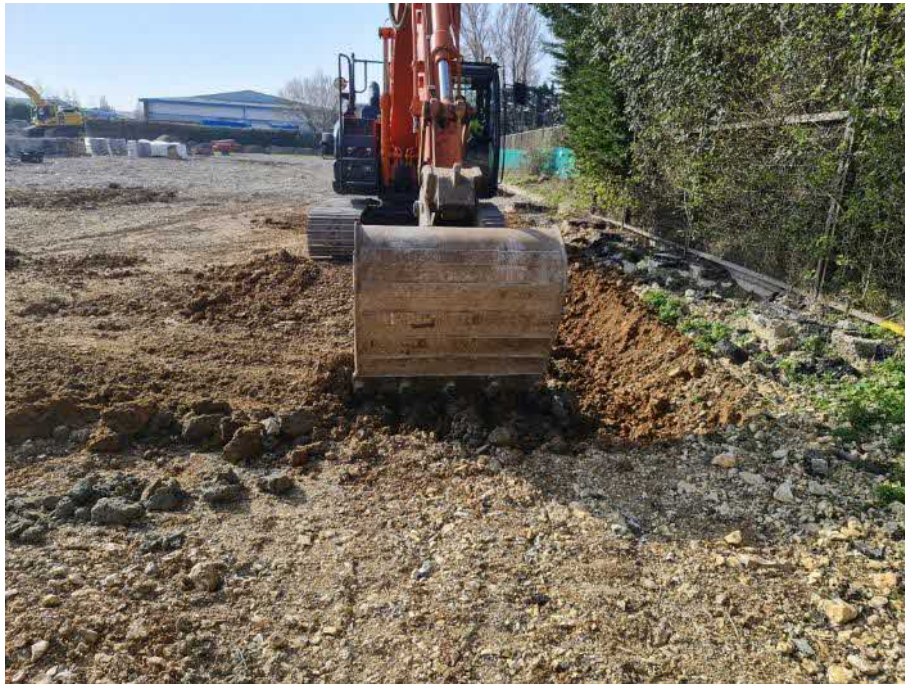
Figure 16 – Excavation of Treatment Grid Area to 1m bgl.

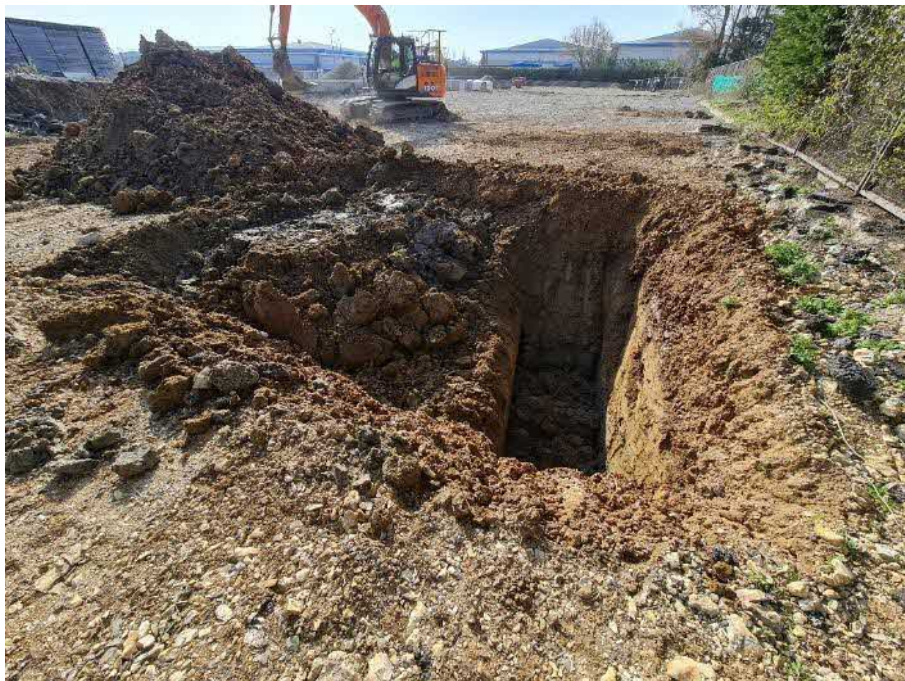
Figure 17 – Fully excavated Treatment Grid (Half) Section for Treatment.

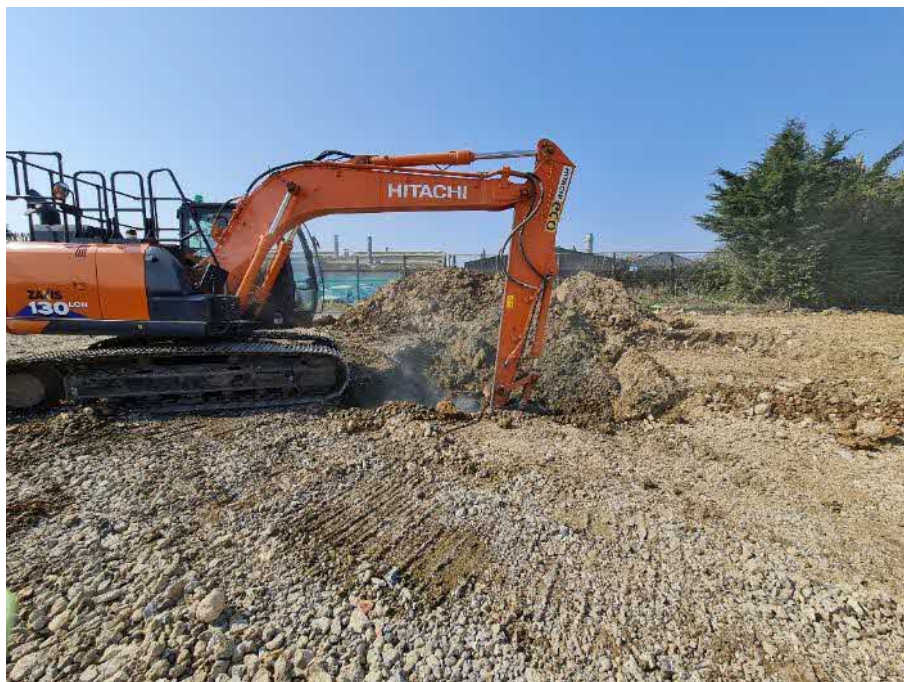
Figure 19 – Addition of E-Clay additive and inn-situ soil mixing to required depth.

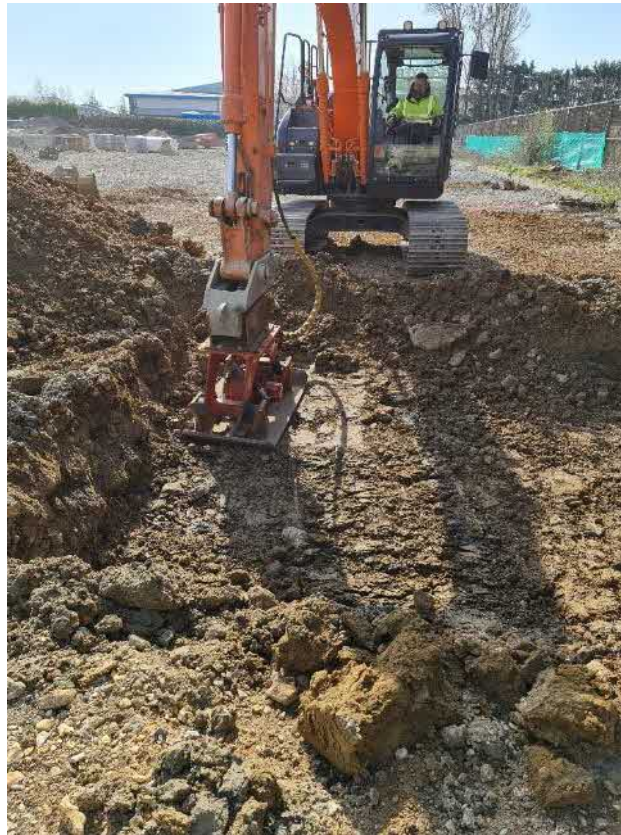
Figure 20 – Reinstatement of treatment Grid area post treatment.

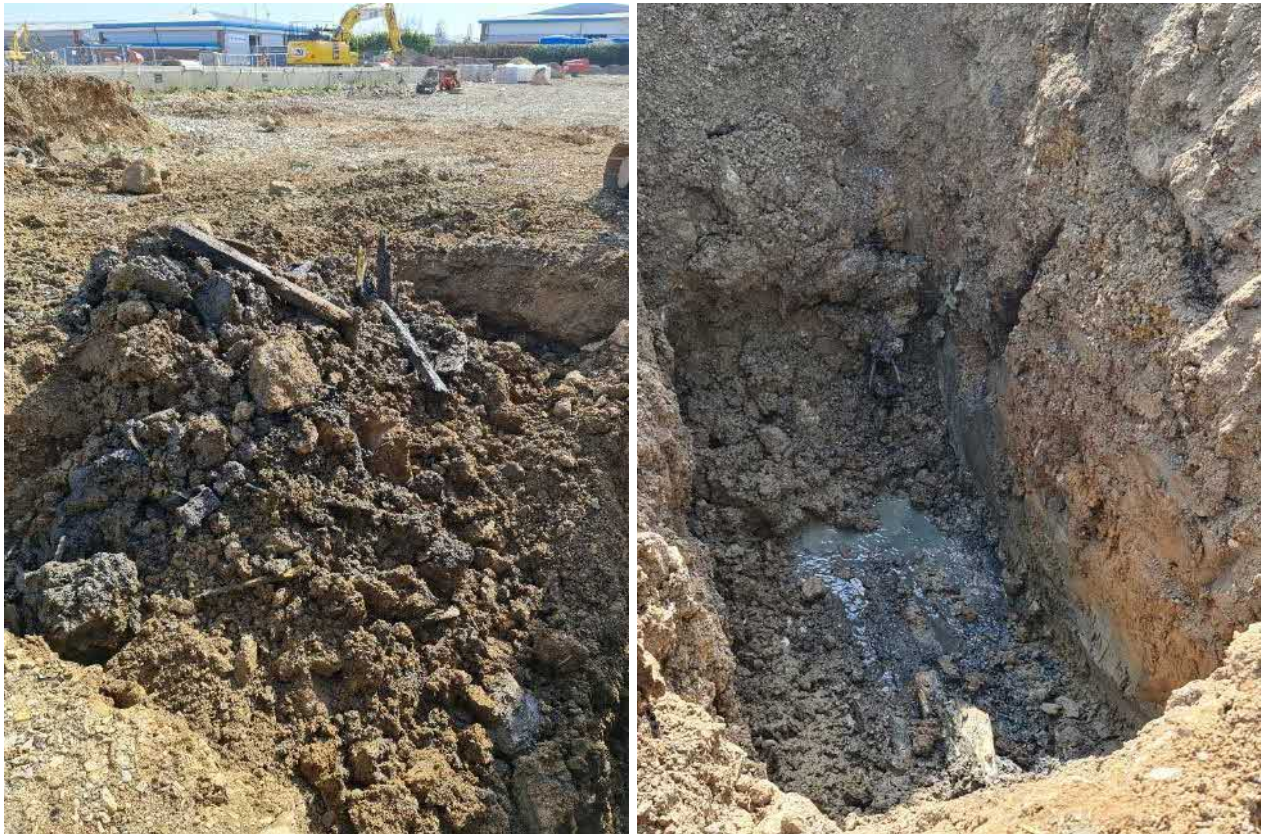
Figure 21 – Typical visual evidence hydrocarbon contamination (staining and odour).

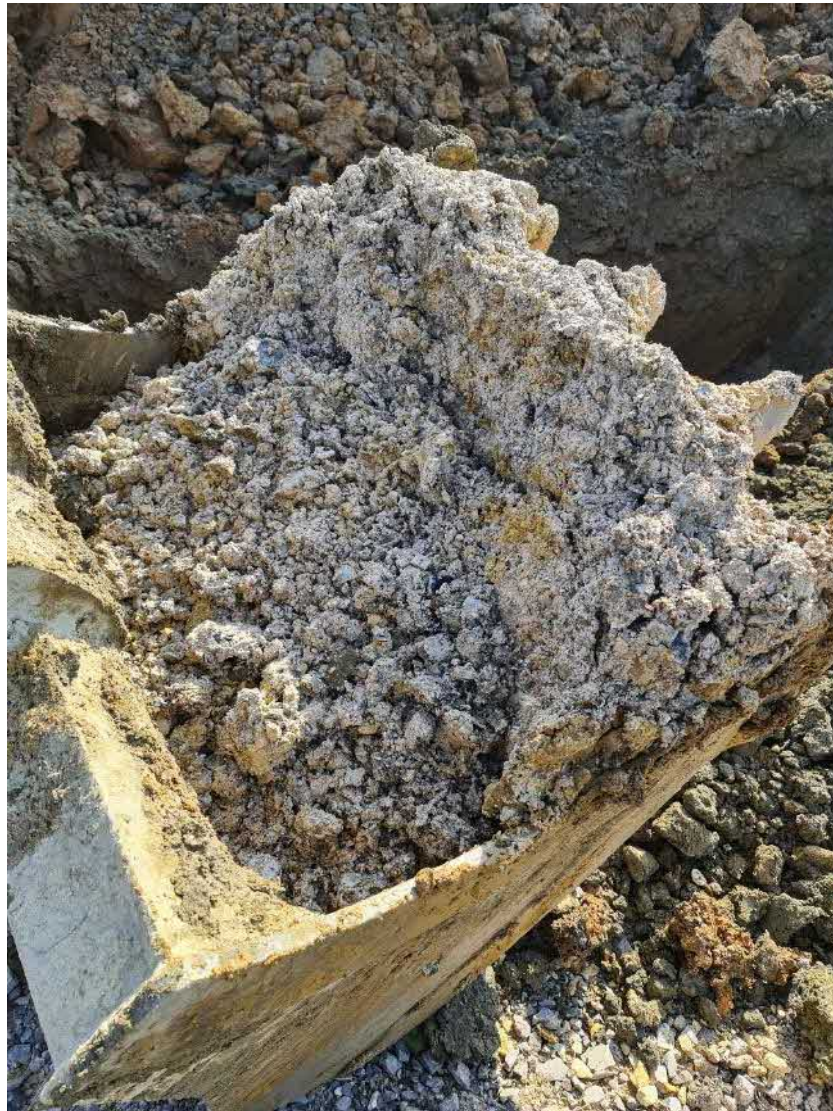
Deeper soils (greater than 2m bgl) within the excavated pit were "loosened up" - disturbed but not fully excavated to allow the Project Manager to assess deeper soils below the groundwater level. The treatment depth was set as being clays which appeared natural in colour and odour.

Figure 22 – “Clean” clays from base of excavations (natural in appearance, no staining, no odour & no VOC).

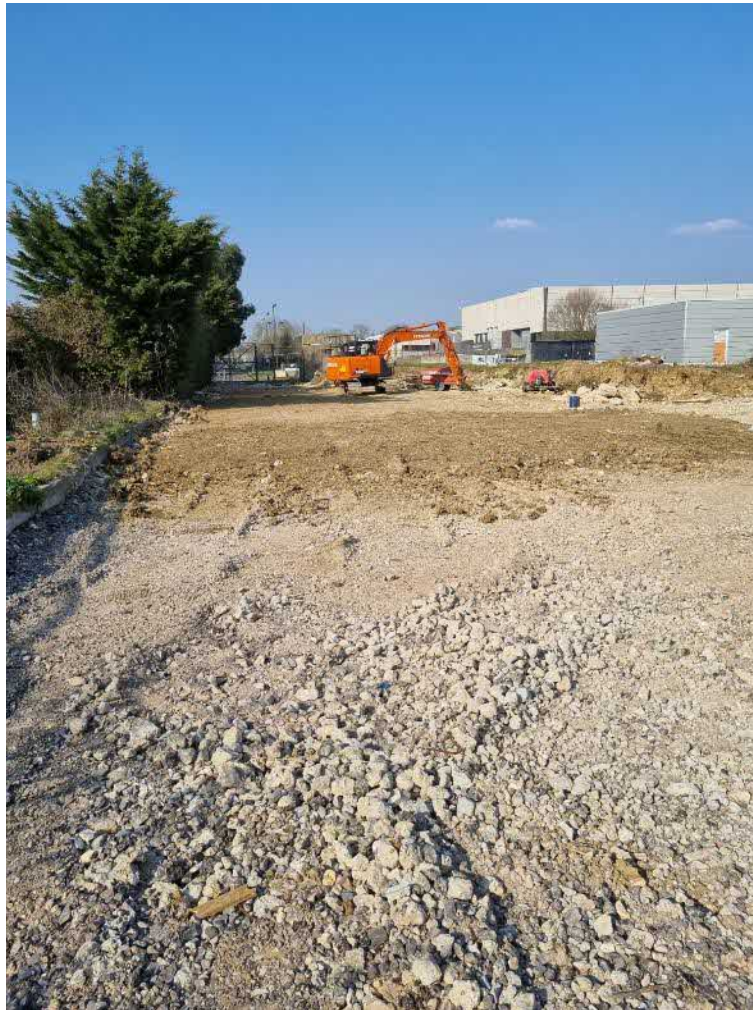
Figure 23 – Area following completion of treatment works..

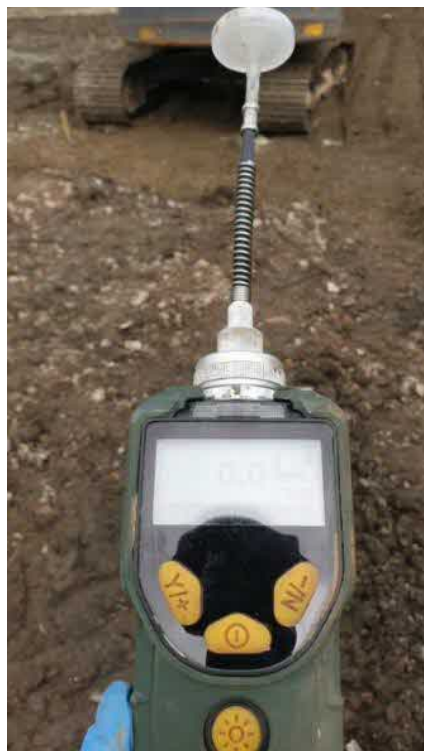
Figure 25 – VOC Monitoring and Quality Plan records.

The VOC monitoring is shown in Figure 25 below. Dust monitoring is shown in Figure 26 below.

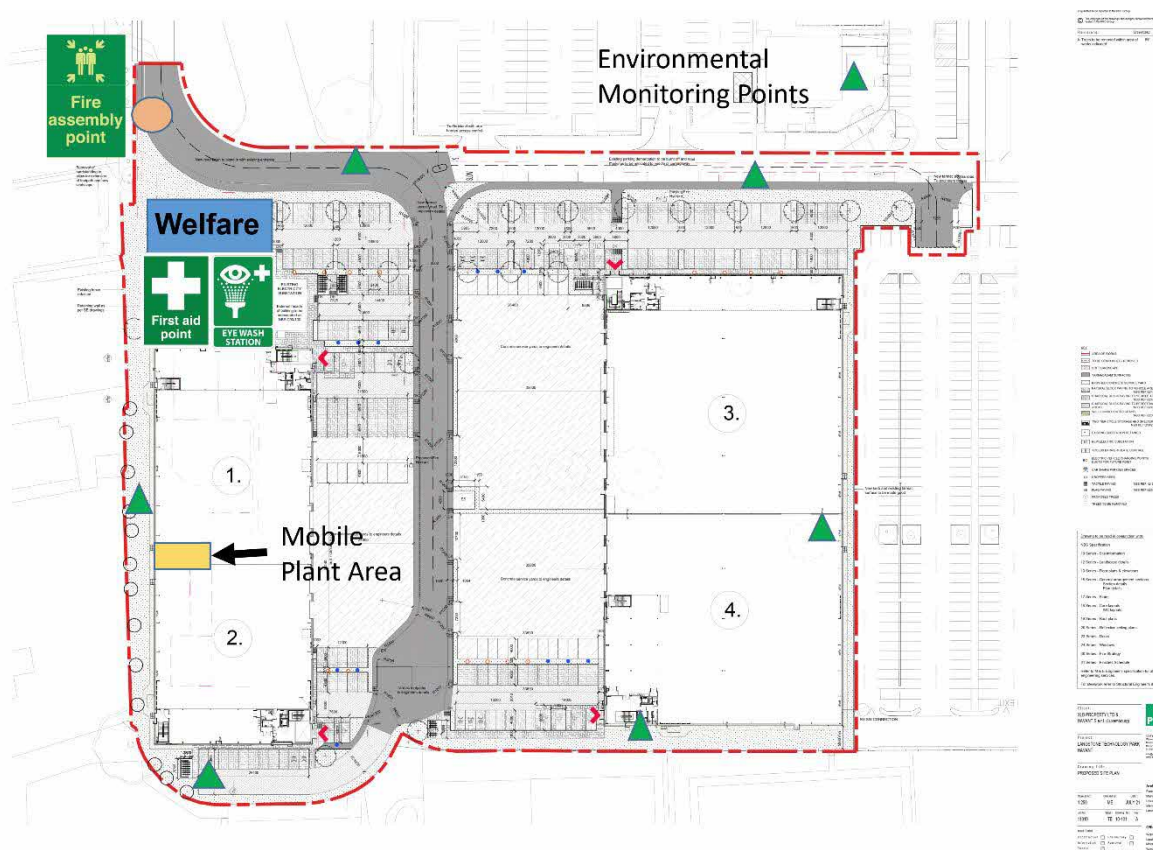
Figure 12 – Environmental Monitoring Locations

Simple olfactory monitoring and VOC monitoring (via hand held PID) will be undertaken by Envirotreat at key Environmental Monitoring Locations (see Figure below 12) during operating days and records of any odours noted in the site logbook.

Noise monitoring (via a hand-held noise meter) will be undertaken by Envirotreat at key Environmental Monitoring Locations (see Figure below 12) during operating days and records of any odours noted in the site logbook.
