## Site Supervision and Monitoring Record

Site: 162 Stakes Hill Road, Waterloooville

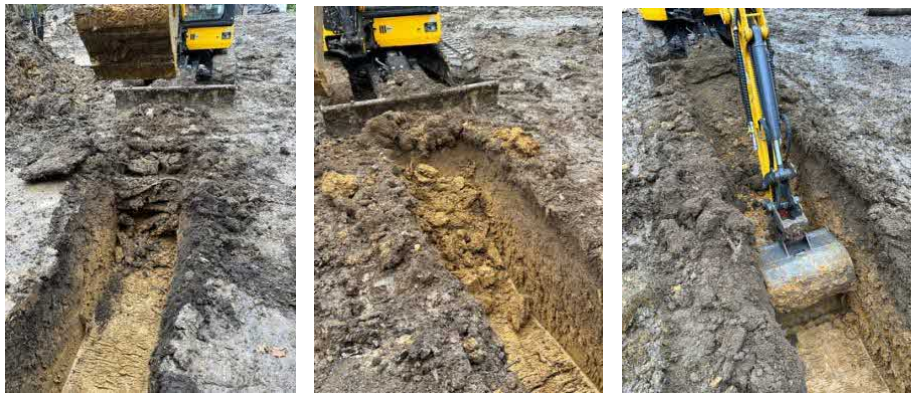
| Visit date | Observations | Recommendations | Photographs |
|---|---|---|---|
| 14.04.2023 | <p>Site set up complete, tree protection fencing erected as approved. Ground protection measures installed and fit for purpose.</p> <p>Foundation excavation marked out within the Precautionary Area and completed under supervision on 14<sup>th</sup> April 2023</p> | <p>Ensure heras panels and other tree protection measures remain place during the construction phase.</p> | |

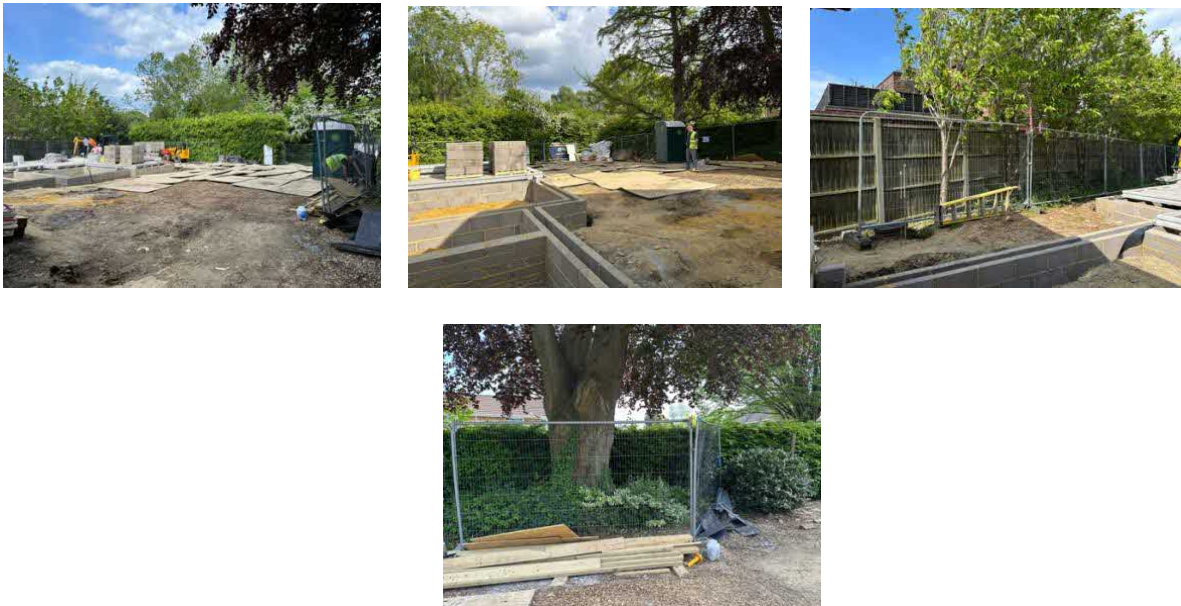
| Visit date | Observations | Recommendations | Photographs |
|---|---|---|---|
| 17.05.2023 | <p>Monthly visit to review tree protection measures in place and fit for purpose. Foundations poured and construction progressing to finished floor level.</p> | <p>Ensure supervision is completed when drainage excavation is undertaken, next visit scheduled to facilitate this.</p> | |

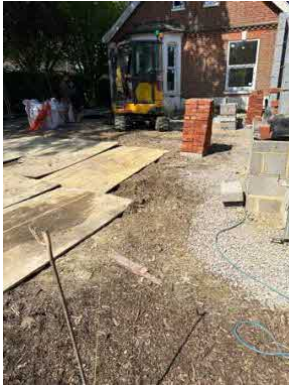
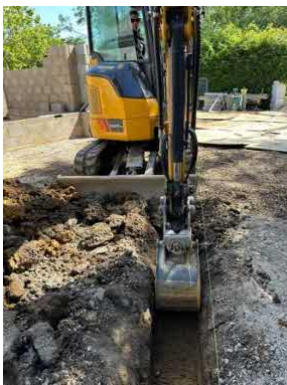
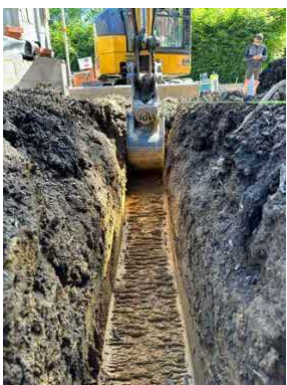
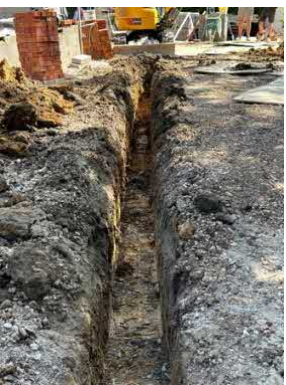
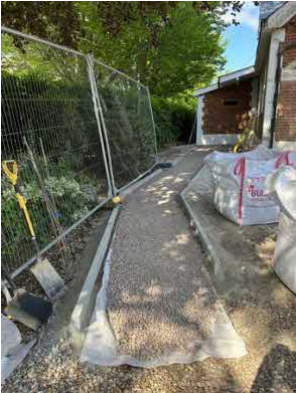
| Visit date | Observations | Recommendations | Photographs |
|---|---|---|---|
| 30.05.2023 | <p>Ground protection measures and tree protection fencing remain in place as approved and fit for purpose.</p> <p>Excavation marked out within the Precautionary Area for the drainage run which was completed under supervision during the site visit.</p> <p>No root growth encountered.</p> | <p>Ensure heras panels and other tree protection measures remain place during the construction phase.</p> | <div></div> |

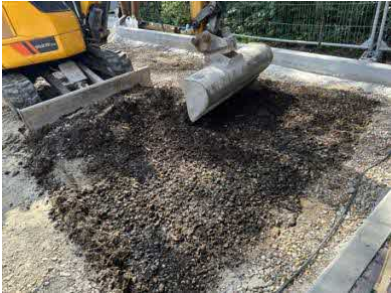
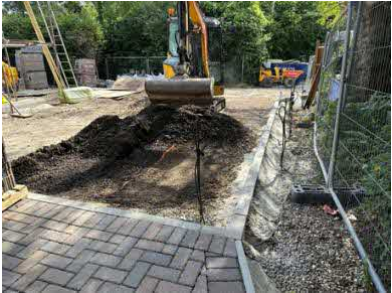
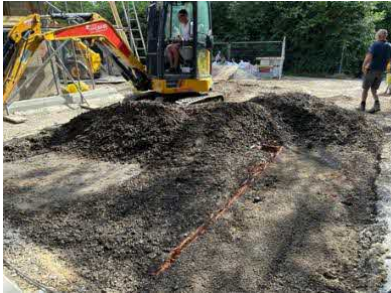
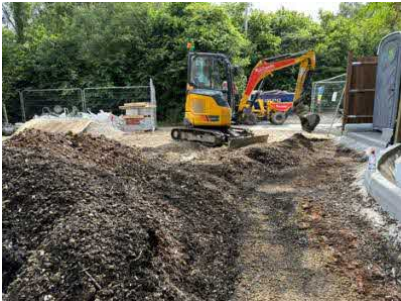
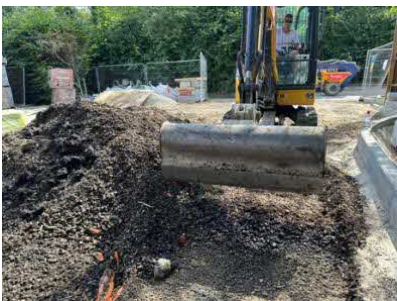
| Visit date | Observations | Recommendations | Photographs |
|---|---|---|---|
| 26.06.2023 | <p>Tree protection fencing remains in place as approved and fit for purpose.</p> <p>Approved access route cleared to enable the installation of the cellular confinement system. Ground protection and underlying aggregate from existing historical access route was removed under supervision.</p> <p>No root growth encountered.</p> | <p>Ensure heras panels and other tree protection measures remain place during the construction phase.</p> | <div></div> |

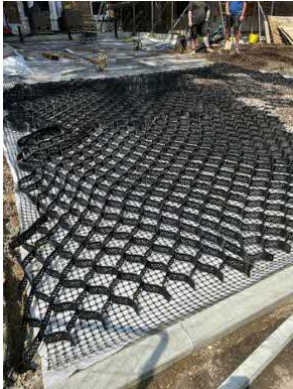
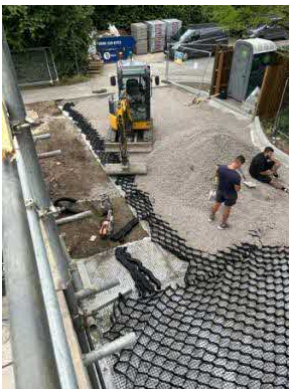
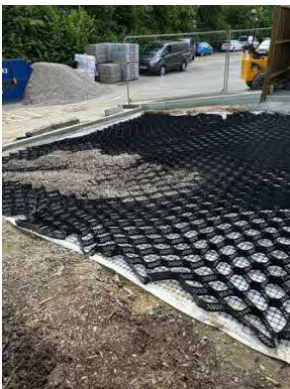
| Visit date | Observations | Recommendations | Photographs |
|---|---|---|---|
| 30.06.2023 | <p>Tree protection fencing remains in place as approved and fit for purpose.</p> <p>Subbase for the approved access route under construction, cellular confinement system being installed in accordance with the approved methodology.</p> | <p>Ensure heras panels and other tree protection measures remain place during the construction phase.</p> | |

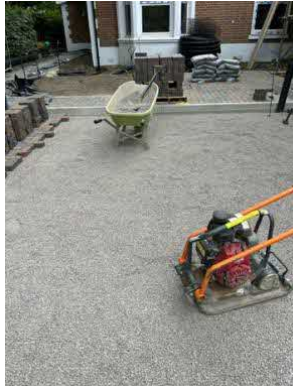
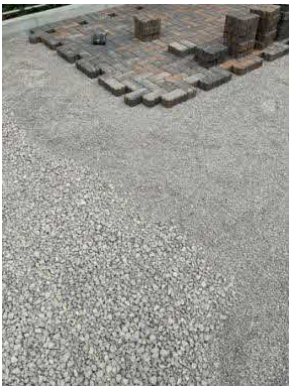
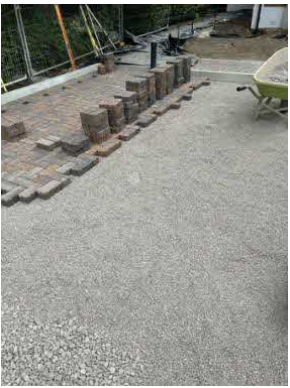
| Visit date | Observations | Recommendations | Photographs |
|---|---|---|---|
| 04.07.2023 | <p>Tree protection fencing remains in place as approved and fit for purpose.</p> <p>Subbase for the approved access route complete and consolidated, final porous block paving being installed in accordance with the approved methodology.</p> | <p>Ensure heras panels and other tree protection measures remain place during the construction phase.</p> | |

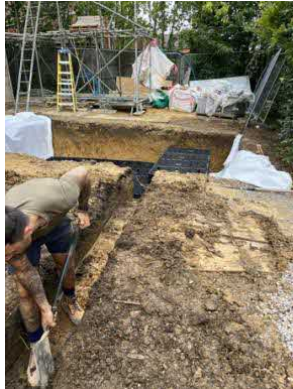
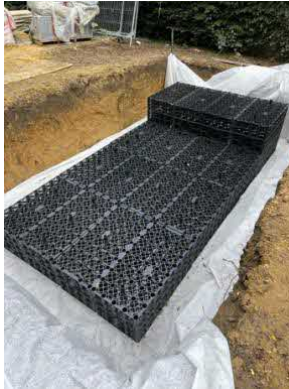
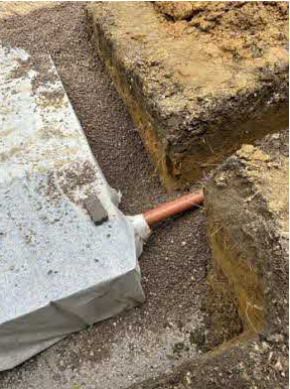
| Visit date | Observations | Recommendations | Photographs |
|---|---|---|---|
| 15.07.2023 | <p>Tree protection fencing remains in place as approved and fit for purpose.</p> <p>Excavation for the attenuation tank completed under supervision, route for connecting pipework excavated by hand under supervision and in accordance with the approved methodology.</p> <p>No root growth encountered.</p> | <p>Ensure heras panels and other tree protection measures remain place during the last elements of the construction phase. Once all machinery is off site the fencing can be removed to enable final landscaping.</p> <p>Final visit scheduled for landscaping completion.</p> | |

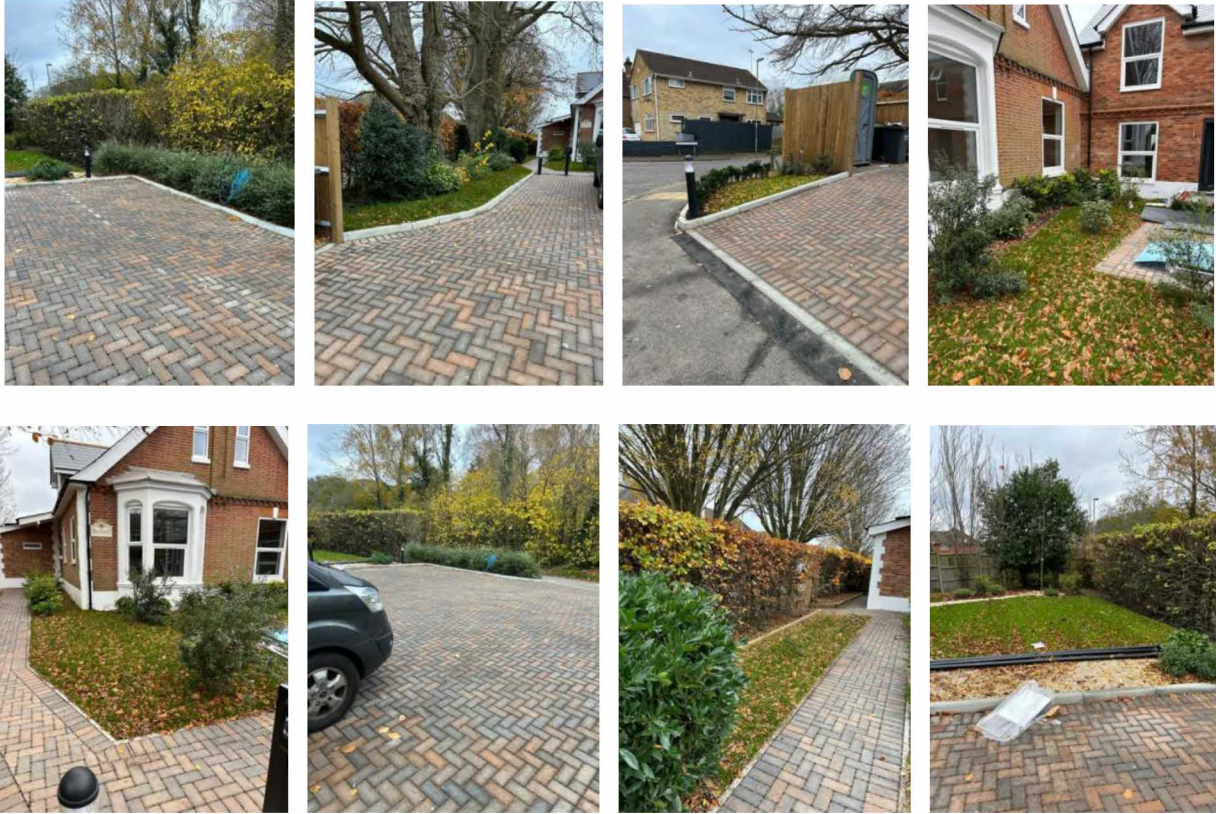
| Visit date | Observations | Recommendations | Photographs |
|---|---|---|---|
| 21.11.2023 | <p>Tree protection measures removed, all hard surfacing and soft landscaping work complete.</p> <p>All works to date completed in accordance with the approved methodology.</p> | <p>The Arboricultural Method Statement has been complied with fully and supervision and monitoring has been completed as detailed herein.</p> <p>This record can now be submitted to HDS for discharge of Condition 9 part ii.</p> | |
