Hampshire Homes Group

# Land at 31a North Street, Emsworth

Preliminary Risk Assessment

Project no. 305019

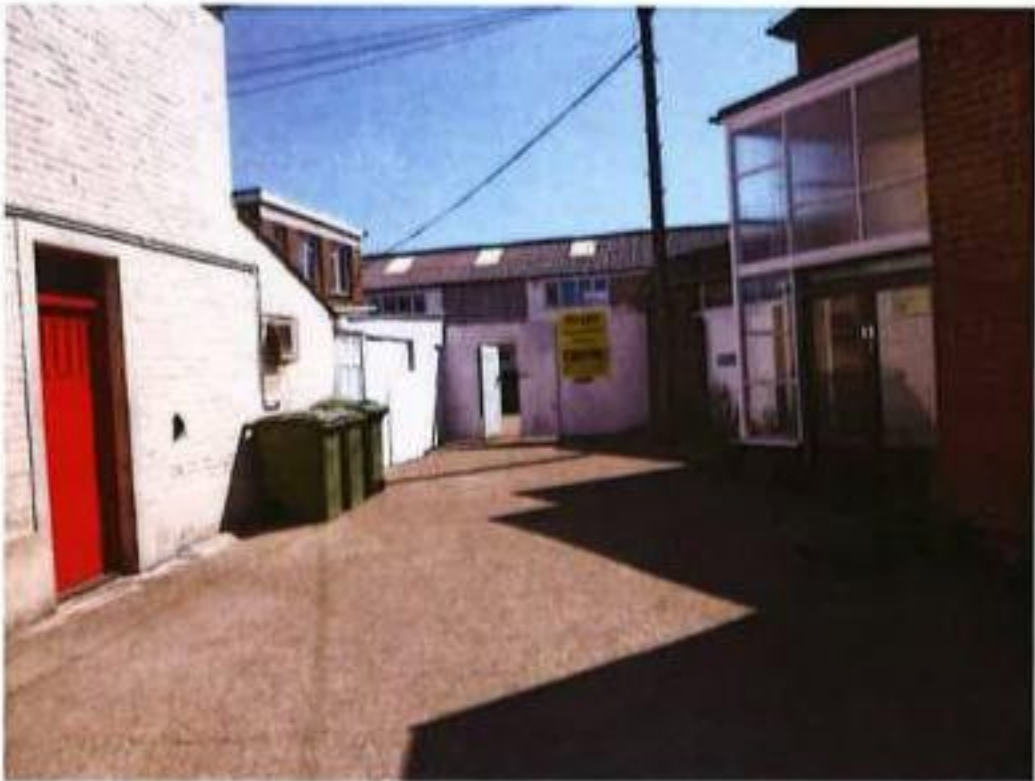
| PHOTOGRAPHIC LOG | | |
|---|---|---|
| Photo no.<br>1 | Date:<br>23/07/2018 | |

| PHOTOGRAPHIC LOG | | |
|---|---|---|
| Description:<br>View of the site entrance<br>from North Street | | |

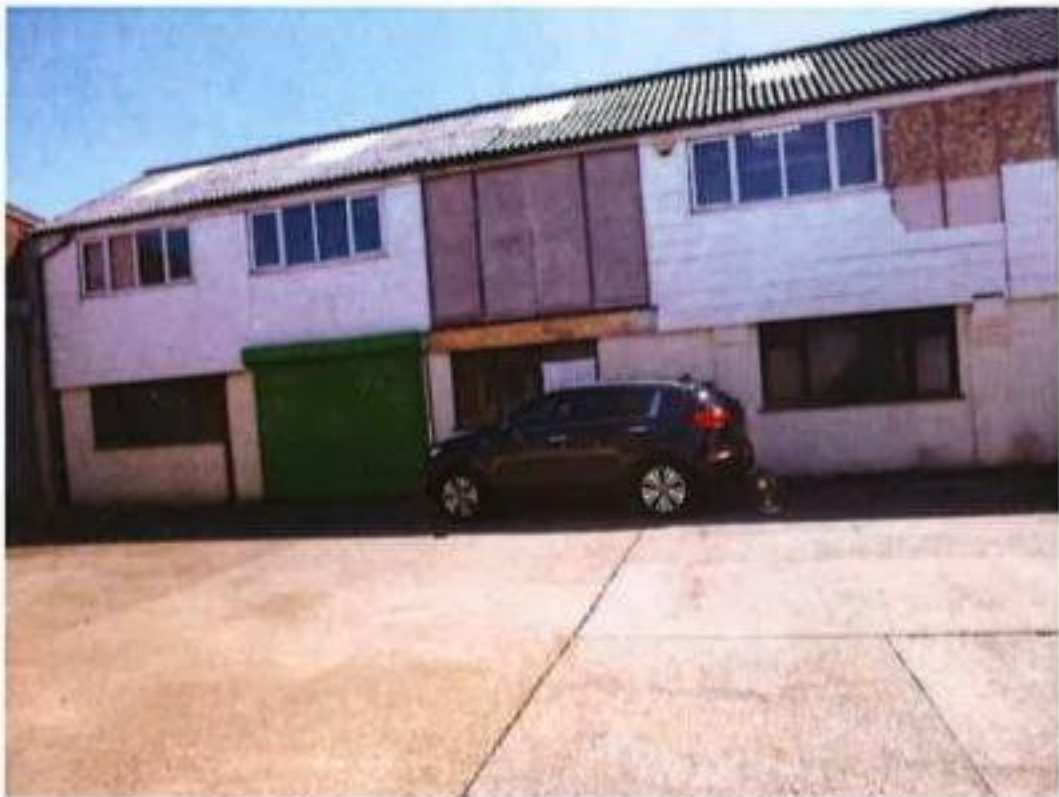
| PHOTOGRAPHIC LOG | | |
|---|---|---|
| Photo No.<br>2 | Date:<br>23/07/2018 | |

| PHOTOGRAPHIC LOG | | |
|---|---|---|
| Description:<br>View of the central<br>hardstanding area and<br>the building along the<br>eastern boundary | | |

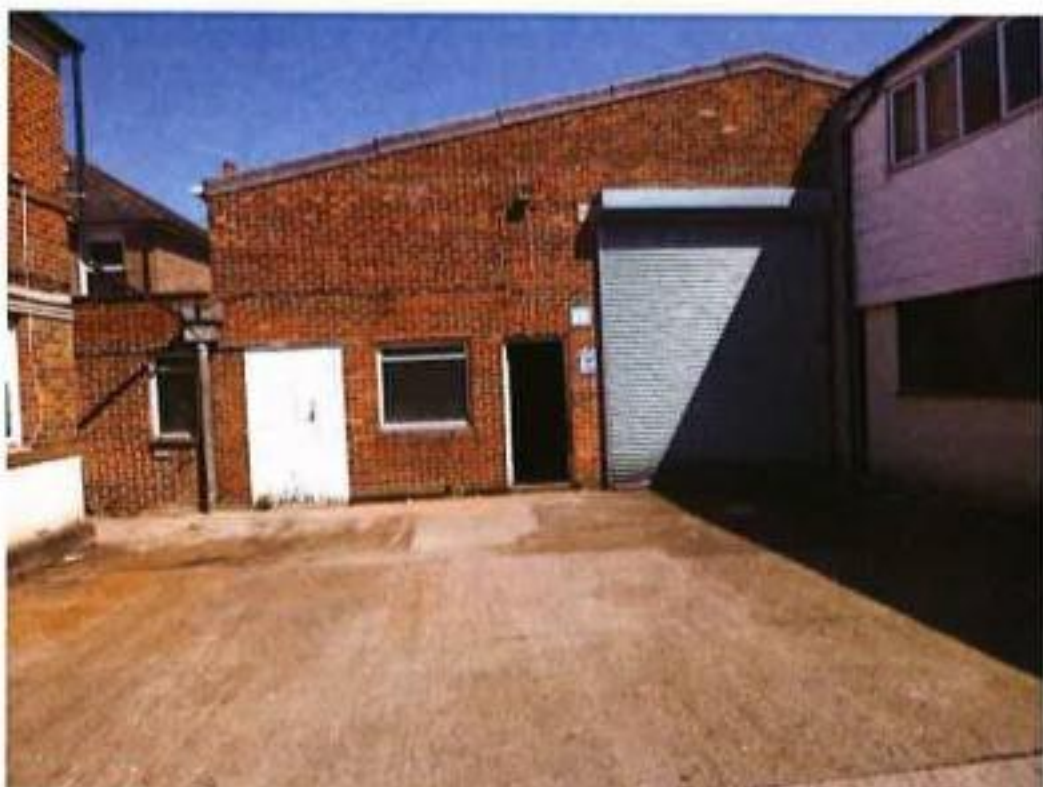
| Photo No.<br>3 | Date:<br>23/07/2018 | |

| Description:<br>View of the warehouse/workshop in the north of the site plus the remaining hardstanding courtyard | | |

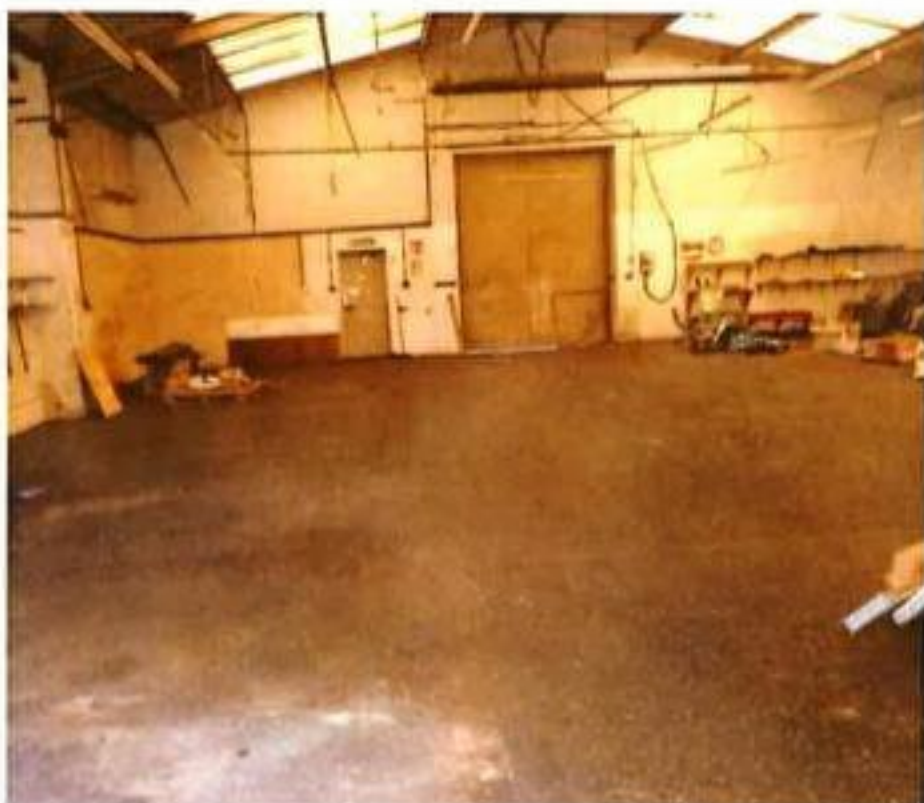
| Photo No.<br>4 | Date:<br>23/07/2018 | |

| Description:<br>View inside the workshop, showing minor staining on the hardstanding floor and vehicle parts in the north eastern corner | | |

A number of vehicle parts were noted within the workshop, suggesting some vehicle maintenance has been carried out on site. No evidence of fuel or waste storage was noted. Areas of the workshop floor were noted to be stained with substances likely associated with the vehicle parts.

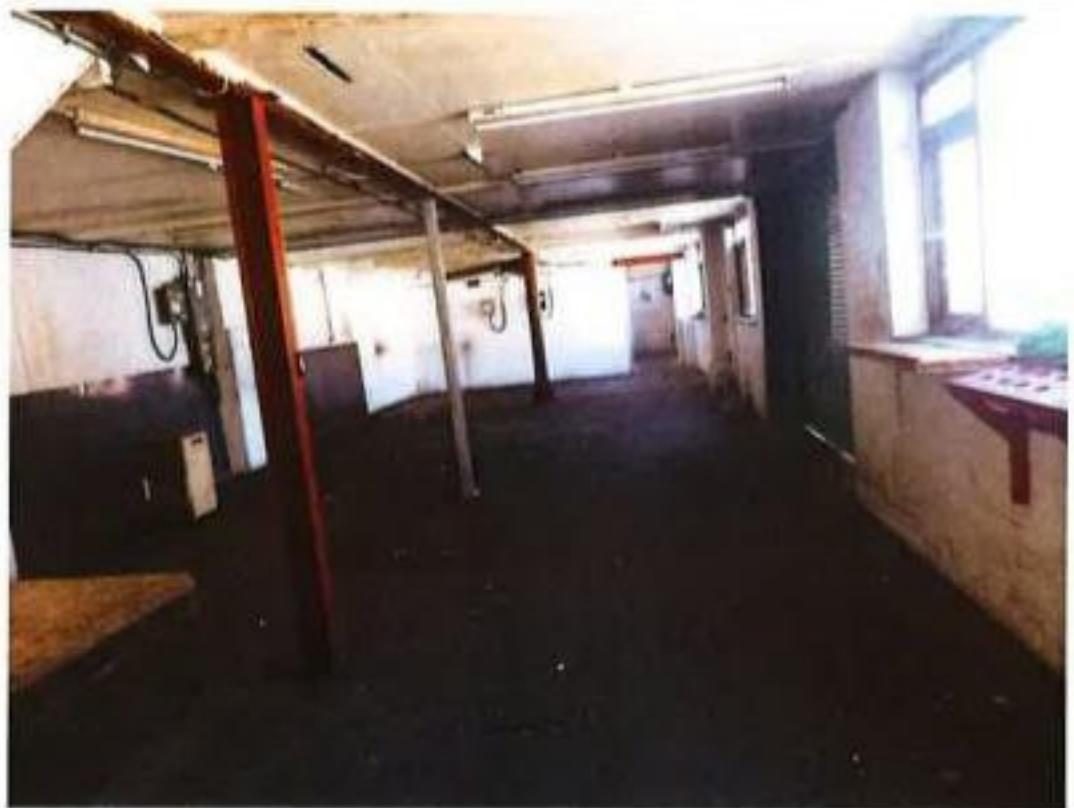
| Photo No.<br>5 | Date:<br>23/07/2018 | |

| Description:<br>View showing the ground floor of the workshop adjoining office block along the eastern boundary | | |

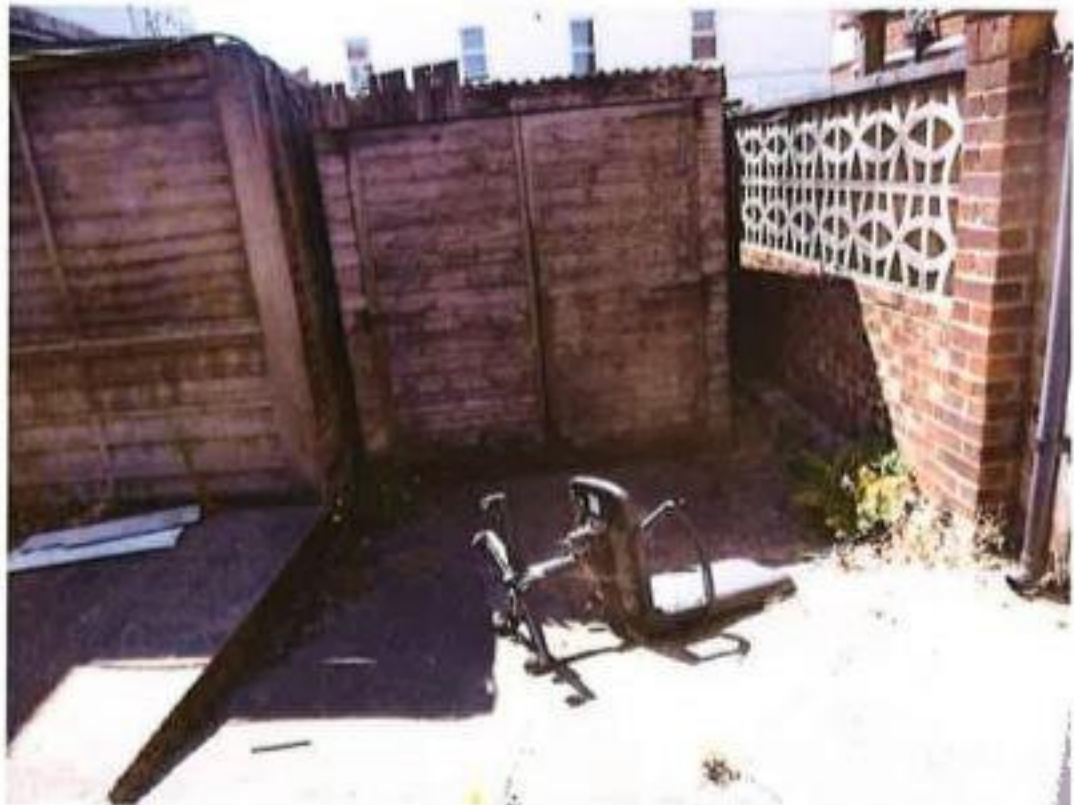
| Photo No.<br>7 | Date:<br>23/07/2018 | |

| Description:<br>View showing the shed in the south of the site and the level change noted in the site walkover. | | |

| Features | Description | Photo no. | Map ref. |
|---|---|---|---|
| j) Note any abrupt changes in ground level. Is there evidence of Made Ground/fill on site<br><i>May indicate that minerals have been worked in surface excavations. May indicate cut and fill.</i> | Level change to shed as previously noted. | | |

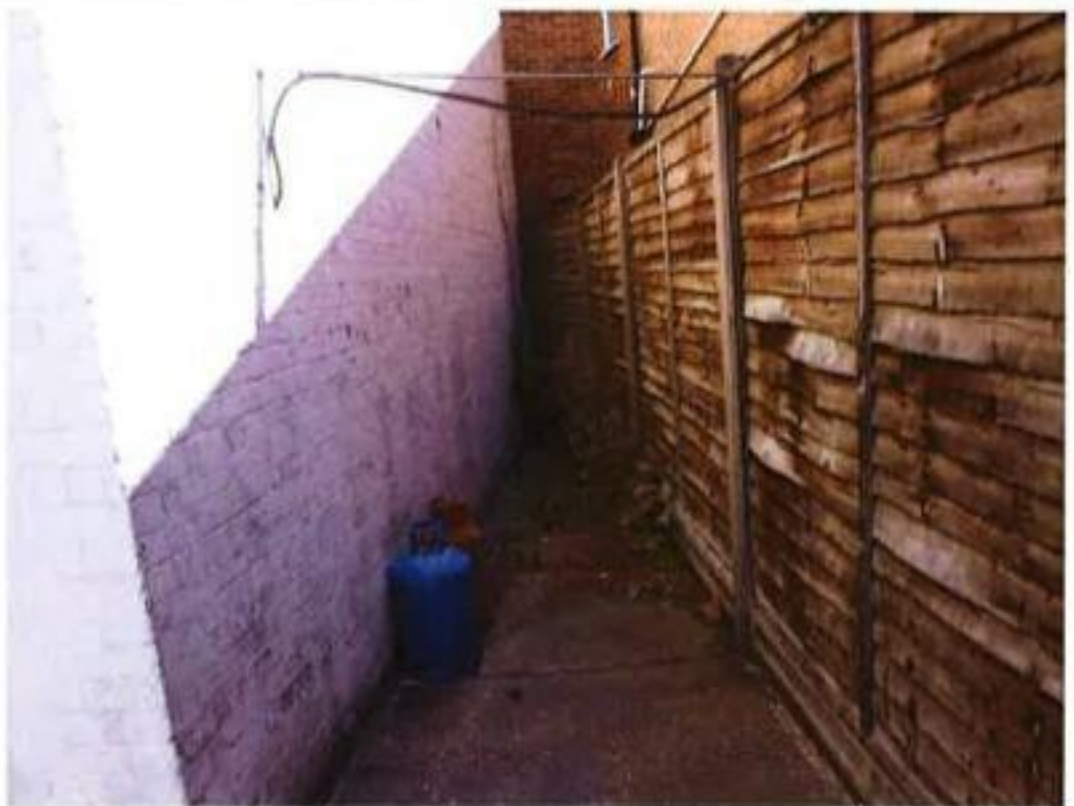
| Photo No.<br>8 | Date:<br>23/07/2018 | |

| Description:<br>View showing the butane bottles to the south of the commercial building in the east of the site. | | |

| Features | Description | Photo no. | Map ref. |
|---|---|---|---|
| r) Describe storage of fuels and chemicals. Are there any drums/containers (if yes, describe quantity, full/empty, stored on hardstanding/softstanding, banded)?<br><i>Is there evidence of underground fuel tanks (if yes, describe locations, how many, volumes, bunding, used/disused, condition)?</i> | Site heating run off mains gas. Hot water heated electrically using wall mounted heaters. No access to office to confirm.<br>2 gas bottles noted within east of site to side of warehouse unit. | | |
