## **Main Investigation Report**

**Warehouse Extension, Unit 3, Station Approach, North Street,  
Emsworth, Hampshire PO10 7PW**

**Racquet Sports Group**

**Reference: I7974/MIR\_R27  
December 2019**

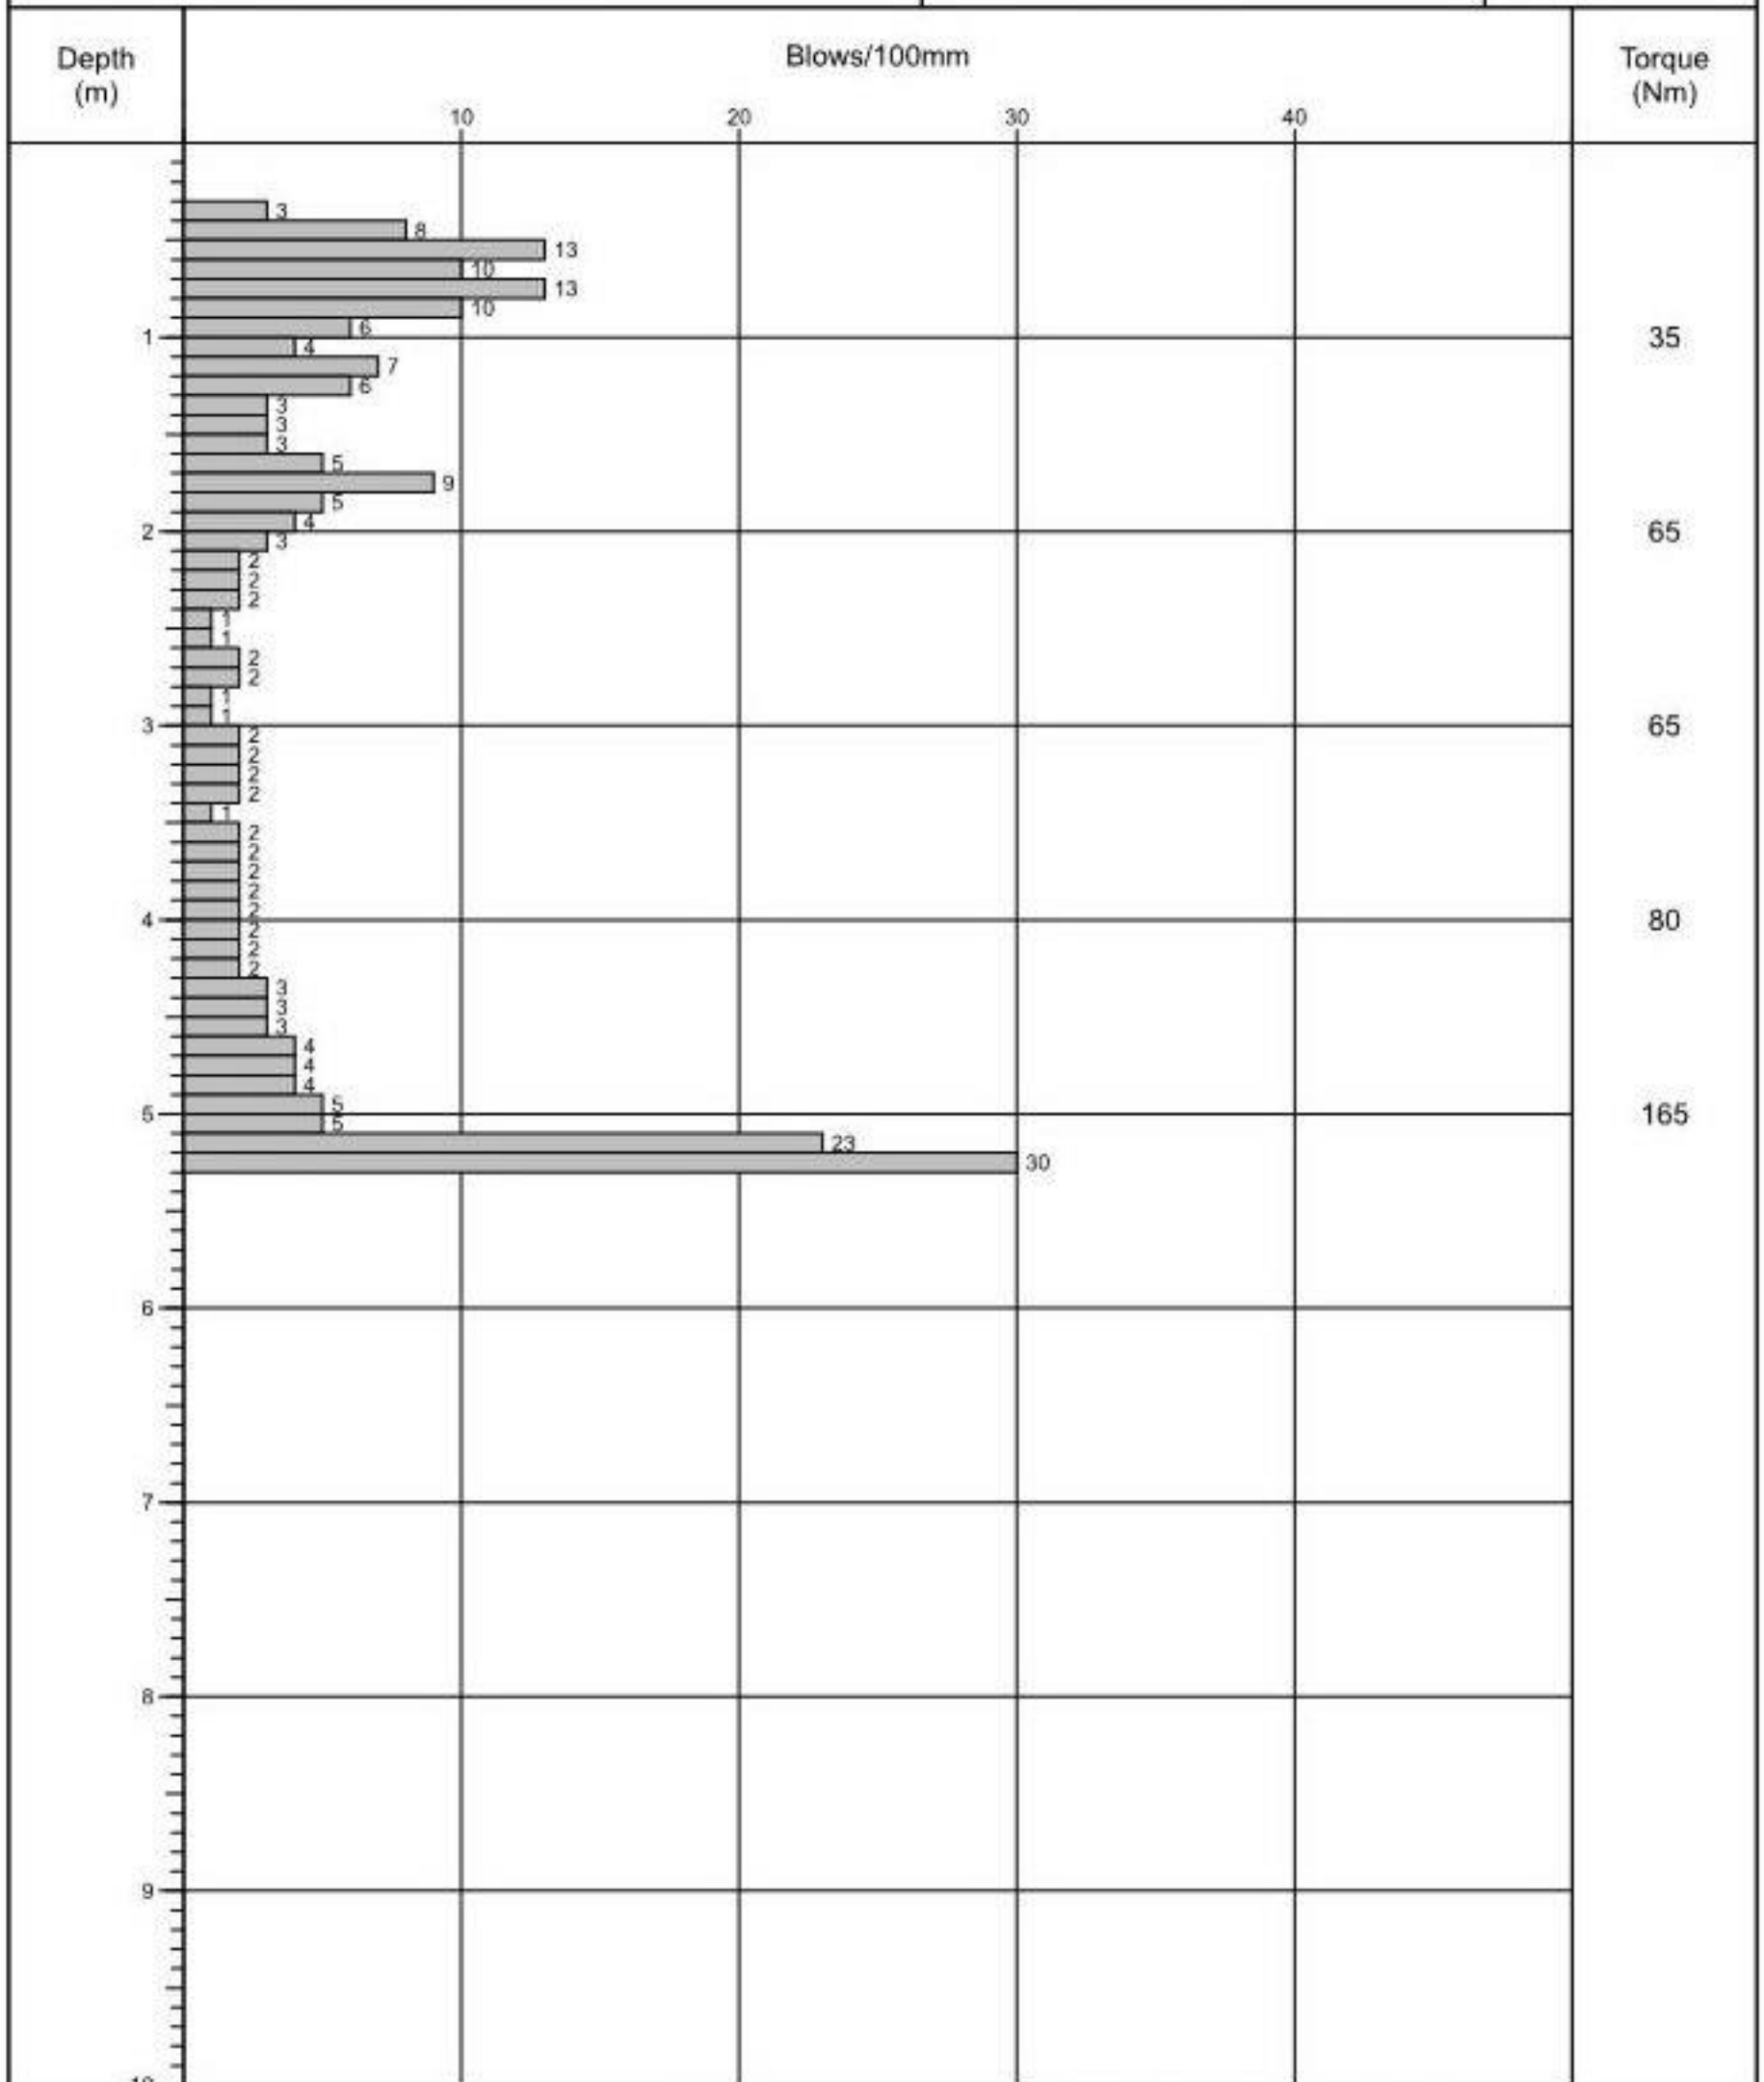
| Remarks | Fall Height | 750mm | Cone Base Diameter | 50.5mm |
| | Hammer Weight | 63.5kg | Final Depth | 5.2m |

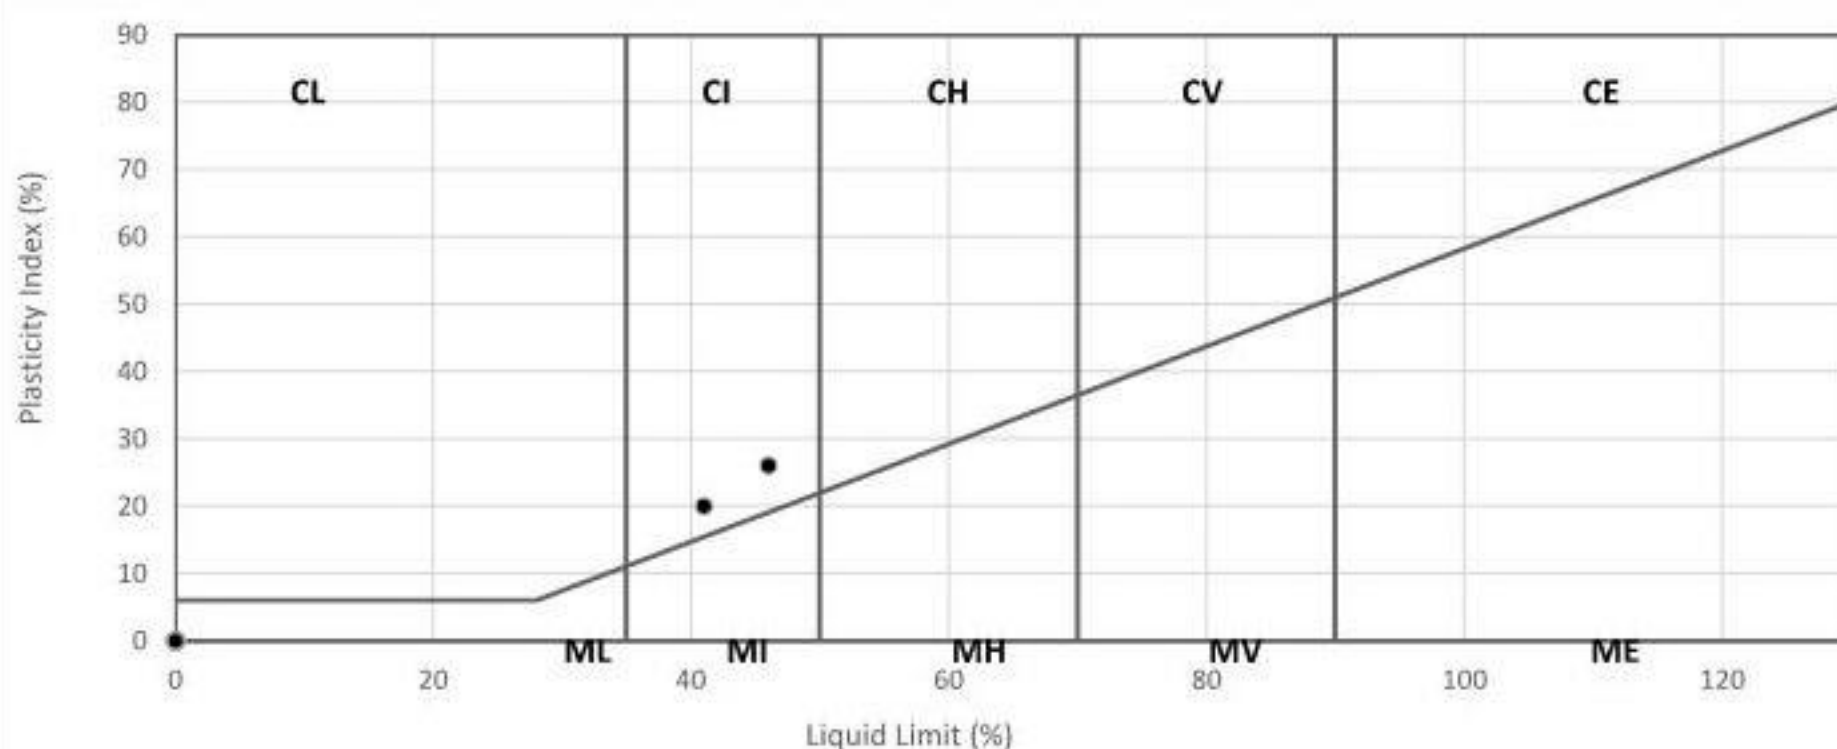
**PLASTICITY CHART FOR CASAGRANDE CLASSIFICATION**  
**BS 5930:1999+A2:2010**

**NATURAL MOISTURE, LIQUID LIMIT, PLASTIC LIMIT AND PLASTICITY INDEX**  
( BS 1377 : Part 2 : 1990 Method 5 )

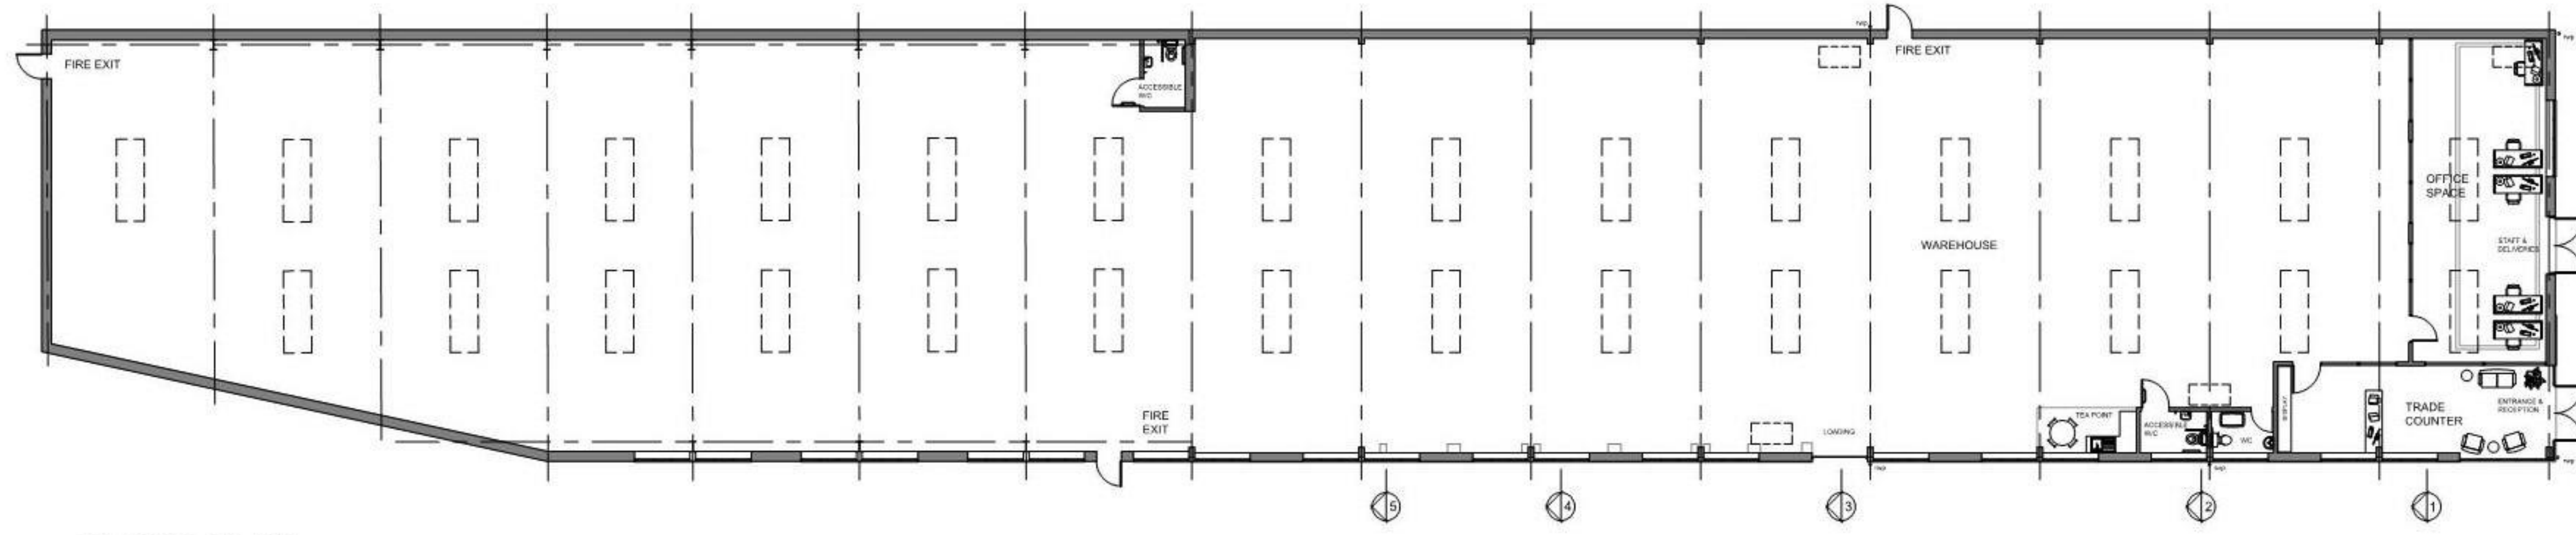
FLOOR PLAN  
Gross Internal Area: Existing Warehouse 725m<sup>2</sup>  
Proposed Extension = 575m<sup>2</sup> approx.

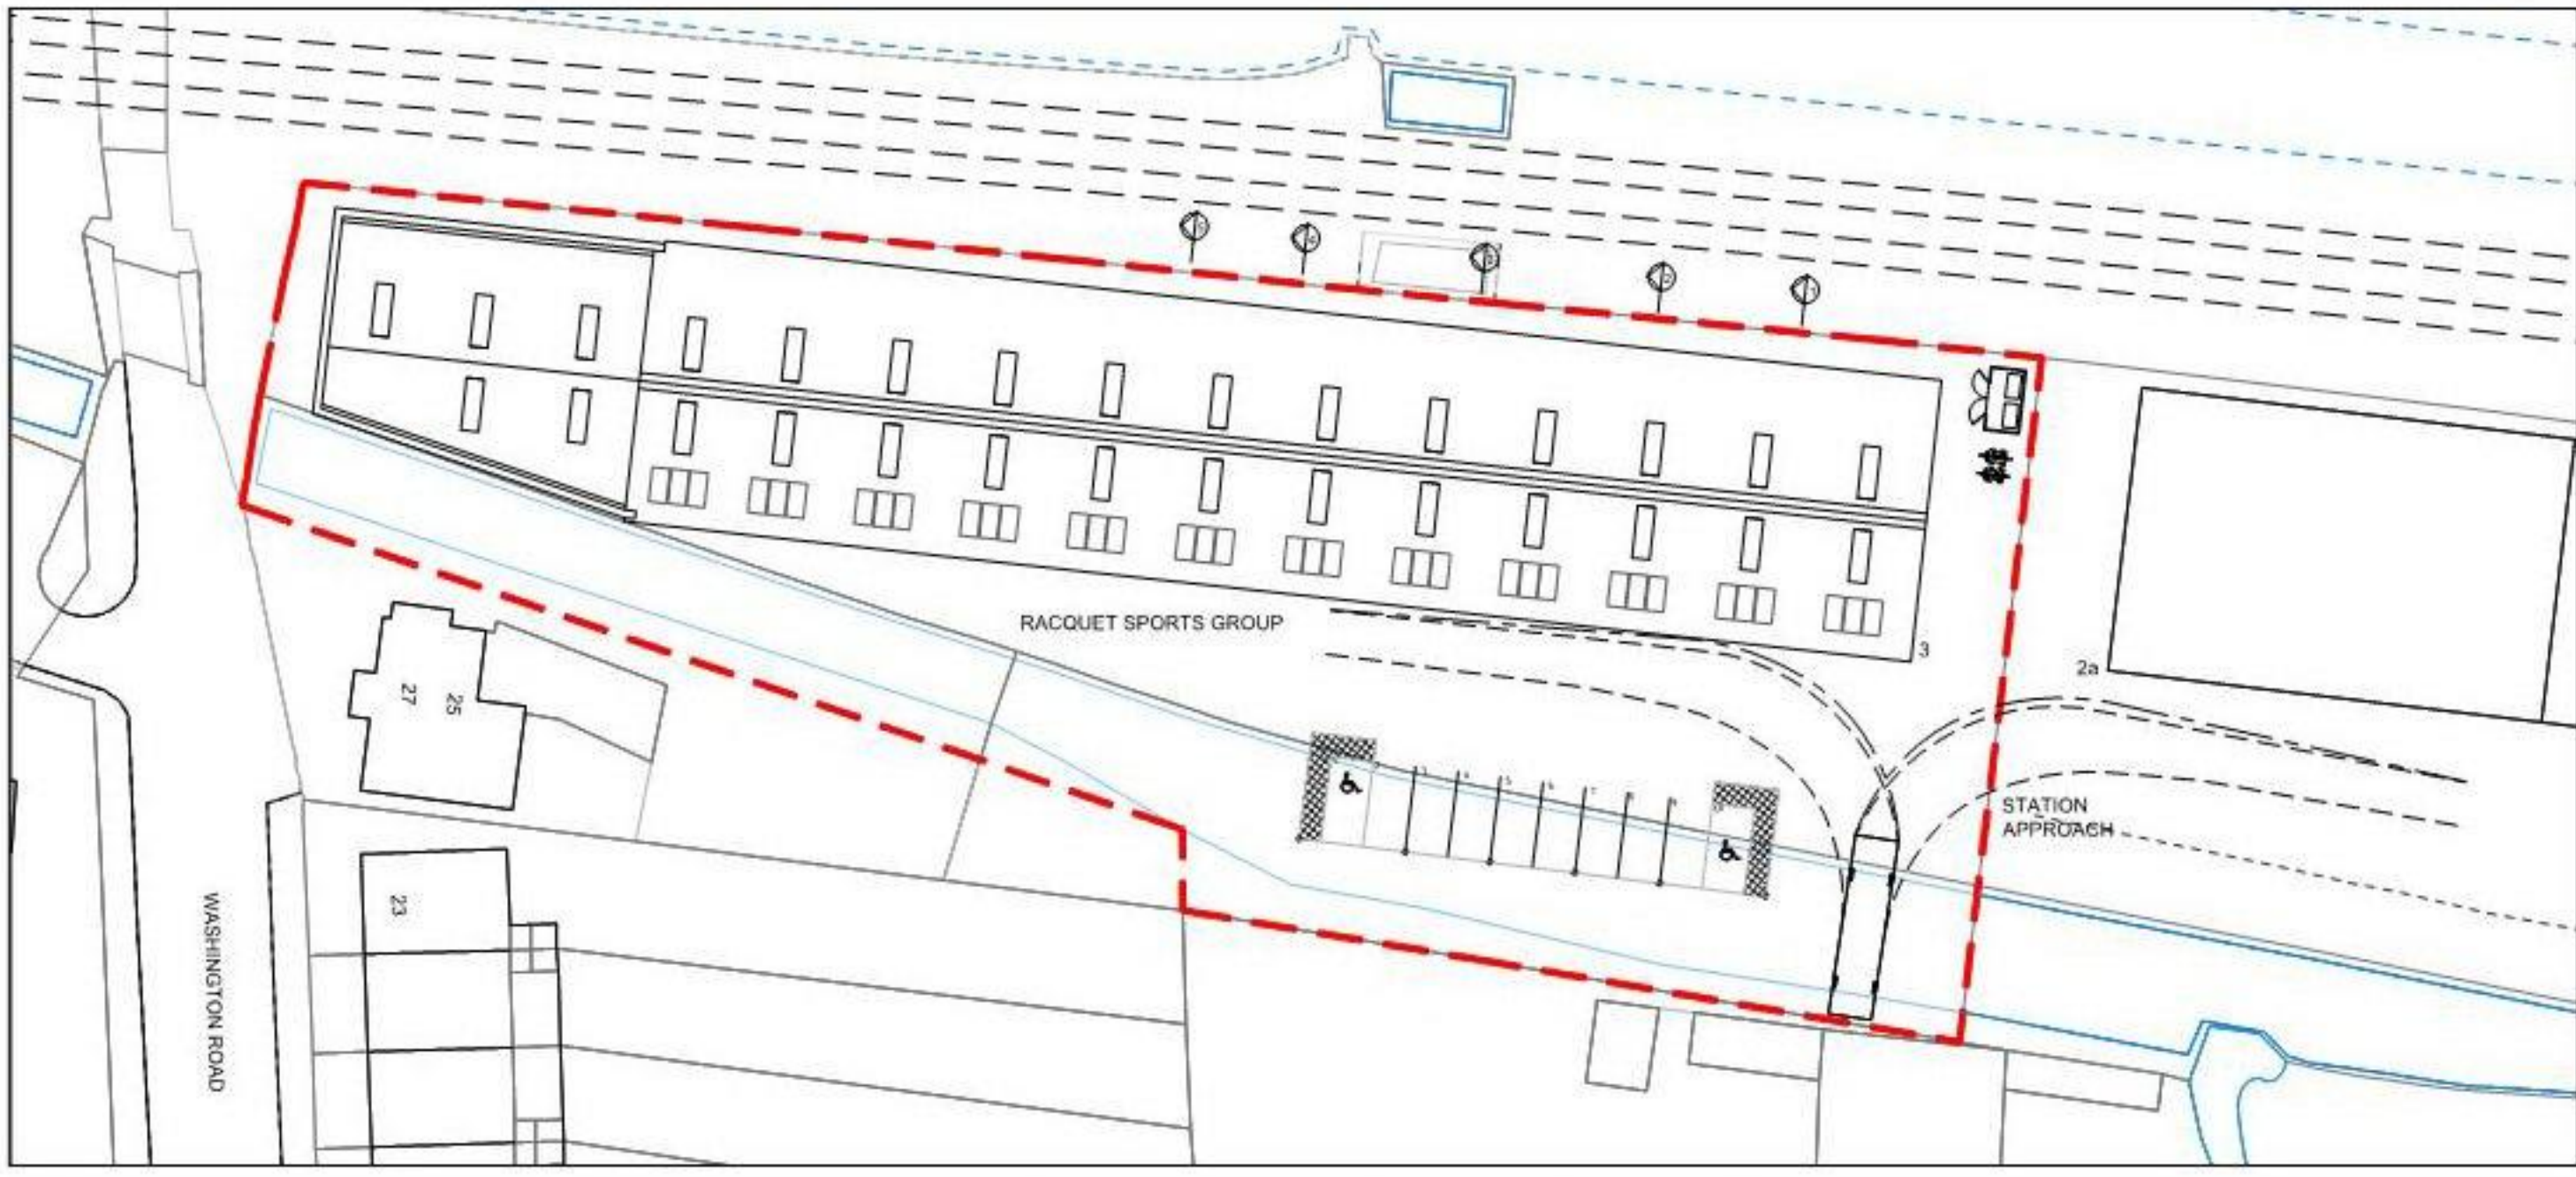
PROPOSED SITE PLAN 1:500  
Scale 1/500 (in metres)

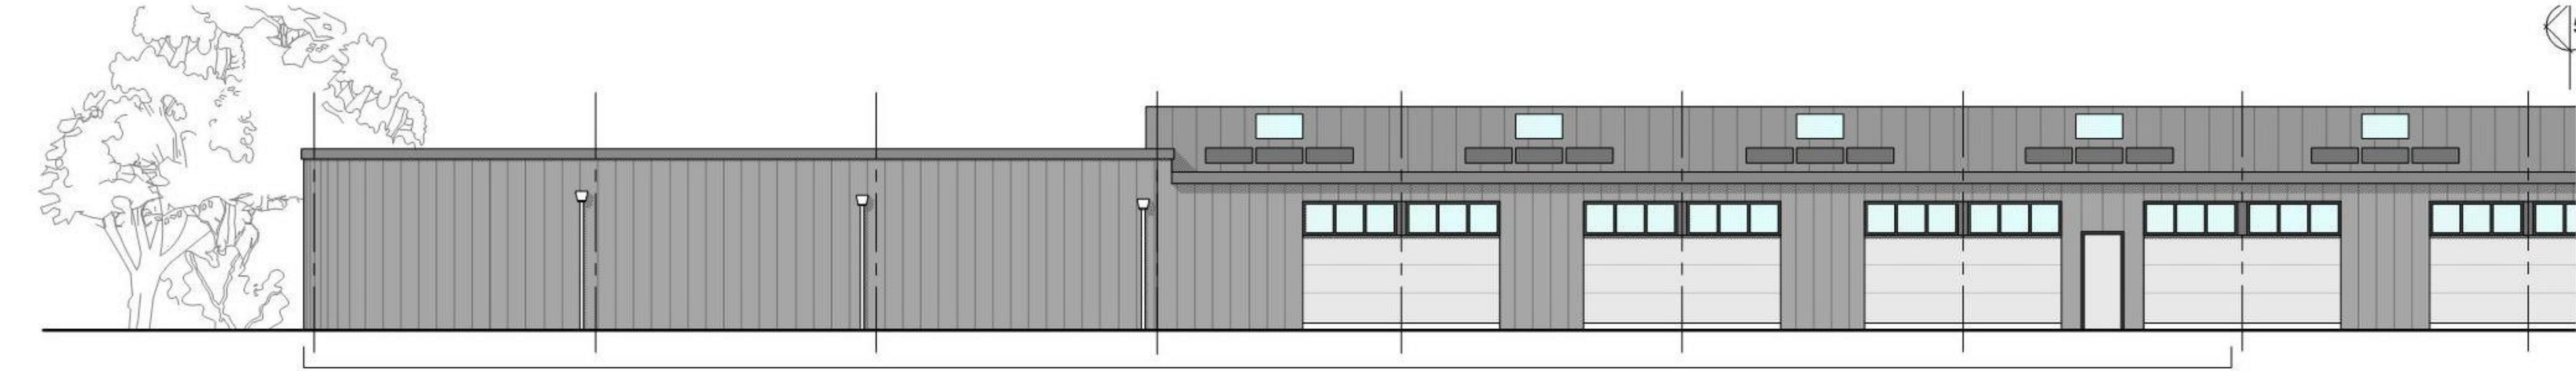
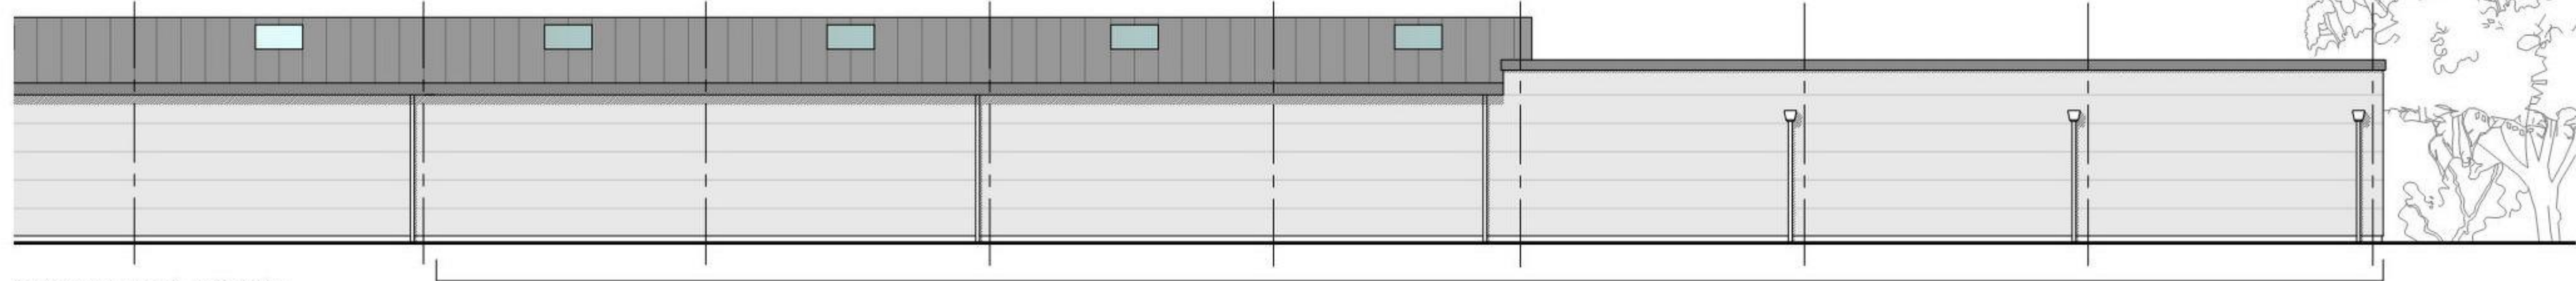
EXTENSION ELEVATIONS 1:100  
Scale 1/100 (in metres)

PROPOSED EXTENSION
