# GROUND INVESTIGATION REPORT

Proposed Residential Development  
Robin Gardens, Waterloooville, Hampshire

Prepared for: Portsmouth City Council

Report No: PO-22-040/GIR

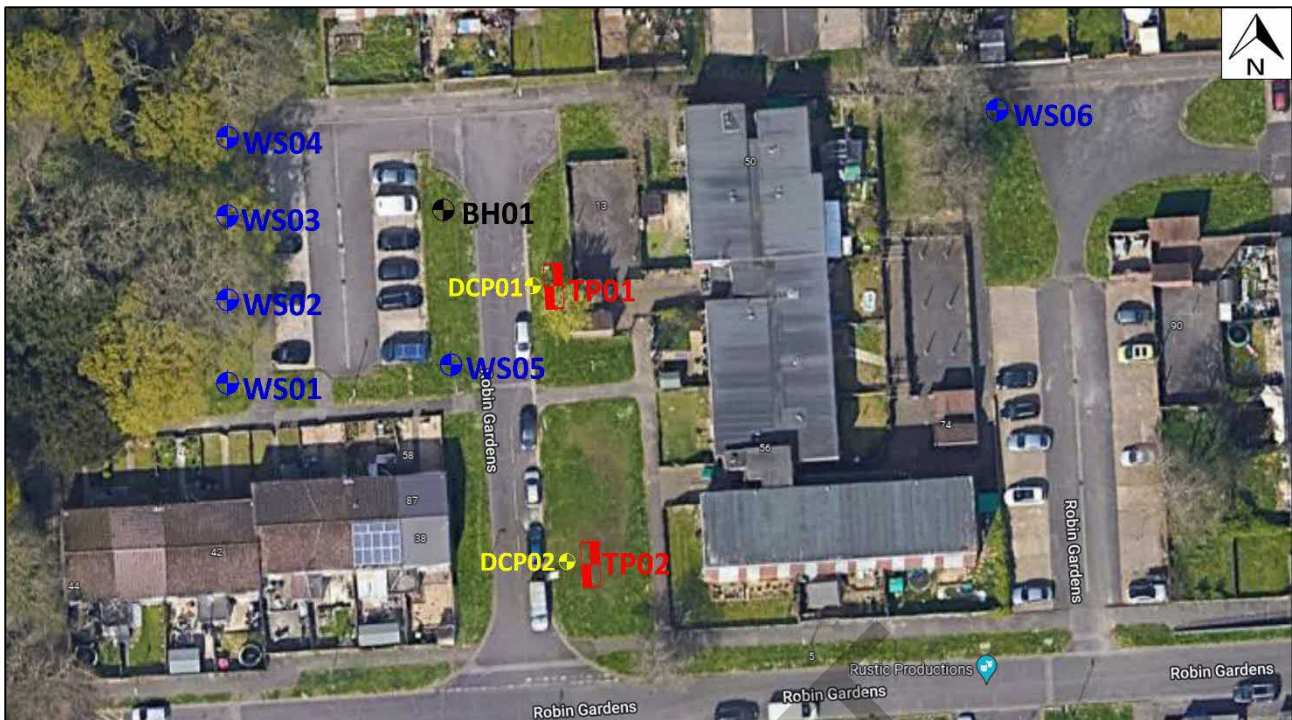
Drawing 3.1: Exploratory Hole Location Plan

The exploratory hole logs and in-situ test result are presented in Annex A and Annex B respectively, and their locations shown on Drawing 3.1 below.
