Proposed artificial sports pitch  
Havant RFC  
Havant

## Ground Investigation Report

**Proposed artificial sports pitch  
Havant Rugby Football Club  
Havant  
PO9 3EJ**

**GROUND INVESTIGATION REPORT**

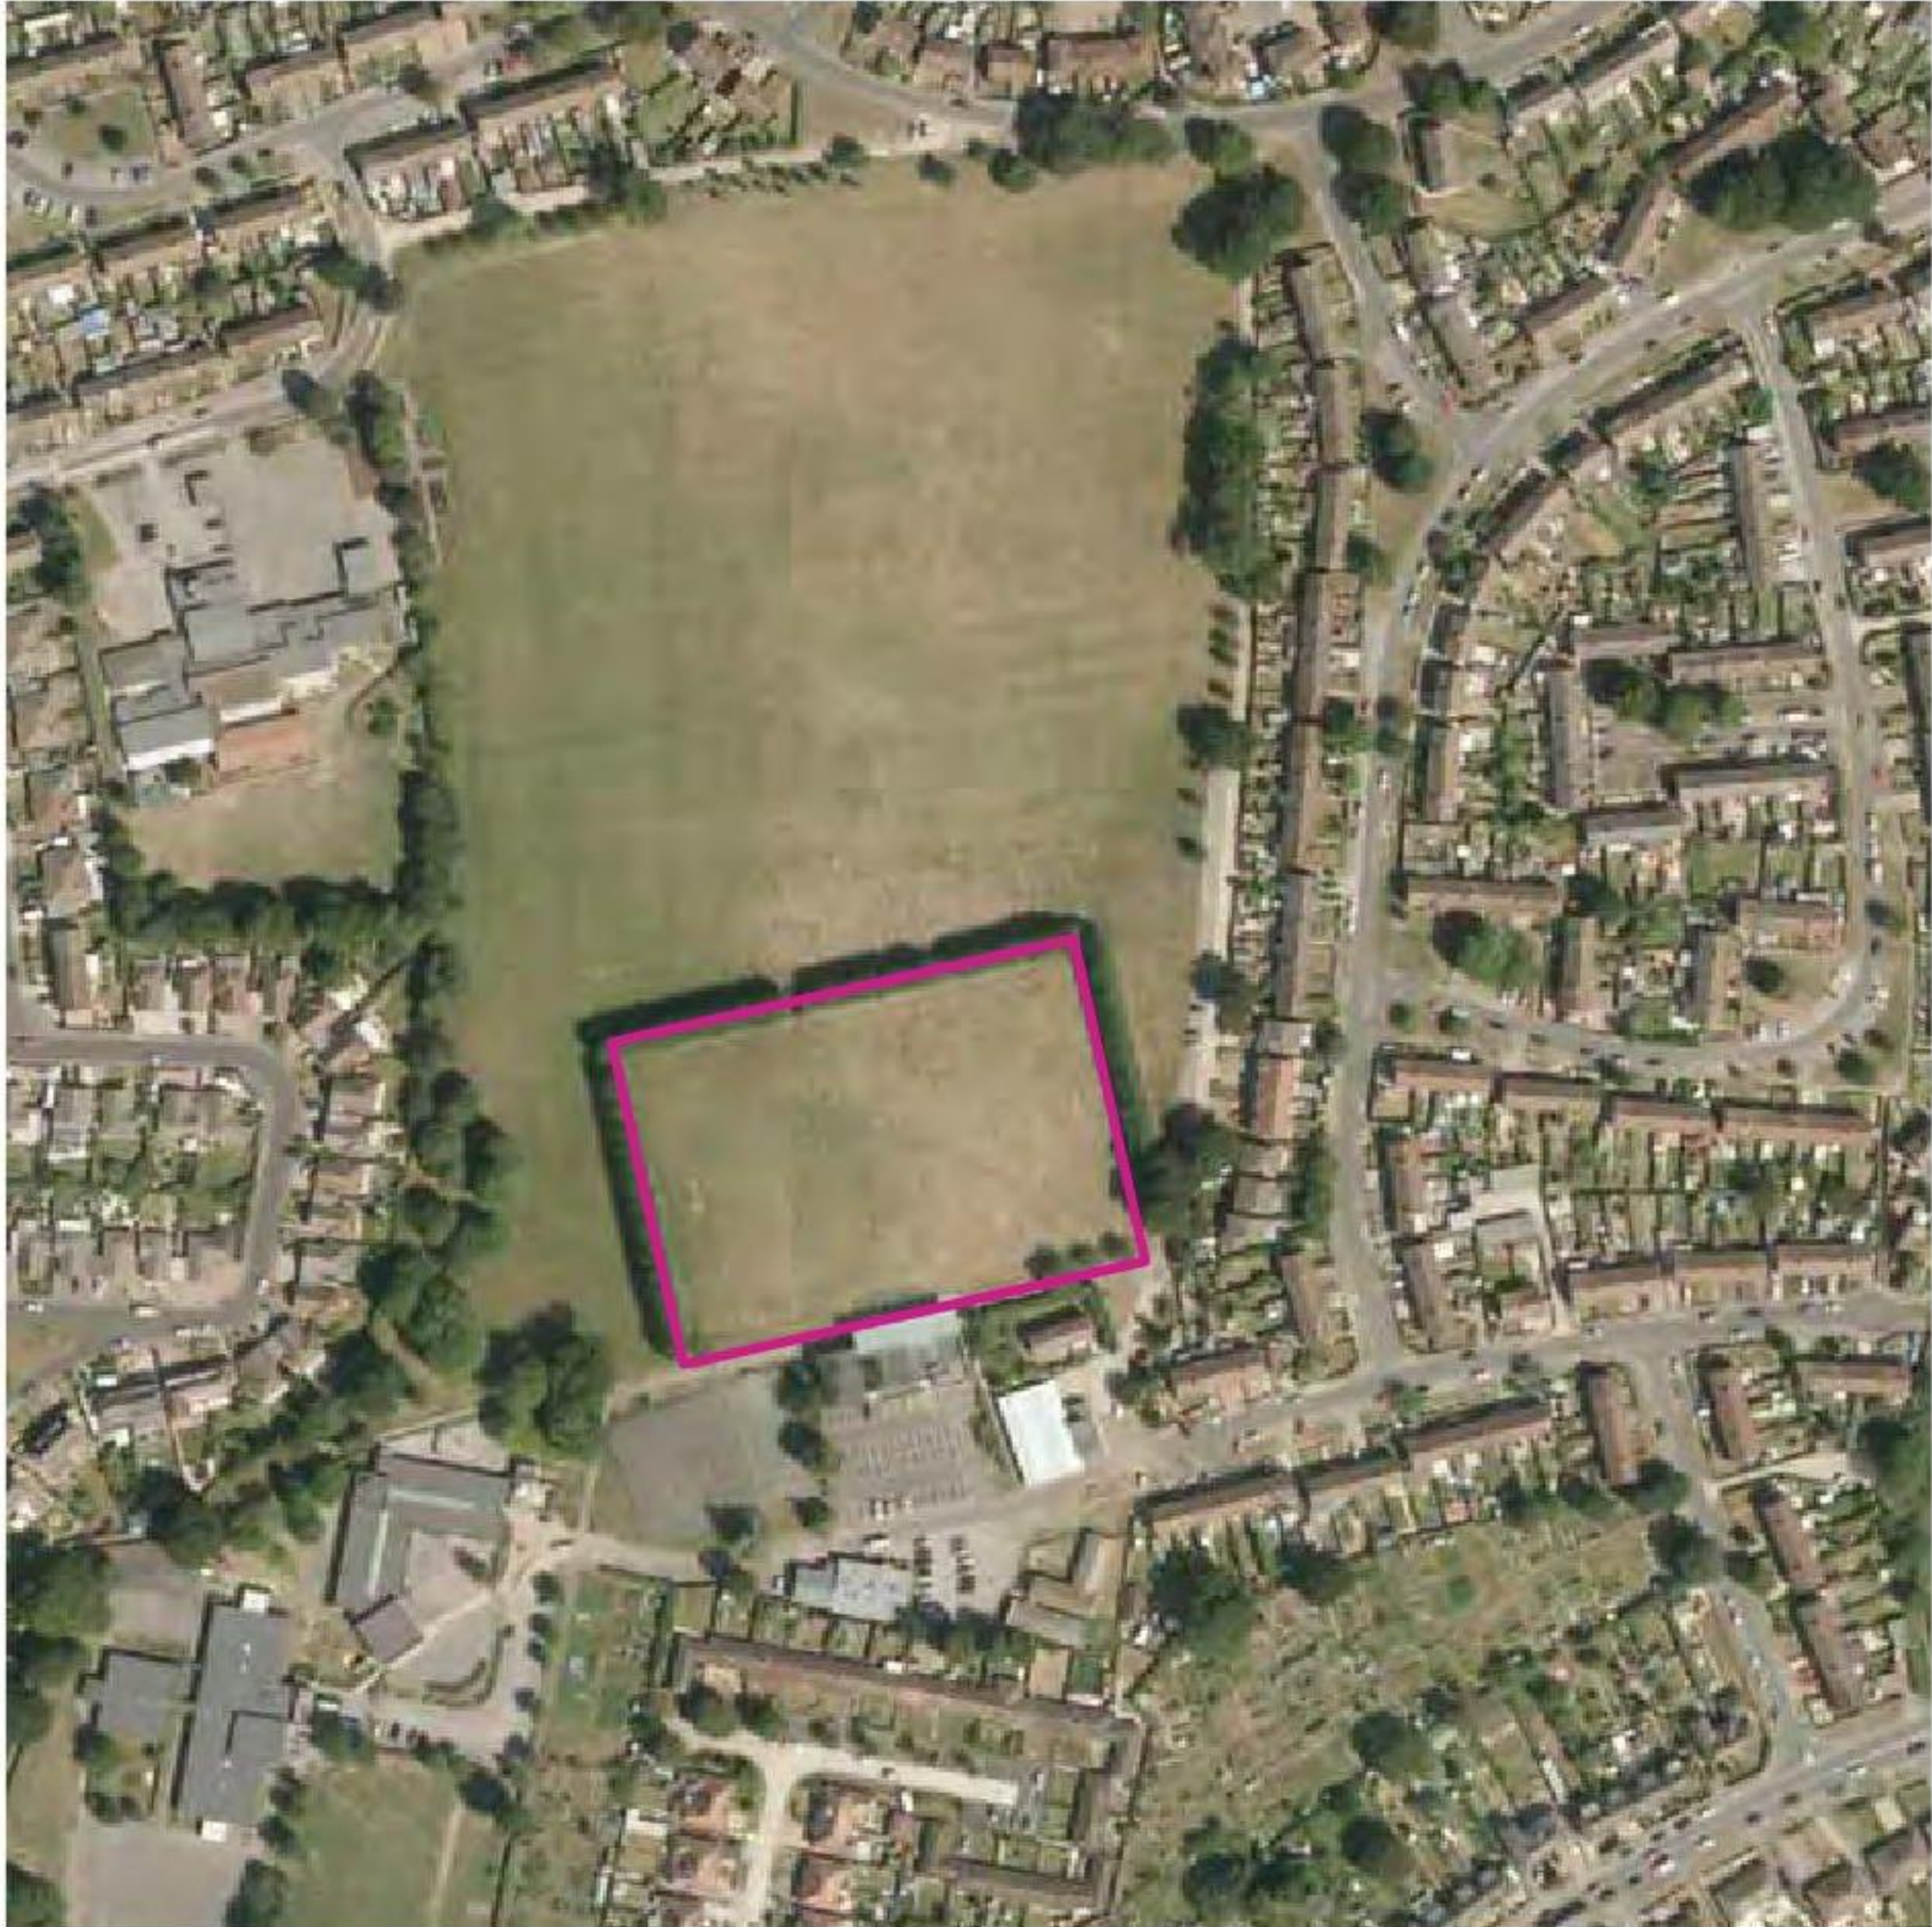
## Aerial photograph of site

The approximate location of the proposed pitch boundary is highlighted in **magenta**
