Emsworth EWI & D&W, V45

# Bat Roost Assessment and Bat Emergence / Return Survey Report

Vivo Defence Services

September 2023

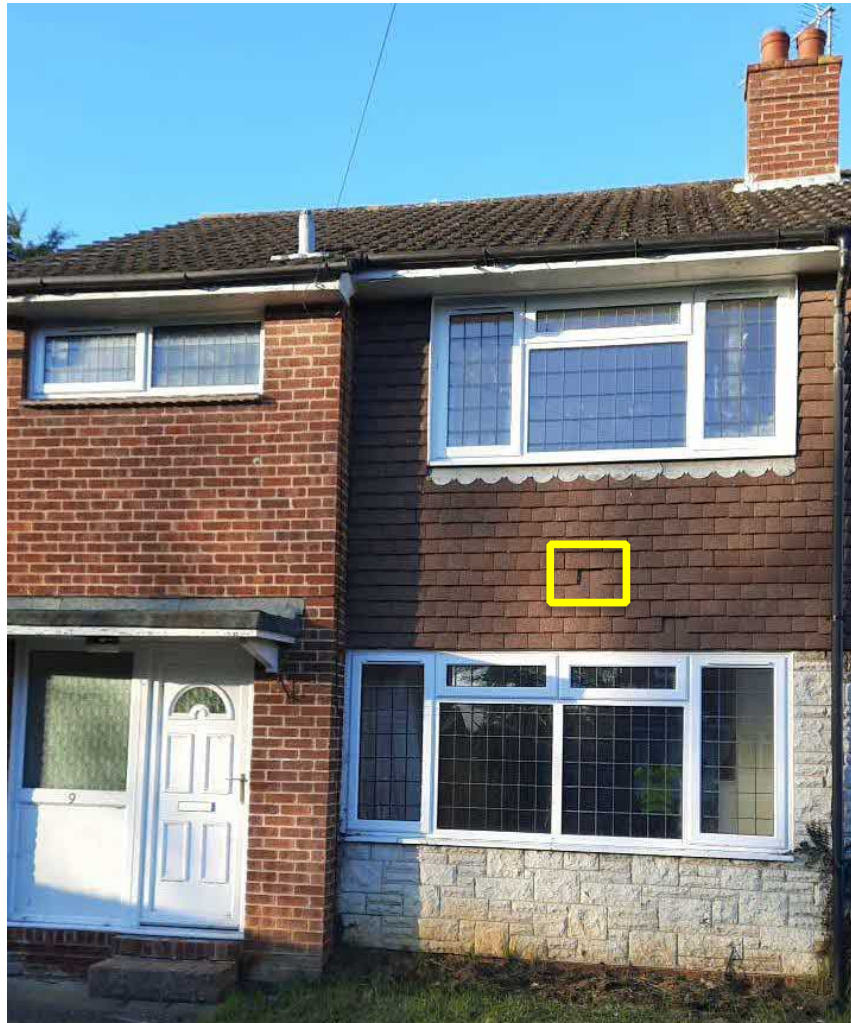
**Photograph 1: Example of a typical property, with missing hanging tiles visible.**

The 48 SFA were a mixture of detached and semi-detached houses constructed in the 1970's. The properties were all of the same structure; comprised of two-storey, cavity-walled buildings with pitched

pantile roofs and concrete ridge. Hanging tiles were present on most properties, with some missing (see Photograph 1). Windows and doorframes comprised uPVC. The pantiles were generally intact, and the soffit boxes flush to the walls, reducing potential access points for bats. Properties with a gable end comprises a concrete verge with only occasional gaps present. Lead flashing was present around the chimneys and below the windows by the hanging tiles and was lifted at some of the properties creating a potential access point.

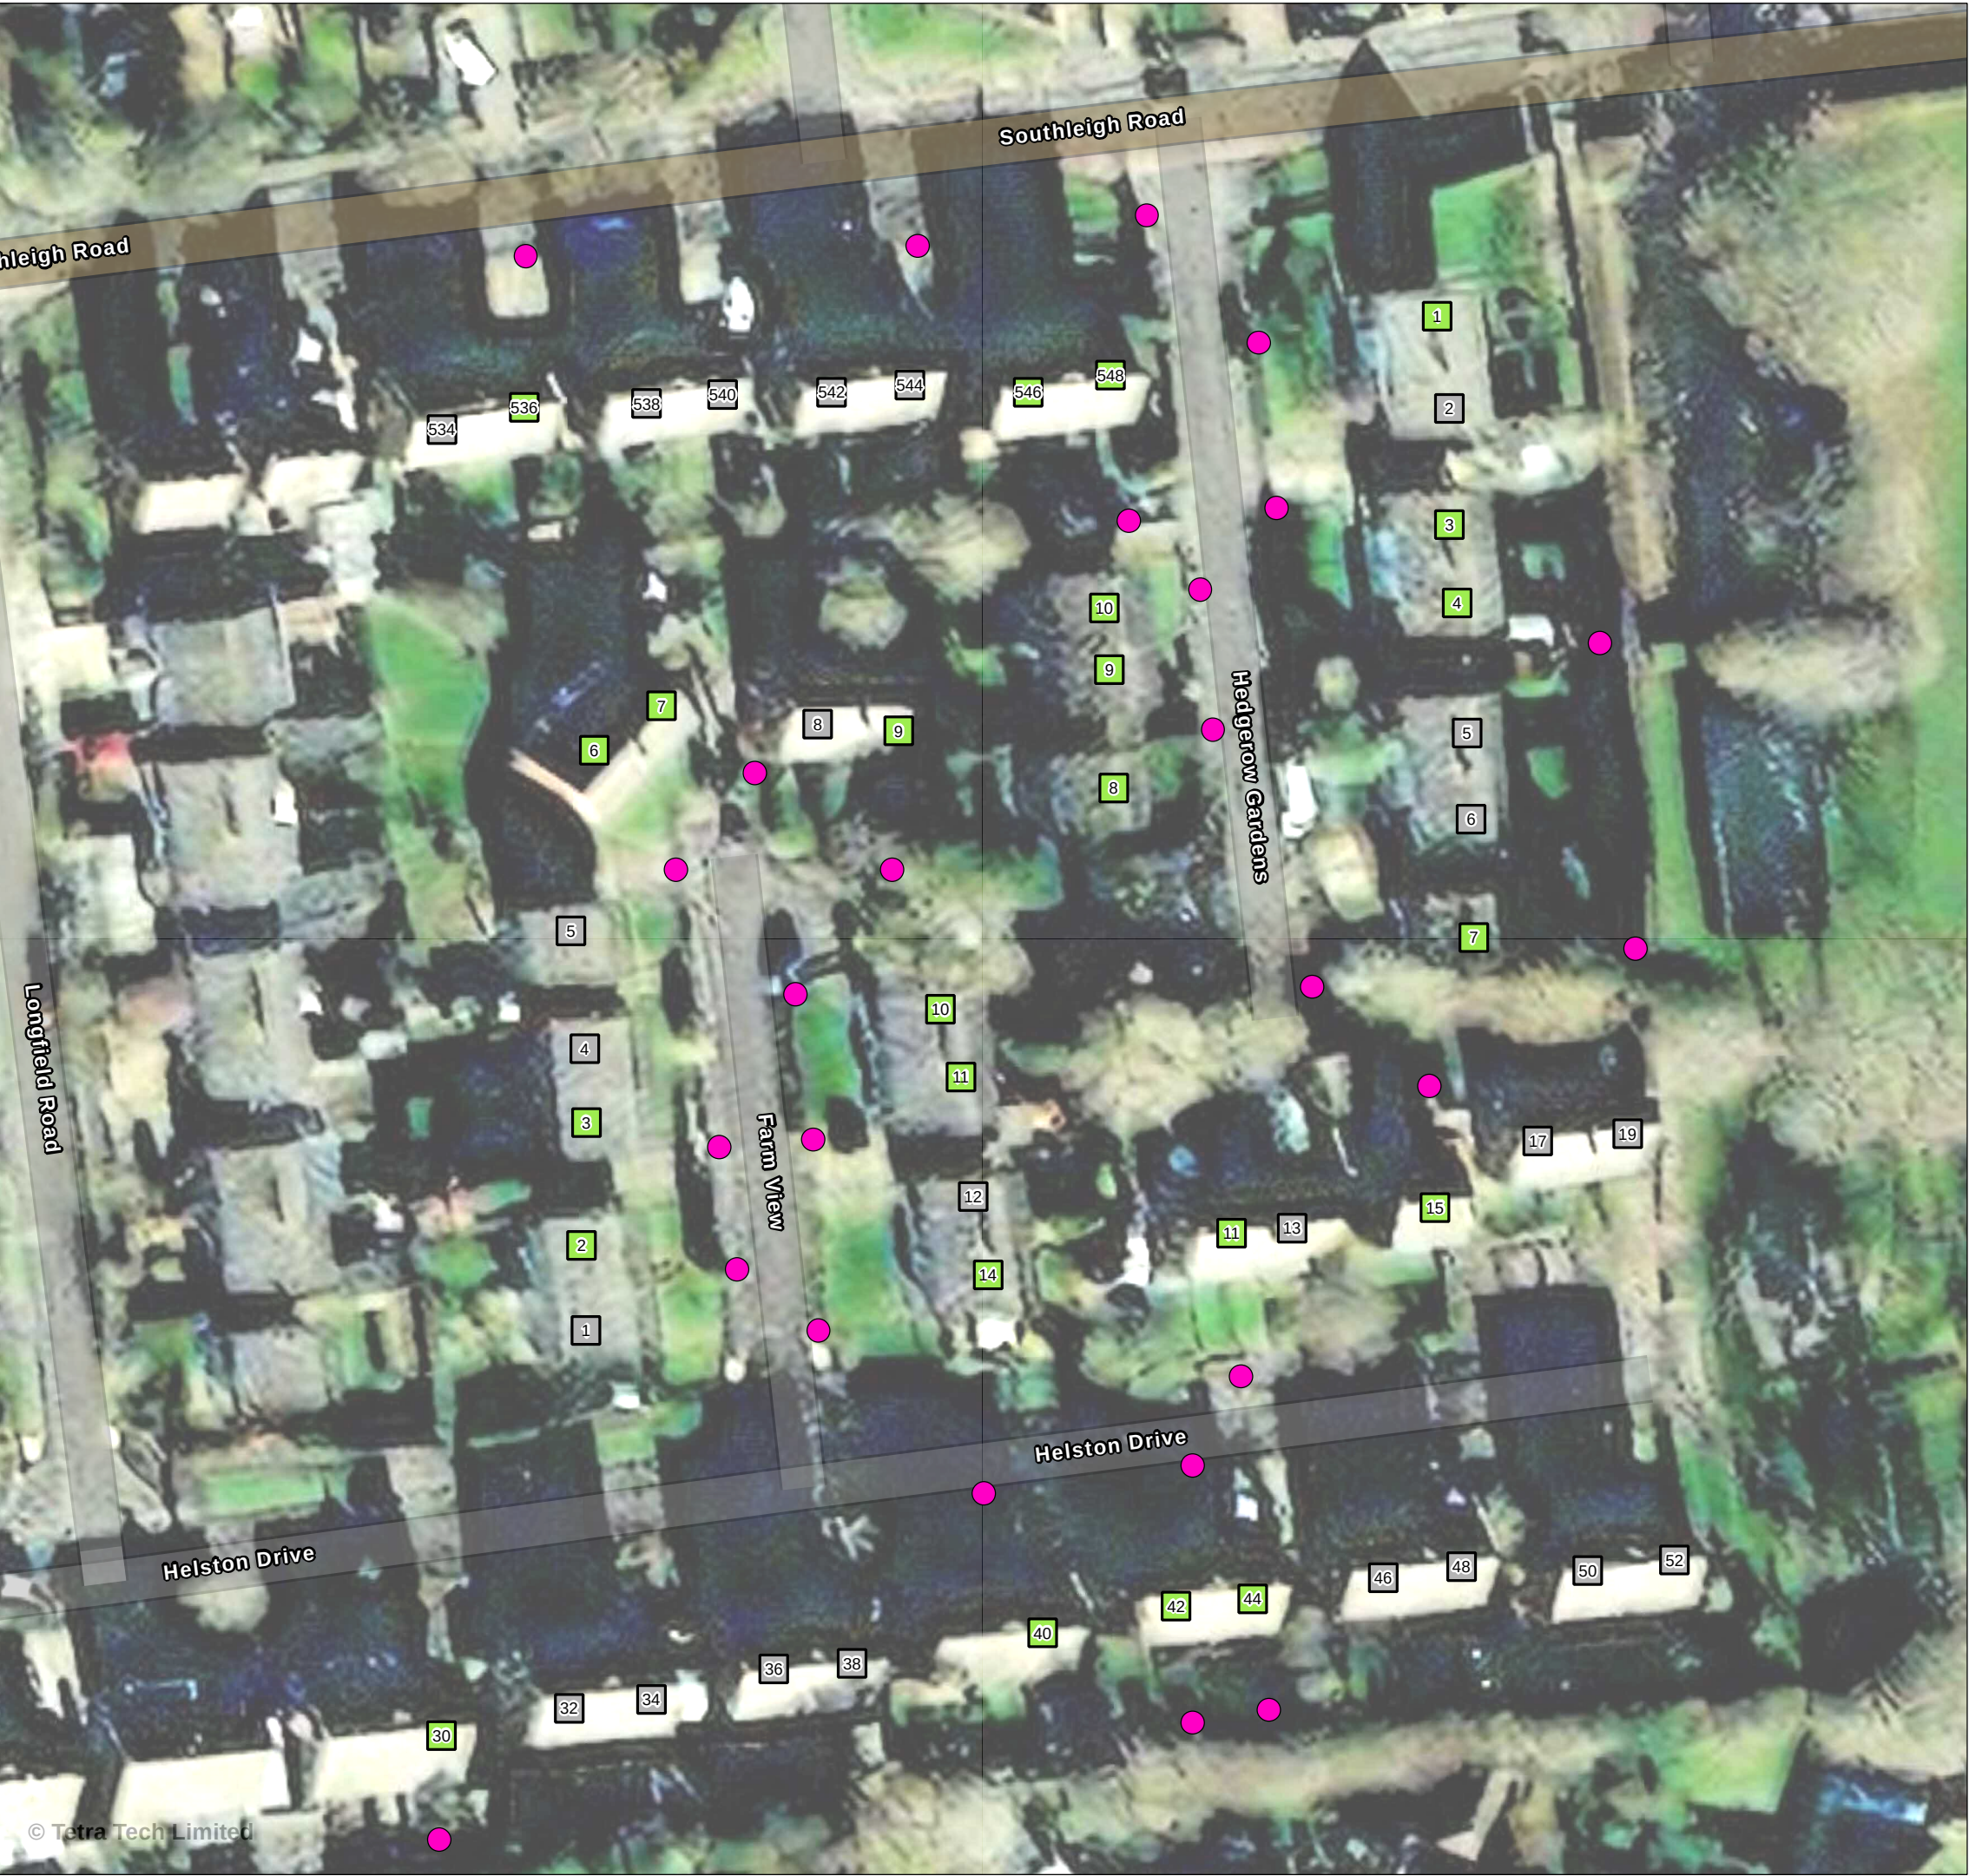
## FIGURE 1: SITE LOCATION PLAN AND SURVEYOR LOCATIONS

During the surveys, surveyors were positioned to view the PRFs identified on each property. Vantage points were iterative and changed as necessary on the second and/or third visits dependant on roost access points identified. During the surveys, bat emergences and returns were recorded on survey sheets and their calls recorded using Elekon Batloggers. BatExplorer software was subsequently used to analyse these calls. Temperature readings, cloud cover and wind conditions were also recorded. The metadata for each survey is provided in Appendix C. Surveyor positions are illustrated in Figure 1.

Further details describing the individual buildings, potential roost features (PRFs) and overall suitability for roosting bats / BRA classification is found in Appendix B. Figure 1 shows the buildings on site and the confirmed BRA classifications.
