## **Supplementary Phase II Geo-Environmental Assessment**

**Pfizer**  
32 New Lane  
Havant  
PO9 2NG

**PFIZER, 32 NEW LANE, HAVANT**

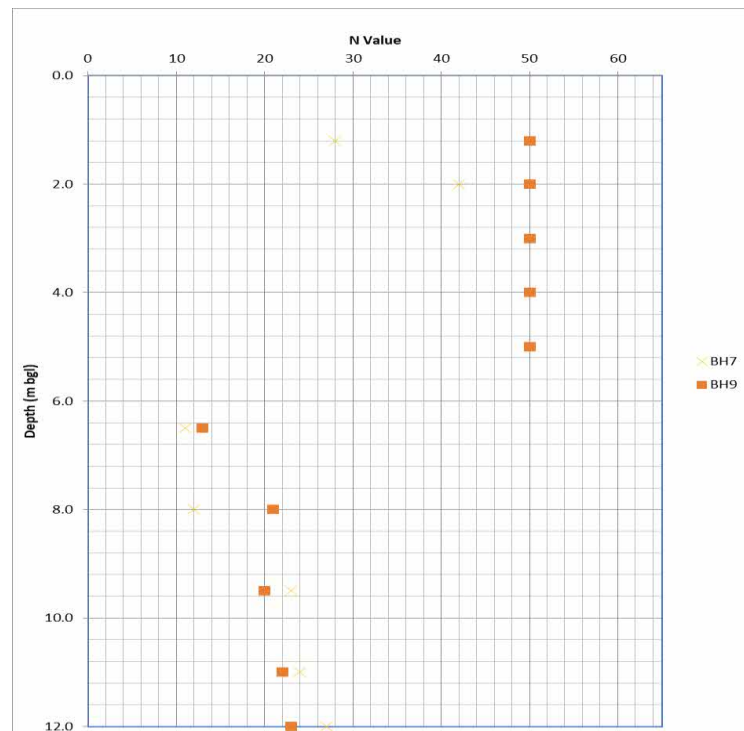
The results of in-situ geotechnical testing are summarised in the graph below.

The above data indicates that the natural granular River Terrace Deposits that were encountered in these two boreholes to depths of around 5.0m are very dense, although the slightly shallower clay in BH7 is lower strength, nevertheless it remains firm. However, below the granular River Terrace Deposits, the upper silty layer of the London Clay deposits is softer in nature, although still fairly competent and typically increases in strength with depth.

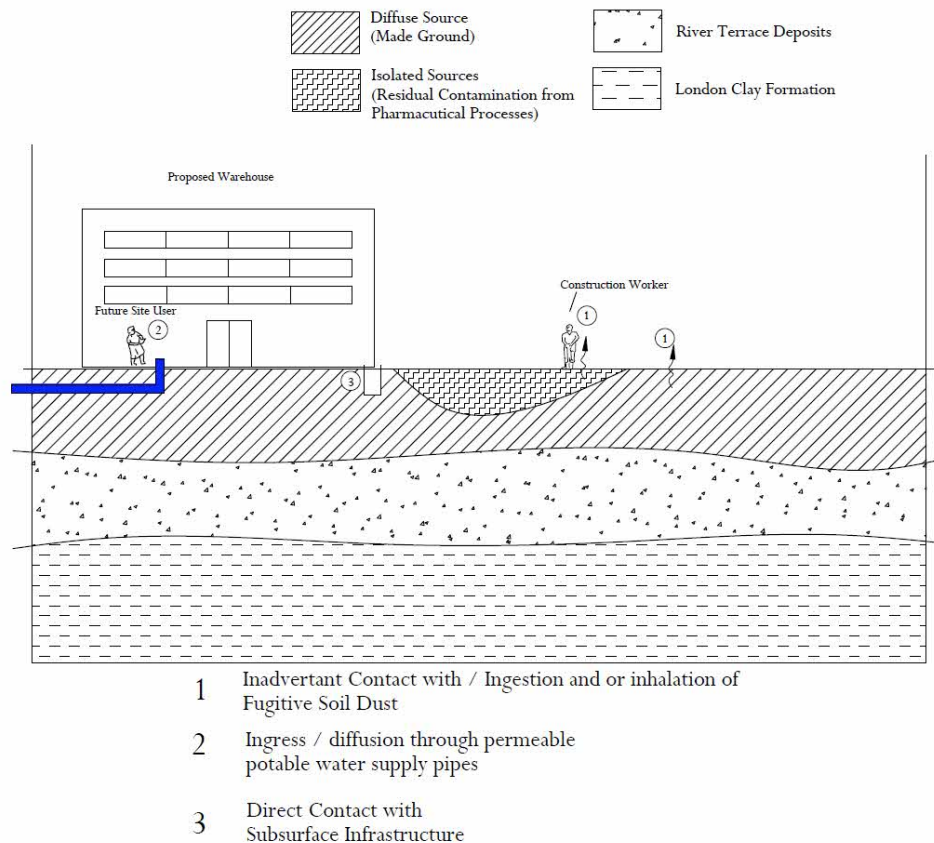
### Illustrative Conceptual Site Model – Pfizer, Havant

The following diagram provides an illustration of the plausible contaminant linkages that may be active at the site and which may need further investigation or control to ensure safe development:

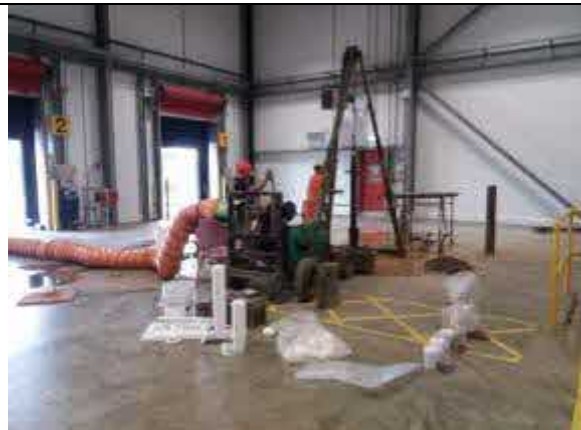
Photo 5: Drilling of BH9 towards the south-centre of the onsite buildings, slightly north of the loading bay entrances.

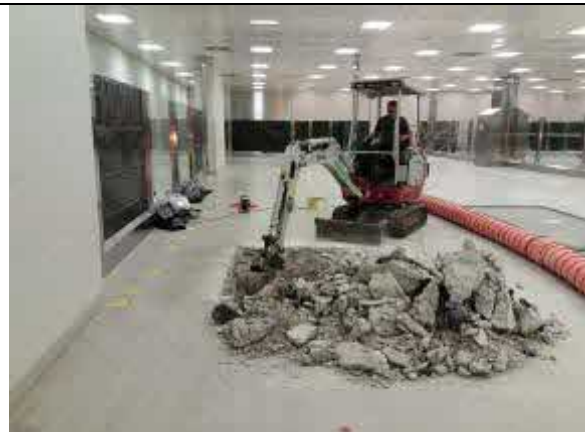
Photo 9: Trial pit excavation within building towards the northeast of the site.
