**GROUND APPRAISAL REPORT**  
**for the site at**  
**HORNDEAN ROAD, EMSWORTH**  
**HAMPSHIRE, PO10 7PU**  
**on behalf of**  
**METIS HOMES**

| Report: | GROUND APPRAISAL REPORT |
| Reference: | GE18313-GAR-JUL19 |

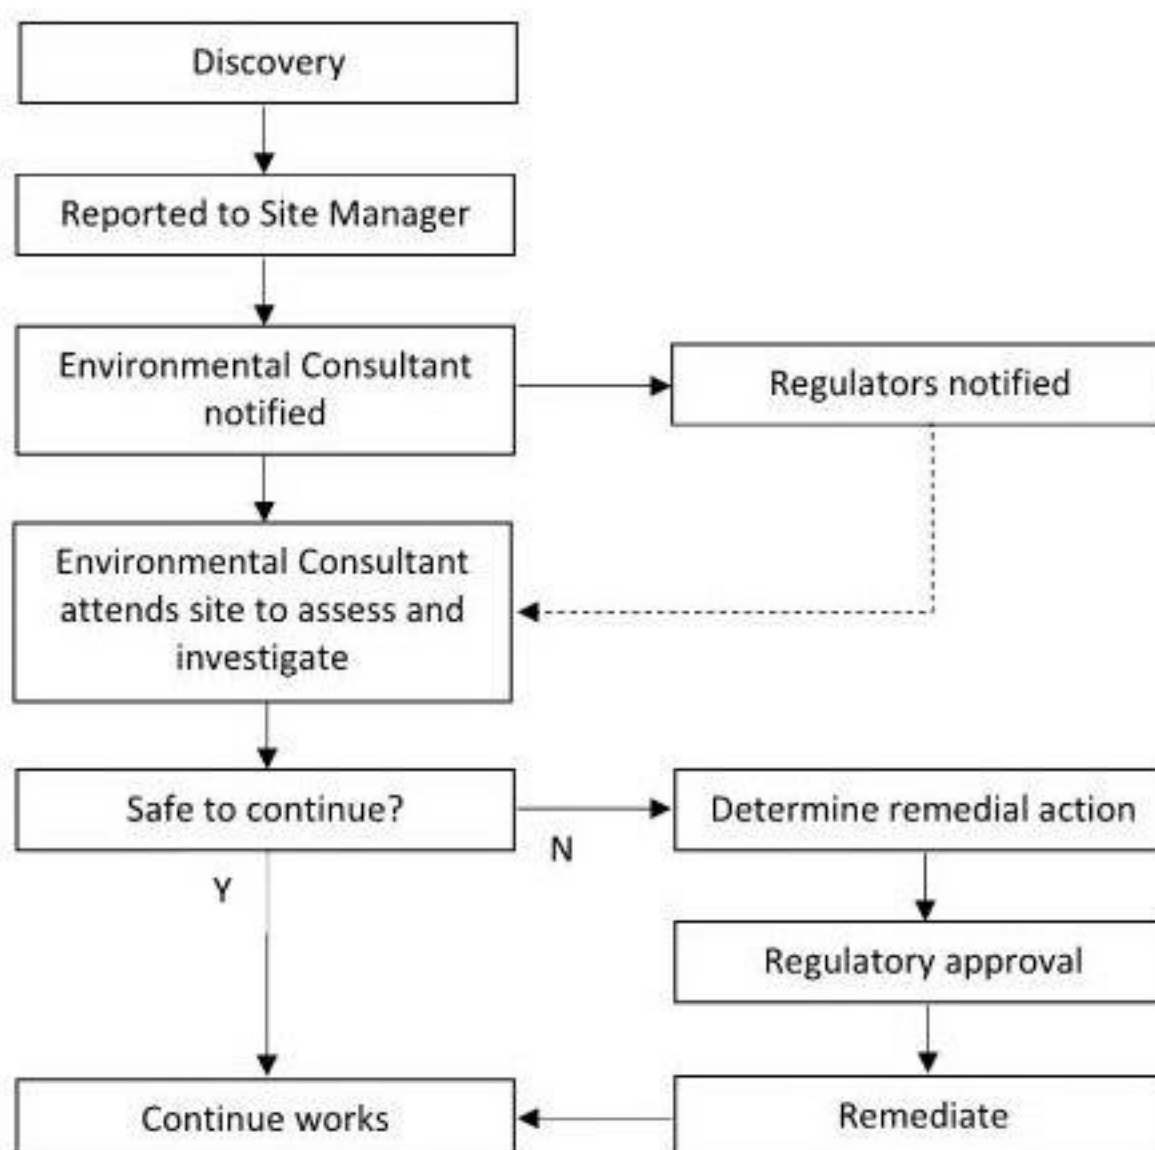
**Discovery Strategy Process**

The process is summarised overleaf:

A copy of this strategy should be lodged on site, and provisions made to ensure that all workers are made aware of their responsibility to observe, report, and act on any potentially suspicious or contaminated materials they may encounter.

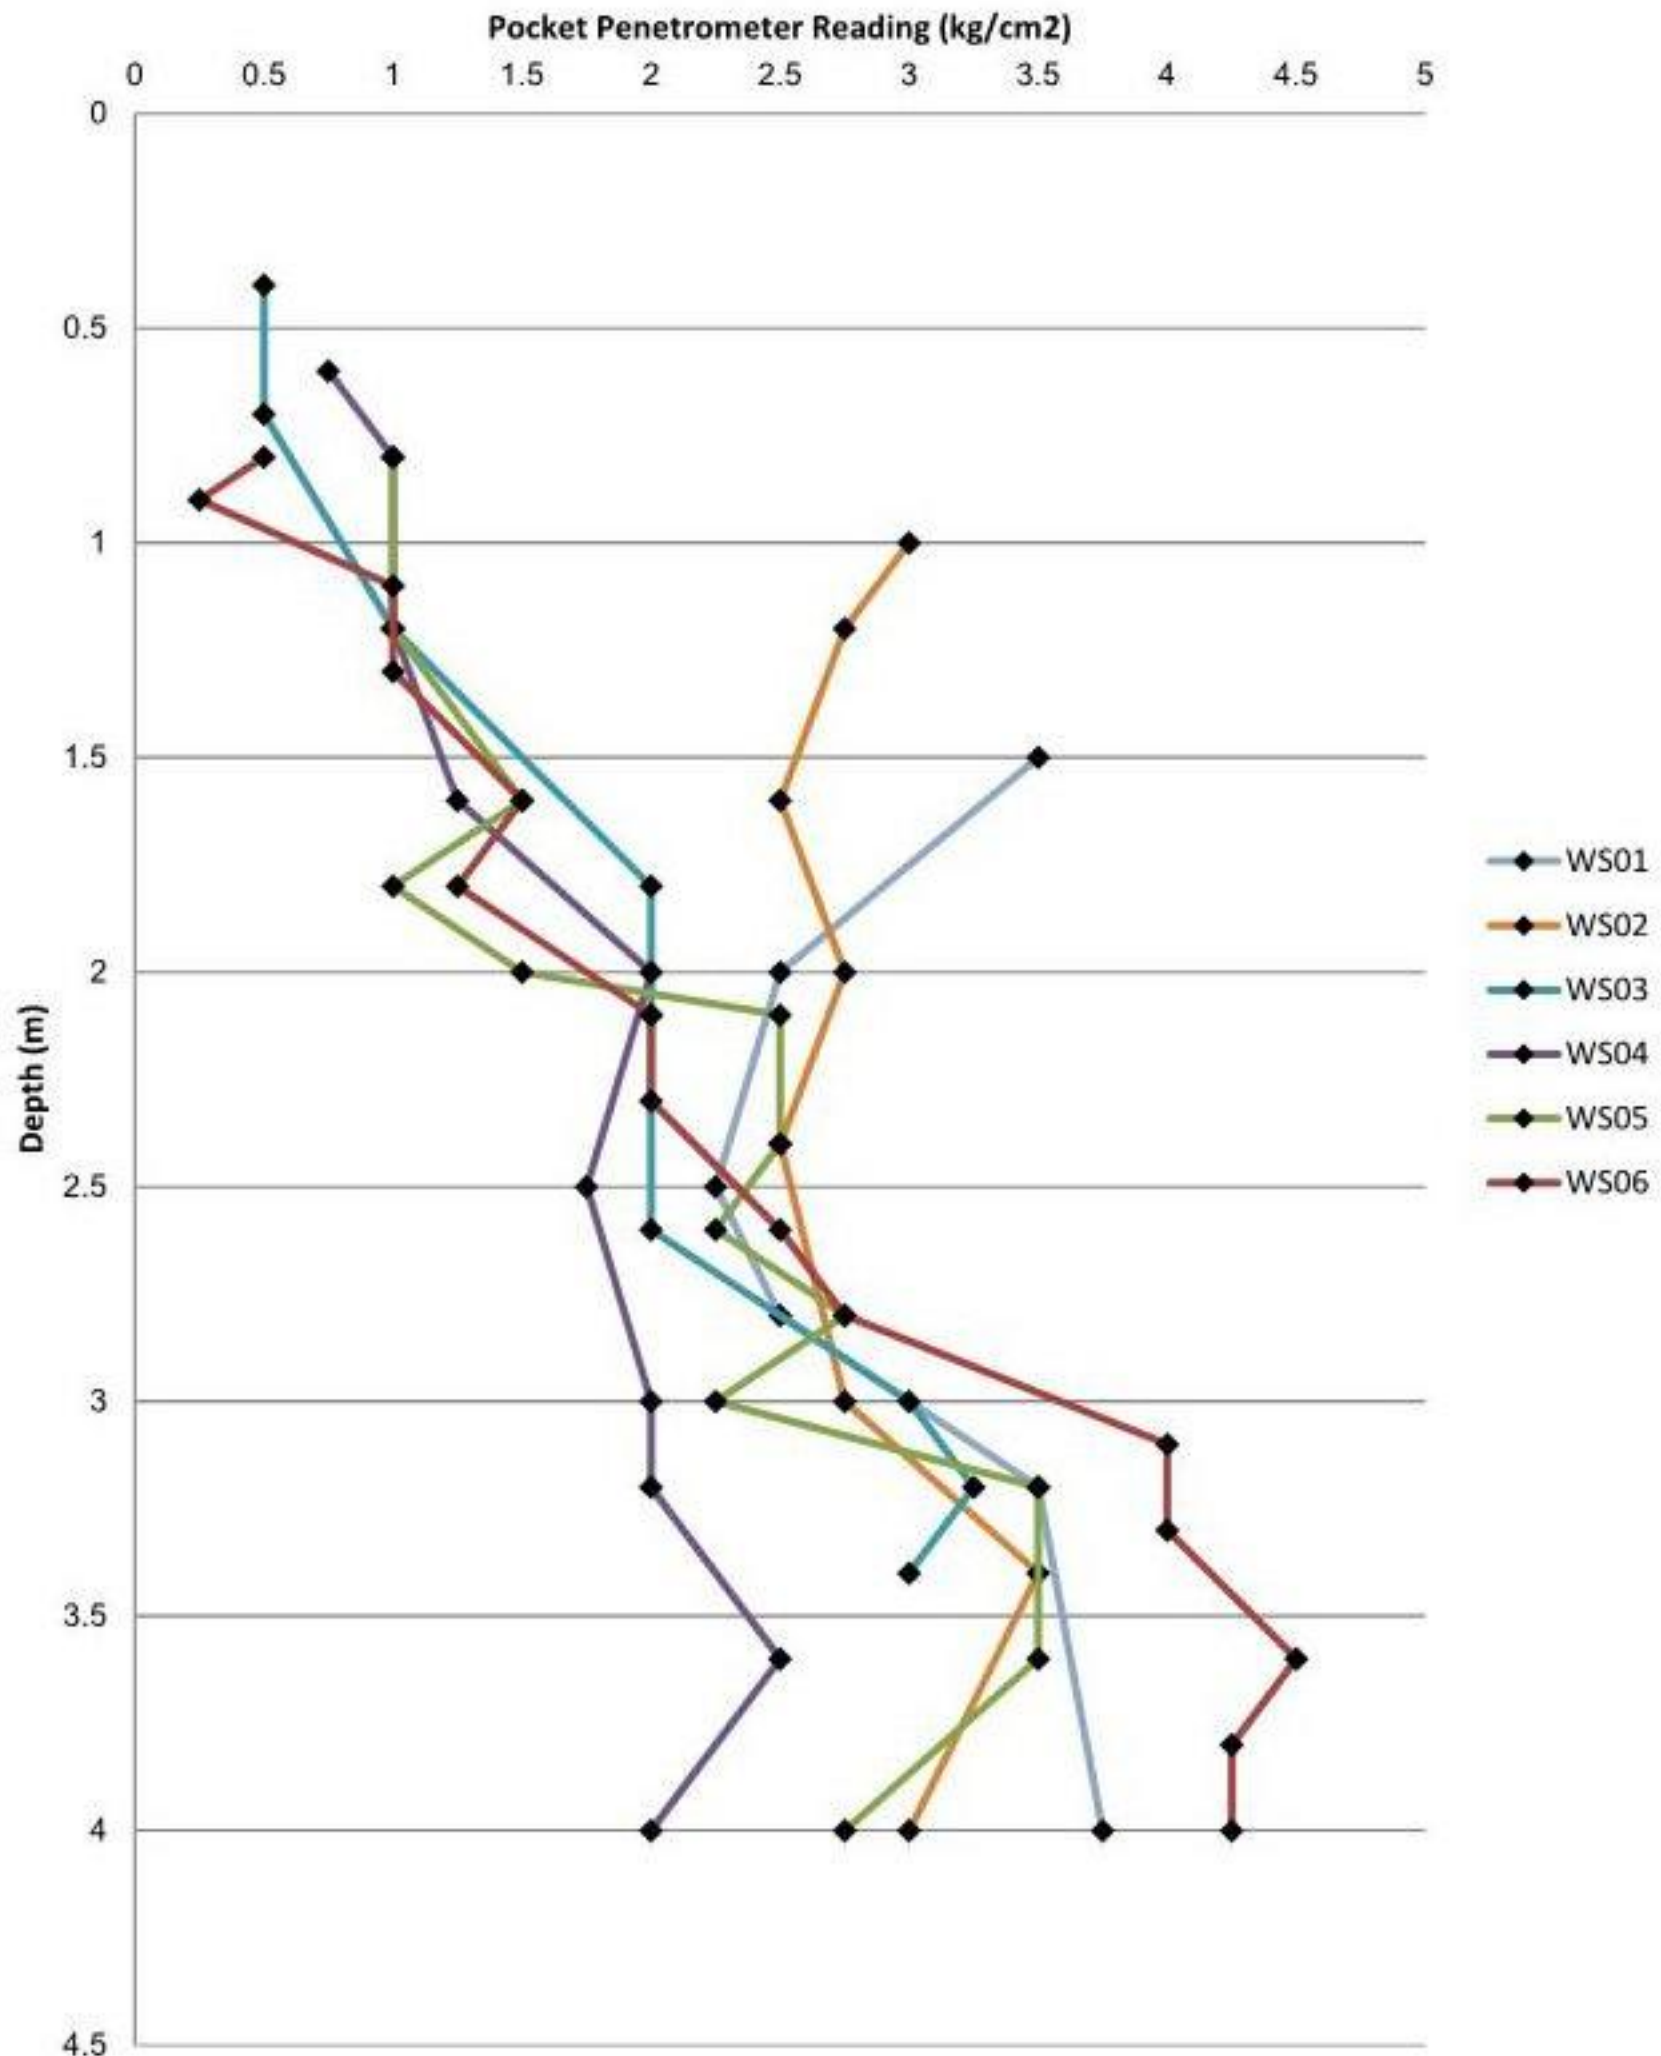
# HPEN Vs DEPTH

In addition to the above testing, two moisture content profiles were completed through WS03 (in close proximity to the trees bounding the site) and WS05 (the most remote location from trees). A potential difference was seen in moisture content profile and a hand penetrometer versus depth graph (Figure 3) indicates potential evidence of desiccation within WS01 and WS02 to between 2.0m and 2.5m bgl again in proximity to the trees bounding the site. Please see plots presented on Figure 3 and Figure 4.

As noted previously, potential indicators of desiccation were identified to depths of 2.0-2.5m bgl in WS01, WS02 and WS03, seemingly associated with tree influence. Construction of conventional foundations in this scenario is not considered feasible (groundwater present at shallower depth) and thus a piled foundation is considered to be required.

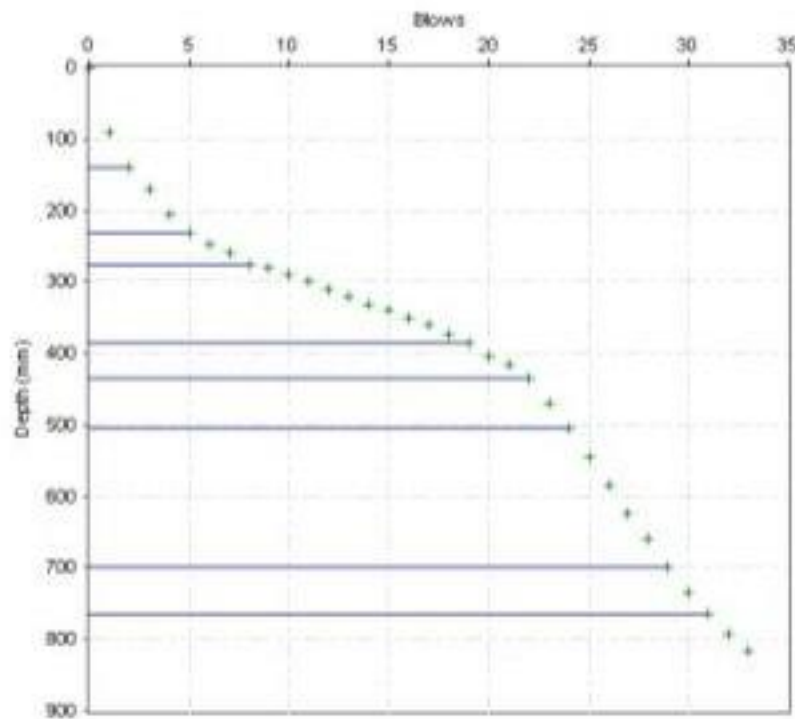
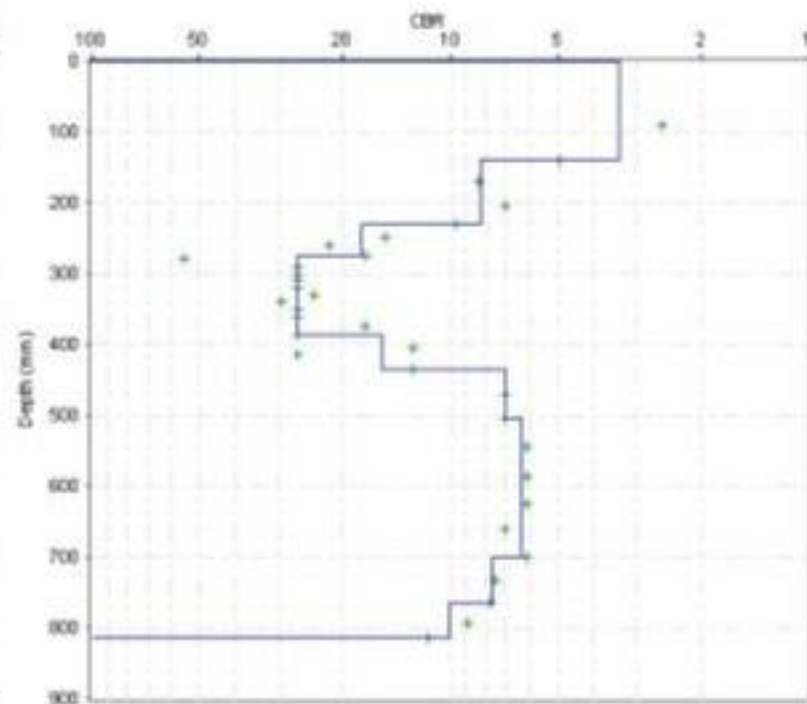
CBR Chart

Layer Boundaries: Chainage 0.000

Based on the DCP test results and TRRL LR1332 guidance an estimated suction index, a CBR value of 2% is recommended for the Head Deposits.
