## **Outline Remedial Strategy & Implementation Plan**

**Pfizer**  
32 New Lane  
Havant  
PO9 2NG

**EPS Project Reference:** UK20.5052D

**PFIZER, NEW LANE, HAVANT**

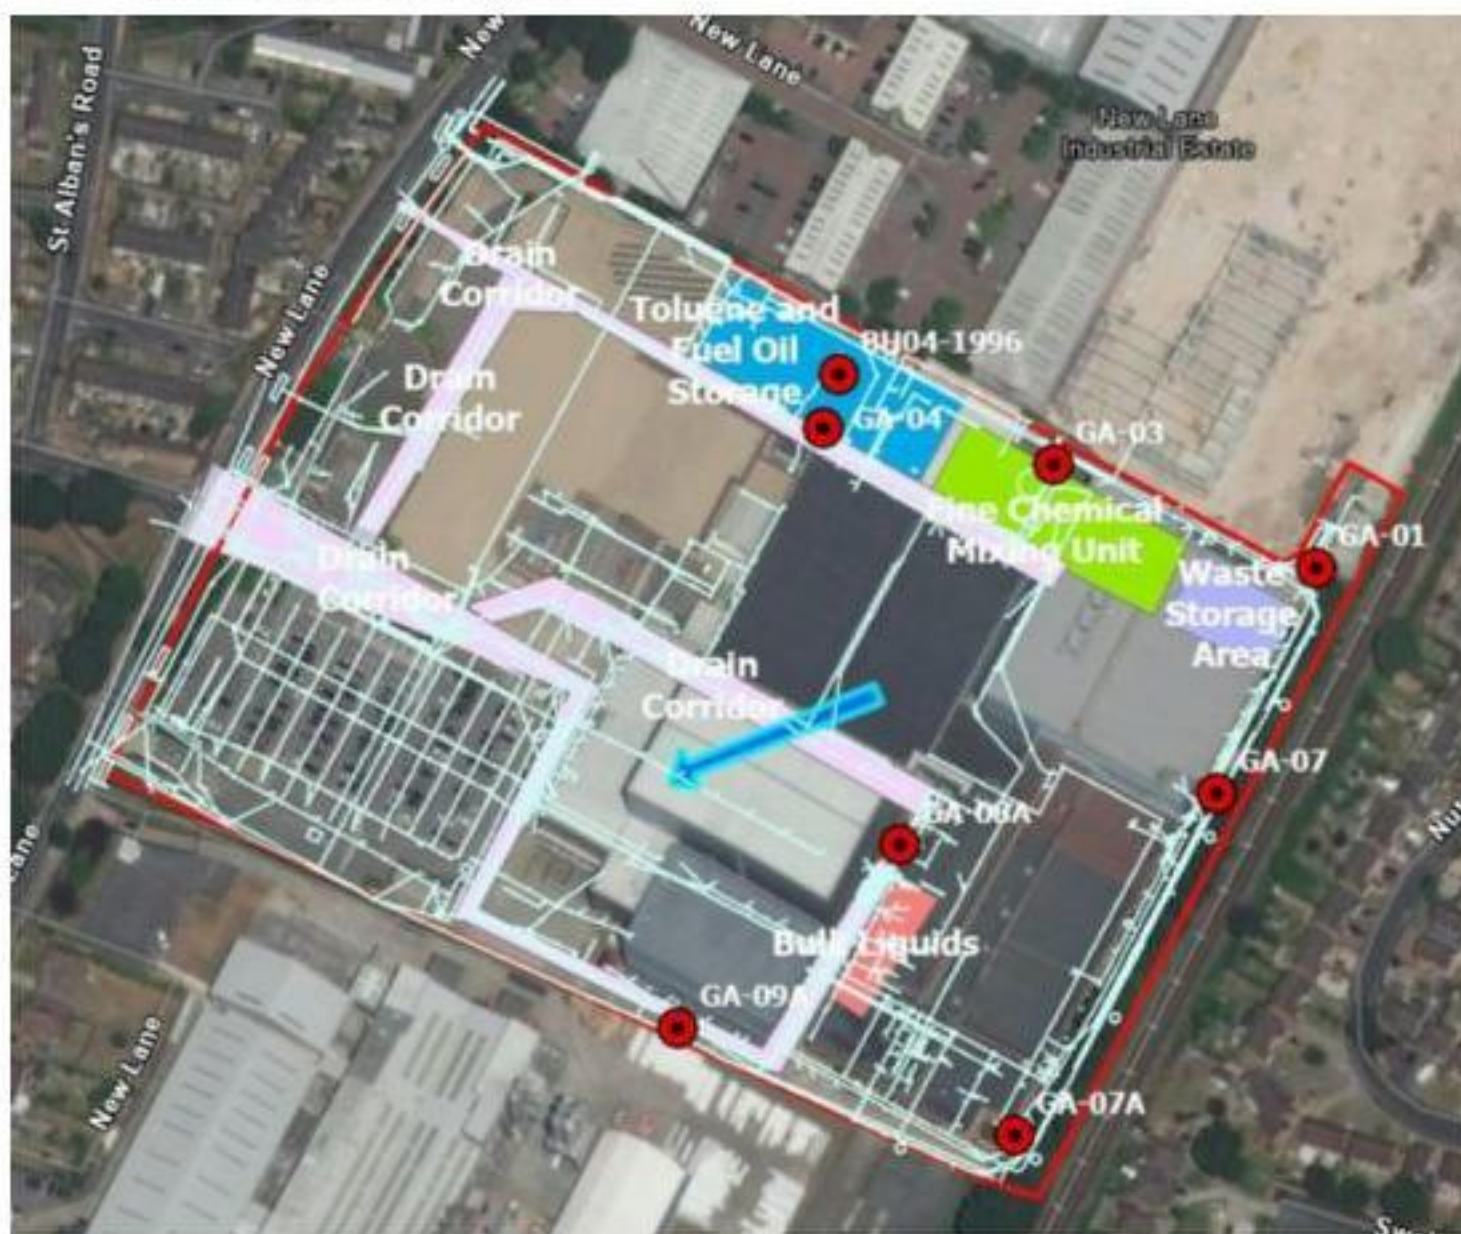
Figure 3 - Site Plan showing the location of potentially contaminating land uses (blue arrow signifies interpreted groundwater flow direction)

- The locations occupied by potentially contaminating activities as shown in Figure 3 below.

These land uses are such that we consider the areas they occupied as AOPCs. They are as follows:

- Toluene and Fuel Storage Area
- Fine Chemical Mixing Unit
- Waste Storage Area
- Bulk Liquids Storage

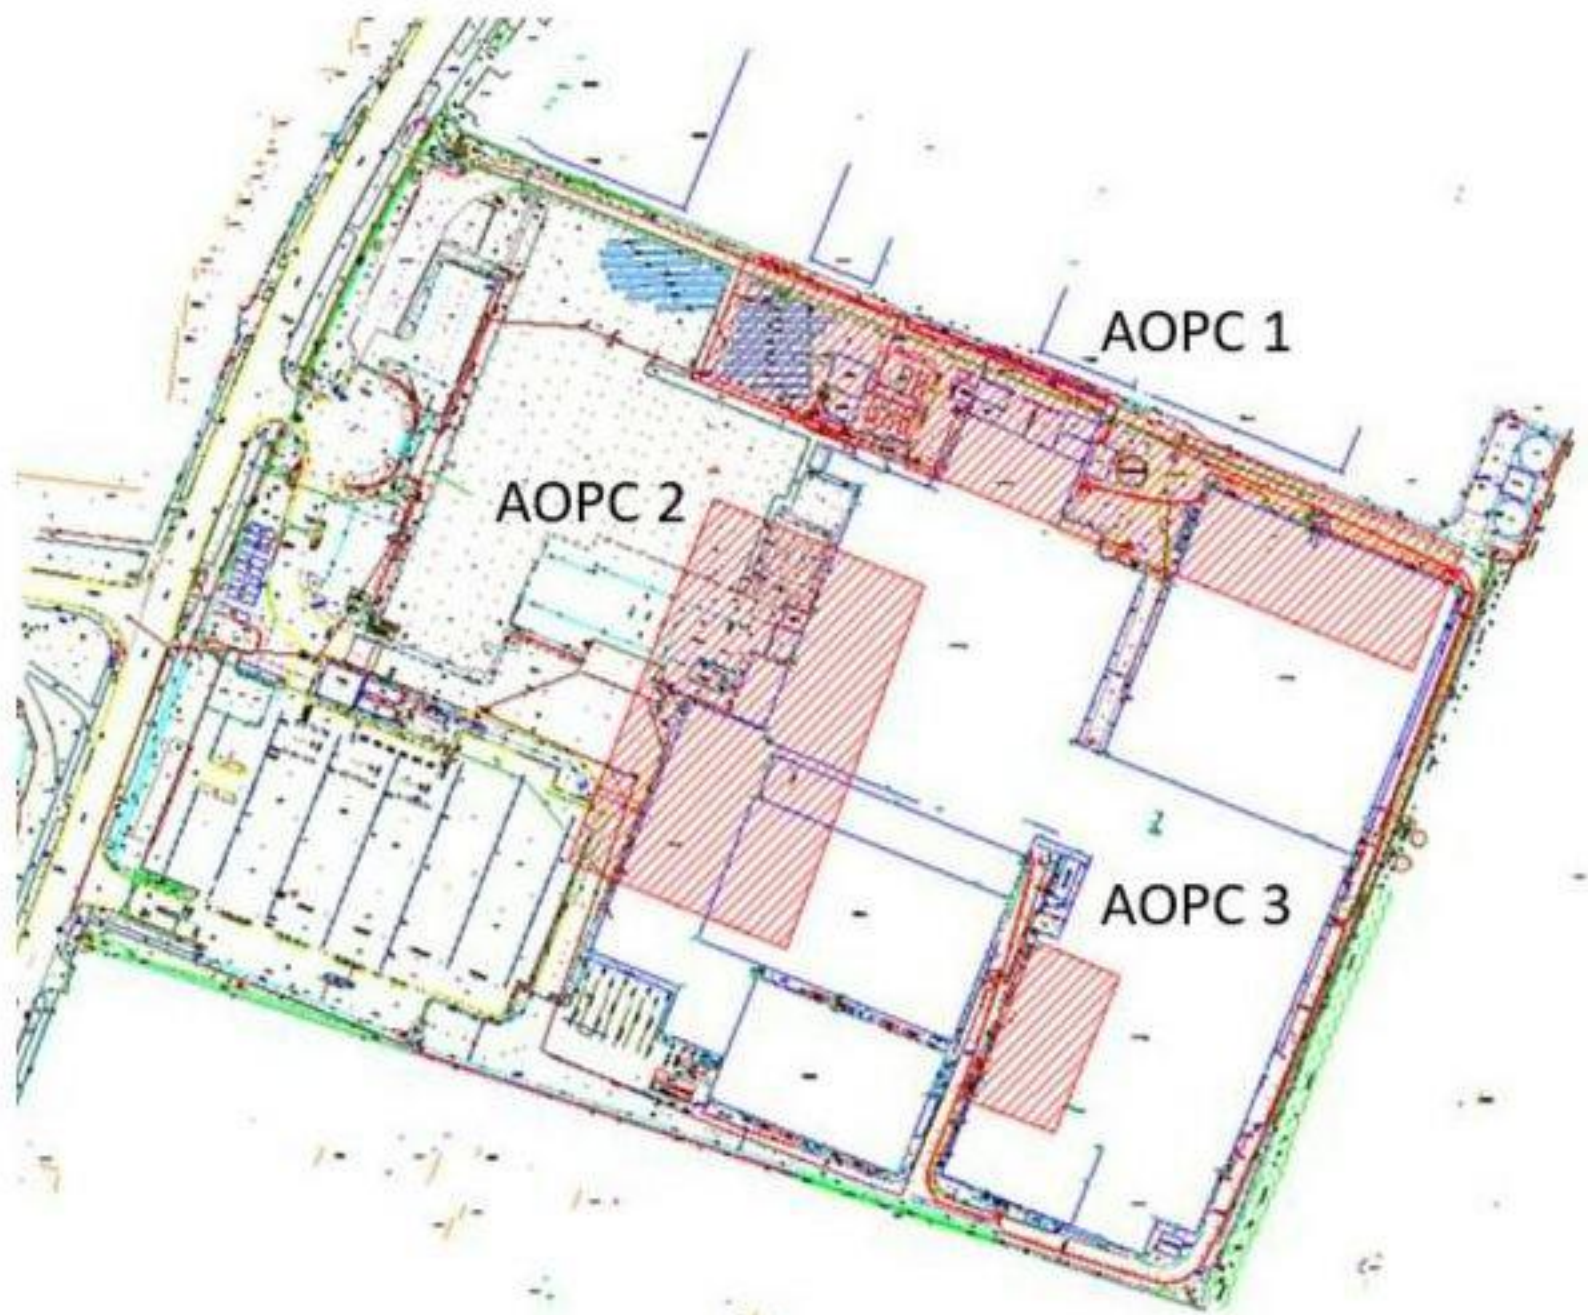
Figure 5 - Location of AOPCs

The footprints of the combined AOPCs are shown in Figure 5 below.

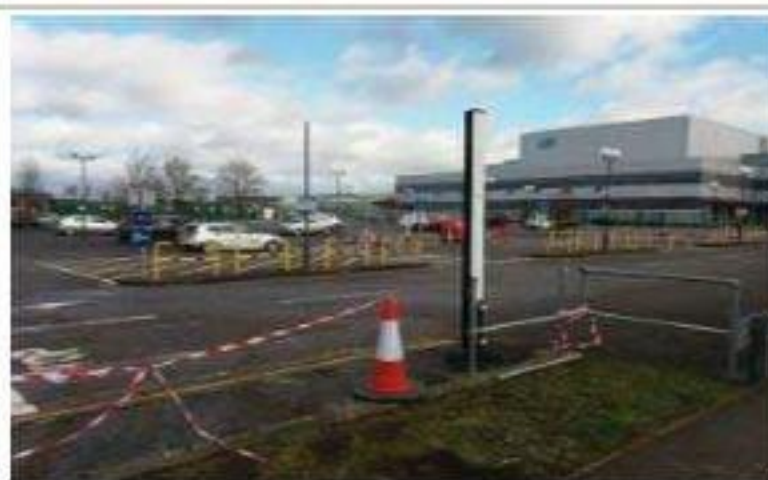
Photo 5: View looking west at the southwest corner of the site, with BH12 underway.
