## **Phase I Geo-Environmental Desk Study**

### **Land at ASDA Havant**

Larchwood Avenue  
Havant  
Hampshire  
PO9 3QW

**EPS Project Reference:** UK19.4632b

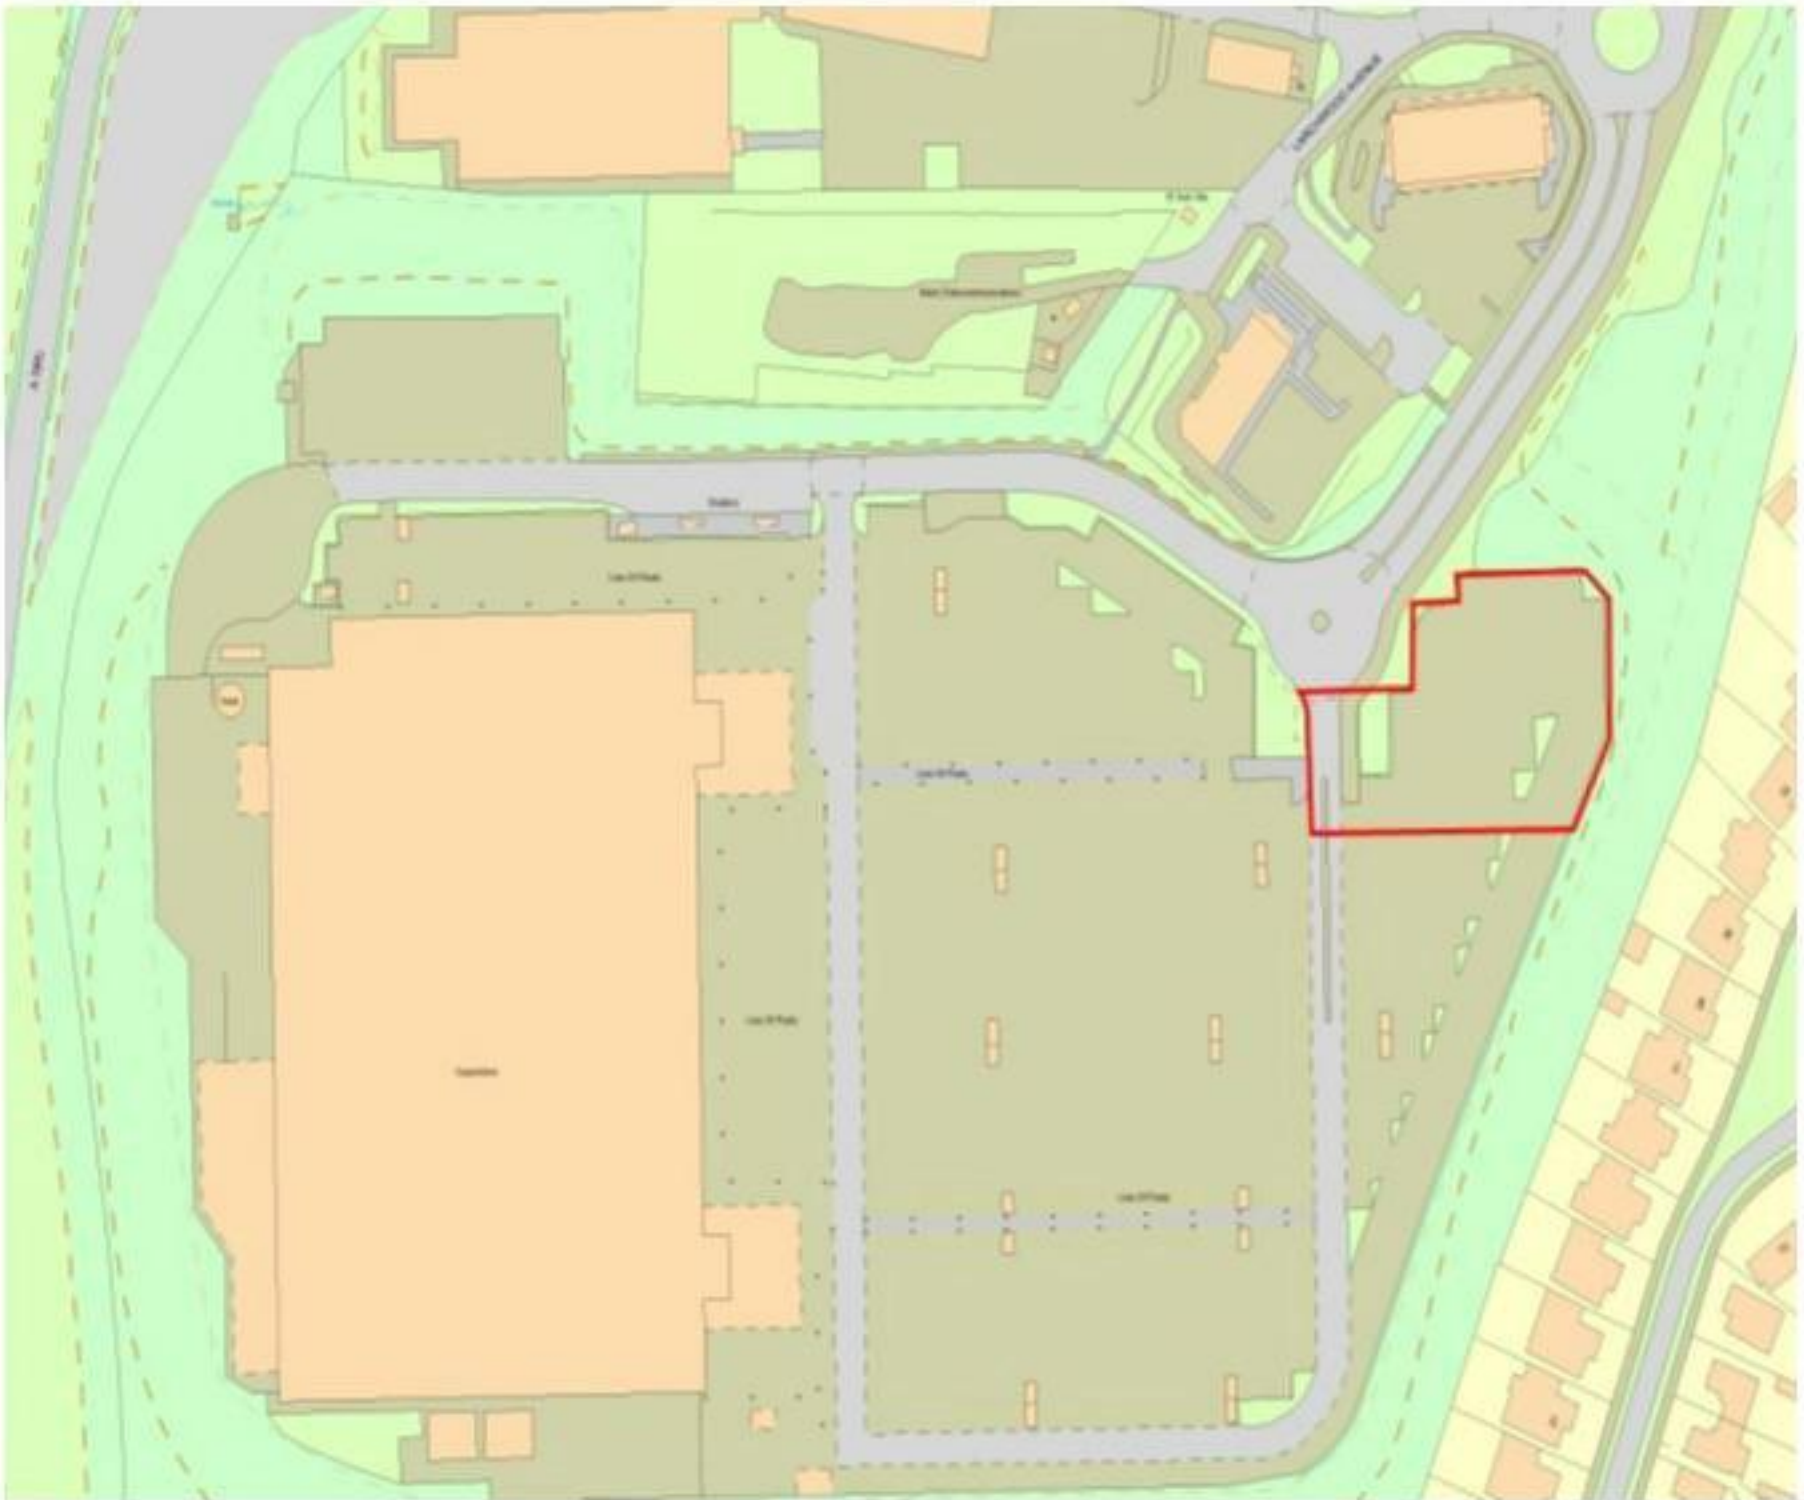
Title: Current Site Layout

Approximate Site Boundary

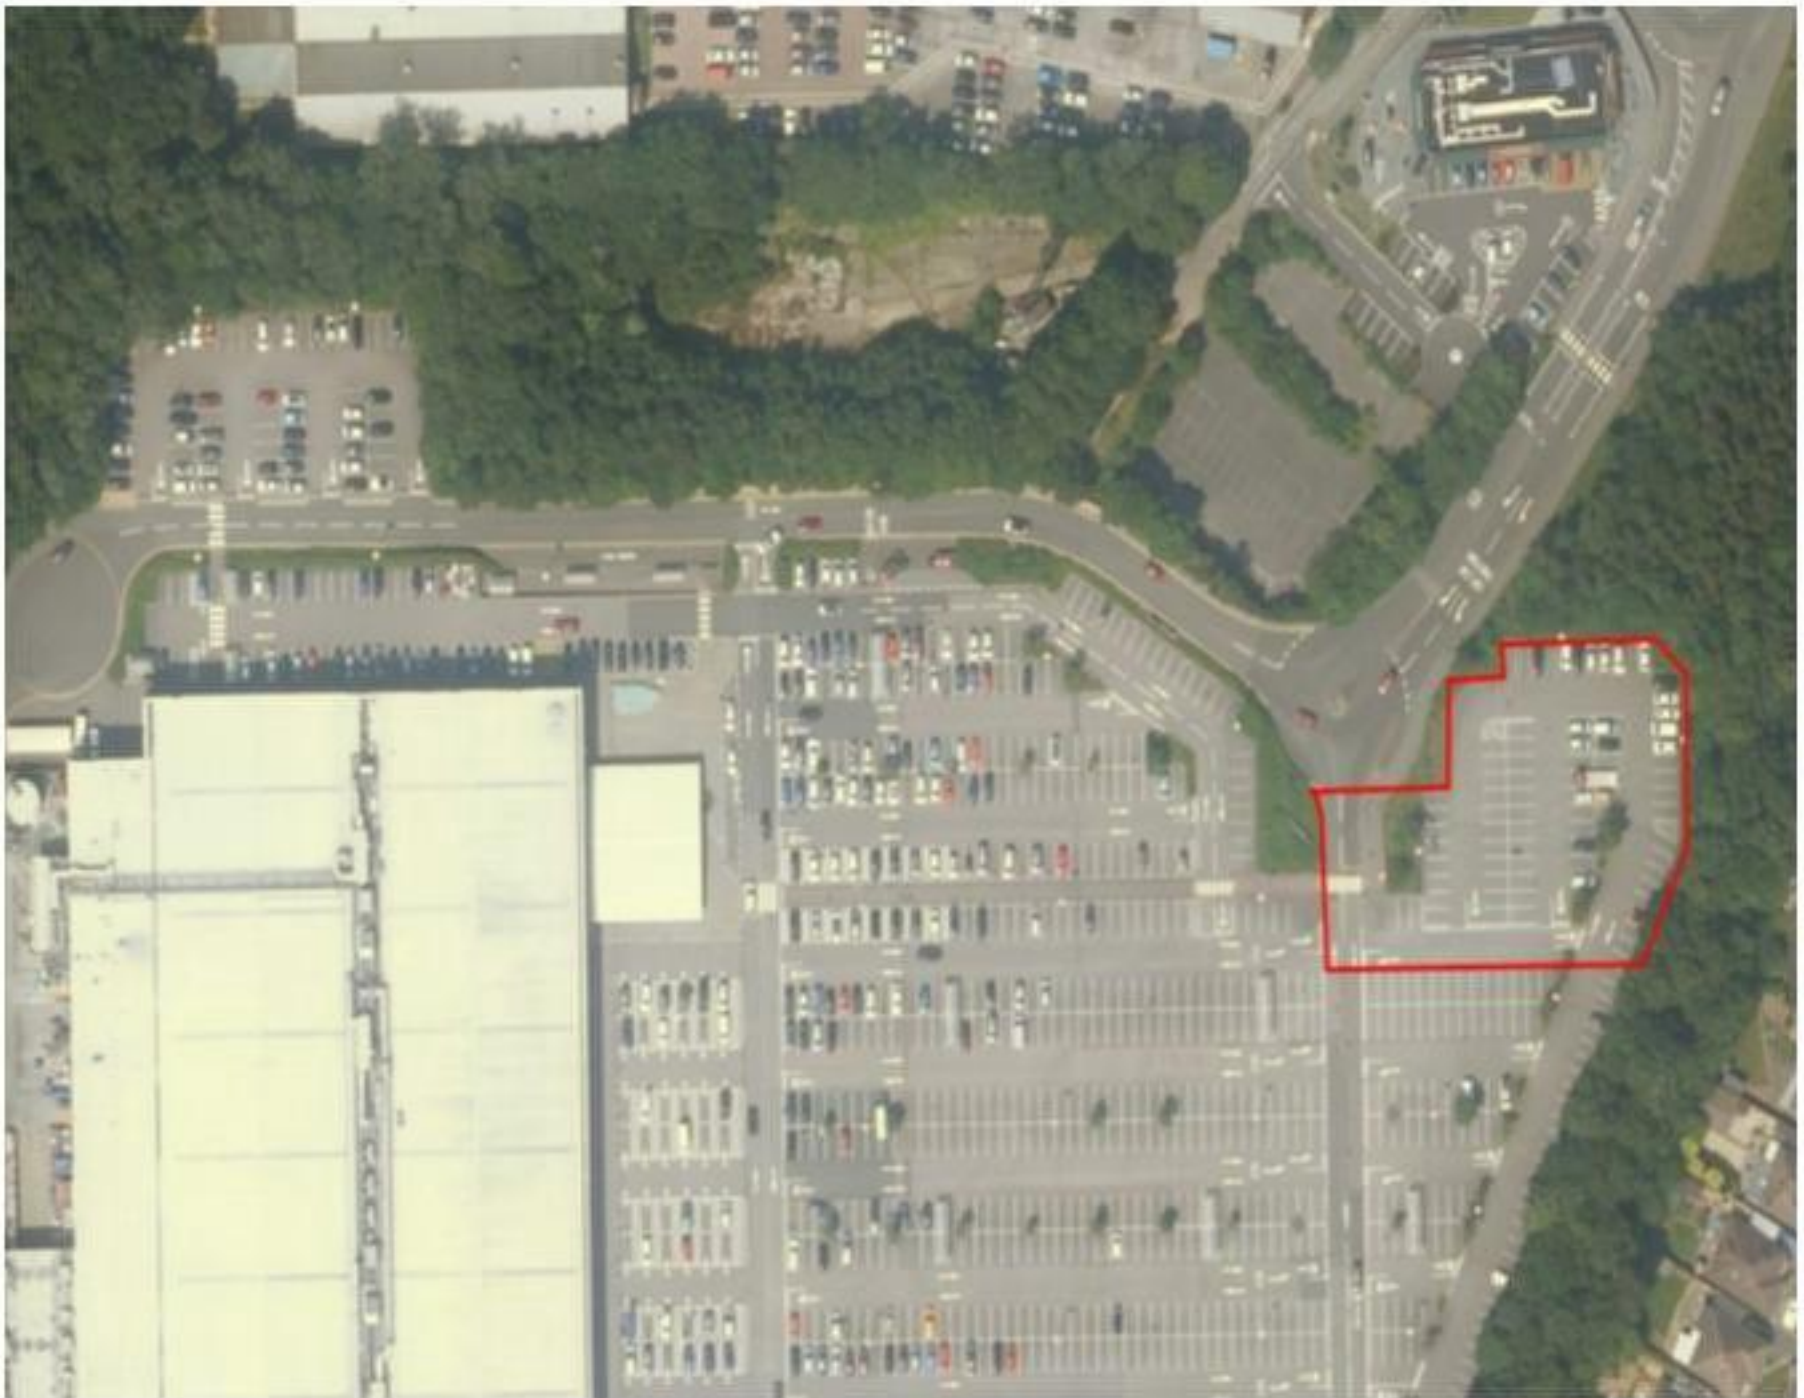
Title: Aerial Photograph

Approximate Site Boundary

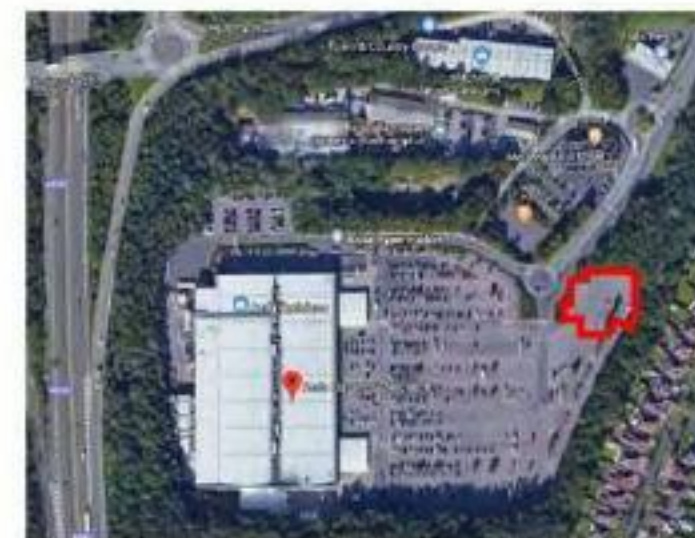
SITE LOCATION PLAN

1. Title to be confirmed - acquisition boundary shown for indicative purposes only.
2. Topographical & Subscan survey to be completed.
3. Public Utility Searches to be completed.

----- To be surveyed & leveled\*

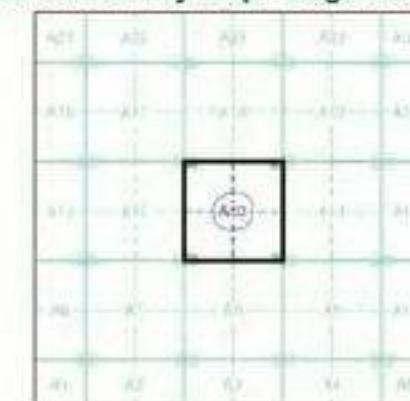
### Site Sensitivity Map - Segment A13

Order Number: 215765235\_1\_1  
Customer Ref: UK19.4632b  
National Grid Reference: 469650, 107520  
Slice: A  
Site Area (Ha): 0.26  
Plot Buffer (m): 100

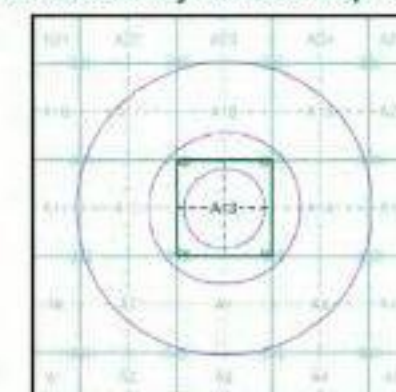
### Site Sensitivity Context Map - Slice A

Soluble Rock

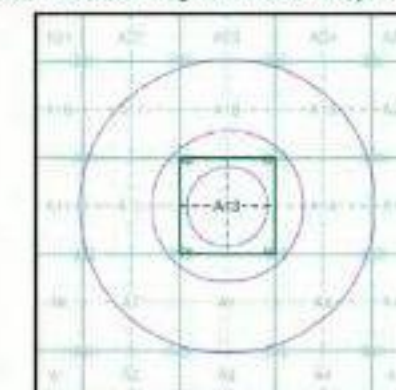
### Site Sensitivity Context Map - Slice A

- Principal Aquifer
- Secondary A Aquifer
- Secondary B Aquifer
- Secondary Undifferentiated
- Unproductive Strata
- Unknown
- Unknown (Lakes and Landship)

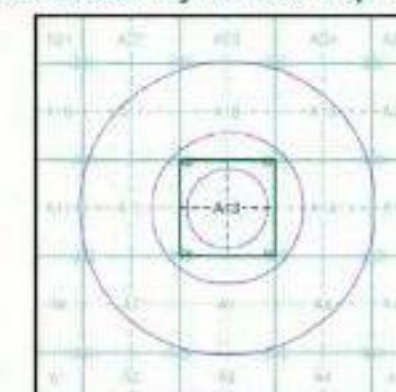
### Site Sensitivity Context Map - Slice A

- Principal Aquifer
- Secondary A Aquifer
- Secondary B Aquifer
- Secondary/Undifferentiated
- Unproductive Strata
- Unknown
- Unknown (Lakes and Landship)

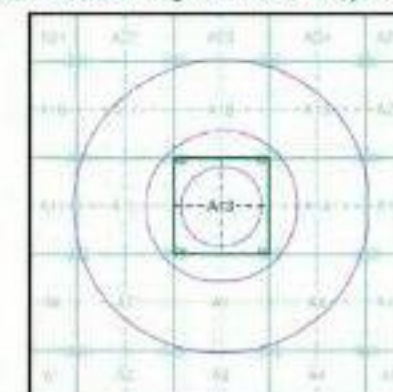
### Site Sensitivity Context Map - Slice A

- Inner zone (Zone 1)
- Inner zone - subsurface activity only (Zone 1c)
- Outer zone (Zone 2)
- Outer zone - subsurface activity only (Zone 2c)
- Total catchment (Zone 3)
- Total catchment - subsurface activity only (Zone 3c)
- Special interest (Zone 4)

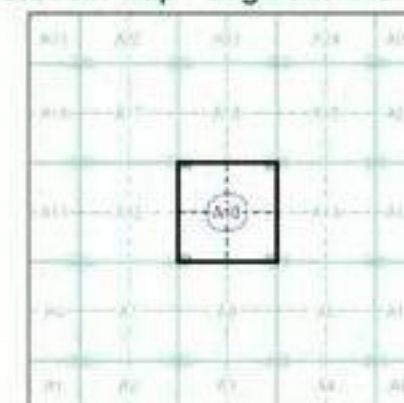
### Historical Map - Segment A13

| SU8907SW<br>1993<br>1:1,250 | SL8957SE<br>1993<br>1:1,250 |

- By 1985/87, according to mapping a second superstore had been developed to the north of the boundary, and the petrol filling station had been installed. The site then remained unchanged until 2006, when the hypermarket site was reconfigured, with a superstore being built within the same area but on the footprint that can be observed on the most modern maps available.
