# Former Dunham Bush Site

**RE: Former Dunham Bush Site, Downley Road, Havant –Technical Note**

## 1.0 Introduction

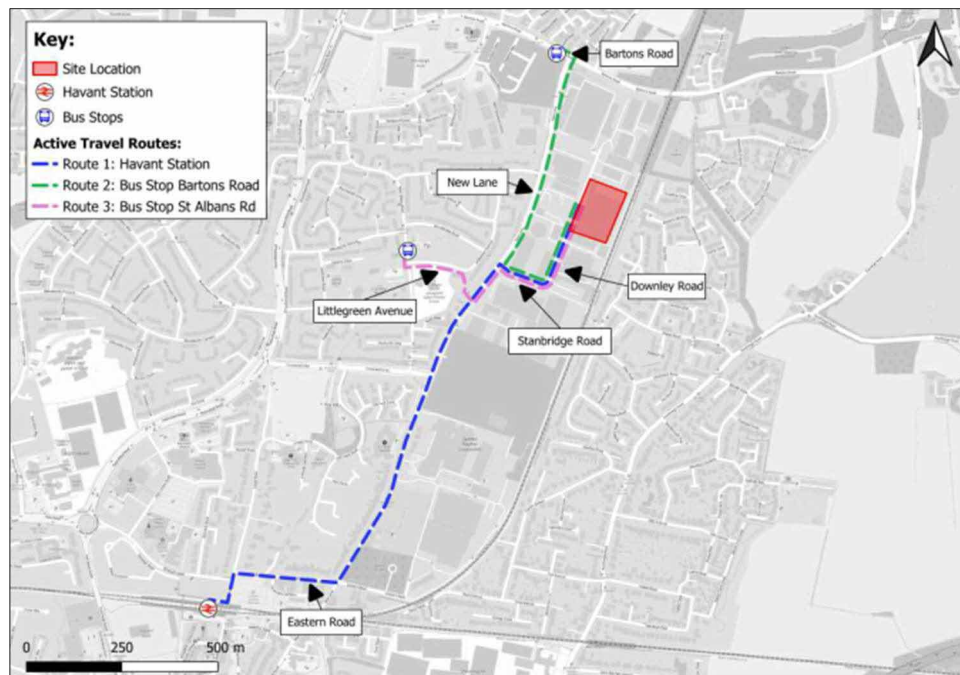
**Figure 3-1 Active Travel Routes**

3. It was agreed with HCC that a Walking and Cycling Audit would be undertaken of the three active travel routes shown at **Figure 3-1** below. The routes were:

- Route 1 –Havant Railway Station
- Route 2 –Bus Stops Bartons Road
- Route 3 –Bus Stops St Albans Road

4. The Walking and Cycling Audit Report is included at **Appendix A**. It identified that along the three routes the existing footway was of good width and quality without significant defaults. It also highlighted the quality of the active travel infrastructure along New Lane, especially for cyclists. It concluded by identifying the below potential improvements that would make the routes more attractive to users:

- Route 1 –Improve the visibility at the New Lane / Eastern Road crossing by trimming back the existing hedge in line with the footway line.
- Route 2 –Improve the level of infrastructure at the Bus Stop on Bartons Road to add shelter, seating and live journey time updates.
- Route 3 –Add tactile paving at the crossing point on Littlegreen Avenue in order to increase the accessibility of Bus Stop St Albans Road to those from all walks of life, particularly those with visual impairments.
- All Three Routes –Improve the provision of wayfinding along New Lane to be in line with the wayfinding present in the vicinity of Havant Station and Town Centre.

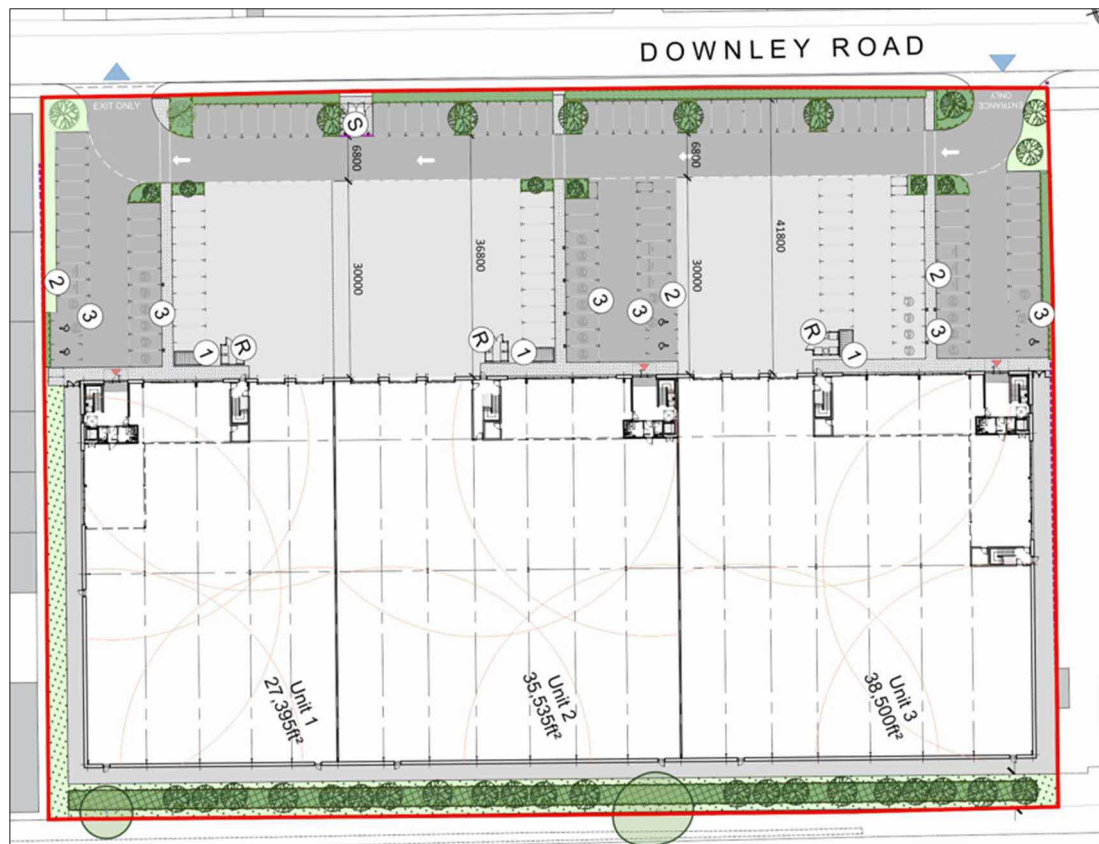
Figure 4-1 Proposed one-way operation of Site

- In light of the HCC comments on the proposed site layout, it is proposed to modify the accesses to better accommodate HGV movements. This includes providing bellmouth junctions and installing a one-way operation whereby the northern access be used for access only and the southern access be used for egress only. This is demonstrated in Figure 4-1.

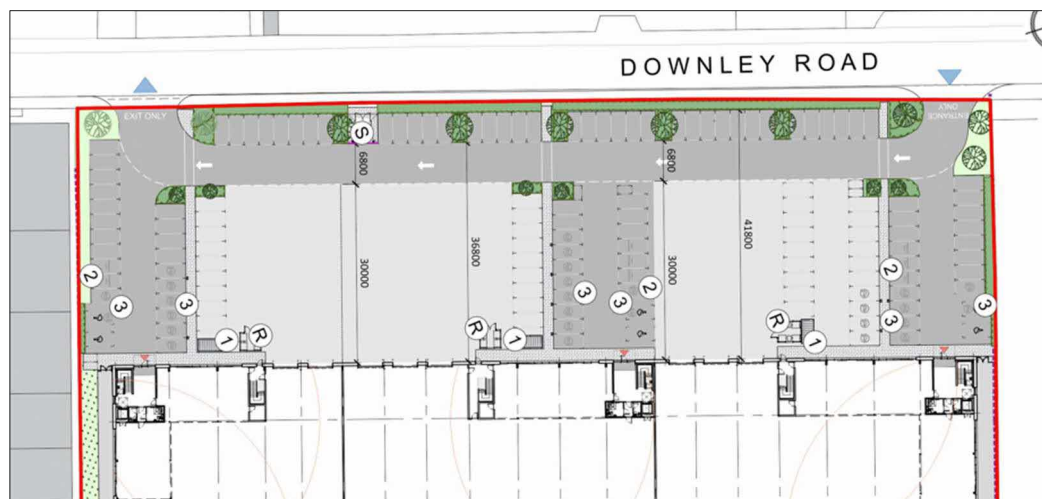
**Figure 4-2 Refuse Store Access**

15. HCC requested that the refuse lorry be shown within the site to demonstrate that should an HGV arrive while it is in situ there is room for the HGV to wait within the Site boundary. The bin storage has now been relocated adjacent to the buildings which allows the refuse lorry to make use of the service yards removing the issue. This can be seen in **Figure 4.2** below, the bin stores marked with an R.

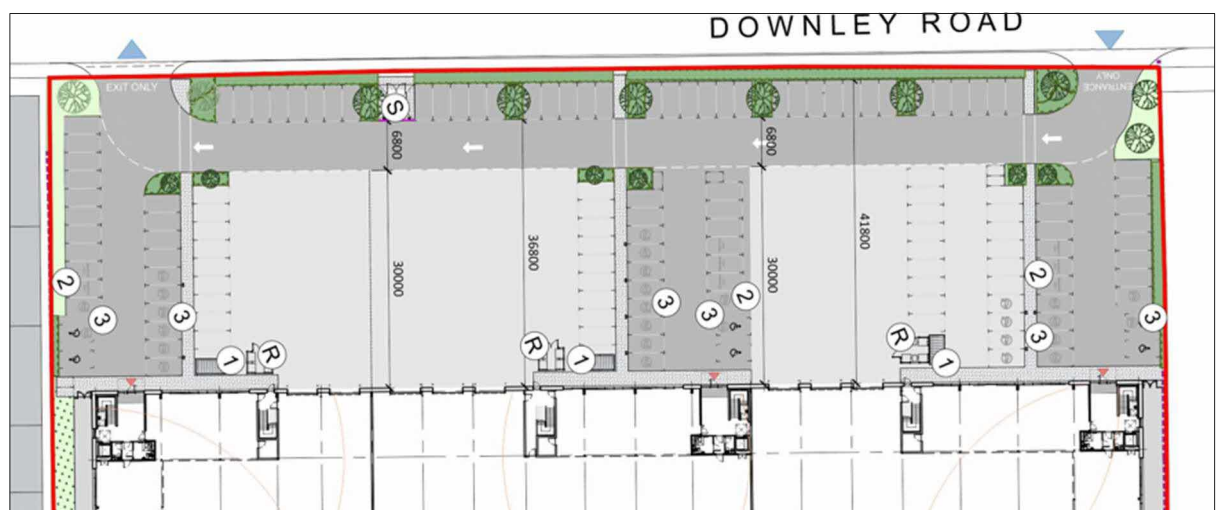
**Figure 4-3 HCC Internal Parking Layout**

16. HCC raised concerns over a potential conflict between HGVs blocking parked cars whilst servicing the Site. The internal parking layout as shown in **Figure 4-3** shows a row of parking either end of the service yard shared between Units 1 and 2, all other parking has an aisle running between spaces. Amble space has been provided between the docking bays and parking. Due to the relocation of bin stores there maybe a short period where a refuse lorry may block the spaces nearest the bin stores, however this is a quick process and would not be different to refuse lorries servicing on street and momentarily blocking parked cars and those waiting behind them.

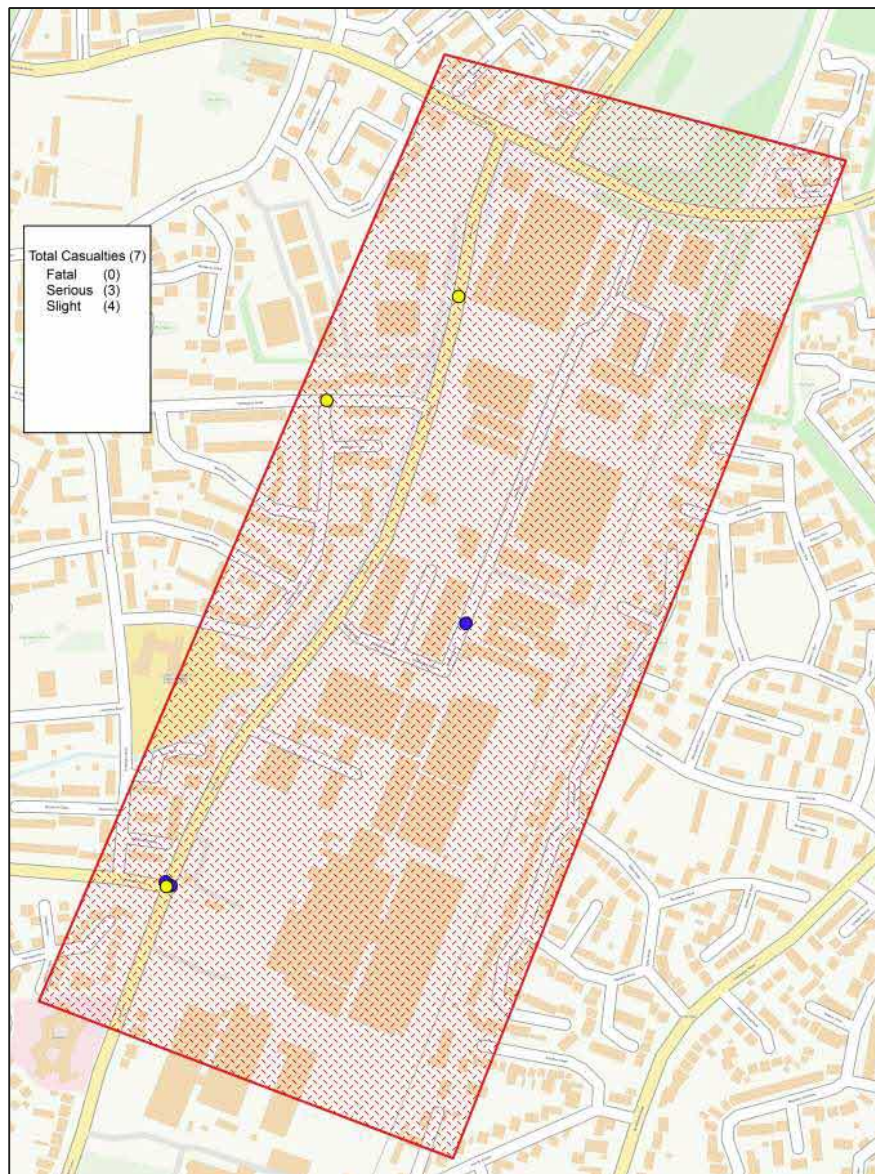
**Figure 5-1: HCC Collision Data**

28. **Figure 5-1** illustrates the study area for which data was obtained and the approximate location of the collisions which occurred during the most recent five-year period. There were a total of seven collisions, four of which were classified as slight and three classified as serious.

29. As illustrated in **Figure 5-1**, there has only been one collision recorded along either Downley Road or Stanbridge Road during the five-year period. This collision was classified as serious and involved a single person on a motorcycle who collided with a wall. The collision occurred as a result of a motorcyclist turning around to review their right light and losing control. As a result, it is argued that human error is the causation for the collision.

30. The only cluster of collisions was at the New Lane/Crosslands Drive junction. Two were classified as serious and one as slight. All three inferred that human error were to blame.

31. Based on the above, it is considered that there is no existing safety issue with the local highway network.

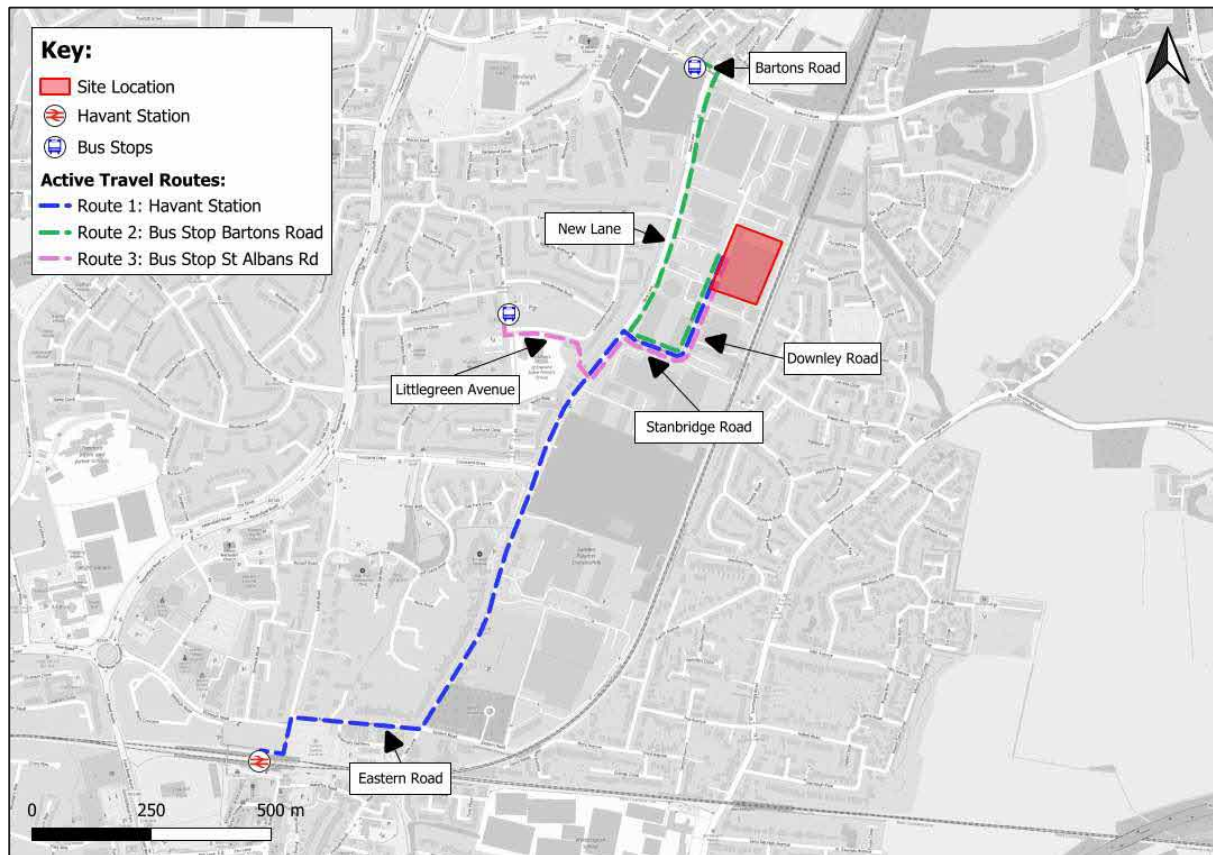
**Figure 1: Active Travel Routes**

The key routes and their proximity to the Site are illustrated below in **Figure 1**.

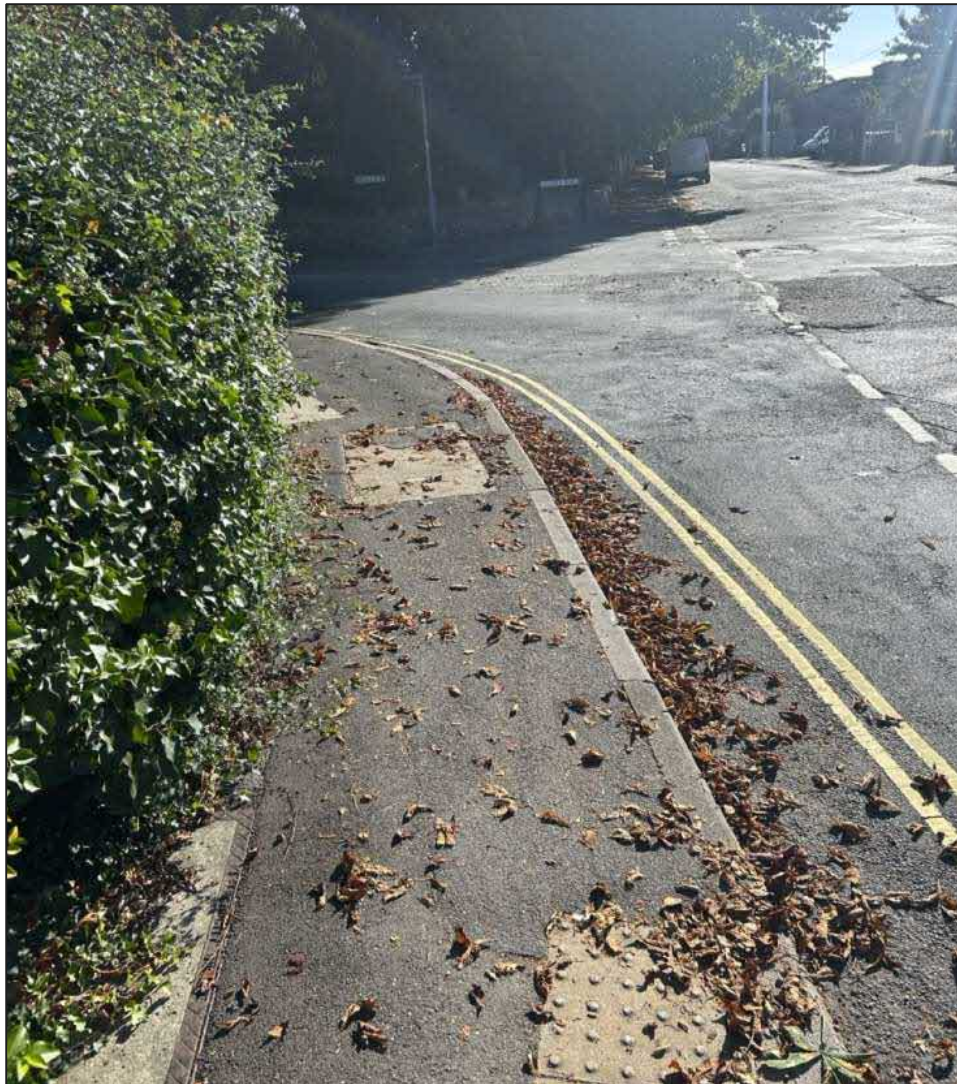
**Photo 1: Lack of Visibility at the New Lane / Eastern Road Intersection**

**Photo 1** is taken from the perspective of a pedestrian walking south from the Site along New Lane at the crossing point which must be used in order to continue westbound along Eastern Road towards the station.

The photo illustrates the lack of available visibility of vehicles north of the intersection along New Lane. This poses a potential safety issues as pedestrians are unable to see vehicles approaching the intersection from the north.

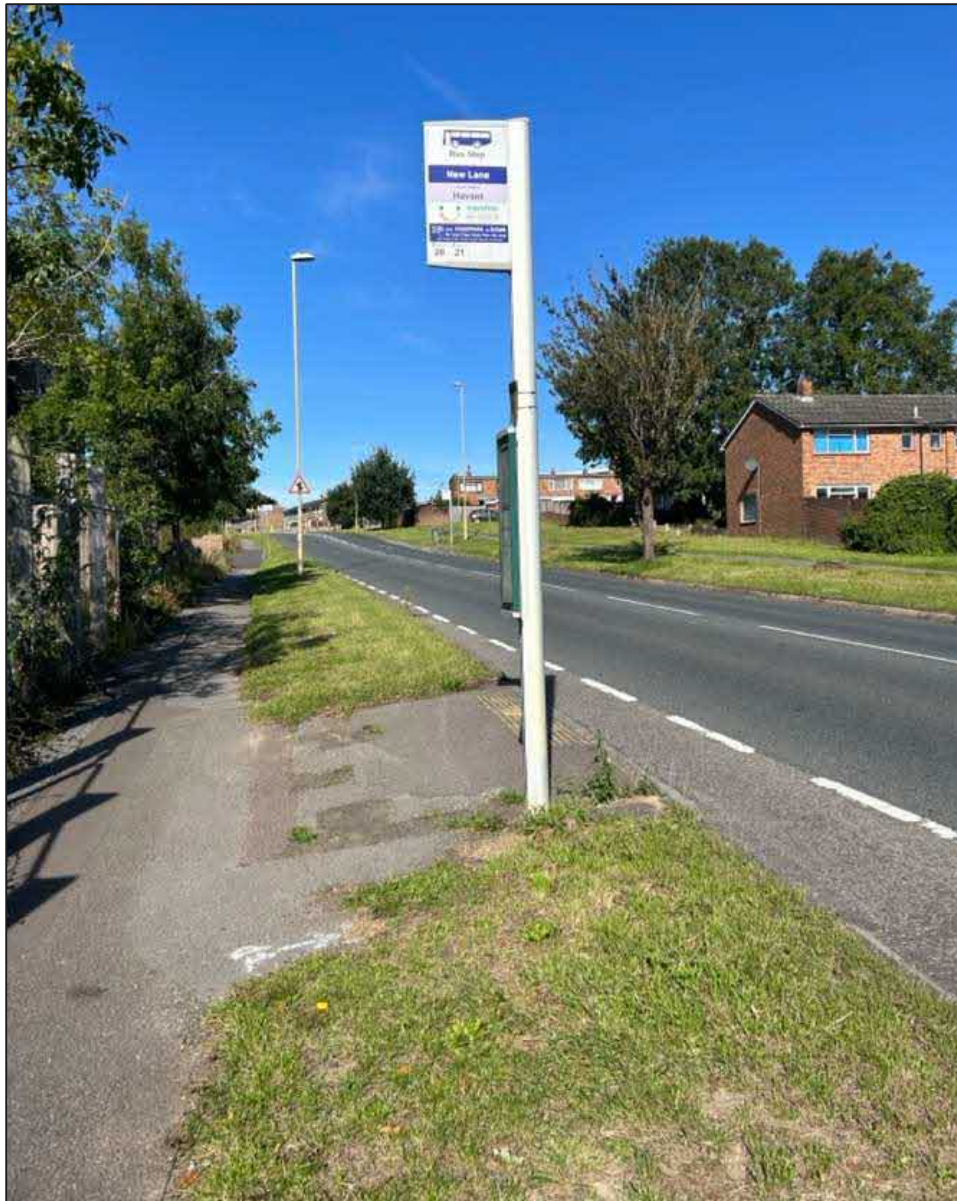
## Photo 2: Bus Stop Bartons Road

**Photo 2** shows the existing bus infrastructure at Bartons Road. A potential improvement could be to improve the bus stop to provide a shelter, seating and live journey time updates. This improvement would make both the route and destination itself more attractive to active travellers.

It is significant to note that the viability of this improvement is subject to the land ownership at each stop and the level of space which is needed to make the improvements. An initial review of the existing highway layout suggests that there is sufficient space to make this improvement.

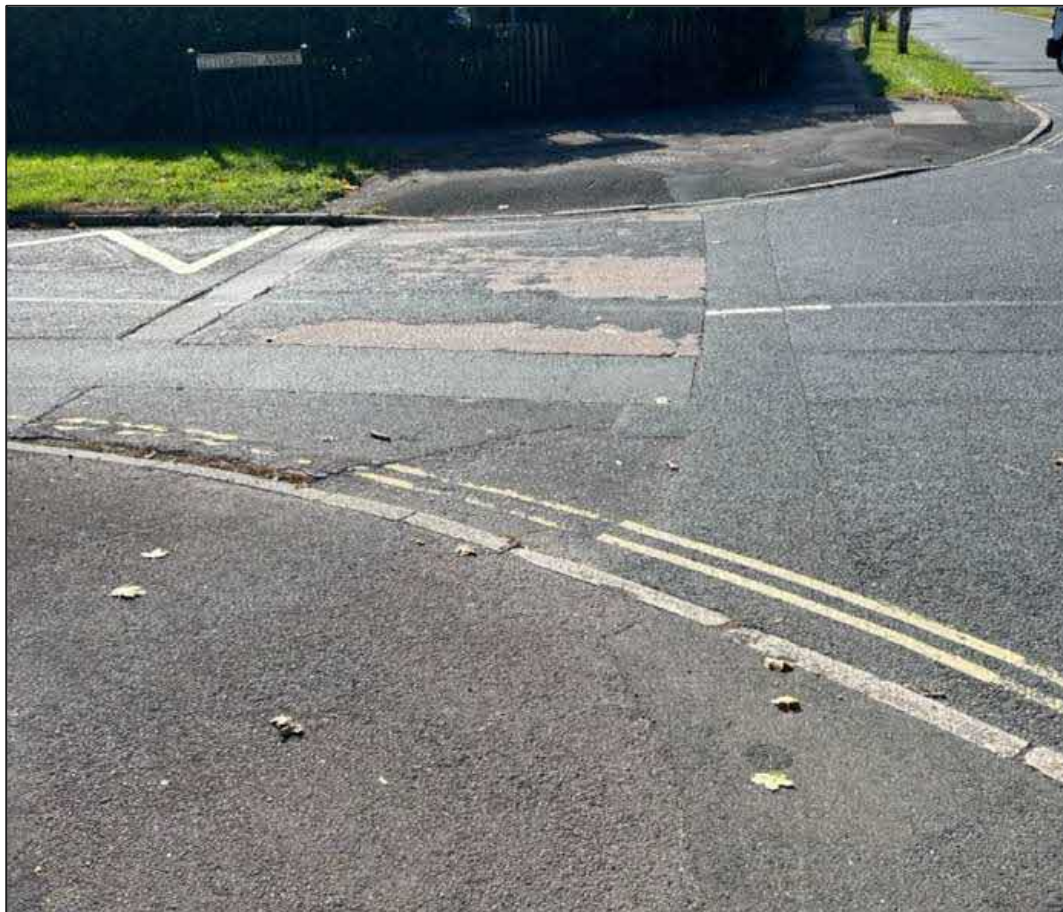
**Photo 3: Littlegreen Avenue Crossing Point**

One identified area for improvement was the lack tactile paving at the crossing point on Littlegreen Avenue, located adjacent to the Littlegreen Avenue / St Albans Road intersection. This is shown below in **Photo 3**.

**Photo 3** shows that although there are dropped kerbs at the crossing, no tactile paving is present. This may inhibit those with visual impairments for undertaking this route.

This could be improved through the addition of tactile paving at the crossing point, thus making the route more accessible to those from all walks of life.

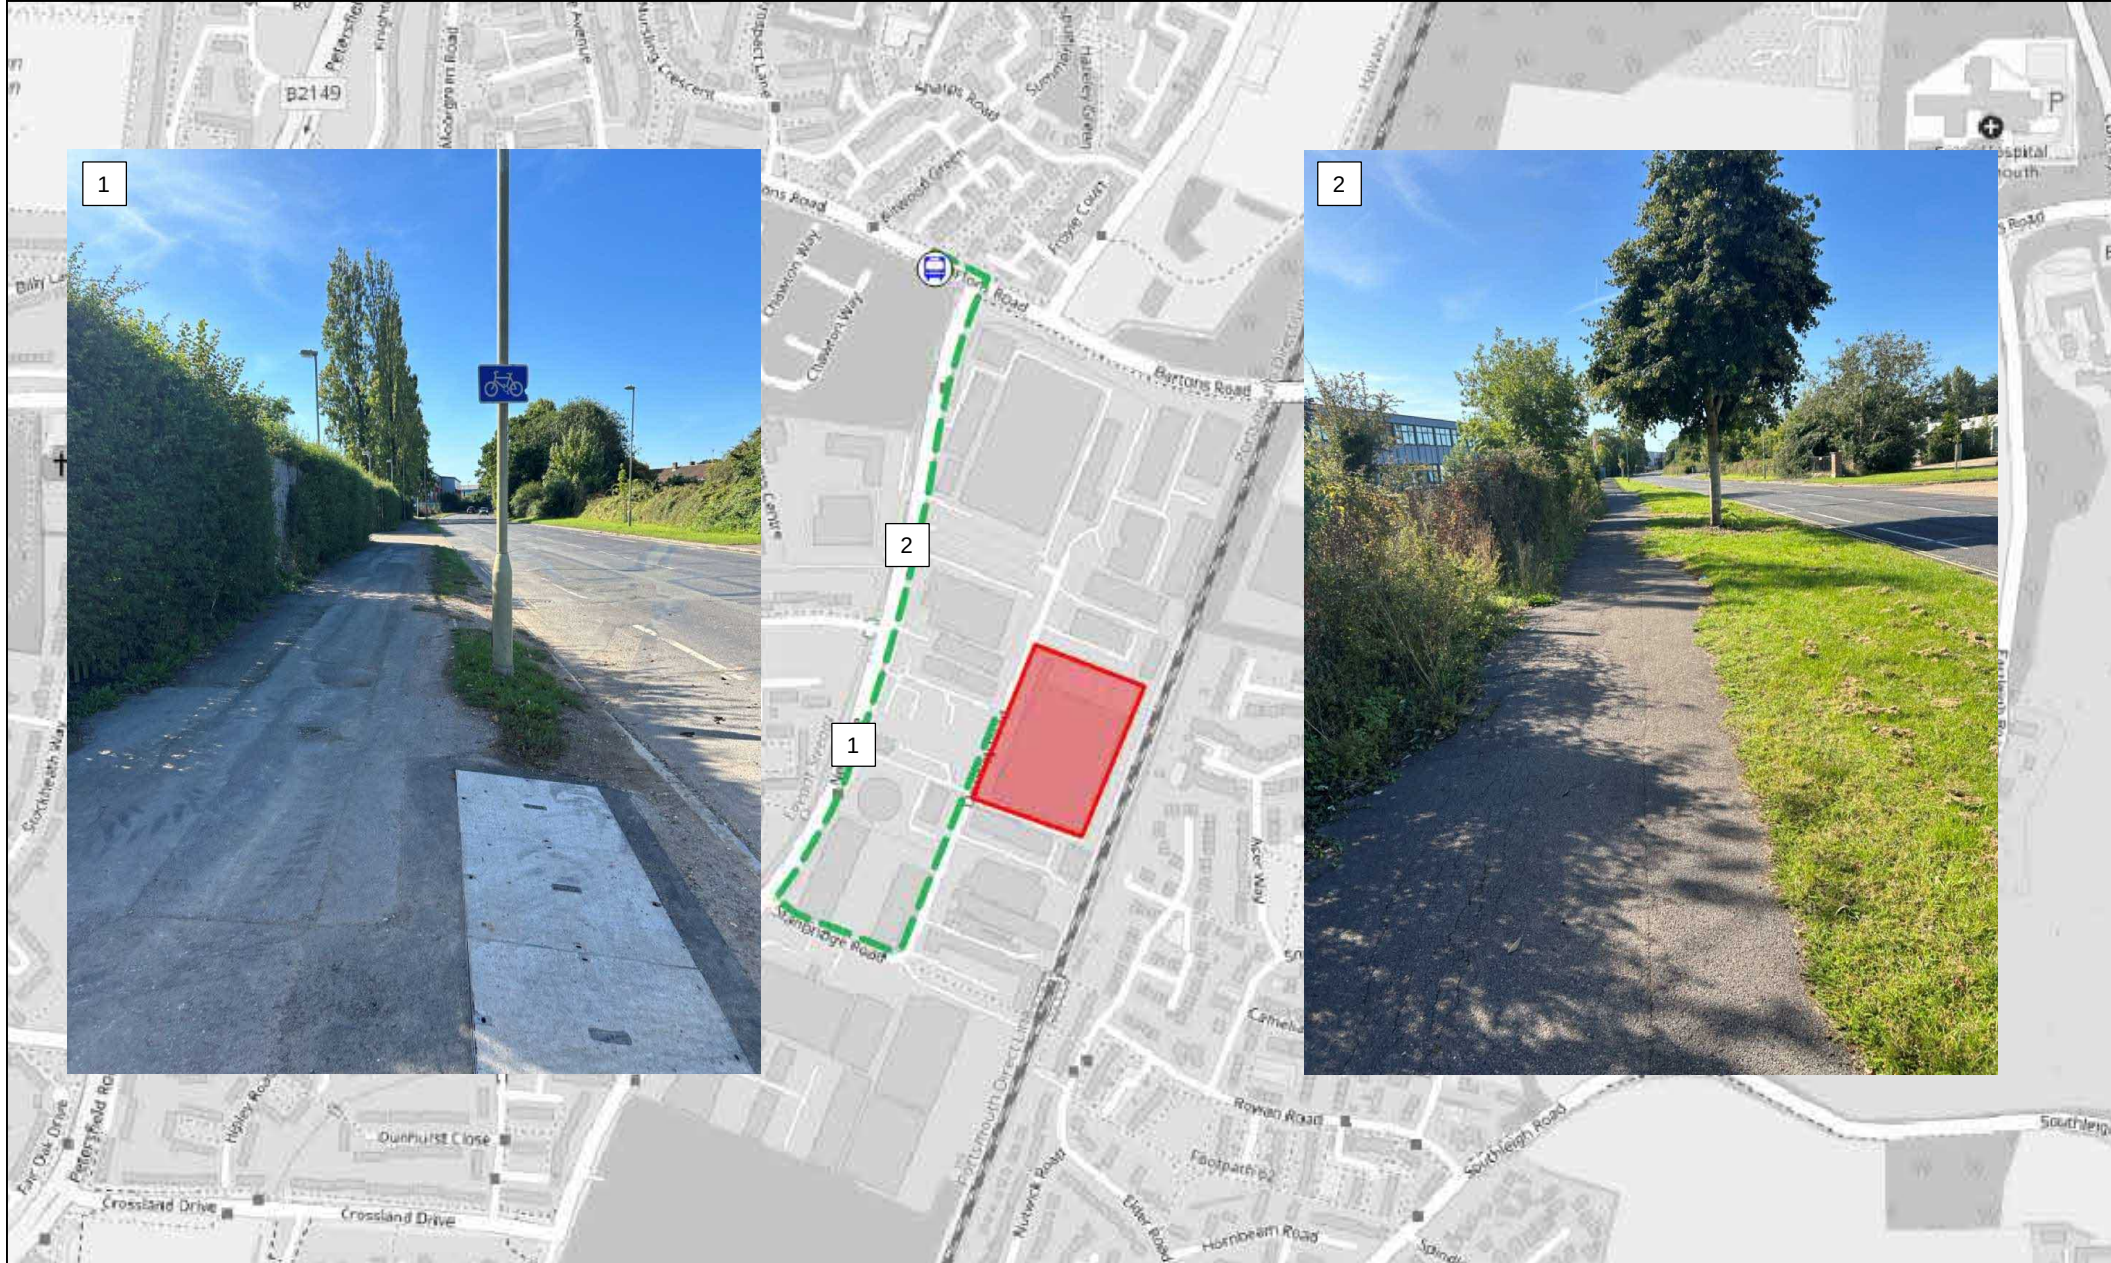
| | <p>DRAWN: BW</p> <p>CHECKED: KL</p> <p>DATE: 18/09/2024</p> <p>SCALE: NTS</p> | <p>DRAWING REFERENCE: Figure 5</p> |

| | <p>Route 2 –Stop Bartons Road</p> | <p>SLR</p> |

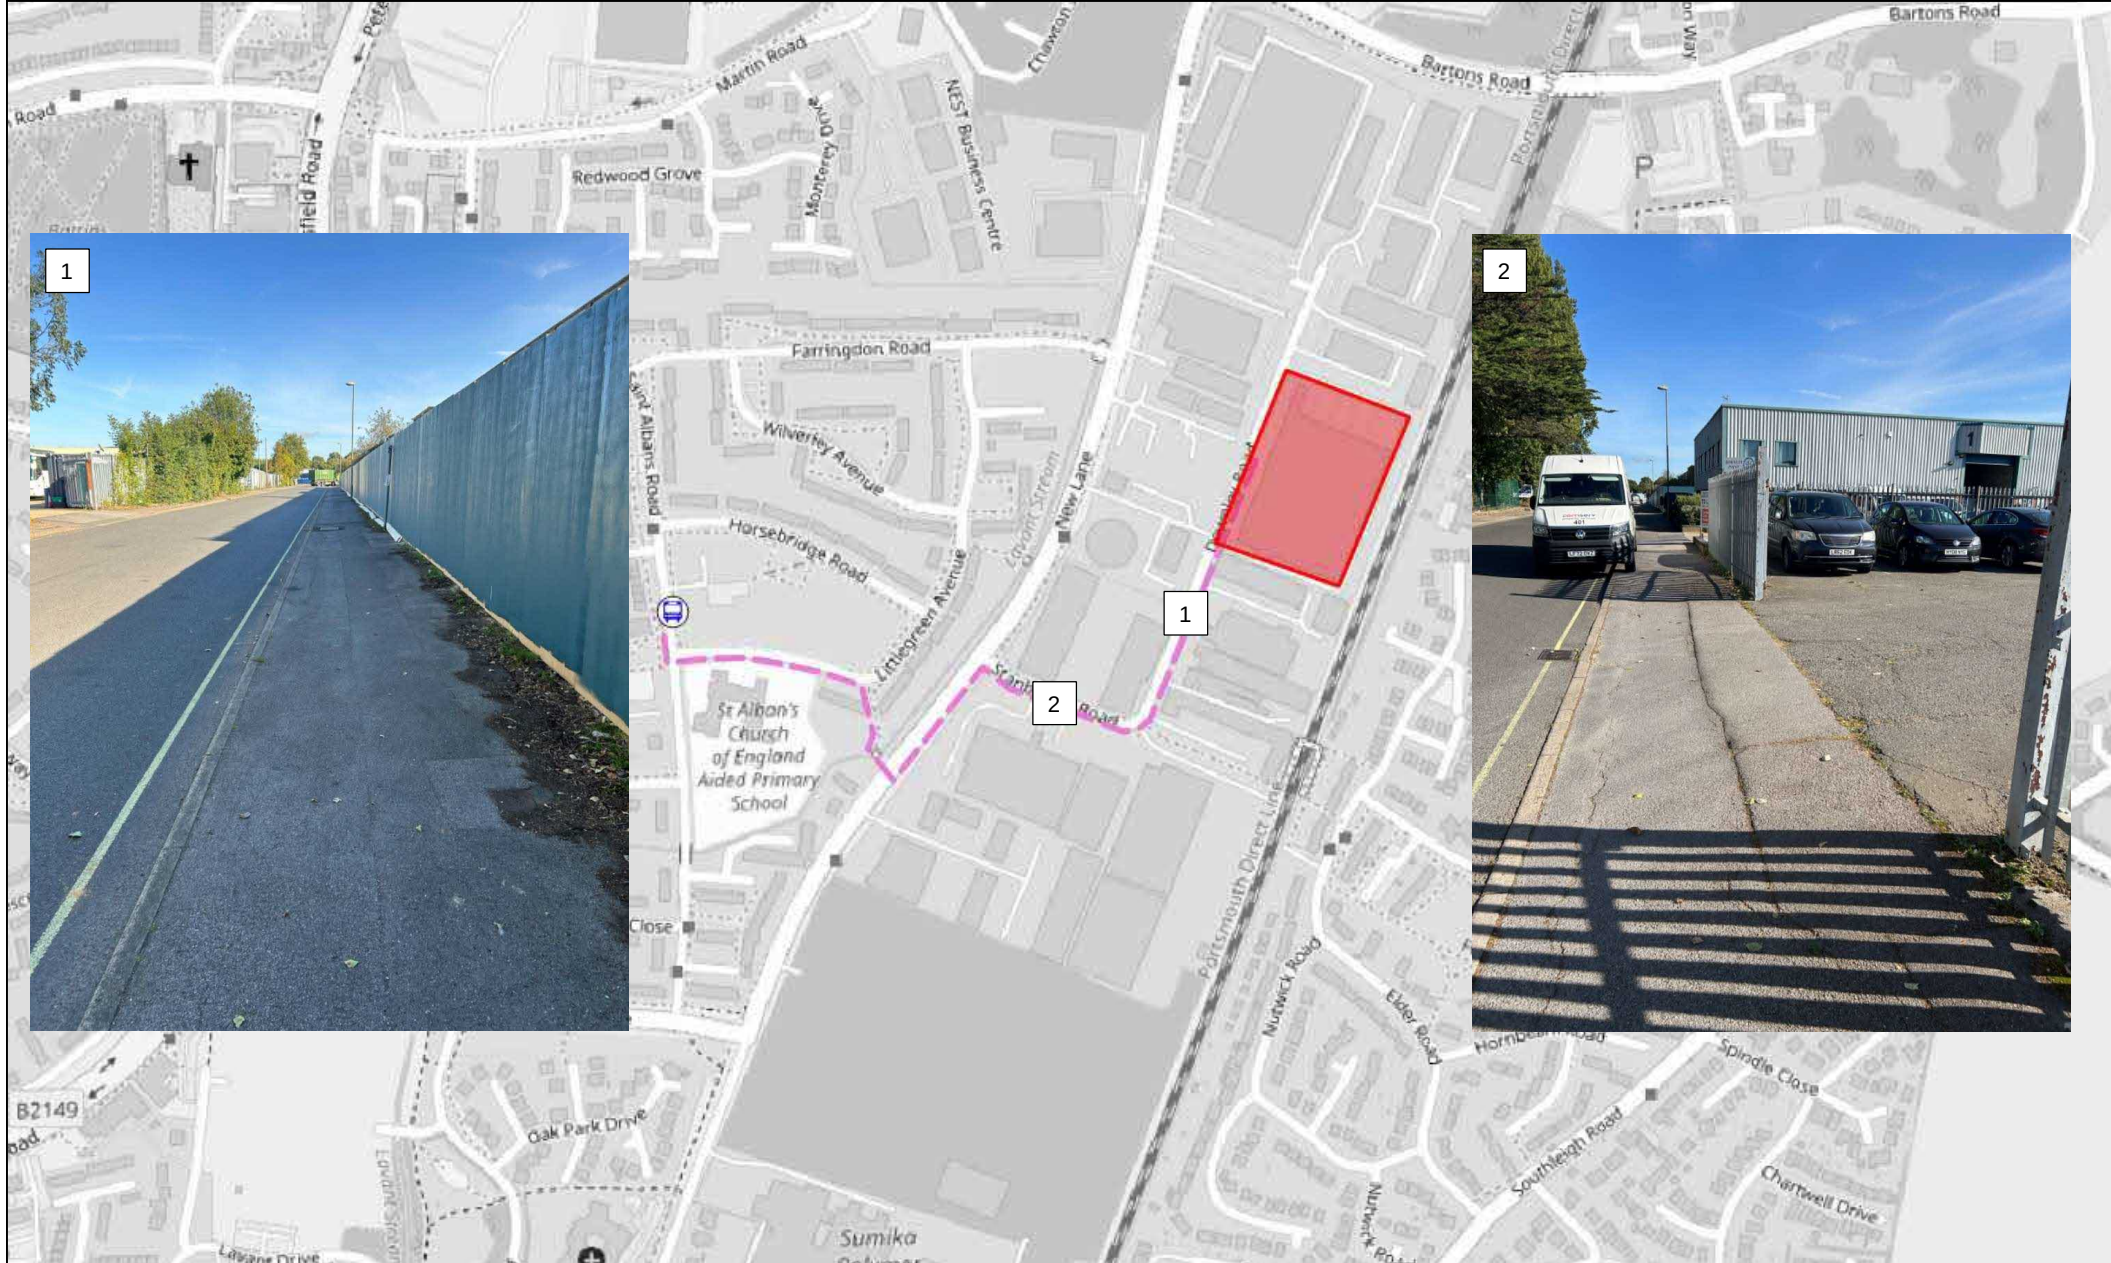
| | DRAWN: BW | CHECKED: KL | DATE: 18/09/2024 | SCALES: NTS<br>DRAWING REFERENCE: Figure 8 |

| | Route 3 – Stop St Albans Road | | | |

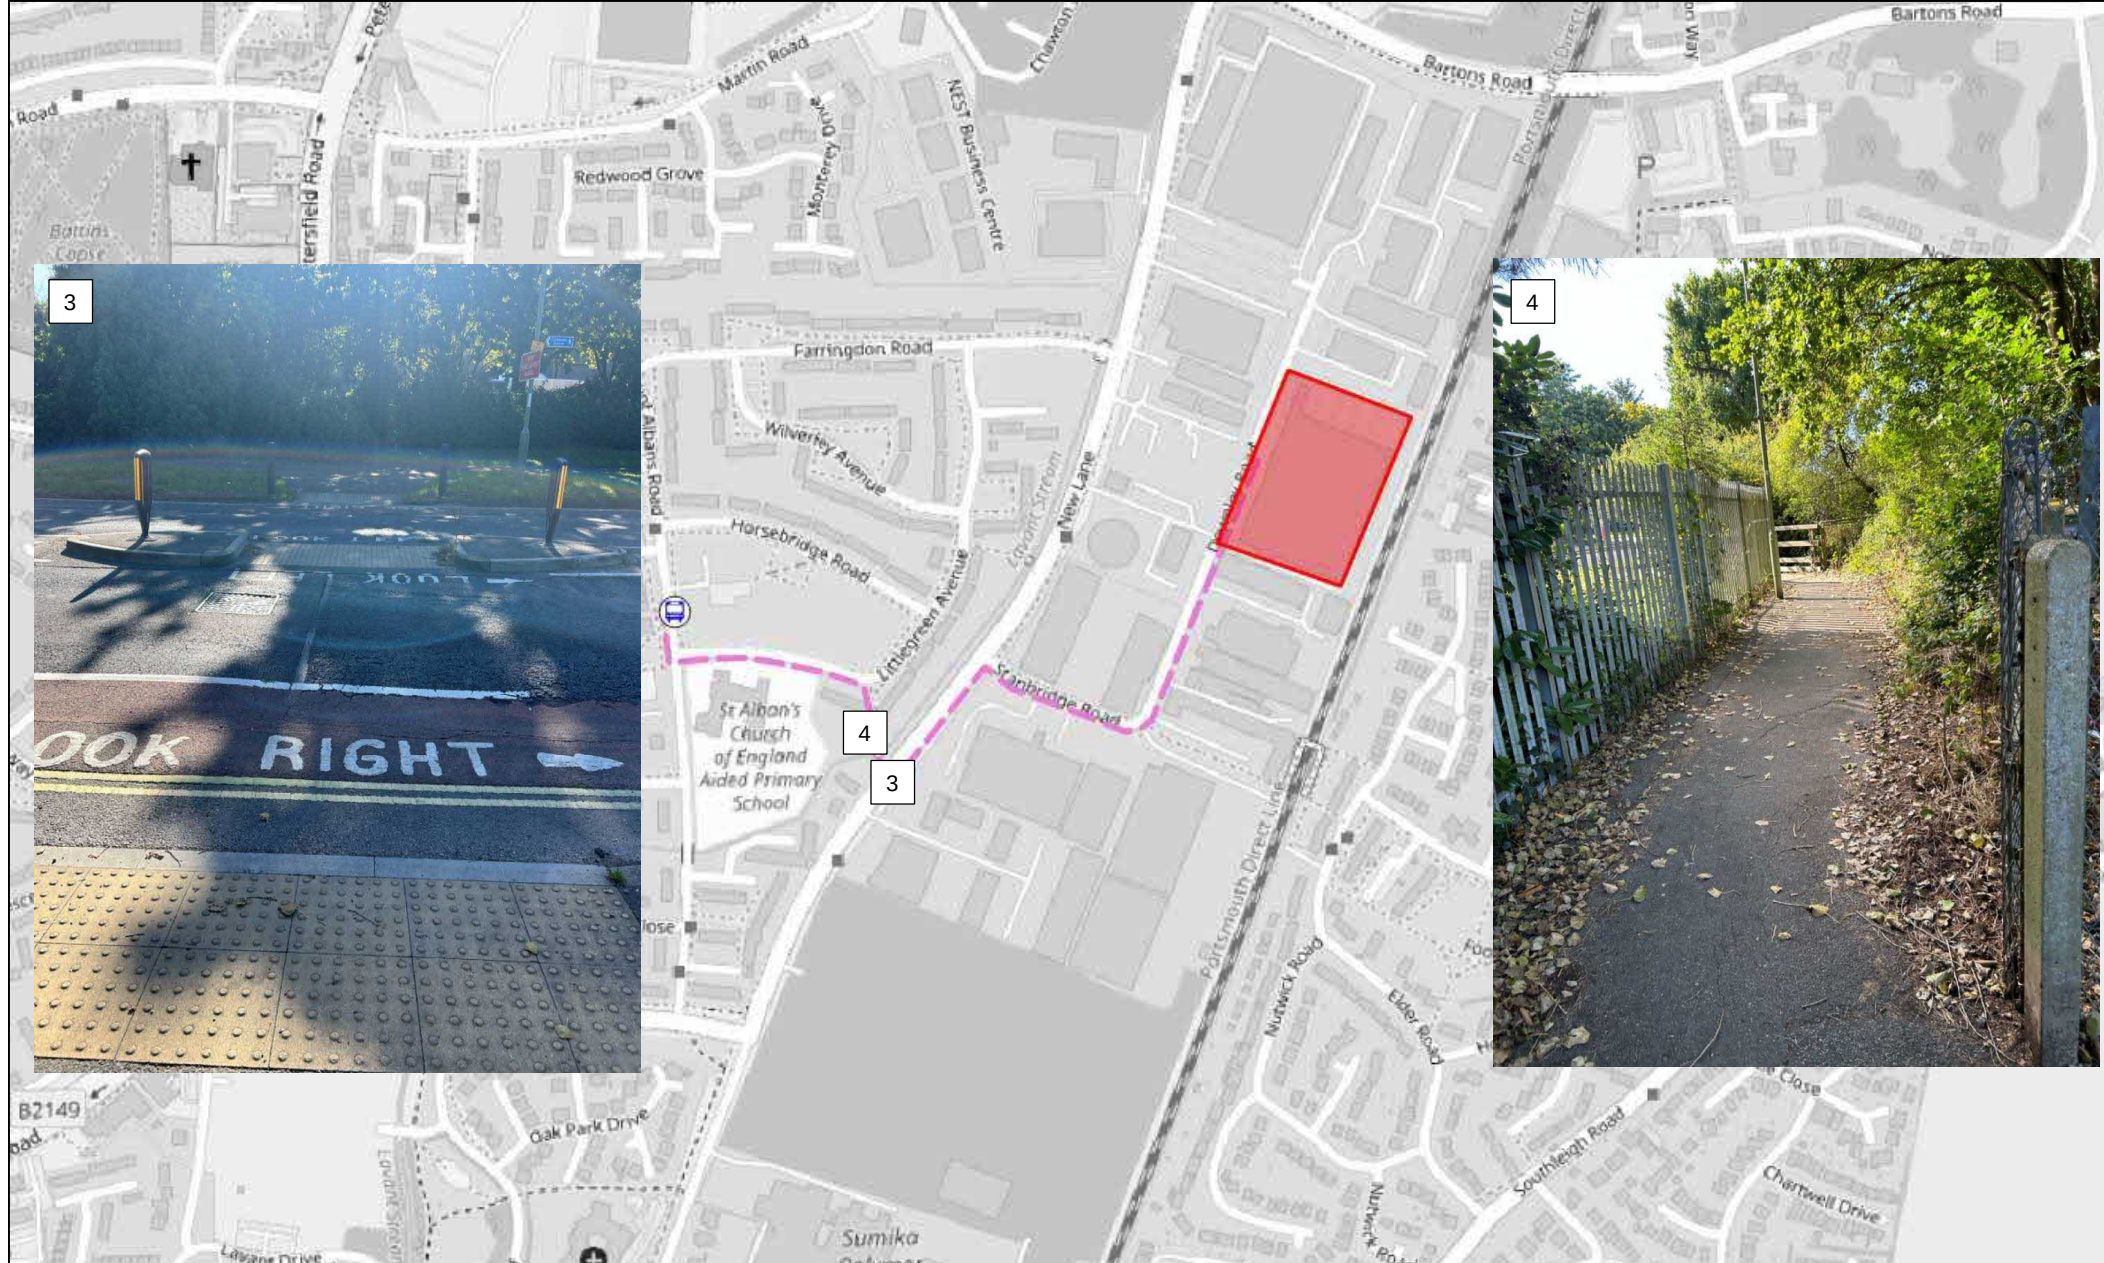
| DRAWN: BW | CHECKED: KL | DATE: 18/09/2024 | SCALES: NTS | DRAWING REFERENCE: Figure 9 |

| <p>10 Location of Google Street View photo</p> | Route 3 – Stop St Albans Road | | | |

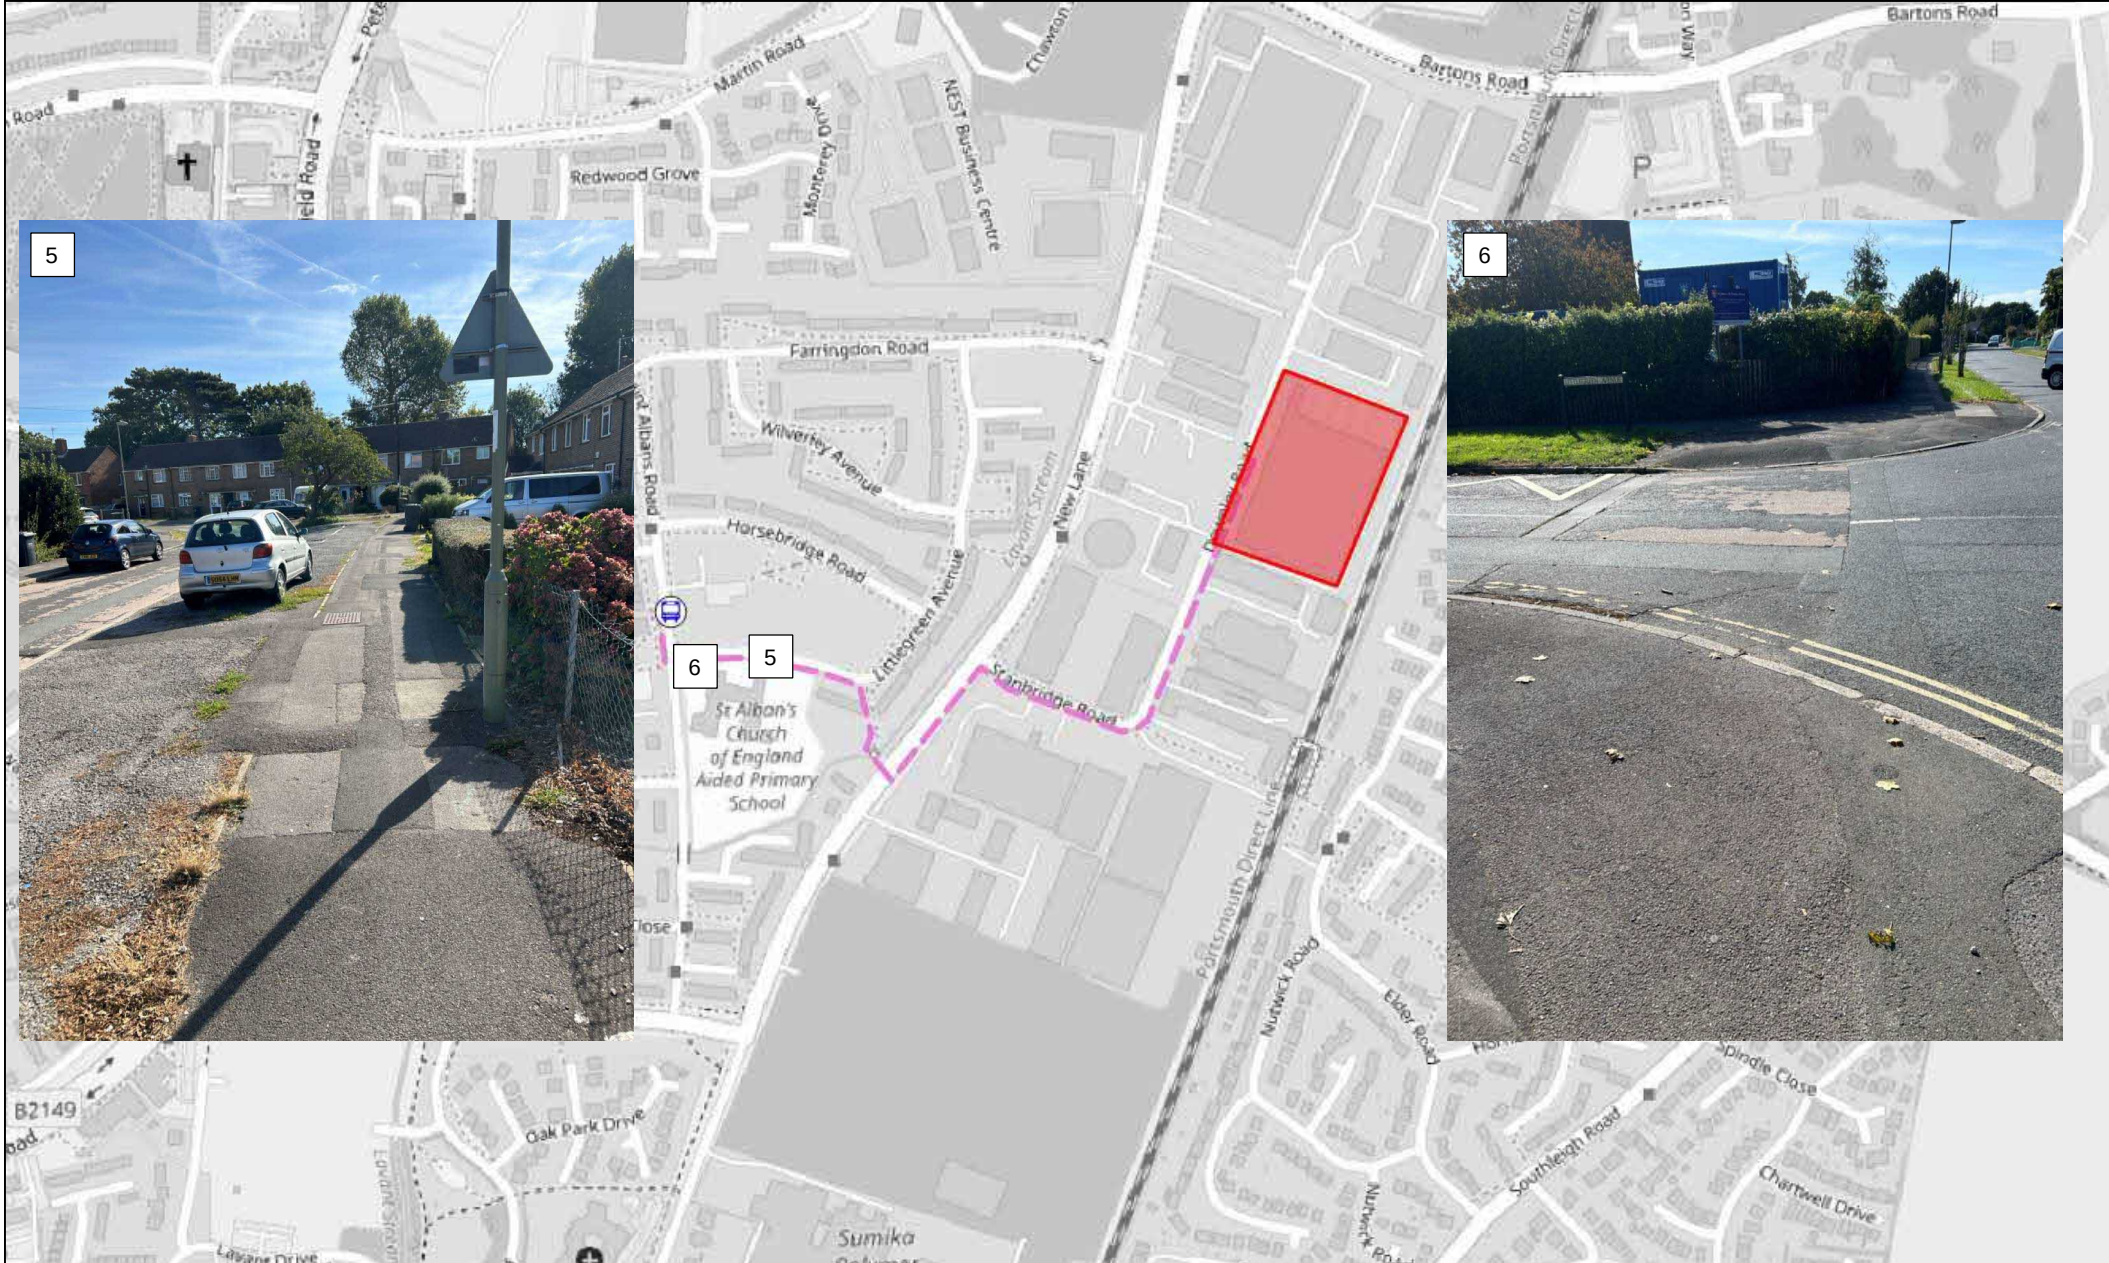
| <p>DRAWN: BW</p> | <p>CHECKED: KL</p> | <p>DATE: 18/09/2024</p> | <p>SCALES: NTS</p> | <p>DRAWING REFERENCE: Figure 10</p> |

| <p>Location of Google Street View photo</p> | Route 3 – Stop St Albans Road | | | |
