# Former Dunham Bush Site

**RE: Former Dunham Bush Site, Downley Road, Havant –Technical Note**

## 1.0 Introduction

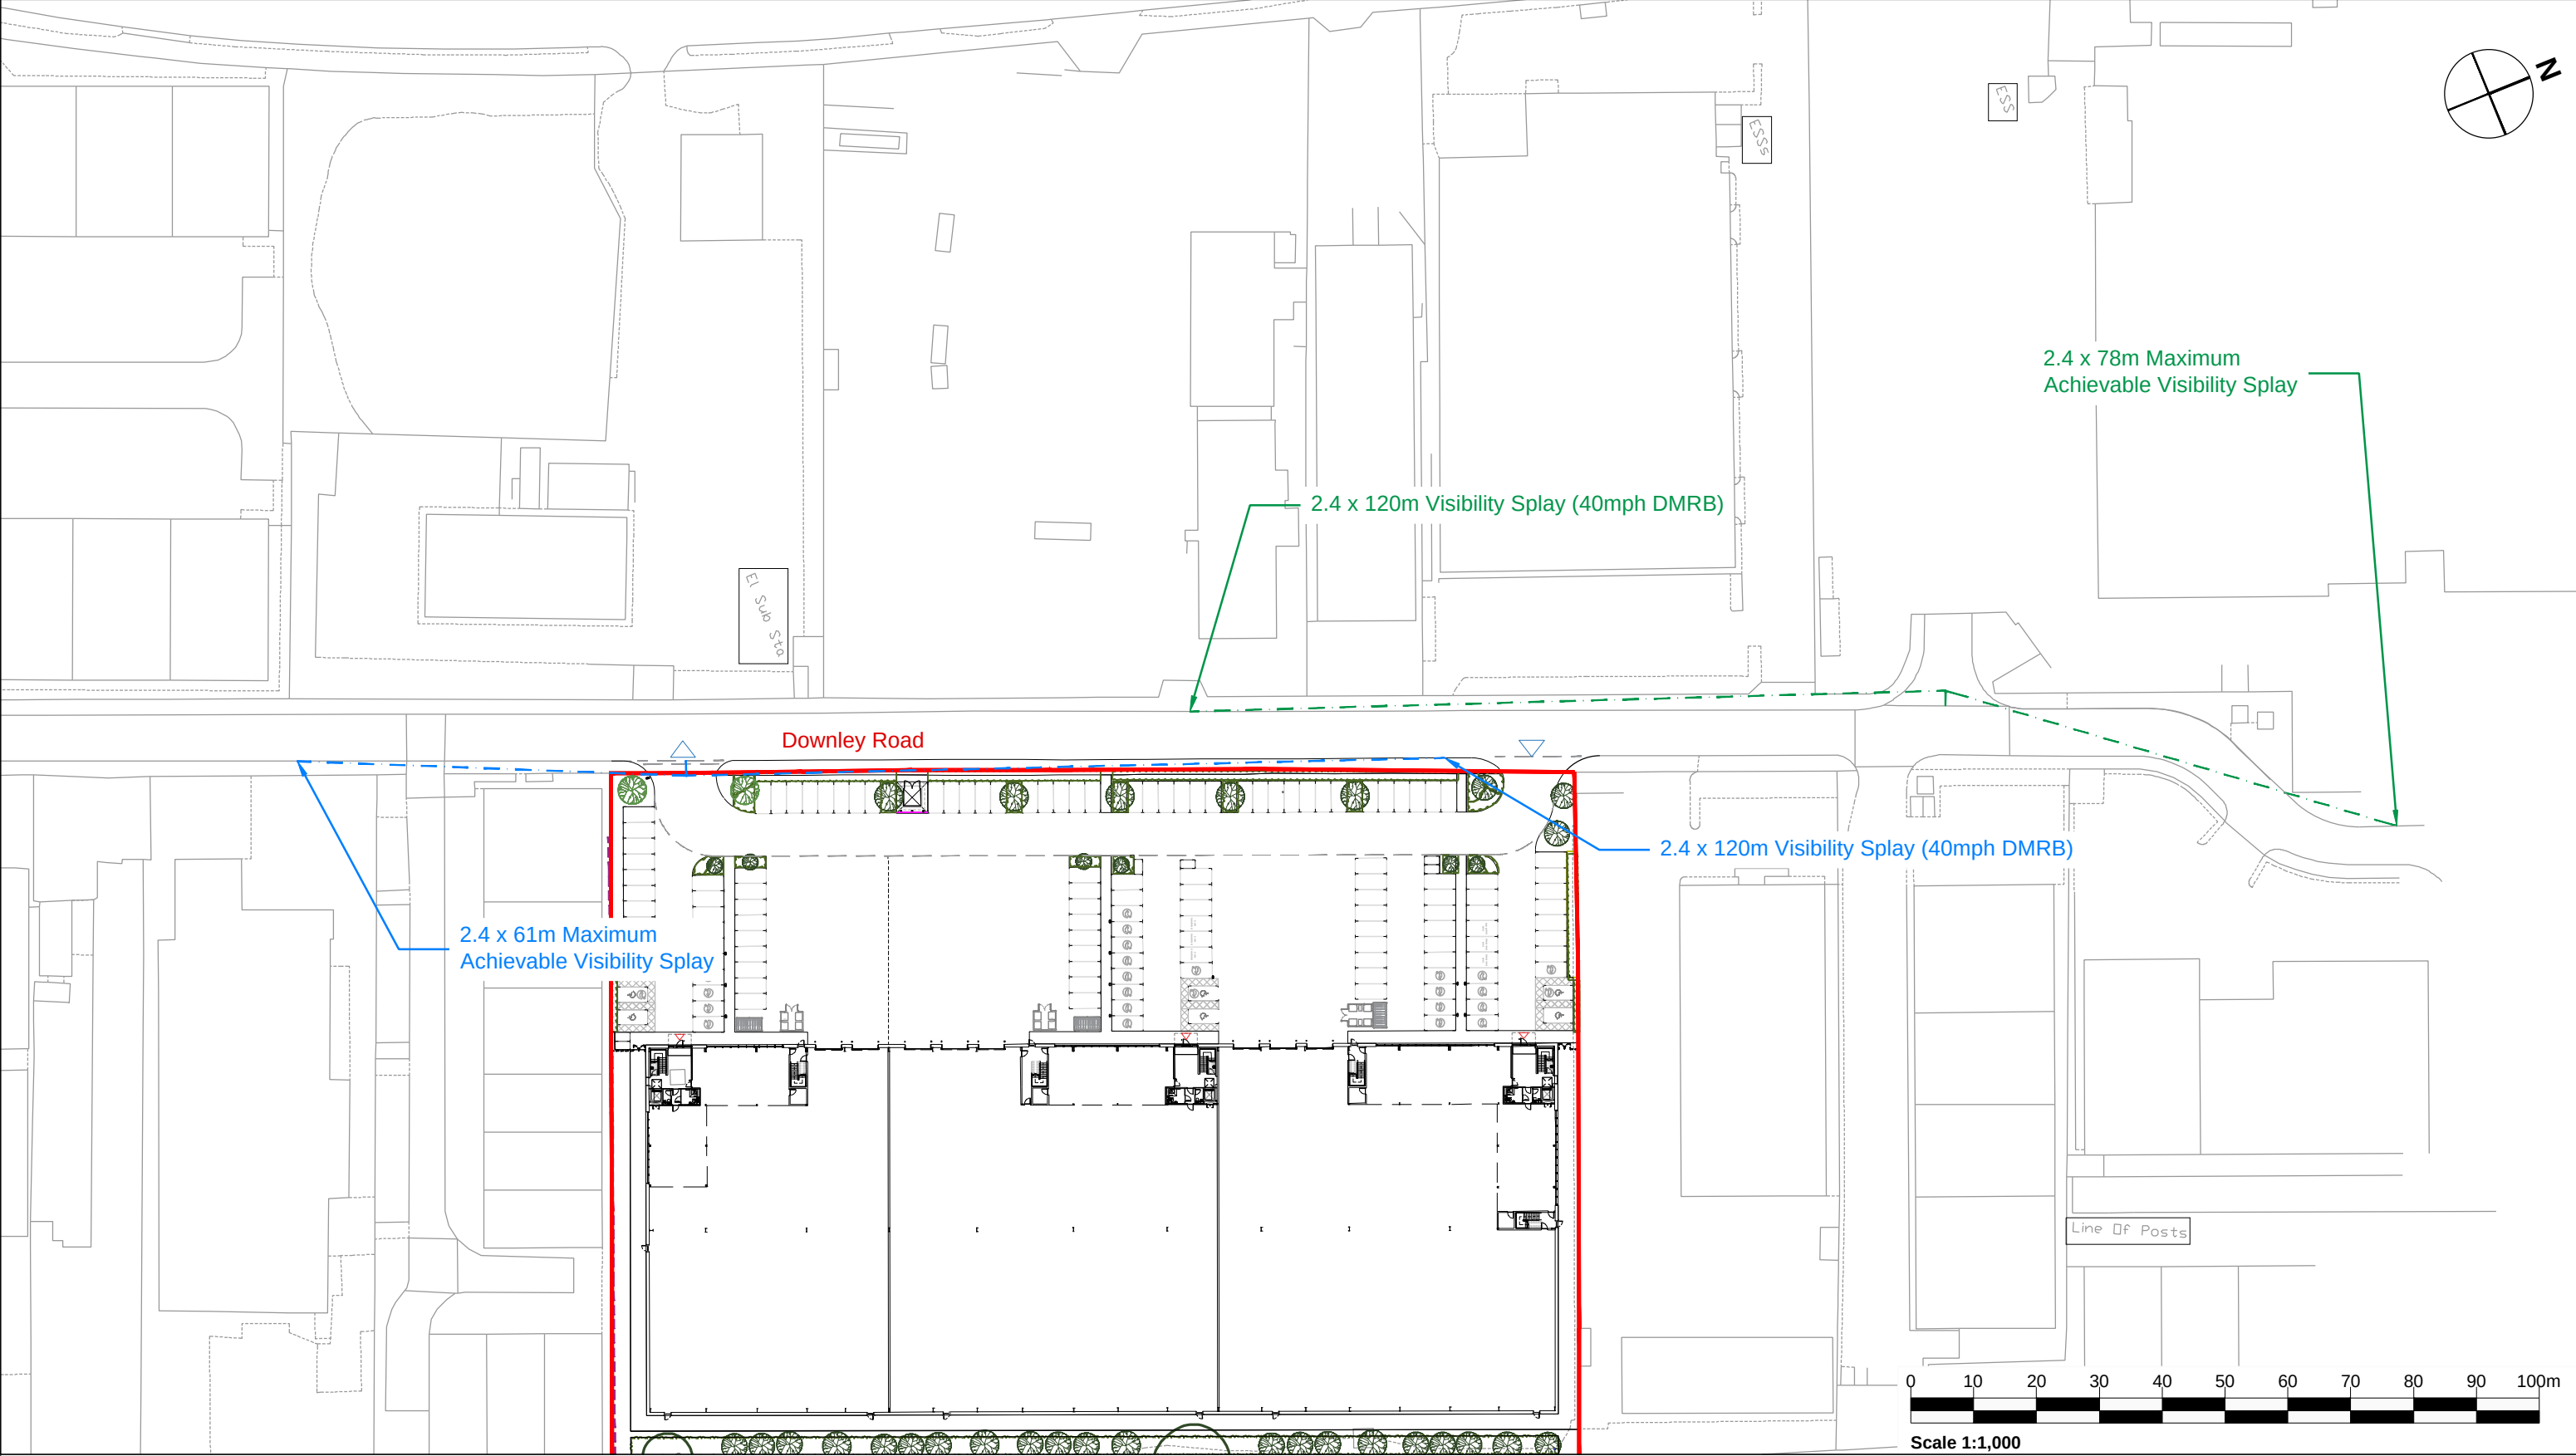
- The drawing included at **Appendix B** shows the proposed site access junctions. These will be created by making minor changes to the existing site access junctions including introducing a bellmouth layout. The location of both existing junctions have been slightly amended to accommodate parking within the Site. For the southern access this also benefits the visibility to the south by moving further north from the boundary of the neighbouring Site. Tactile paving will be added to the footway at the proposed accesses.
- The drawing of the proposed site accesses shows that the maximum achievable visibility to the left for drivers exiting the southern access is 61m from a setback distance of 2.4m.

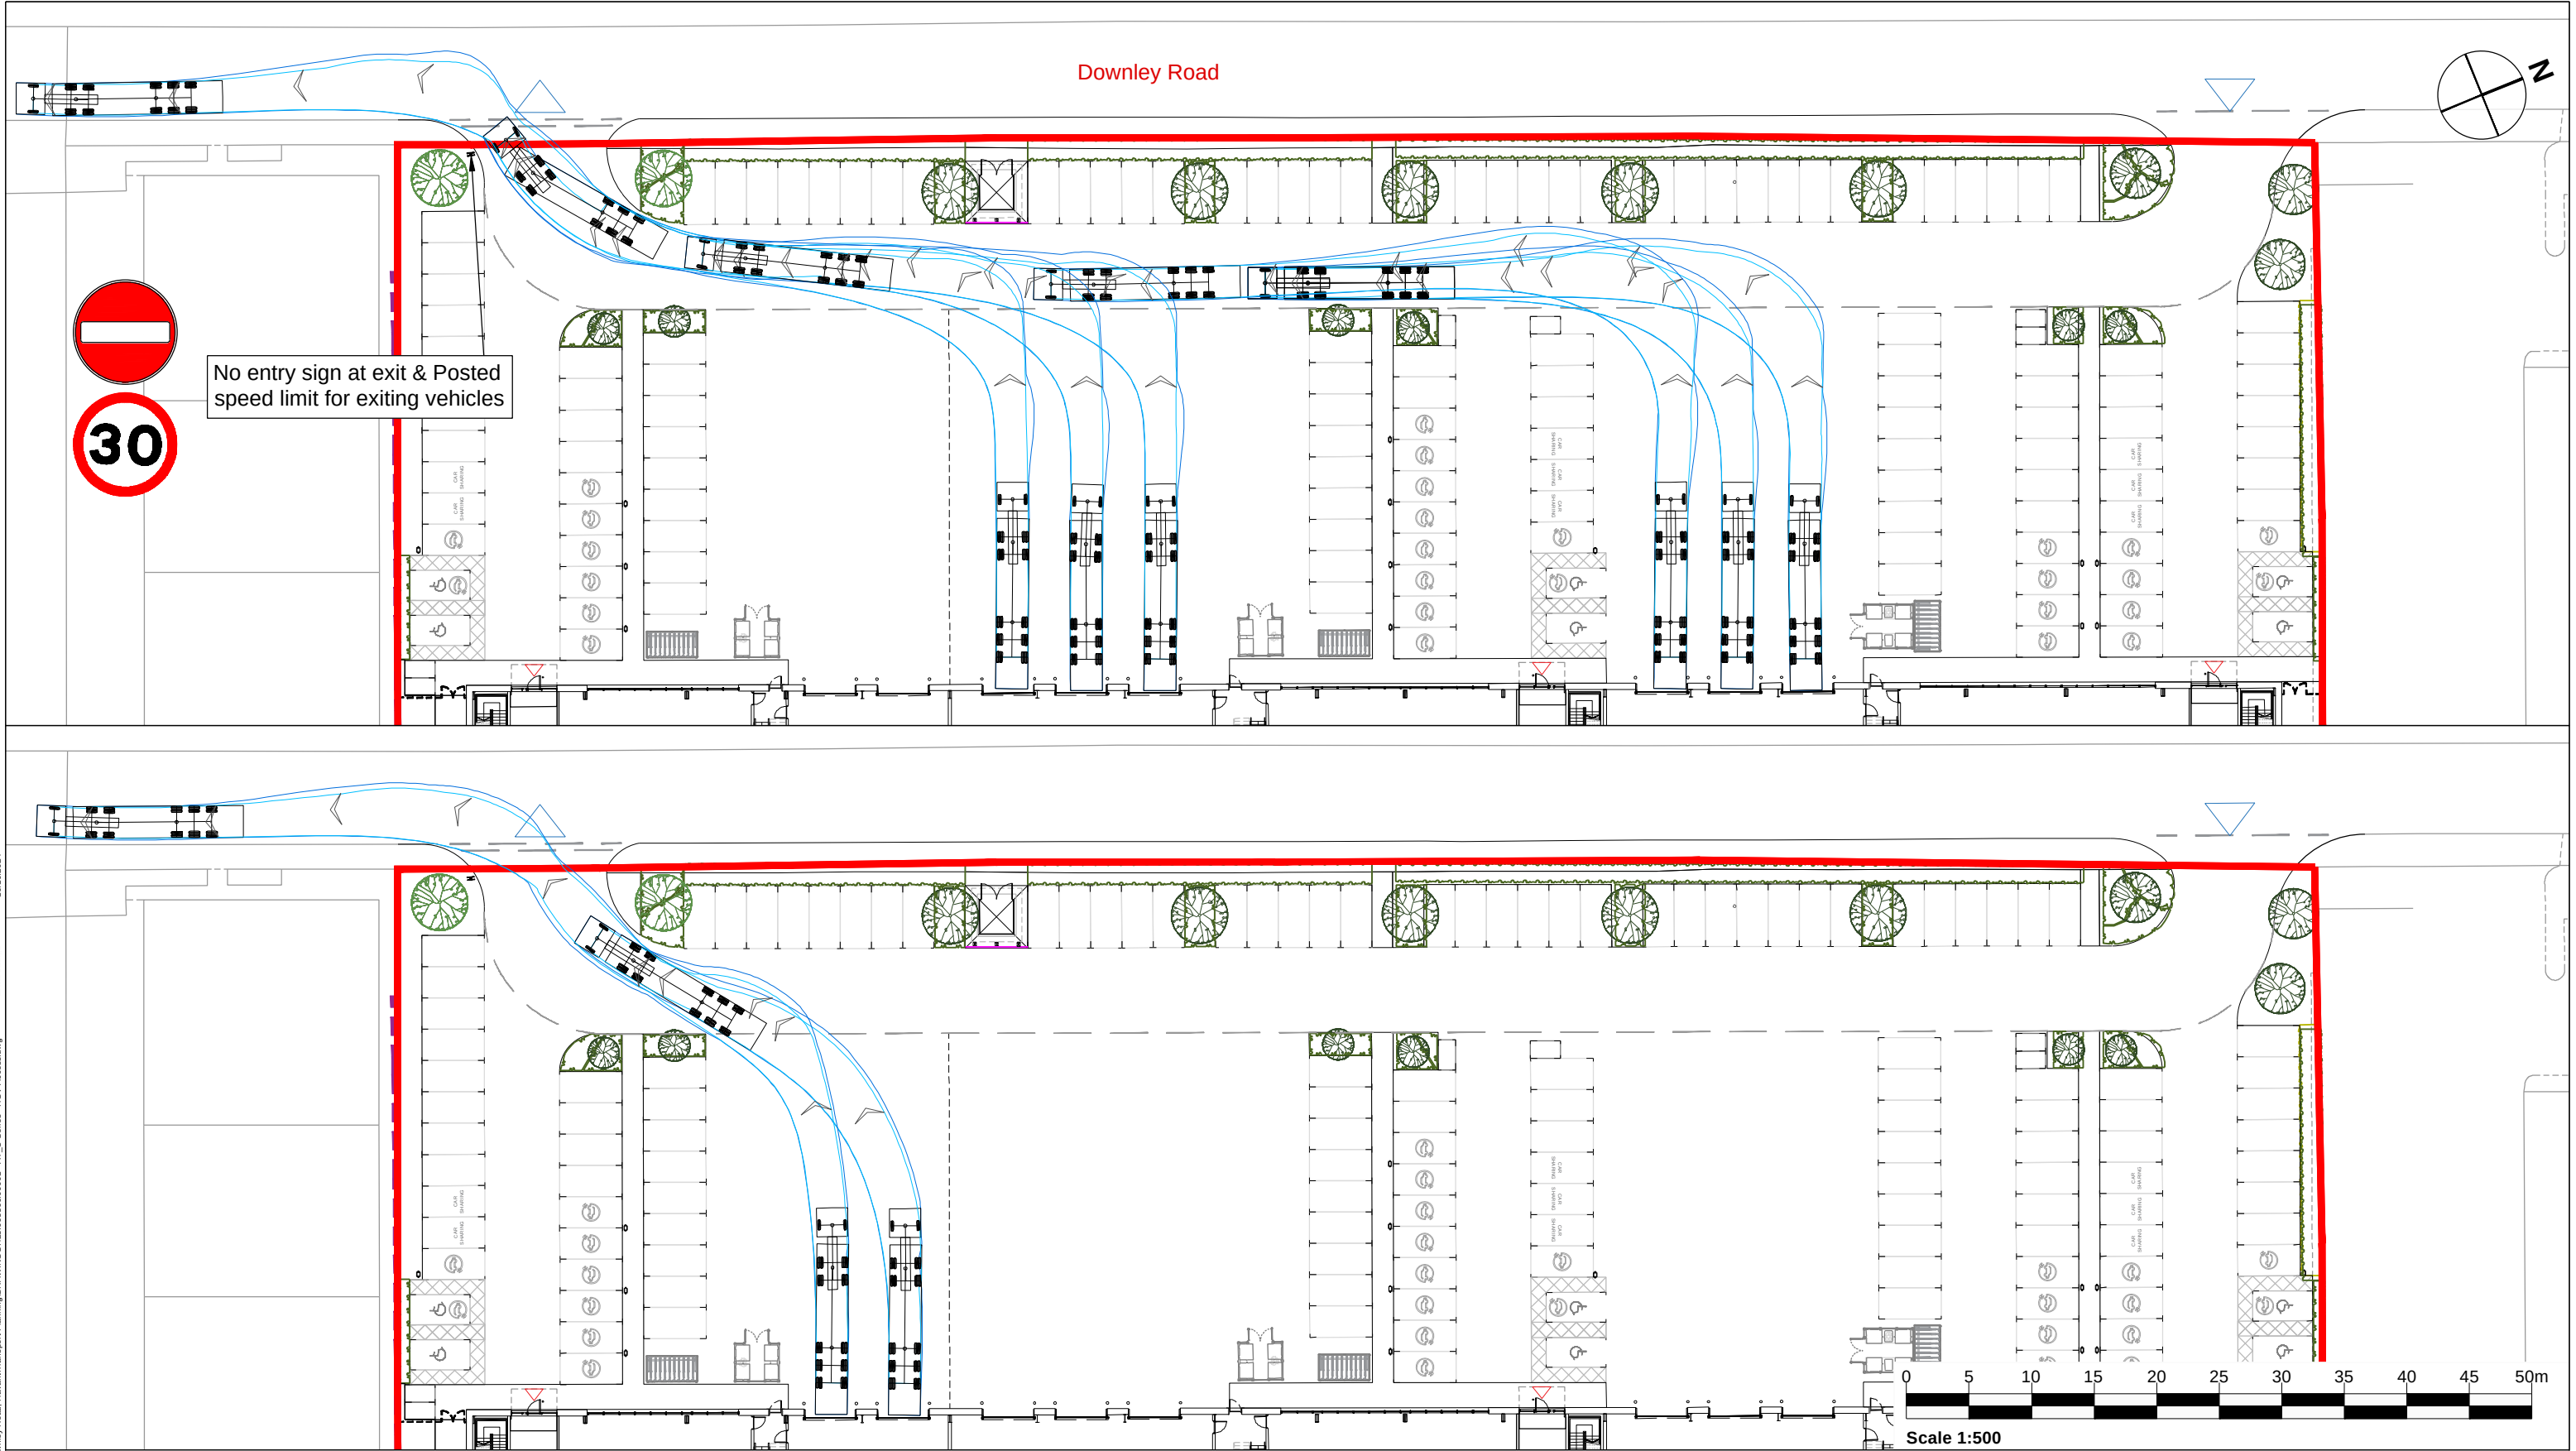
Max Legal Length (UK) Articulated Vehicle (16.5m)  
Overall Length 16.500m  
Overall Width 2.550m  
Overall Body Height 3.681m  
Min Body Ground Clearance 0.411m  
Max Track Width 2.500m  
Lock to lock time 6.00s  
Kerb to Kerb Turning Radius 6.530m

13. The applicant is happy to ensure that proposed trees will be planted outside of the achievable visibility splays.
14. Tracking has been carried out for a 16.5m HGV which is the largest vehicle to access the Site. The speed tracked was 10mph which is considered “standard” for this type of manoeuvre. This is shown in **Appendix C**. A refuse lorry has also been tracked.
