## Design, Access and Heritage Statement

A report by Listed Building Surveys Ltd

Cottrells Farmhouse, 70 Havant Road, Hayling Island, PO11 0LH

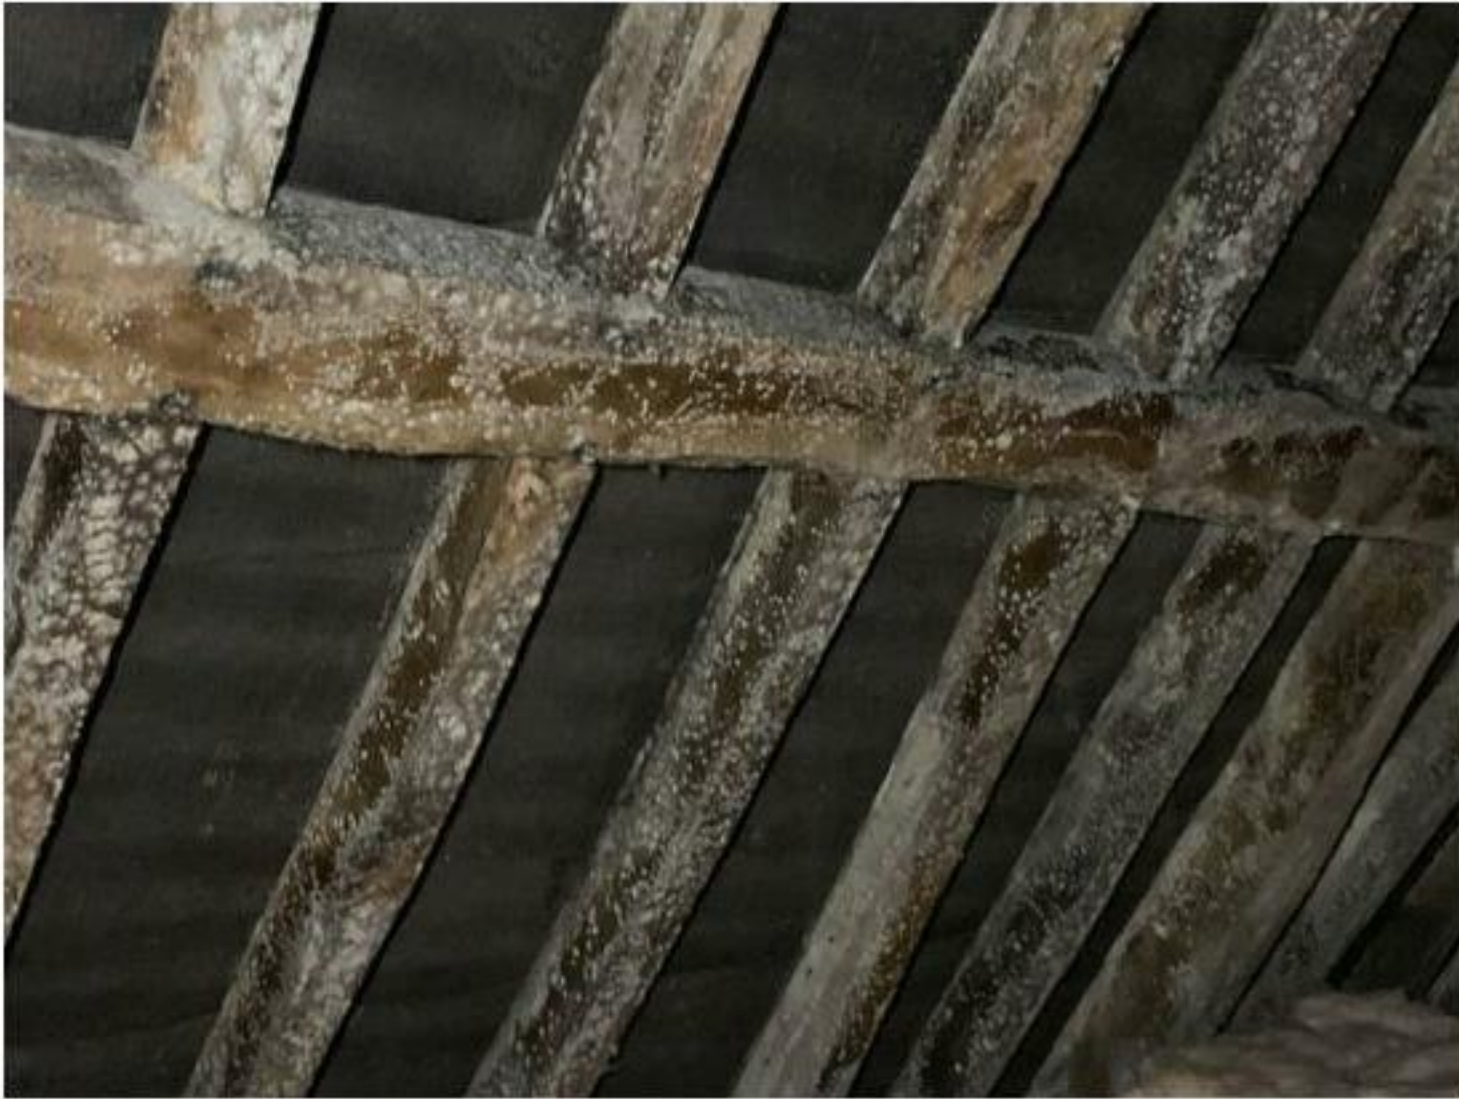
**Image 2 – severe condensation within the roof space**

Some photos taken at the time of the survey are shown below. The moisture content within the roof is exceptional and is not simply due to a lack of ventilation of the roof space. That is a contributory factor but it is not the sole problem. Improved ventilation of the roof space has been carried but the moisture issues persist and are directly related to the weather. The wall is simply too porous.

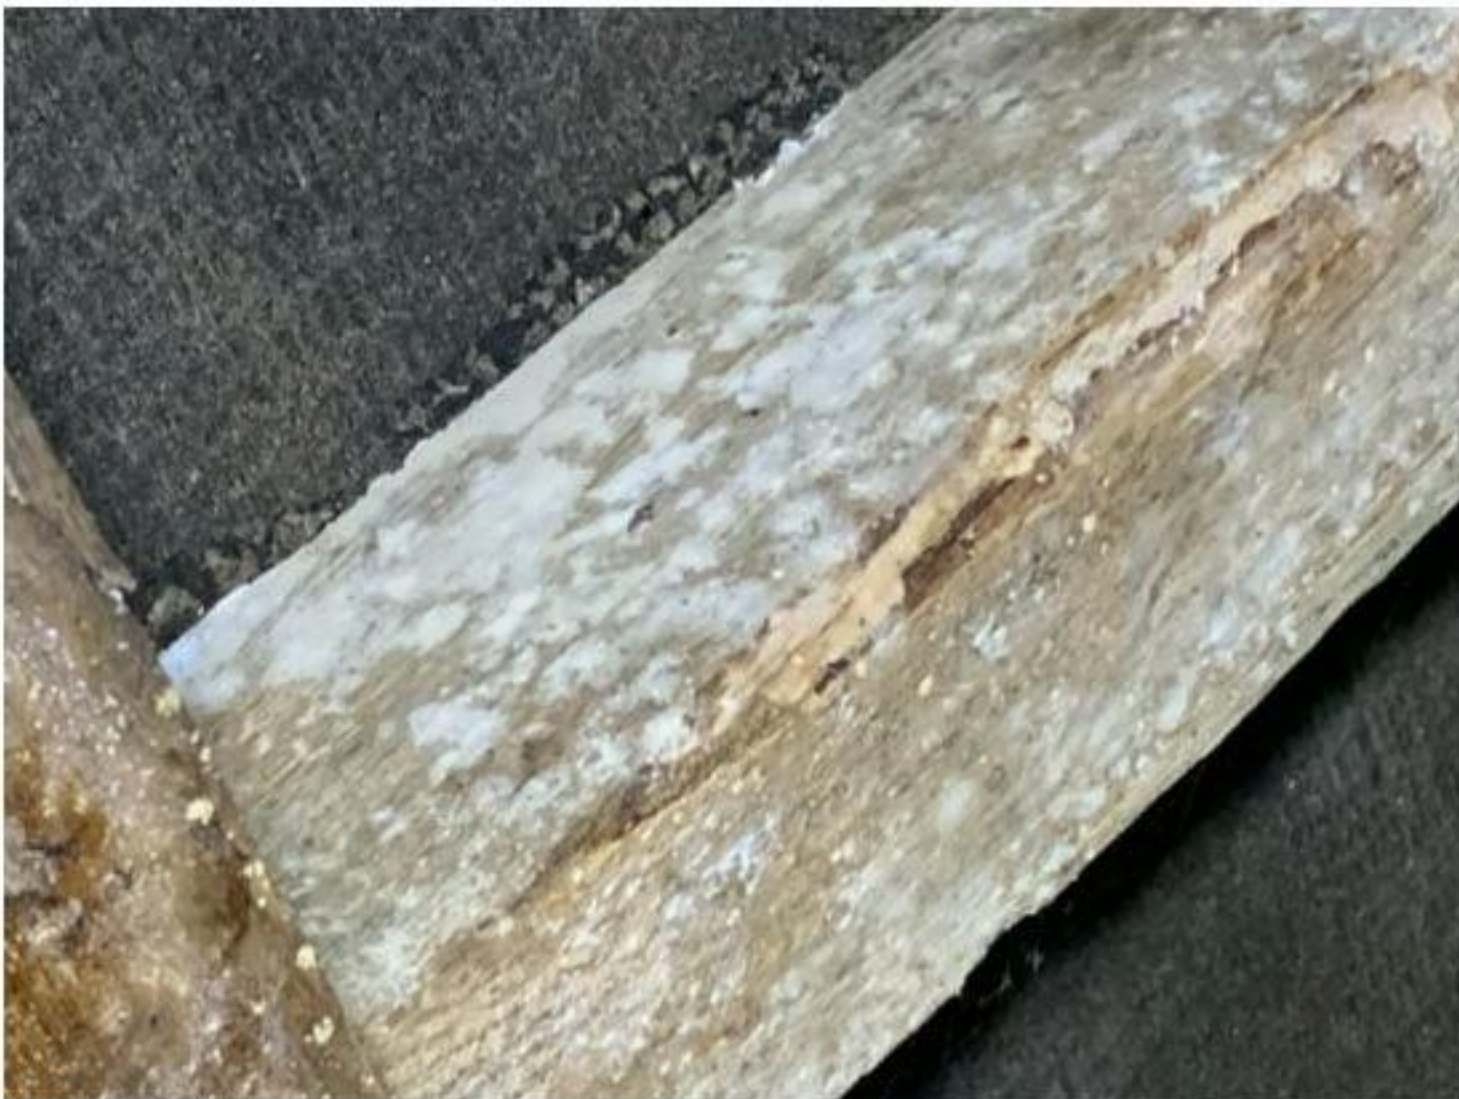
**Image 3 – close-up of the severe condensation resulting from the moisture in the roof**

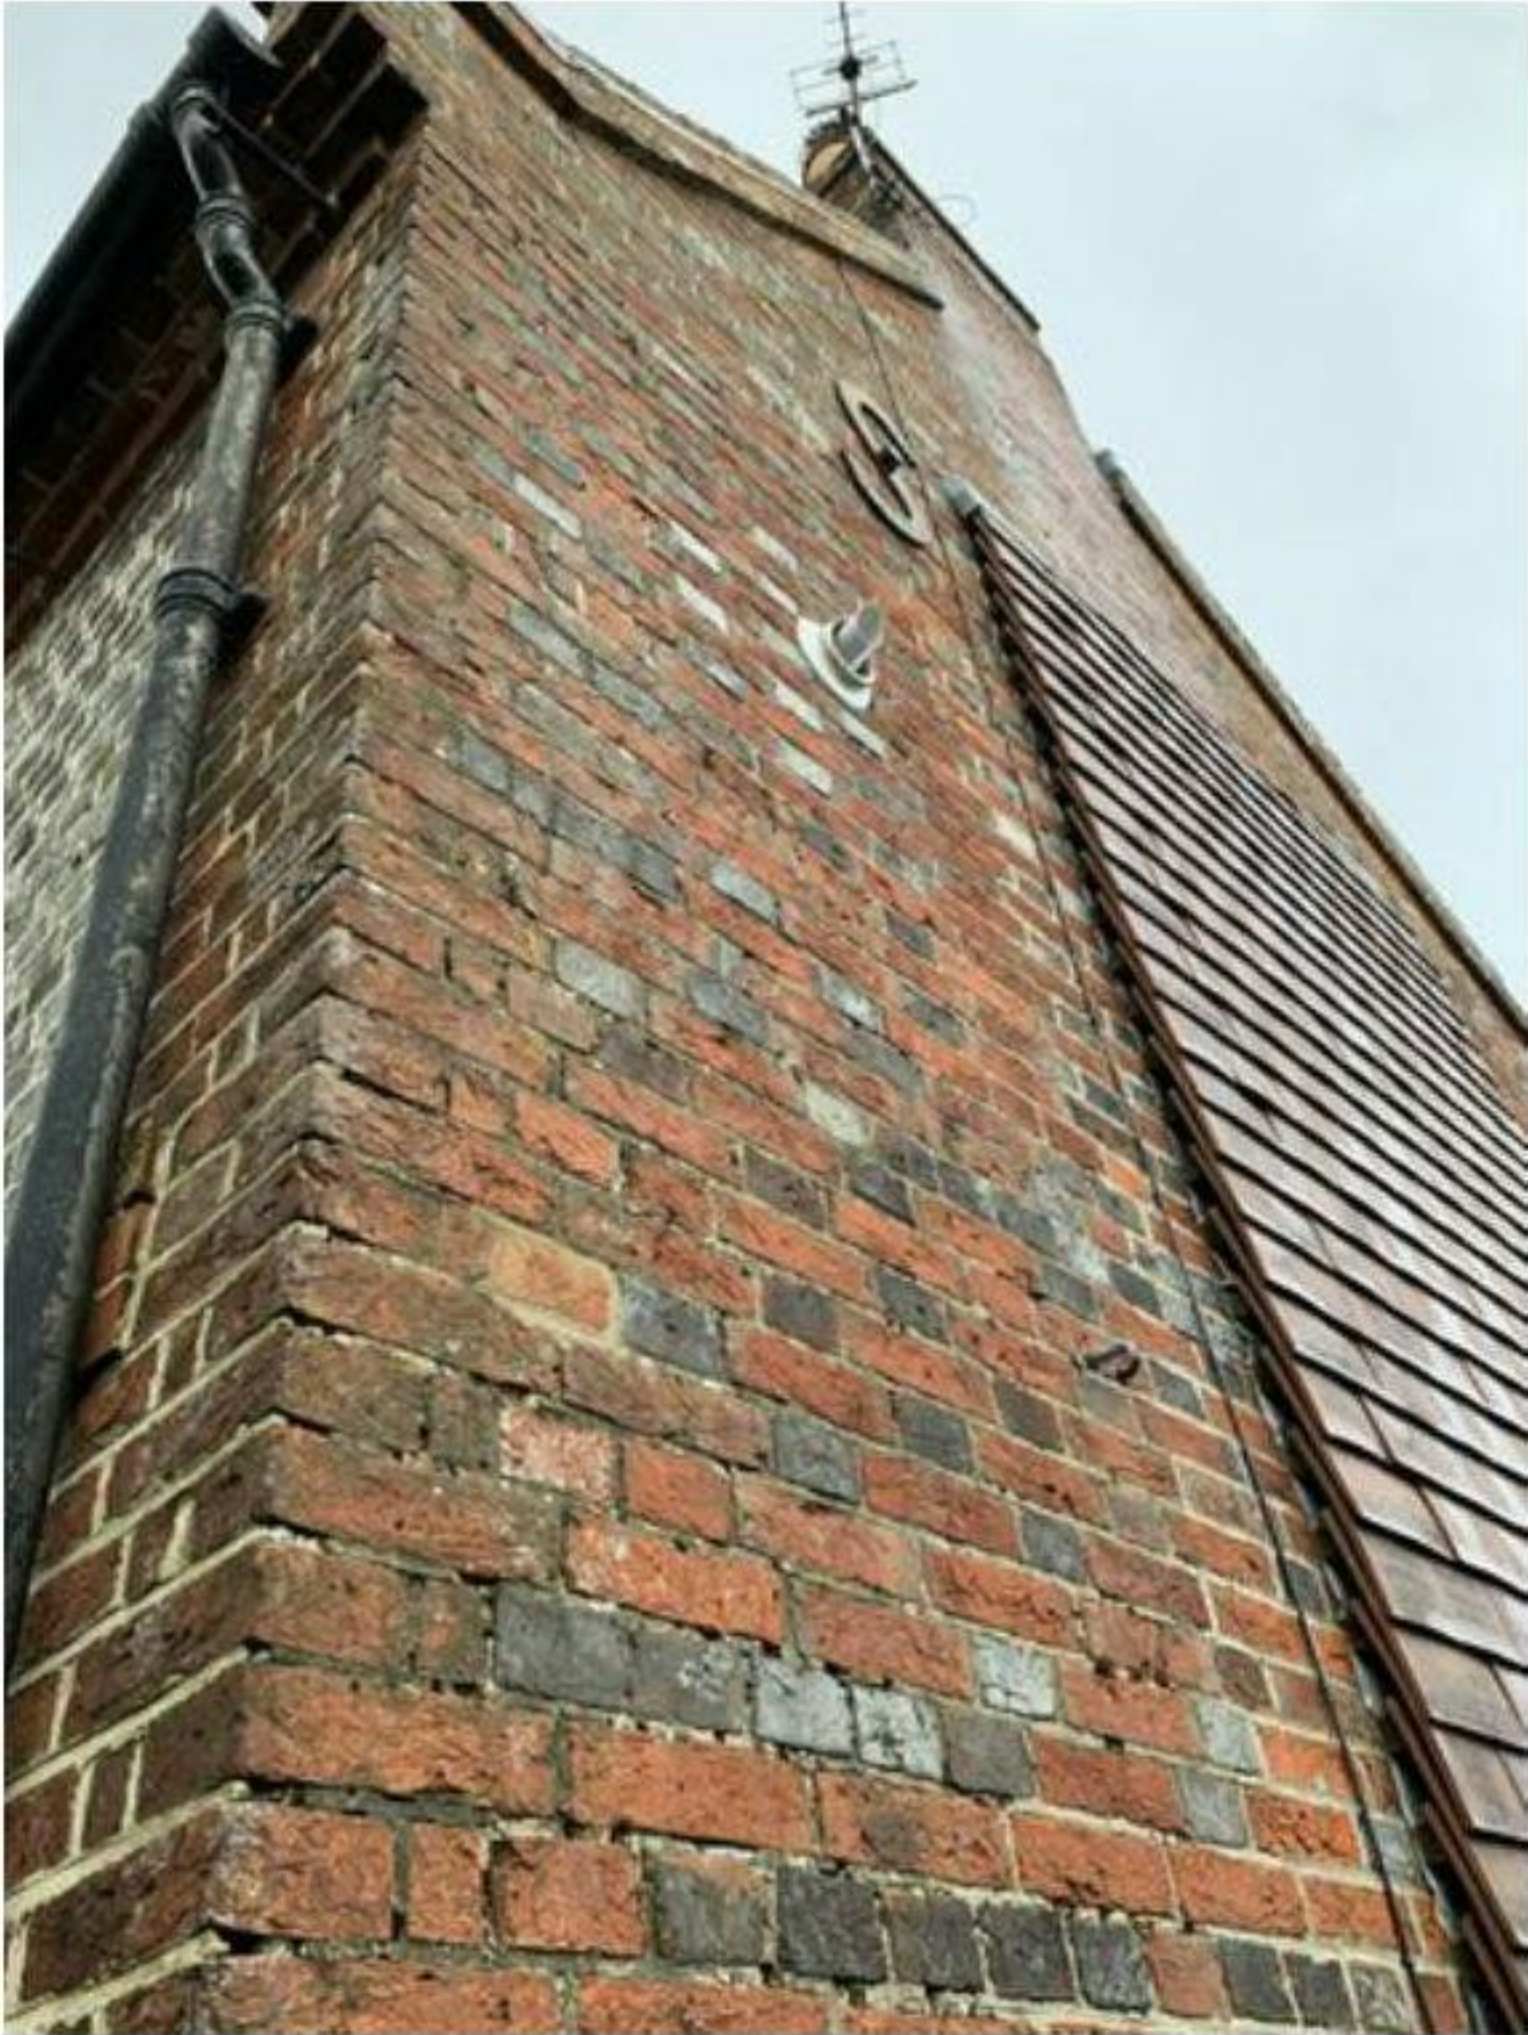
**Image 6 – existing gable wall, showing the modern tile-hanging and some repointing**

The existing tile-hanging is modern and incomplete. The new tile hanging will improve the visual appearance of the house. It will entirely prevent moisture penetration into the wall and thus remove the on-going problem.

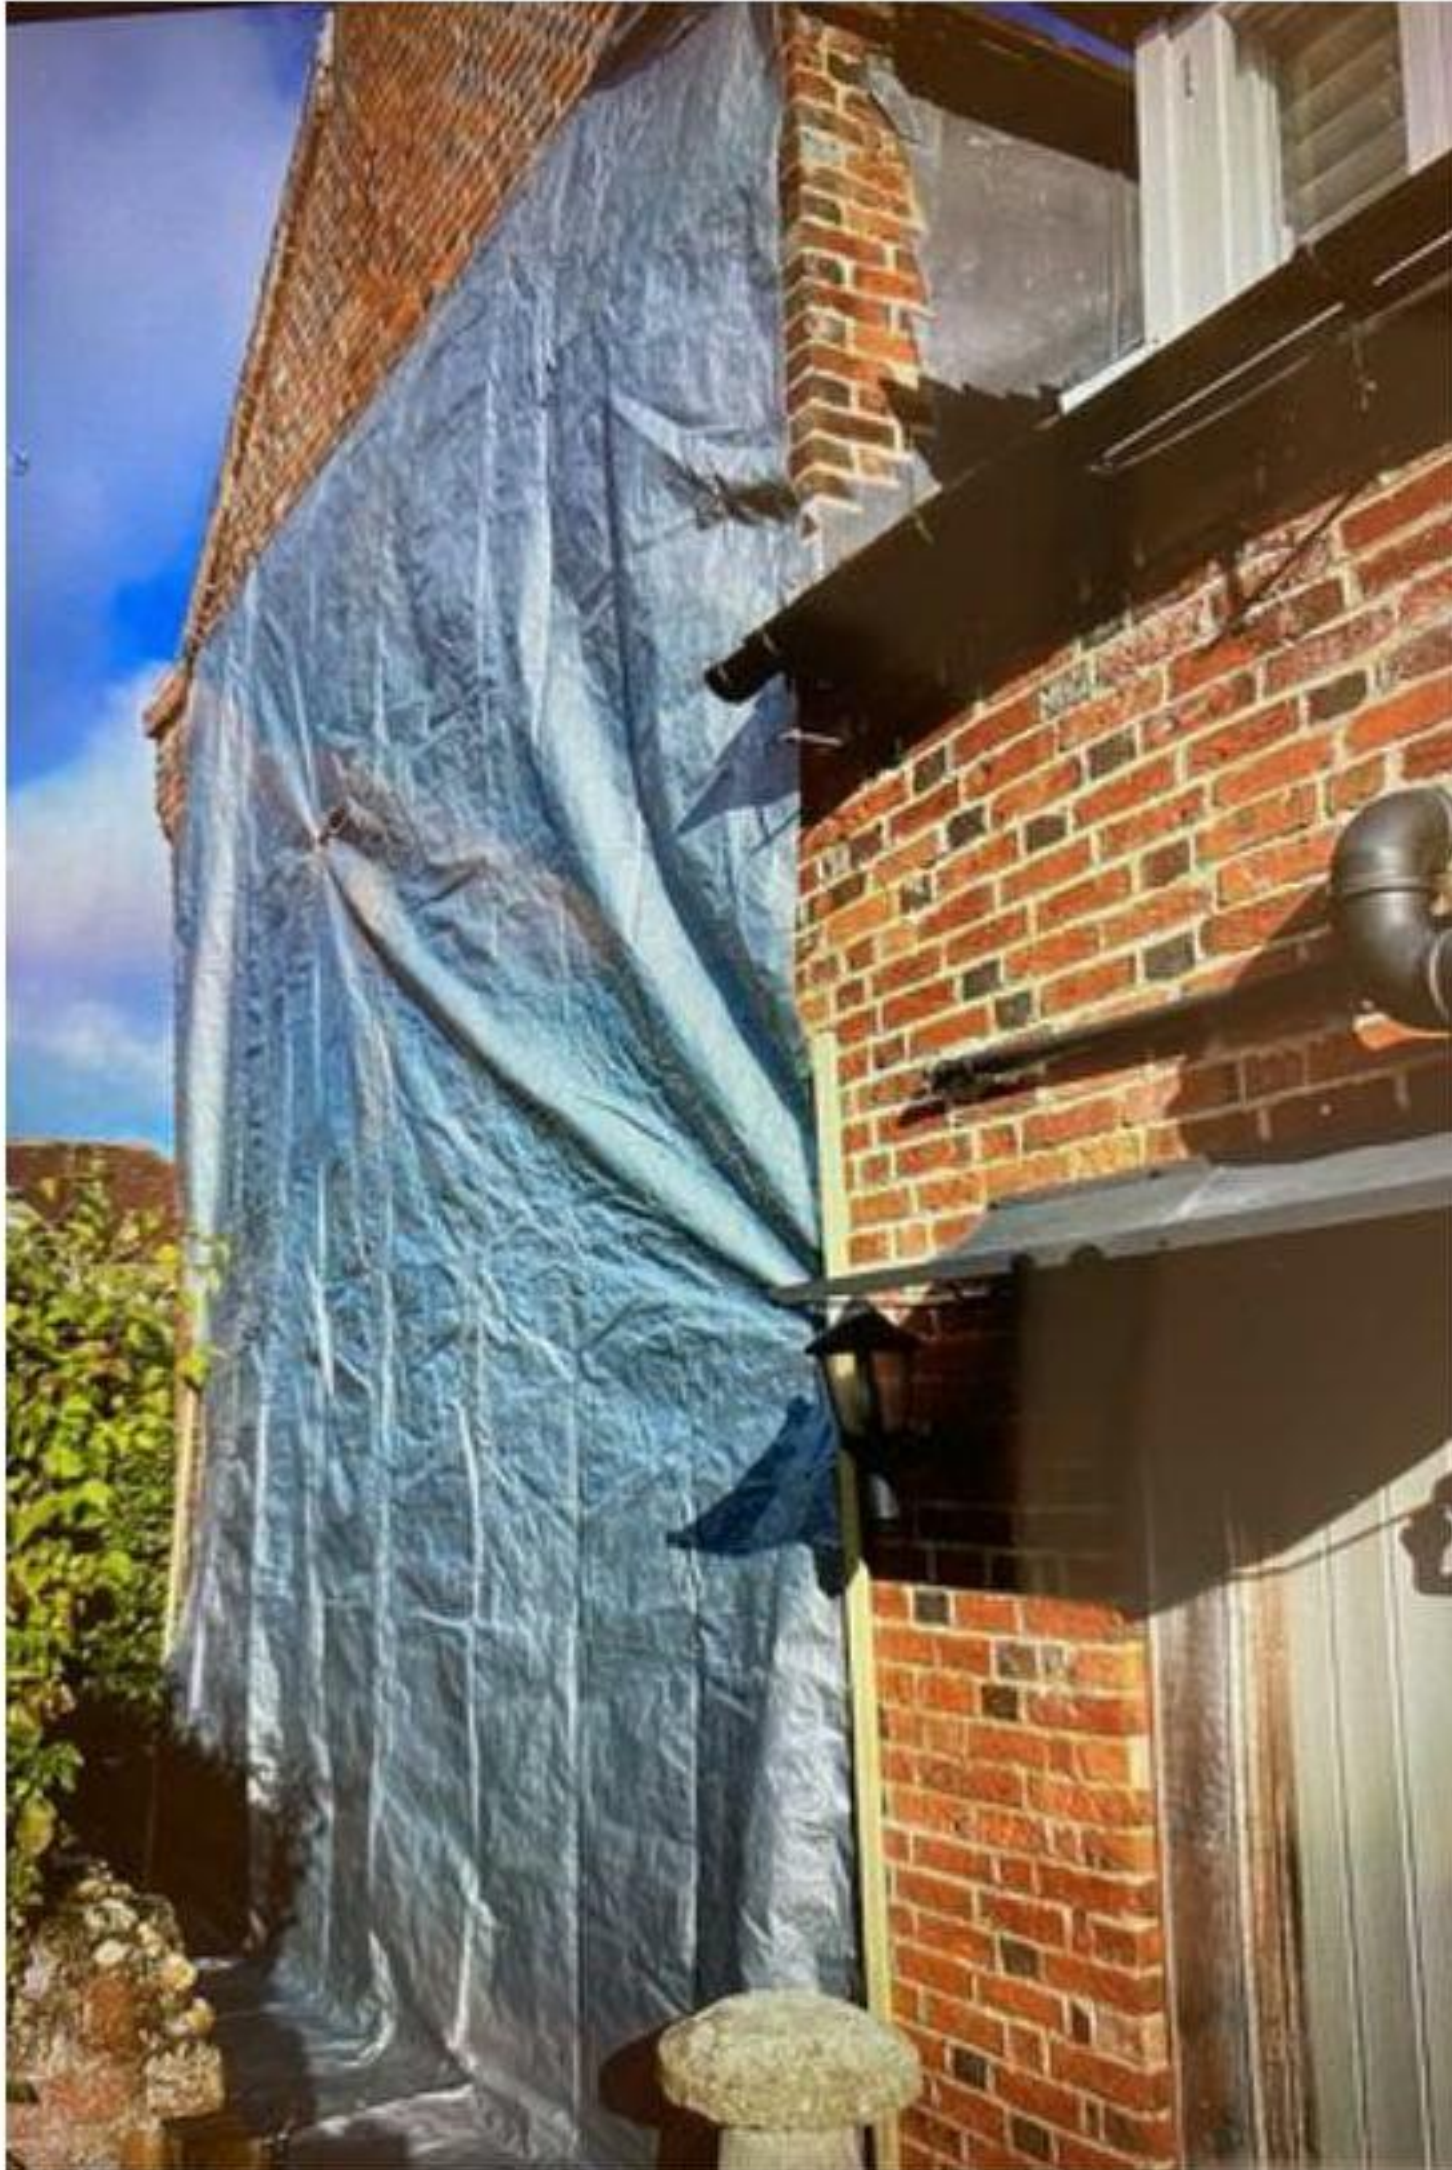
**Image 7 – an emergency effort made to prevent further moisture penetration**

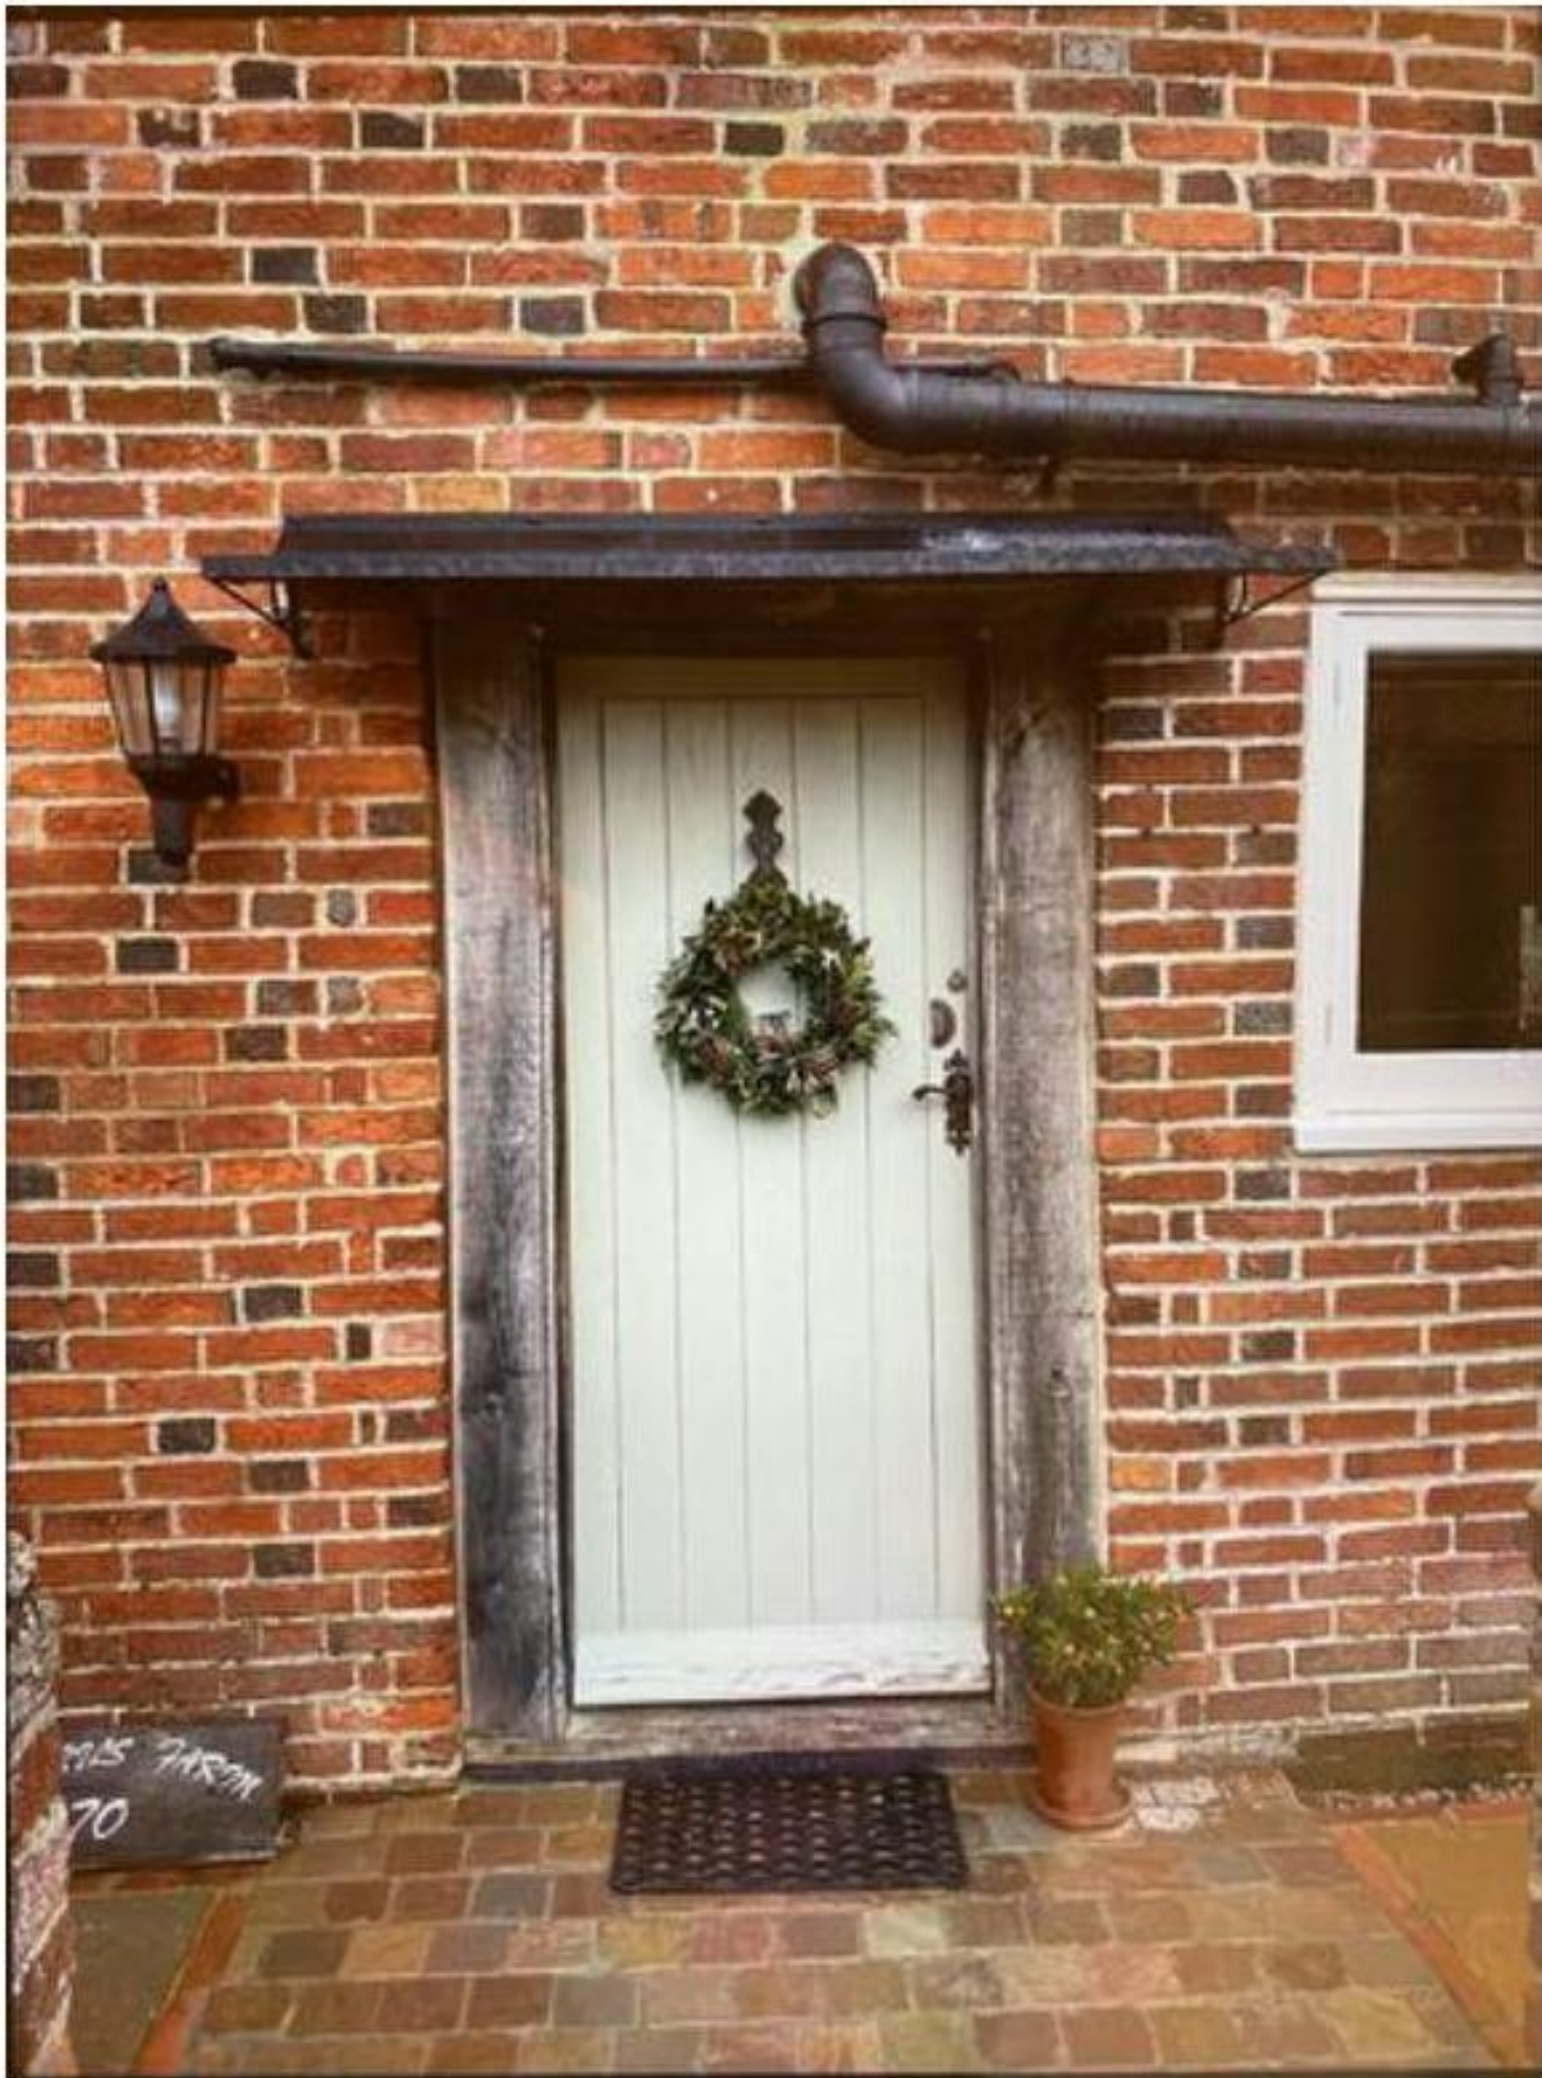
Image 8 – the existing kitchen door is subject to direct weather penetration

The rear kitchen door is equally exposed to the weather and subjected to persistent driving rain and wind.

The existing porch is small, modern design and flimsy and provides no benefit at all to the weather protection of the kitchen door. The new porch is of a sympathetic historic design commonly seen throughout Sussex and Hampshire and would not look out of place. It is an improvement to what is there is now.

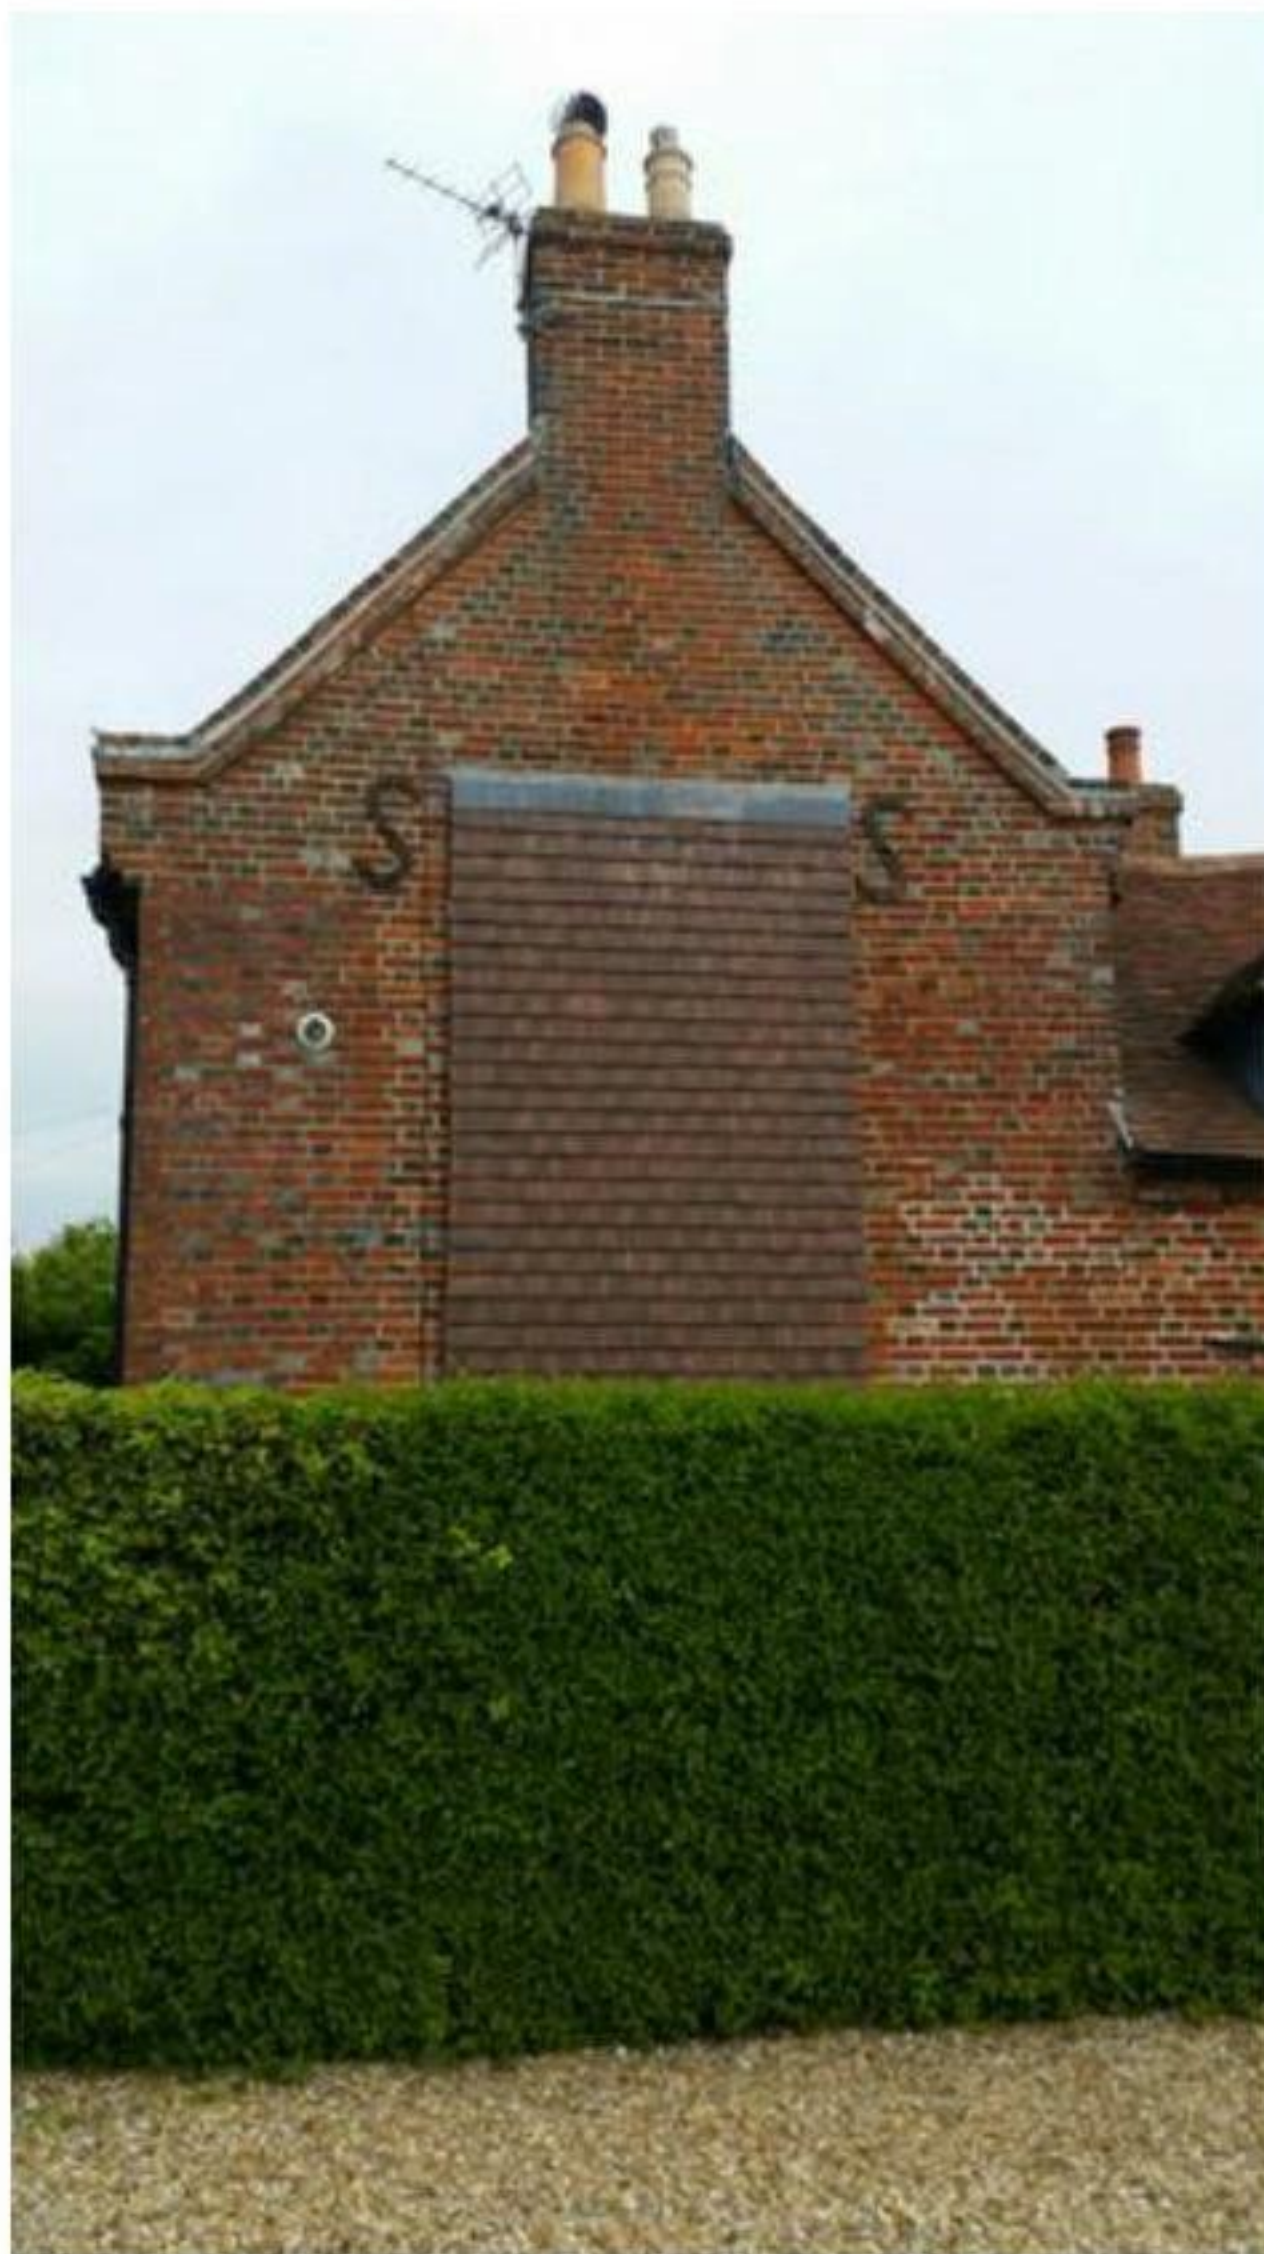
**Image 10 – existing gable wall**

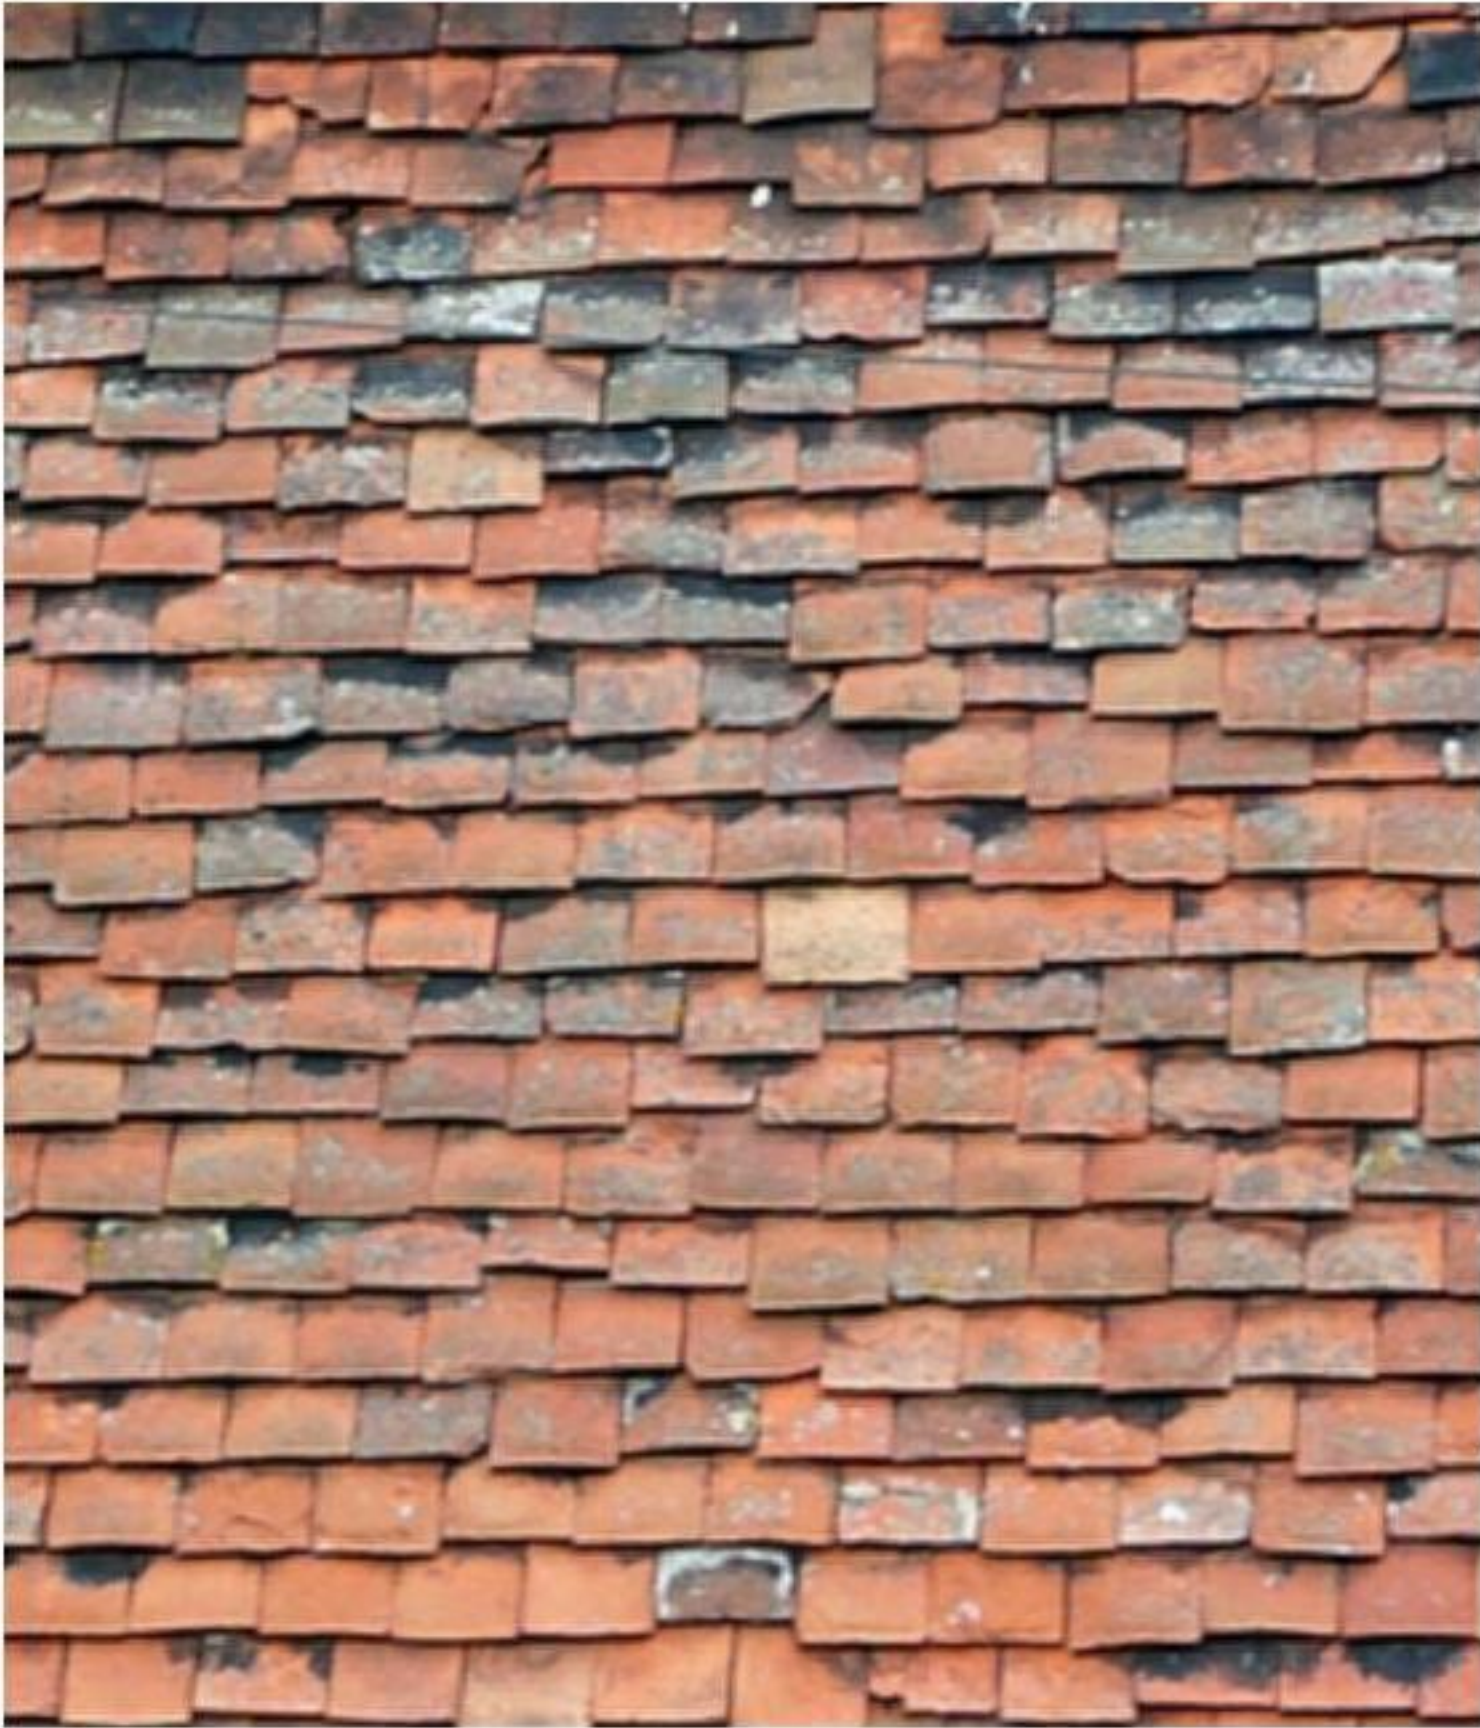
Image 12 – generic suggestion of the possible colour match

1. Tile-hanging to the gable elevations. This will use clay peg tiles on the whole elevations and will significantly improve the appearance of the building. In our view there is no harm or visual distraction from this action. A photo impression is provided. This is entirely reversible and could be removed at a later date if needed. Rainwater will safely fall to a gully and drain to the garden.
2. Construct an open gabled porch. This would replace the existing flimsy porch over the kitchen door. This is entirely removable at a later and does not require any physical alteration to the adjacent brick wall. It will have an oak frame, clay tile roof and salvaged brick plinth.
