# Preliminary Geo-Environmental Risk Assessment

Langstone Technology Park, Portsmouth

Delta-Simons Project No. 19-0687.01

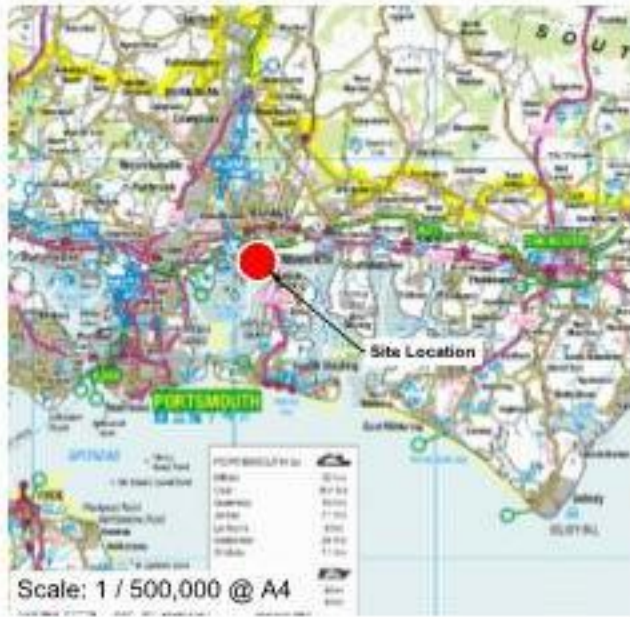
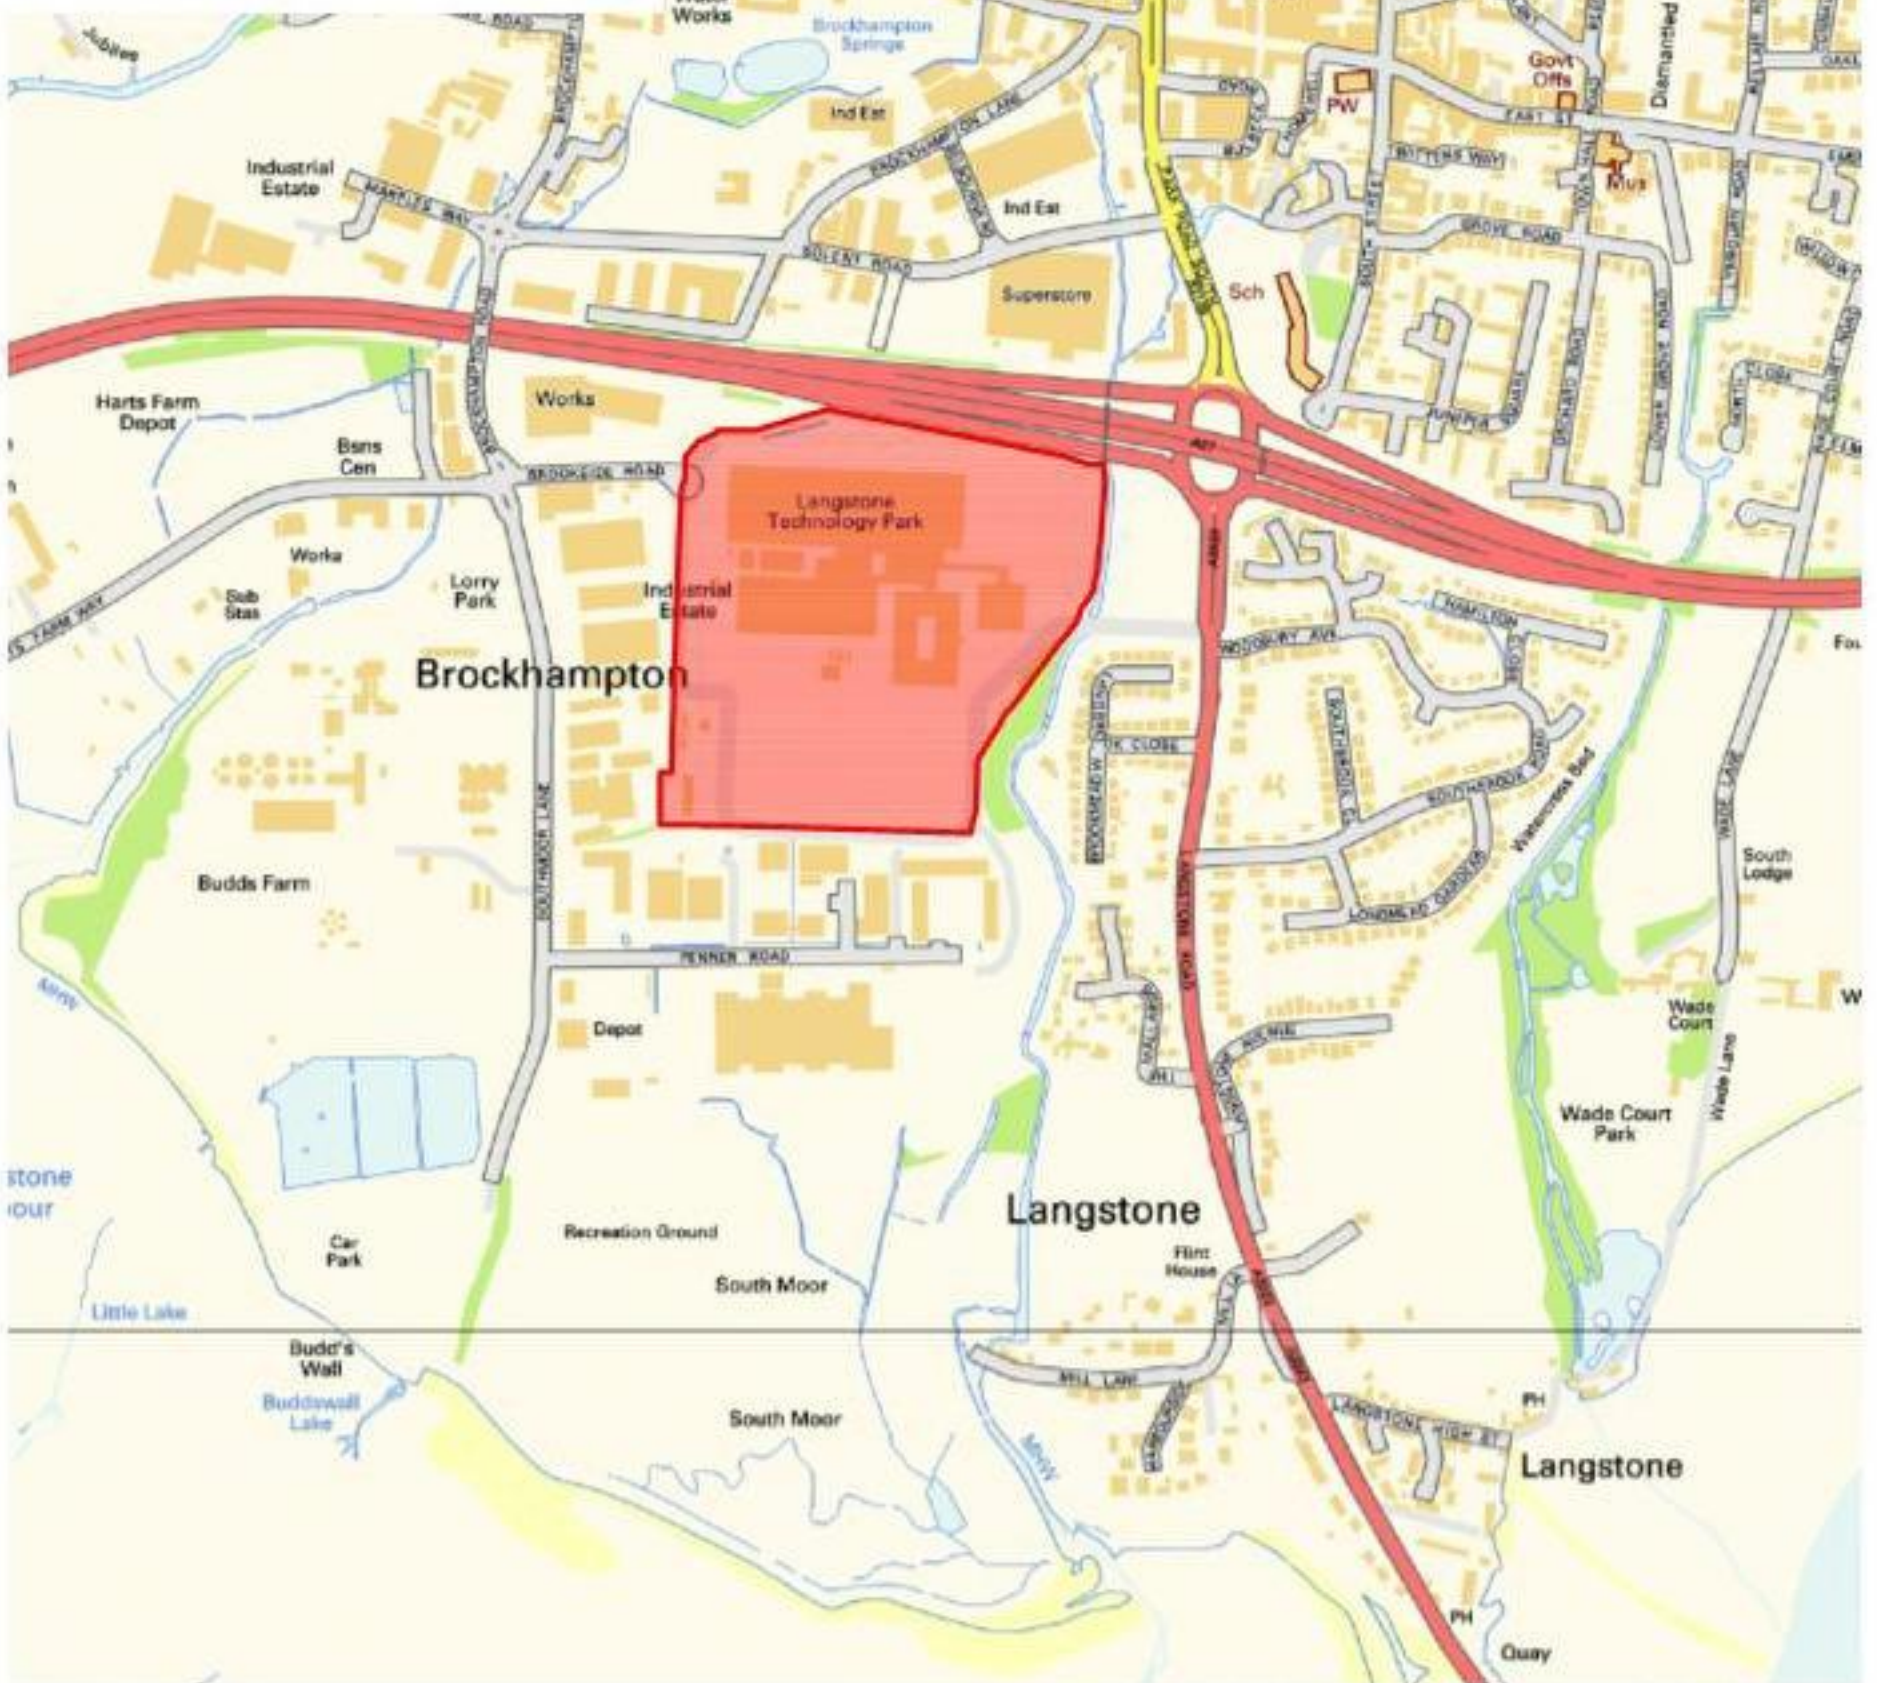
## Figure 1 – Site Location Map

| Site Location | The Site is located on the southern side of the A27, 600 m southwest of Havant town centre. A Site location map is provided as Figure 1. | | | |
