# Northern Access Road, Havant Thicket Reservoir, Havant

RSA Combined Stage 1 and 2

Portsmouth Water

November 2022

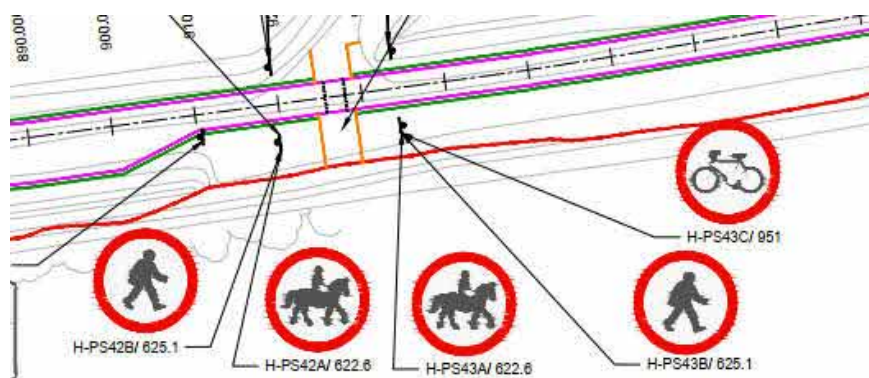
Figure 2-1 – User restriction signs

The proposals include the erection of 'no pedestrians/cyclists/horse rider' signs at either end of the track and where footpaths cross the track as shown in figure 2-1. The RSA team had concerns that these signs are not always understood by members of the public which could lead to prohibited users entering the track and being involved in a collision with a vehicle. This problem could become more pertinent during construction where pedestrians and cyclists may not be seen by drivers of large construction vehicles and may be less aware of vehicular traffic due to the irregularity of traffic using the route. Existing cycle route signs mounted on timber posts along the track indicate that it is currently used by cyclists.

Although supplementary plates are not prescribed by the TSRGD it is recommended that sub plates such as 'no pedestrians' etc are installed alongside the prescribed signs to inform the public of the prohibitions. It is also recommended that existing cycle route signs on timber posts are removed.

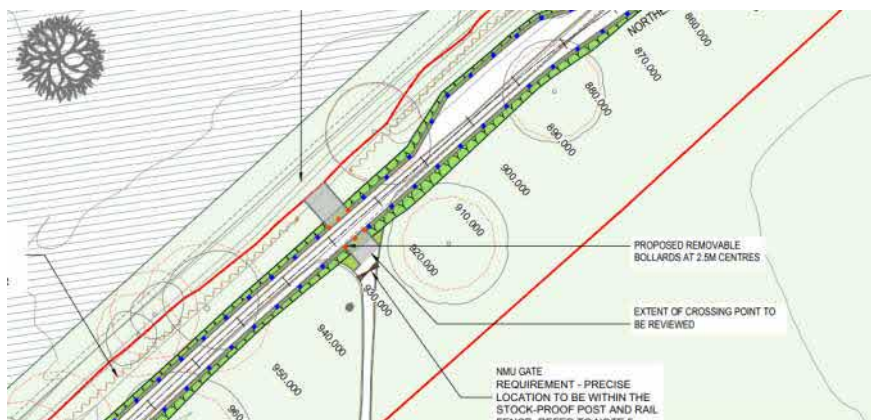
**Figure 2-2 – Trees adjacent to crossing point**

A pedestrian crossing point is provided along the track where the footpath emerges from the wooded area. Tree planting is proposed on both sides of the track on either side of the crossing as illustrated in Figure 2-2. Trees with low hanging branches could obstruct intervisibility between pedestrians using the crossing and approaching drivers leading to a pedestrian stepping out into the path of a vehicle and collision occurring.

It is recommended that pedestrian visibility splays at the crossing points are shown on drawings and that these are kept clear of vegetation and tree branches.

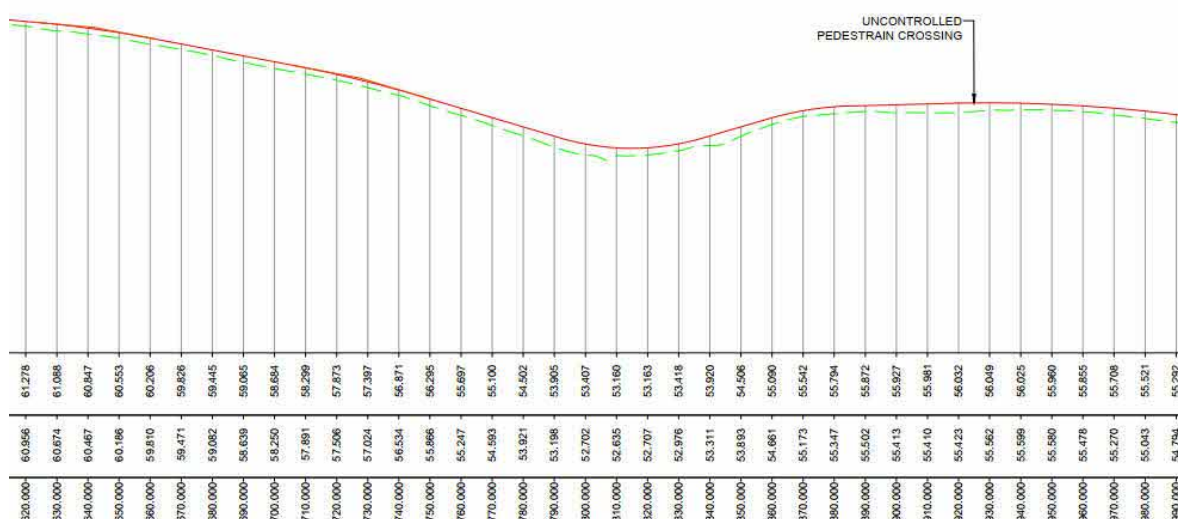
**Figure 2-3 – Vertical alignment on crossing approach**

The proposals include a single track with passing places to accommodate two-way traffic which will be subject to a 20mph speed limit. The vertical alignment of the track is such that there are relatively steep gradients at two locations. One of the steep gradients lies on the southbound approach to the proposed uncontrolled crossing as shown in Figure 2-3. The RSA team had concerns that downhill gradients may reduce speed limit compliance with vehicles travelling at higher speeds than 20mph and increase the risk of head-on collisions with oncoming traffic and collisions with pedestrians at the crossing points.

It should be noted that TAL 02/04 which case studies a similar single track layout indicates that, although the track was subject to a 20mph speed limit, average vehicle speeds were at least 5mph above the posted speed limit.

The RSA Team had further concerns that inappropriate speed on the bend in the track at Ch 820 could lead to loss of control collisions.

It is recommended that traffic calming measures are introduced to encourage speed limit compliance.

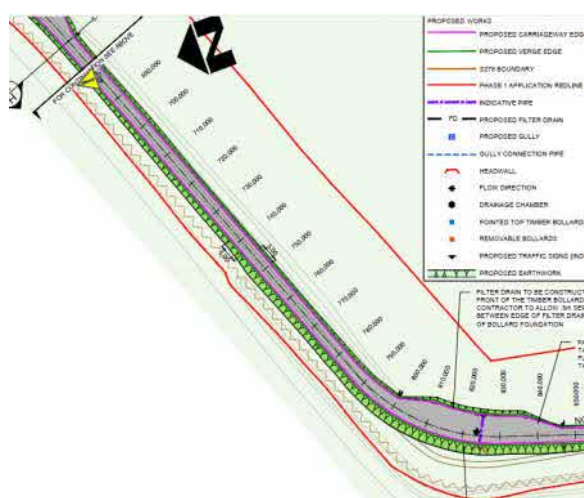
Figure 2-4 – Passing place spacing

Passing bays are proposed at intervals along the access road to facilitate two-way traffic movements. A 150m stretch of single track has been identified with no passing places between Ch 660 and 810 as illustrated in Figure 2-4. TAL 02/04 recommends a distance of no more than 60m between passing places. This section also lies on a downhill gradient for southbound traffic.

The RSA team had concerns that southbound drivers may be reluctant to wait in the passing bay at Ch 660 to allow for a northbound vehicle to travel 150m, particularly as they will be gathering momentum on the downhill gradient. This could result in northbound vehicles being forced to reverse back along the track to allow a southbound vehicle to enter the passing place at Ch 810. Reversing manoeuvres along the track would increase the risk of collisions with following vehicles.

It is recommended that an additional passing place is provided between Ch 660 and Ch 810.

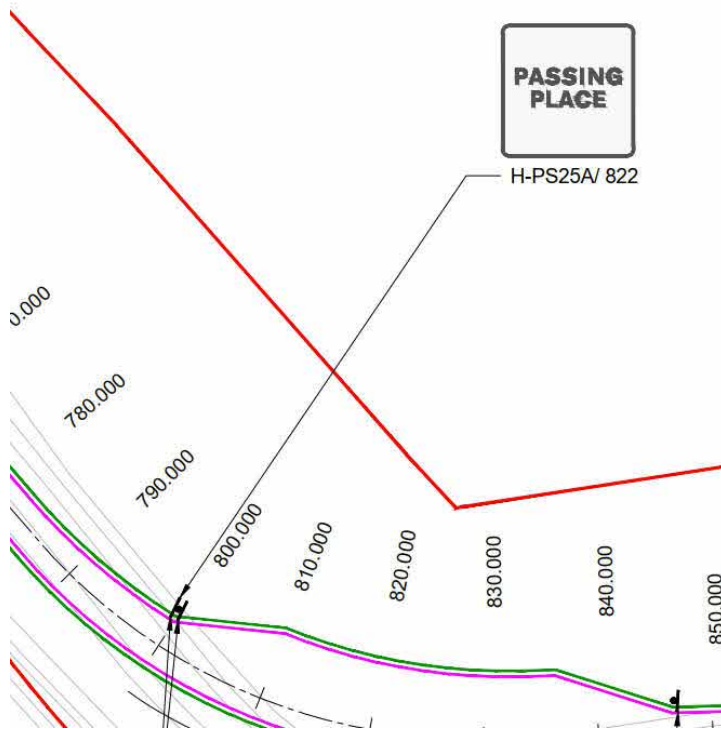
Figure 2-5 – Sign positioning at passing bay

Passing bay signs are proposed at the change in kerb direction on the entry and exit tapers of the passing places. An example of this is provided in Figure 2-5. The swept path of an HGV is shown to pass very close to the signs at each passing place. Inadequate clearance between the signs and a large vehicle with lateral overhang could lead to sign strikes.

It is recommended that sufficient clearance is provided between the signs and the edge of carriageway.

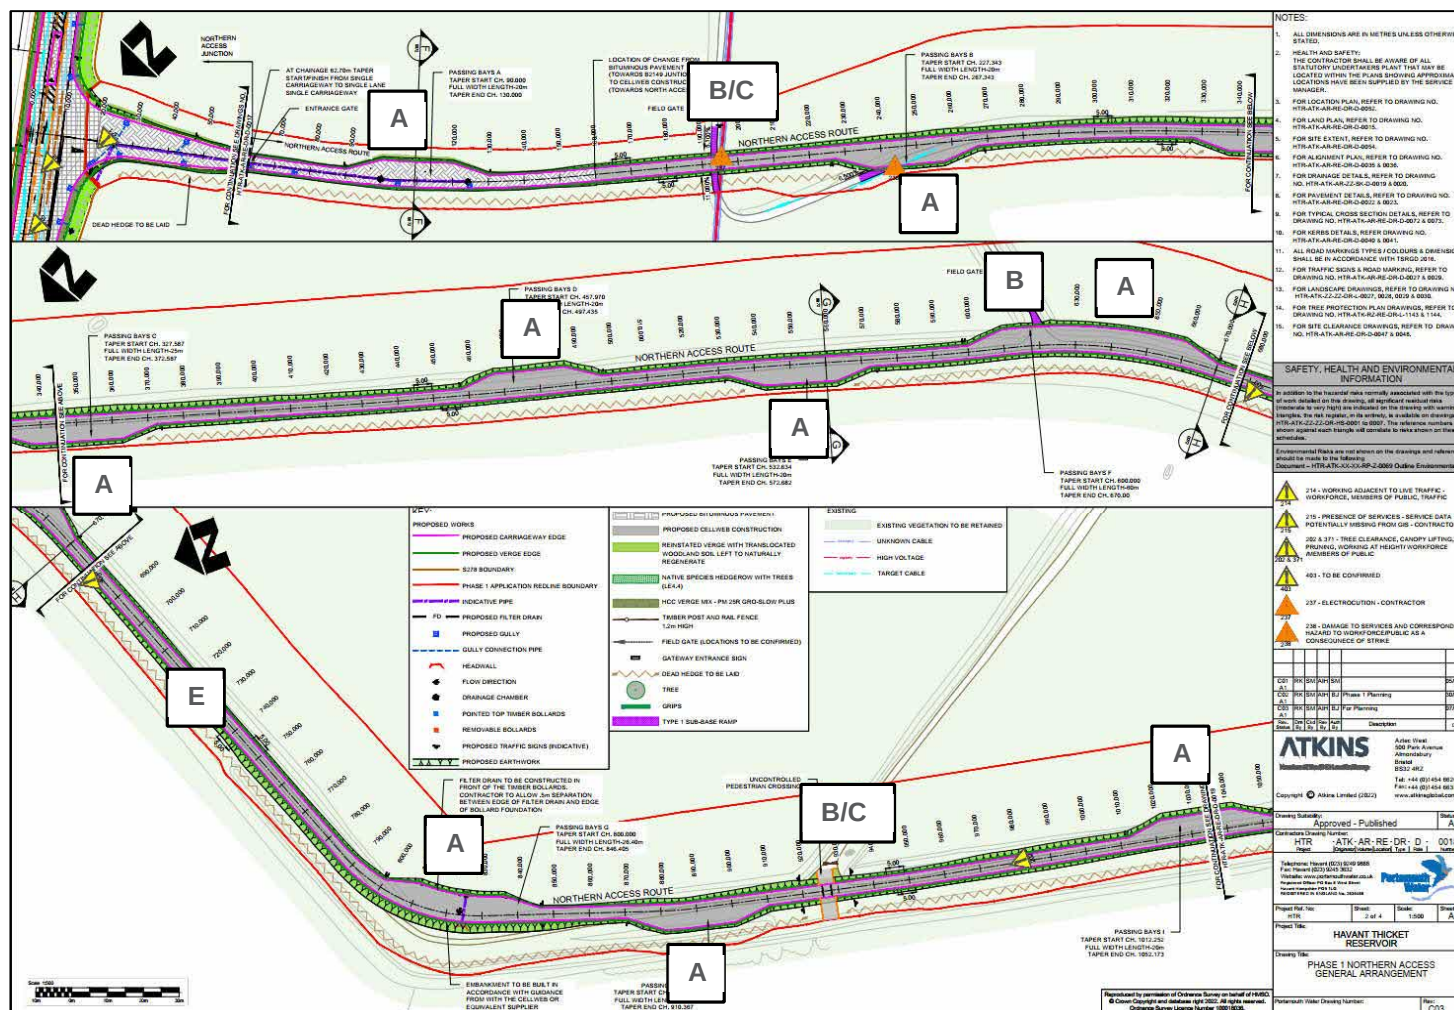
Figure B-1 –Northern Access Road problem location plan Sheet 1

The plan below indicates the location of the problems raised in Section 2 of this combined stage 1 and 2 RSA. The drawing used is not necessarily the source from which the problems have been identified. The plan is not intended to indicate the precise location of the collision risks nor of any recommended remedial actions.
