# PHASE 2 GROUND INVESTIGATION

Lidl Great Britain Ltd  
Purbrook Way, Havant

Client: Lidl Great Britain Limited

770.03.02  
January 2024

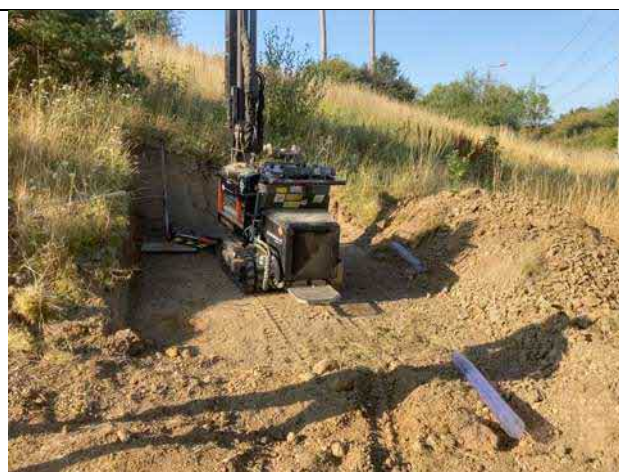
Slope levelled to enable window sampler at WS1. The ground level at the window sample position was reduced by approximately 1m.

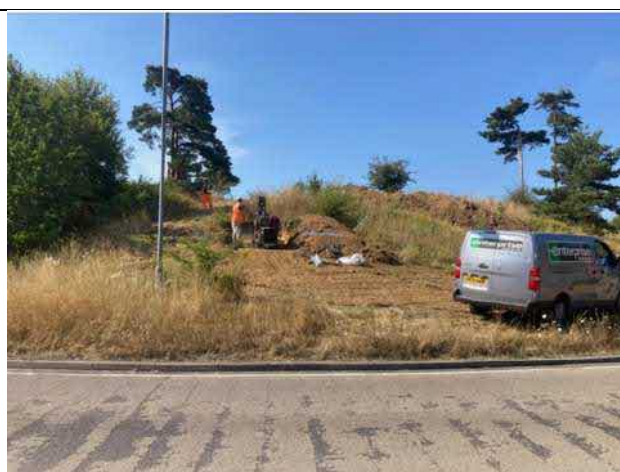
Slope levelled to enable window sampler at WS5. A ramp was formed to the right of WS5 to enable access to exploratory positions at the top of the fill.

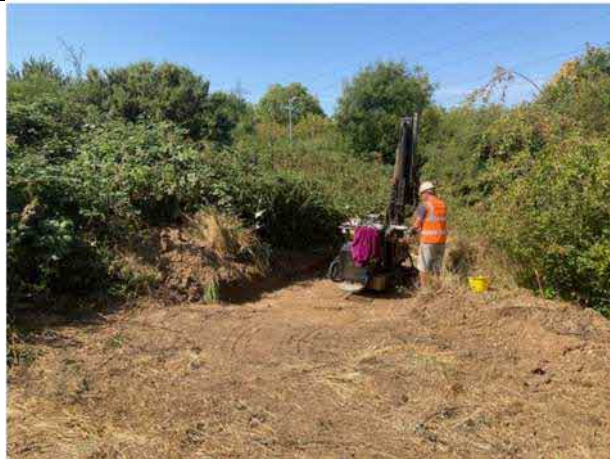
Vegetation clearance to give access to WS2

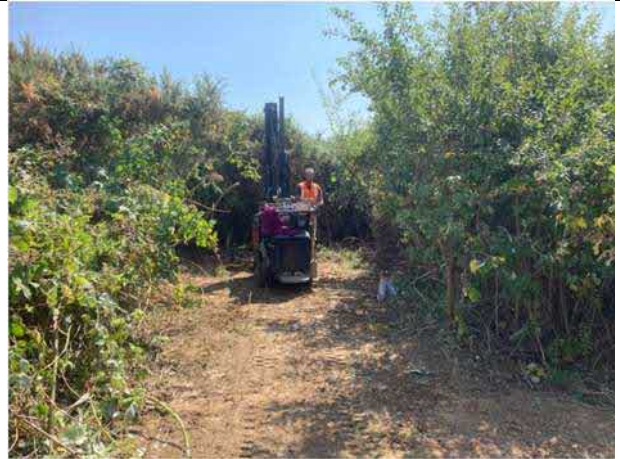
Vegetation cleared to give access to WS3

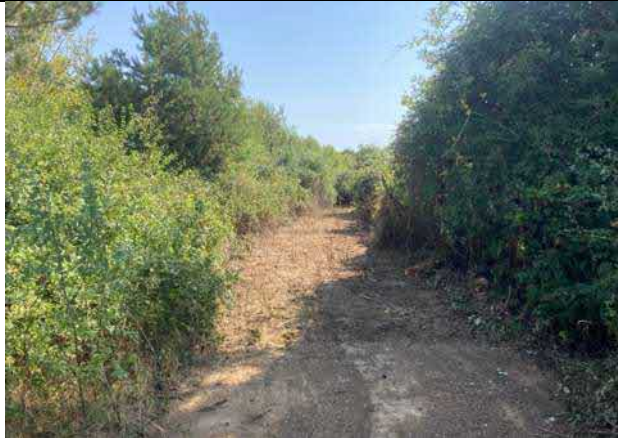
Access route through cleared vegetation to  
Cabletool Holes (CP1 & CP2)

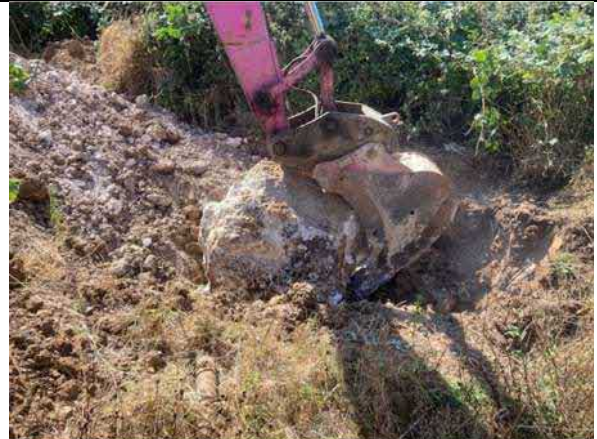
Concrete obstruction being removed from location  
of WS2

At WS02 a hydrocarbon odour was observed within the orange/brown grey clay fill material between 1.0m and 2.75m bgl. The fill material contained boulders of concrete and kerbstones that prevent percussive drilling but there were no visible indicators of contamination including asbestos with the made ground.

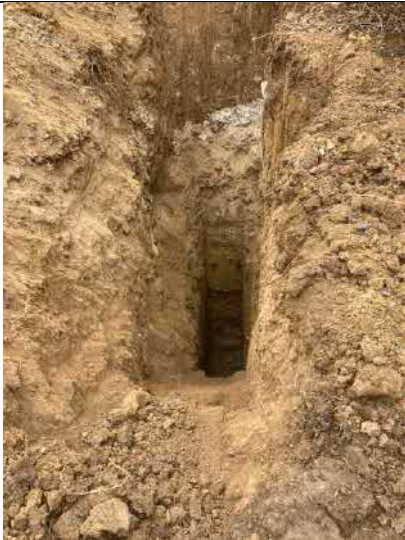
Location of CP3 following excavation of concrete  
obstruction

Made Ground was observed at all exploratory locations as firm to stiff orange/brown grey slightly gravelly clay to a maximum depth of 5.0m in CP1 and CP2 beneath the store footprint. At CP3A and CP3B the fill material contained concrete boulders and concrete kerbstones that were removed by excavator and the exploratory hole was advanced as a trial pit.

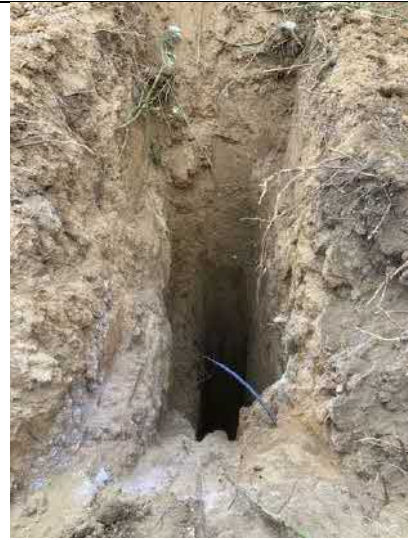
Location of WS3 following excavation of concrete  
obstruction
