FOREMAN HOMES

LAND AT KINGSCROFT FARM, MEYRICK ROAD  
HAVANT  
PO9 1NX

FLOOD RISK ASSESSMENT  
& DRAINAGE STRATEGY

REPORT REF NO. 2200510-01  
PROJECT NO. 2200510  
JUNE 2022

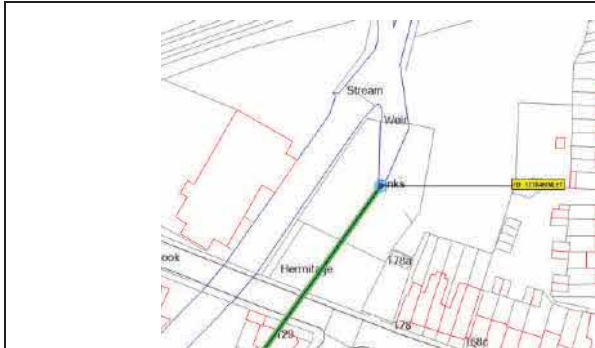
LOCATION SKETCH -

- TRASH SCREEN IN PLACE

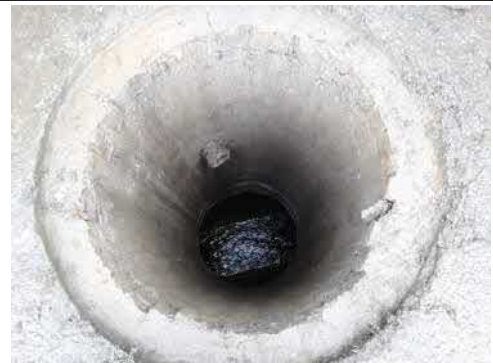
INTERNAL IMAGE -

| STRUCTURAL CONDITION | - | MAINTENANCE CONDITION | - | DEPTH OF FLOW (mm) | 100 | DEPTH OF SILT (mm) | - | HEIGHT SURCH (mm) | - | COVER LEVEL (m AD) | - |

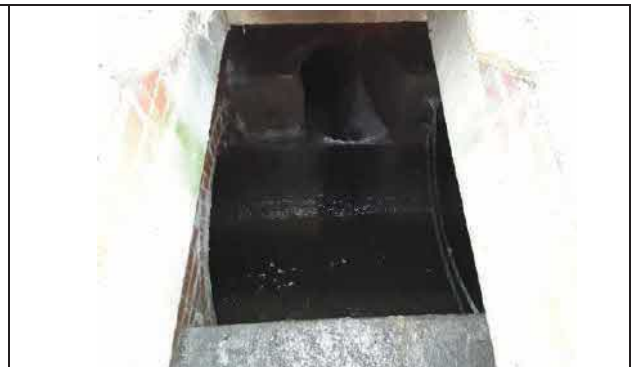
INTERNAL IMAGE -

| STRUCTURAL CONDITION | - | MAINTENANCE CONDITION | - | DEPTH OF FLOW (mm) | 100 | DEPTH OF SILT (mm) | 0 | HEIGHT SURCH (mm) | - | COVER LEVEL (m AD) | - |

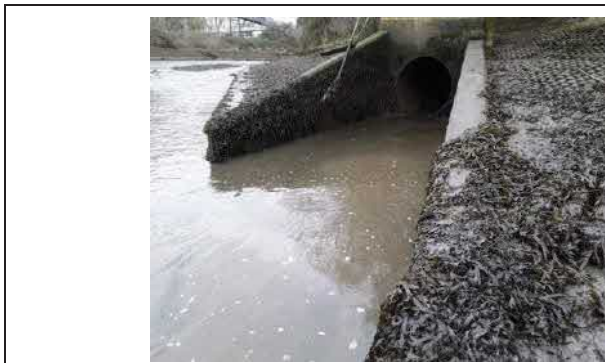
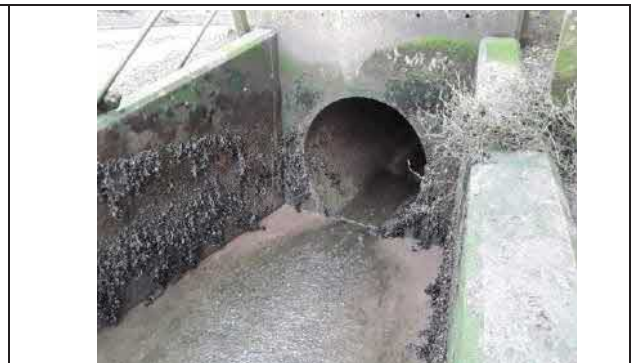
REMARKS  
HEADWALL CRACKED ABOVE CROWN OF PIPE. CRACKS AT BOTH WING WALL AT POINT WHERE THEY MEET HEADWALL

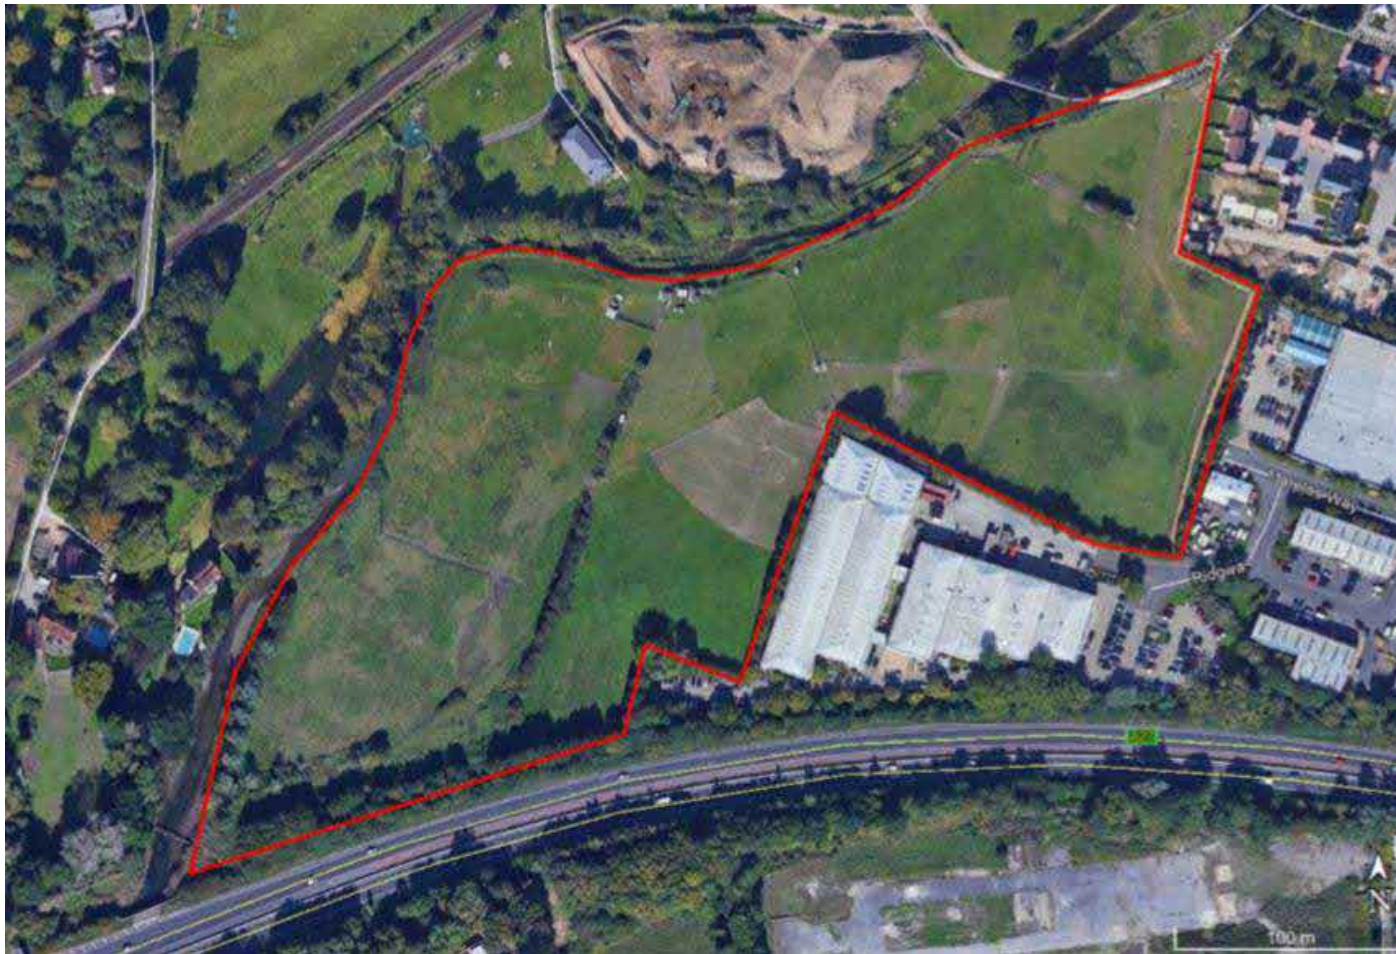
**Figure 2 – Aerial Photograph**

Vegetation was noted the site boundaries comprising mature trees and shrubs. The site was generally flat lying with a gentle slope to the southwest and was predominantly covered in grass.

An aerial photograph has been included in Figure 2.
