# Flood Map for Planning (Rivers and Sea) - Centred on 178a West Street, Havant - Created on 27 August 2019

Our Ref.: 18075/FLR Rev 1.01

**Re: The Burrows, West Street, Bedhampton, Havant, Hampshire PO9 1LG**

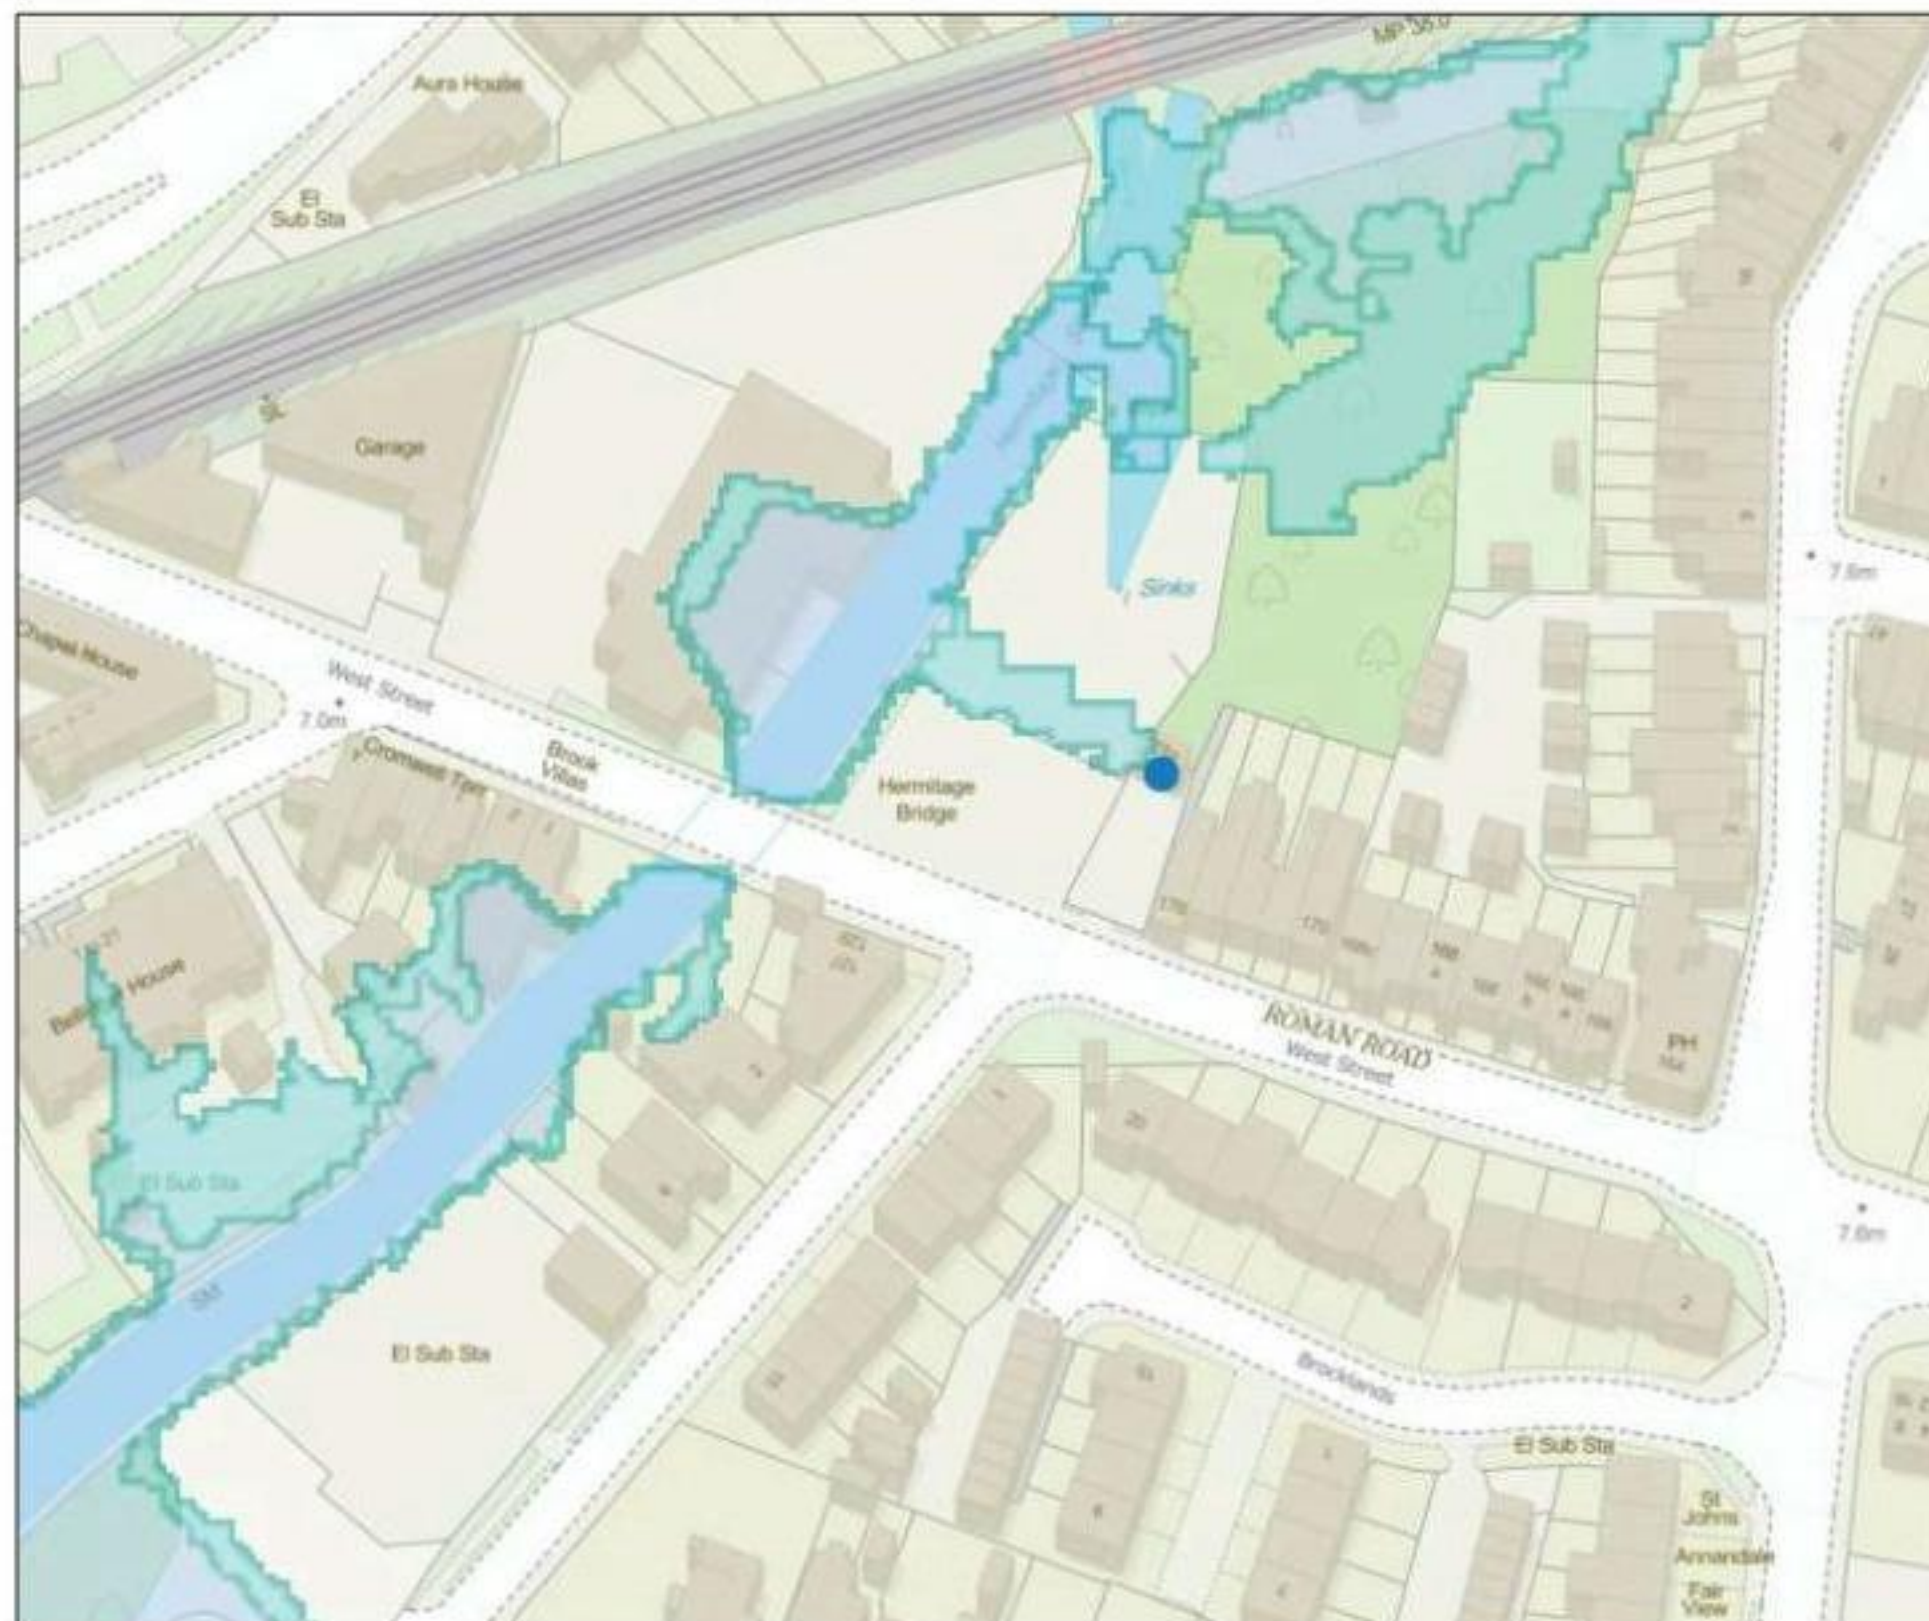
**Flood Zone 3** shows the area that could be affected by flooding:

- from the sea with a 1 in 200 or greater chance of happening each year
- or from a river with a 1 in 100 or greater chance of happening each year.

**Flood Zone 2** shows the extent of an extreme flood from rivers or the sea with up to a 1 in 1000 chance of occurring each year.

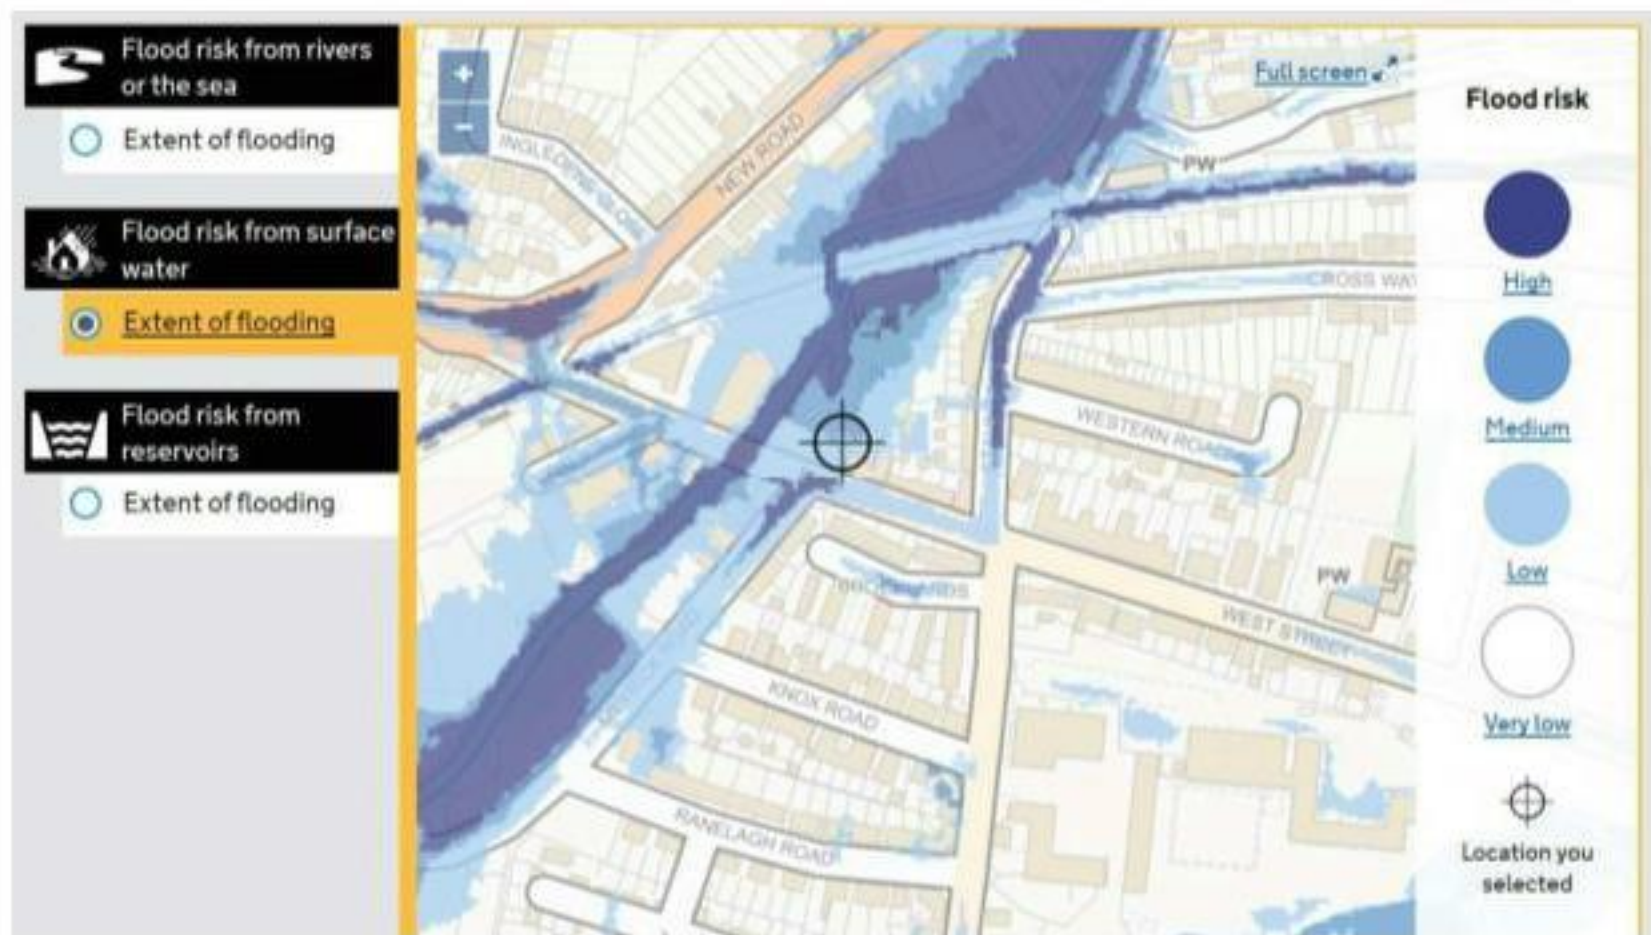
Low Surface water flood risk to front of site

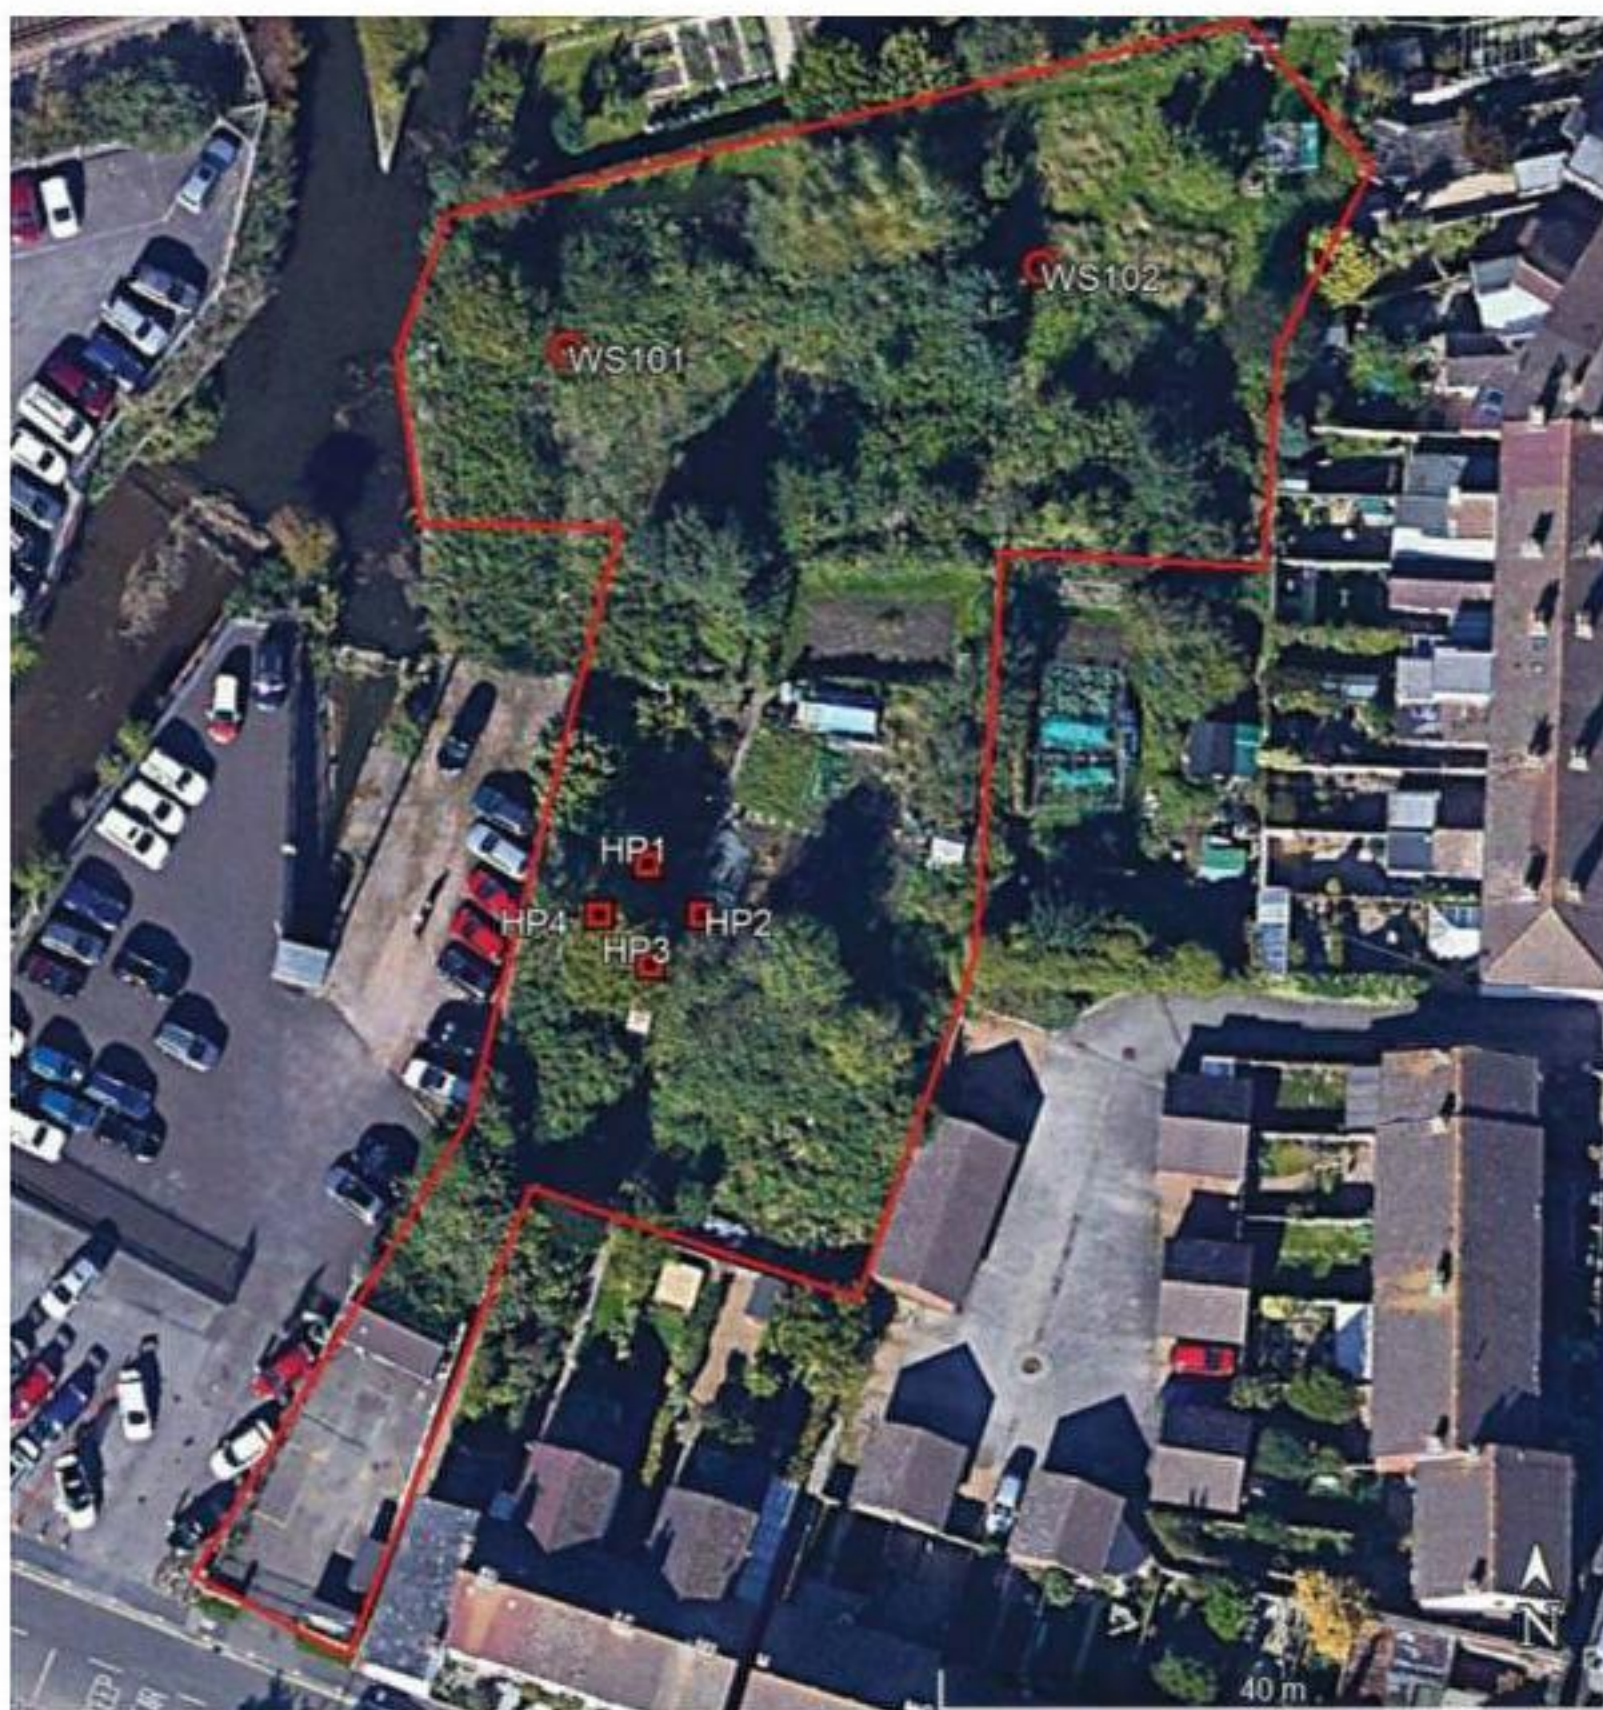
**Figure number**  
1

**Title**  
Trial Hole Location Plan

Four trial pits (HDP1 – HDP4) were hand excavated each to a depth of 0.80m bgl around WS3 location (from main investigation) to delineate a potential lead hot-spot contamination.

Approximate locations of the trial holes have been included as Figure 1.
