# Technical Note on major Safety Hazards arising from shared surface between 2 blind bends in Lower Road

**Land south of Lower Road, Old Bedhampton Conservation Area, Havant**

**Development of 50 new dwellings together with access, landscaping and open space. HBC Ref APP/20/01031 and *Safety of Life concerns on blind triple bend sole access route***

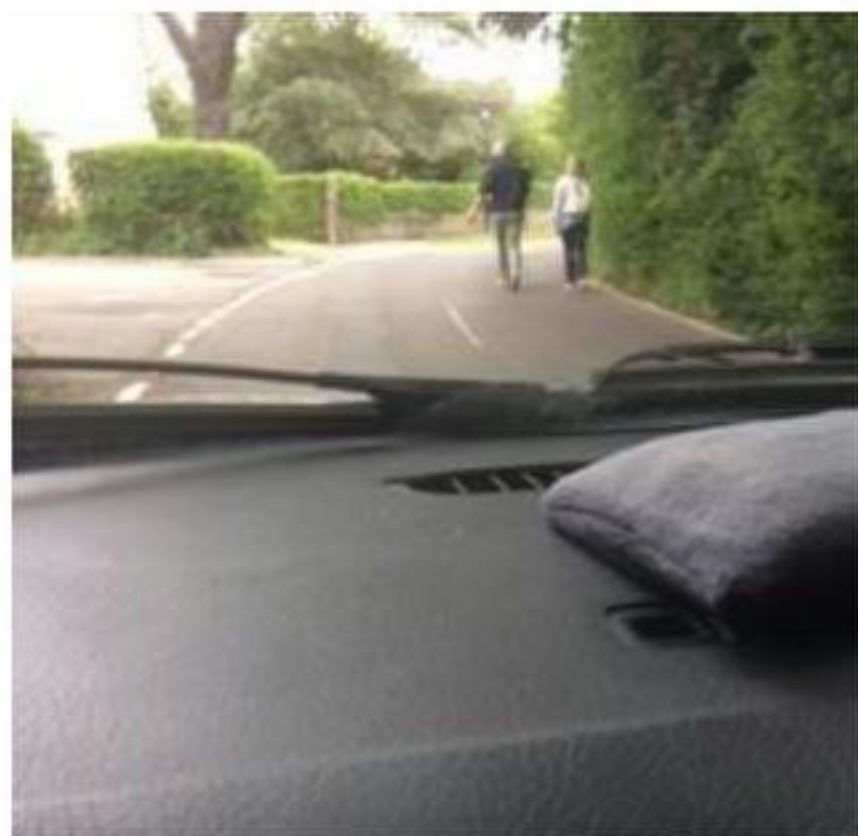
**Fig 1** Photo of pedestrians walking northwards on the **eastern** side around the blind bend.

**Discussion of Fig 1 and safety of life implications :** This photo was taken by the first author on 15th June 2019 at 11:00am from the passenger seat of my wife's car travelling northbound on the shared surface road section of Lower Road where there is no footway. Two pedestrians are clearly visible walking along the eastern side of the road towards the blind bend. The significance of this image is that any oncoming southbound vehicles must either perform an emergency stop, or swerve around the pedestrians to avoid hitting them which would probably result in a collision with my wife's car or other northbound vehicles. i-Transport did not carry out any safety assessment for this scenario and instead assumed that it did not happen. This photo is evidence that it does occur in reality. I would stress that this

The 2 walkers have backpacks and will have walked along the southern verge (also no footway) of Lower Road, most likely entering from the footpath at the western end of Lower Road (near the Rusty Cutter). By naturally choosing to avoid walking across the multiple driveways on the northern side of Lower Road, they enter the blind bends shared section on the **eastern** side. They are walking towards any vehicles which may come towards them but that does not help them – they cannot avoid any such vehicle (eg a large supermarket delivery van) as there is nowhere for them to go. Instead, current safety relies on a driver heading south who is coming around the bend on the same side as the walkers, performing either an emergency stop, or more usually, a "swerve manoeuvre", relying on there being no on-coming traffic (such as our car). By good fortune, there was no oncoming vehicle coming south around the bend on this occasion. For a vehicle approaching around the sharpest point on the bend on the same side of the road as the 2 pedestrians, the driver's forward visibility is only 16.1 metres (See Appendix 2) and such a limited sightline means there is very little time to stop. The calculation in Appendix 2 (and verified in Excel spreadsheet, Appendix 4) shows that with a vehicle speed above 24.2 mph a collision is certain with a pedestrian in the same position as shown in Fig. 1 unless the driver is able to perform the swerve manoeuvre. However, the driver may be blocked from the swerve manoeuvre due to an oncoming vehicle (eg a vehicle positioned such as ours is in the photo), unless there is the presence of mind to accept a head-on collision with said oncoming vehicle, in preference to hitting the pedestrian. It should be noted that even according to the i-Transport Transport Statement ("TS"), (para 6.8.5, page 38 of 385), two vehicles travelling at 21 mph (85<sup>th</sup> percentile), would have a closing speed (at the moment of the swerve manoeuvre) around that blind bend of 42 mph.

In fact, the evidence shows (as visible in the photo, Fig 1, below, and also the video referenced in 2.1 above) that pedestrians often walk on the **eastern** side of the blind bends /shared surface of Lower Road. Given the greatly reduced sightline, this is a major safety concern not even considered by the Transport Statement.

- The curve represents the radius R of the Lower Road corner of the eastern blind bend approx. opposite The Elms entrance. It also approximates to the position of the female pedestrian shown in Fig 1 in Section 2.2. This has been measured to be 41.63 m

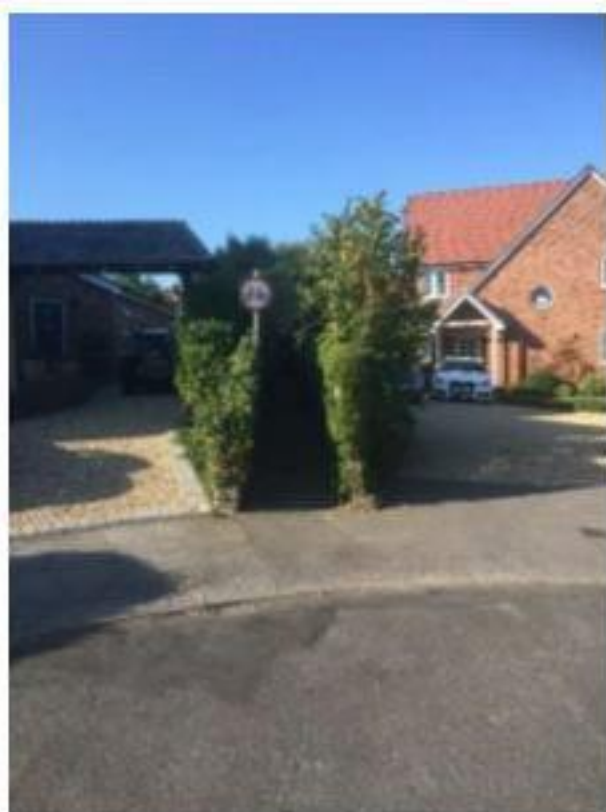
Fig 2 : Entrance to Lodge Road “footpath” or alleyway.

As can be seen from the two photographs below, the “footpath” is more akin to a long, dark alleyway. For most of its 130 metre length, it is only 1 metre wide or less with walls, fences and tall, thorny hedgerows which exceed head height. 35 metres in, the alleyway takes a 90 degree turn to the east. There is a straight section of a further 18 metres before the alleyway turns 90 degrees to the north.
