**CONTAMINATION ASSESSMENT REPORT**

**FORMER COLT INTERNATIONAL, NEW LANE, HAVANT PO9 2LZ**

**DREW SMITH GROUP**

| Report Reference: GWPR3192/CAR/November 2019 | | Status: FINAL |

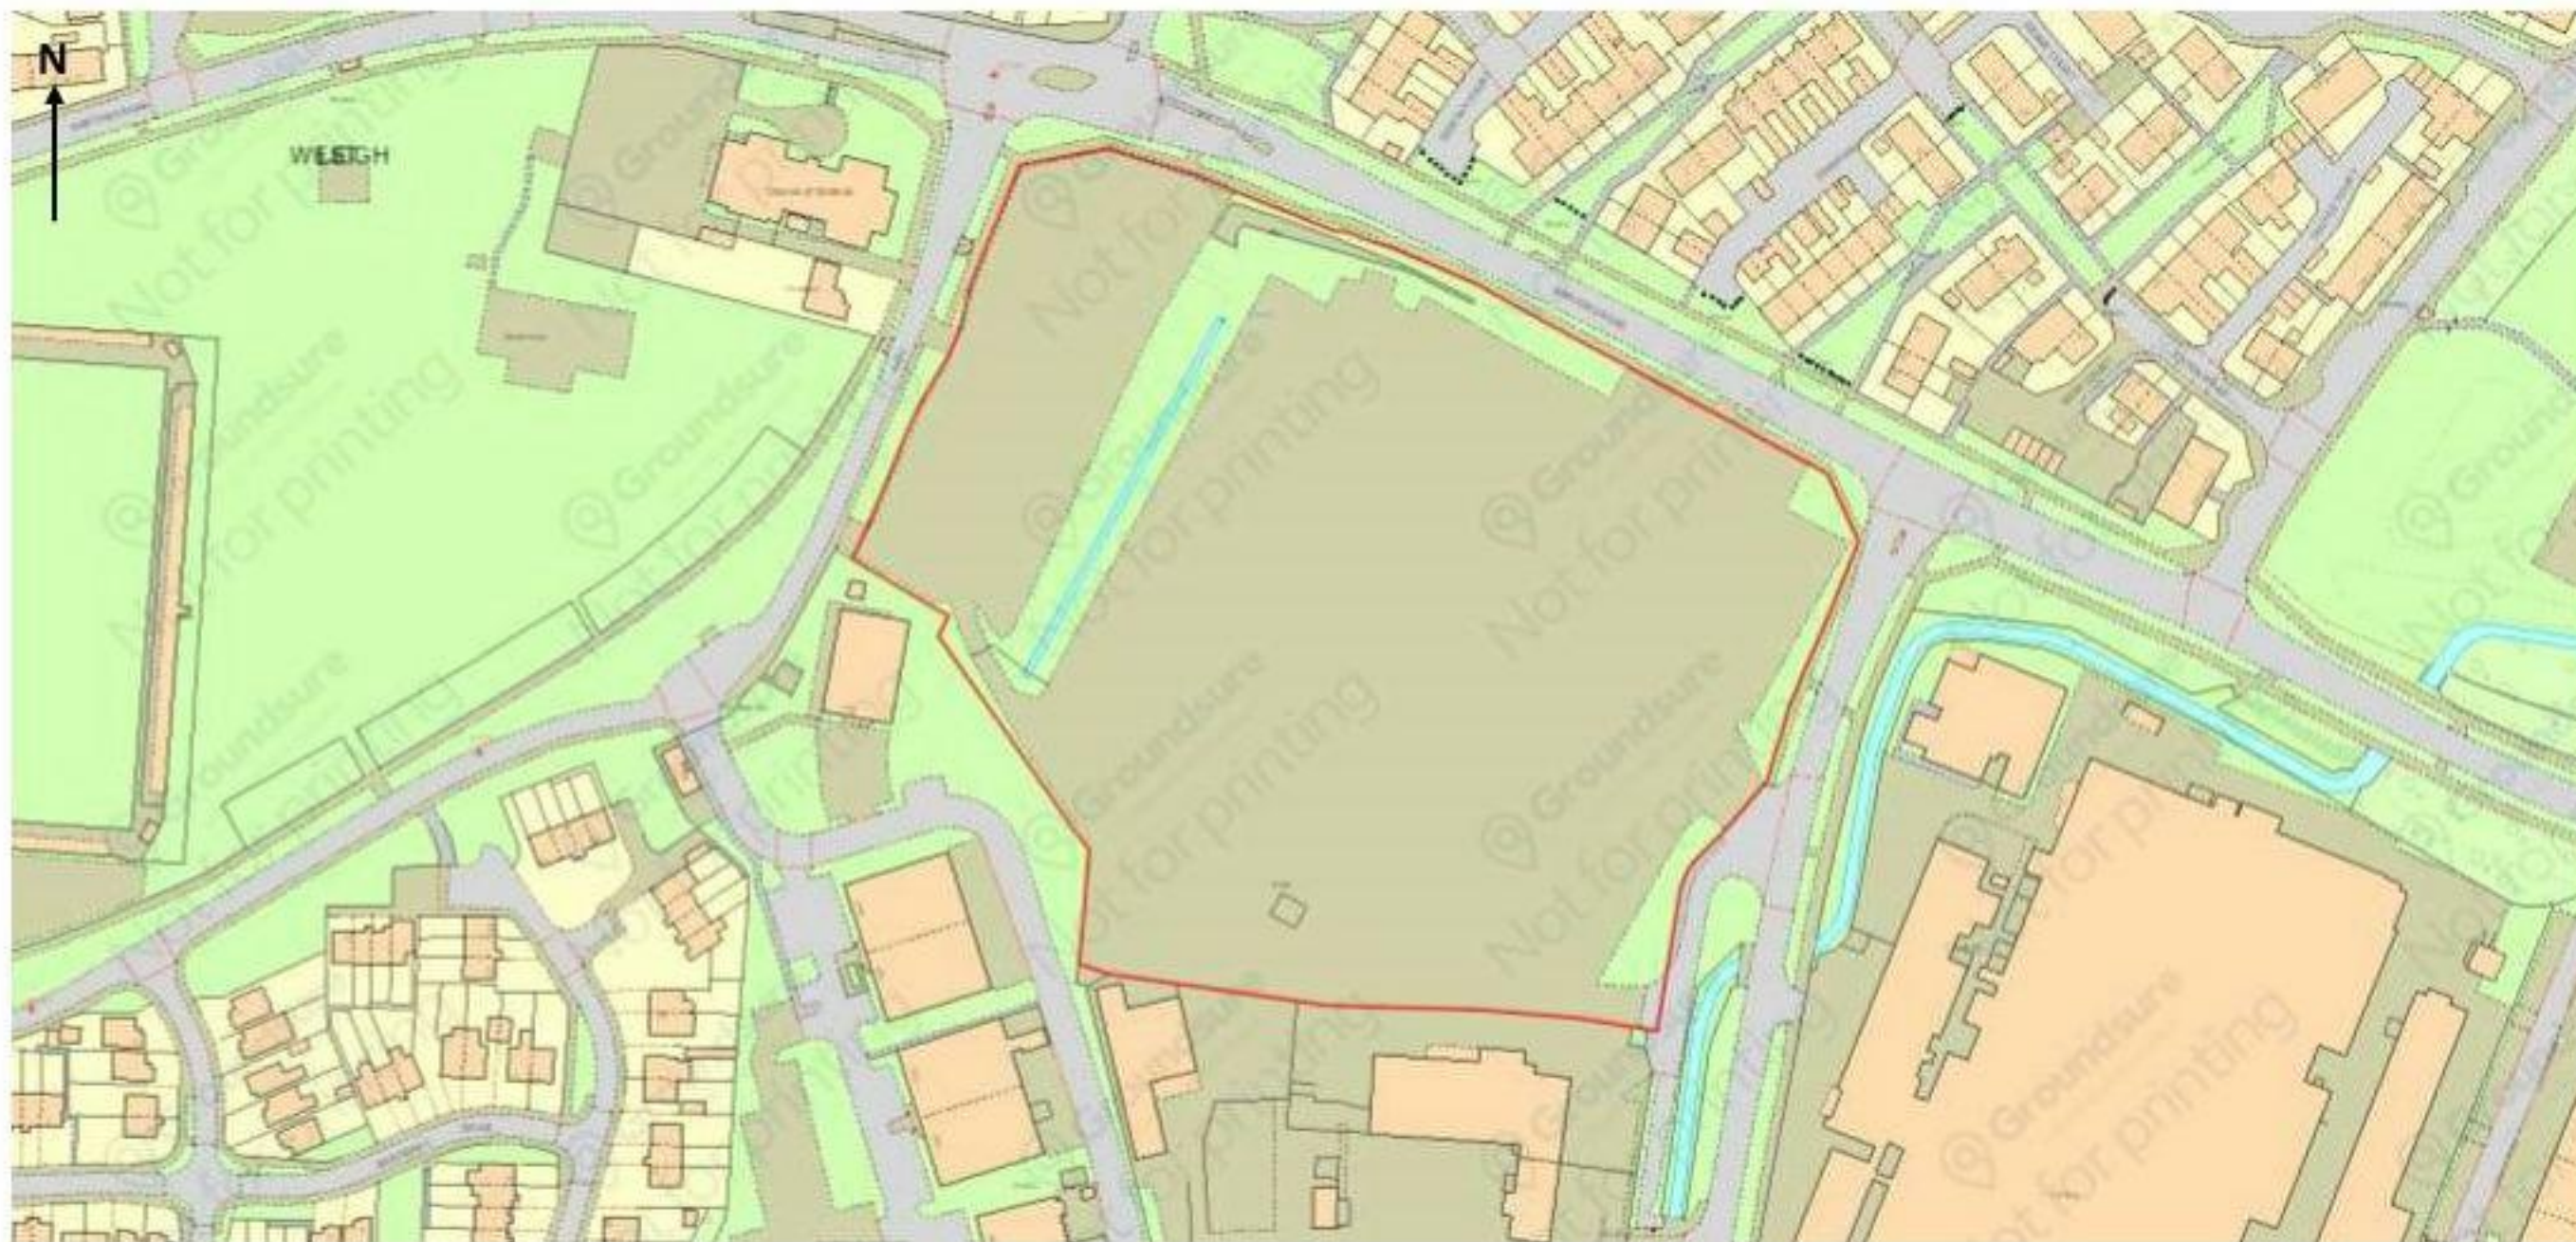
Figure 1

APPROXIMATE  
SITE BOUNDARY

The national grid reference for the centre of the site was approximately SU 72615 07997. A site location plan is given within Figure 1. A plan showing the site boundary can be seen in Figure 2.

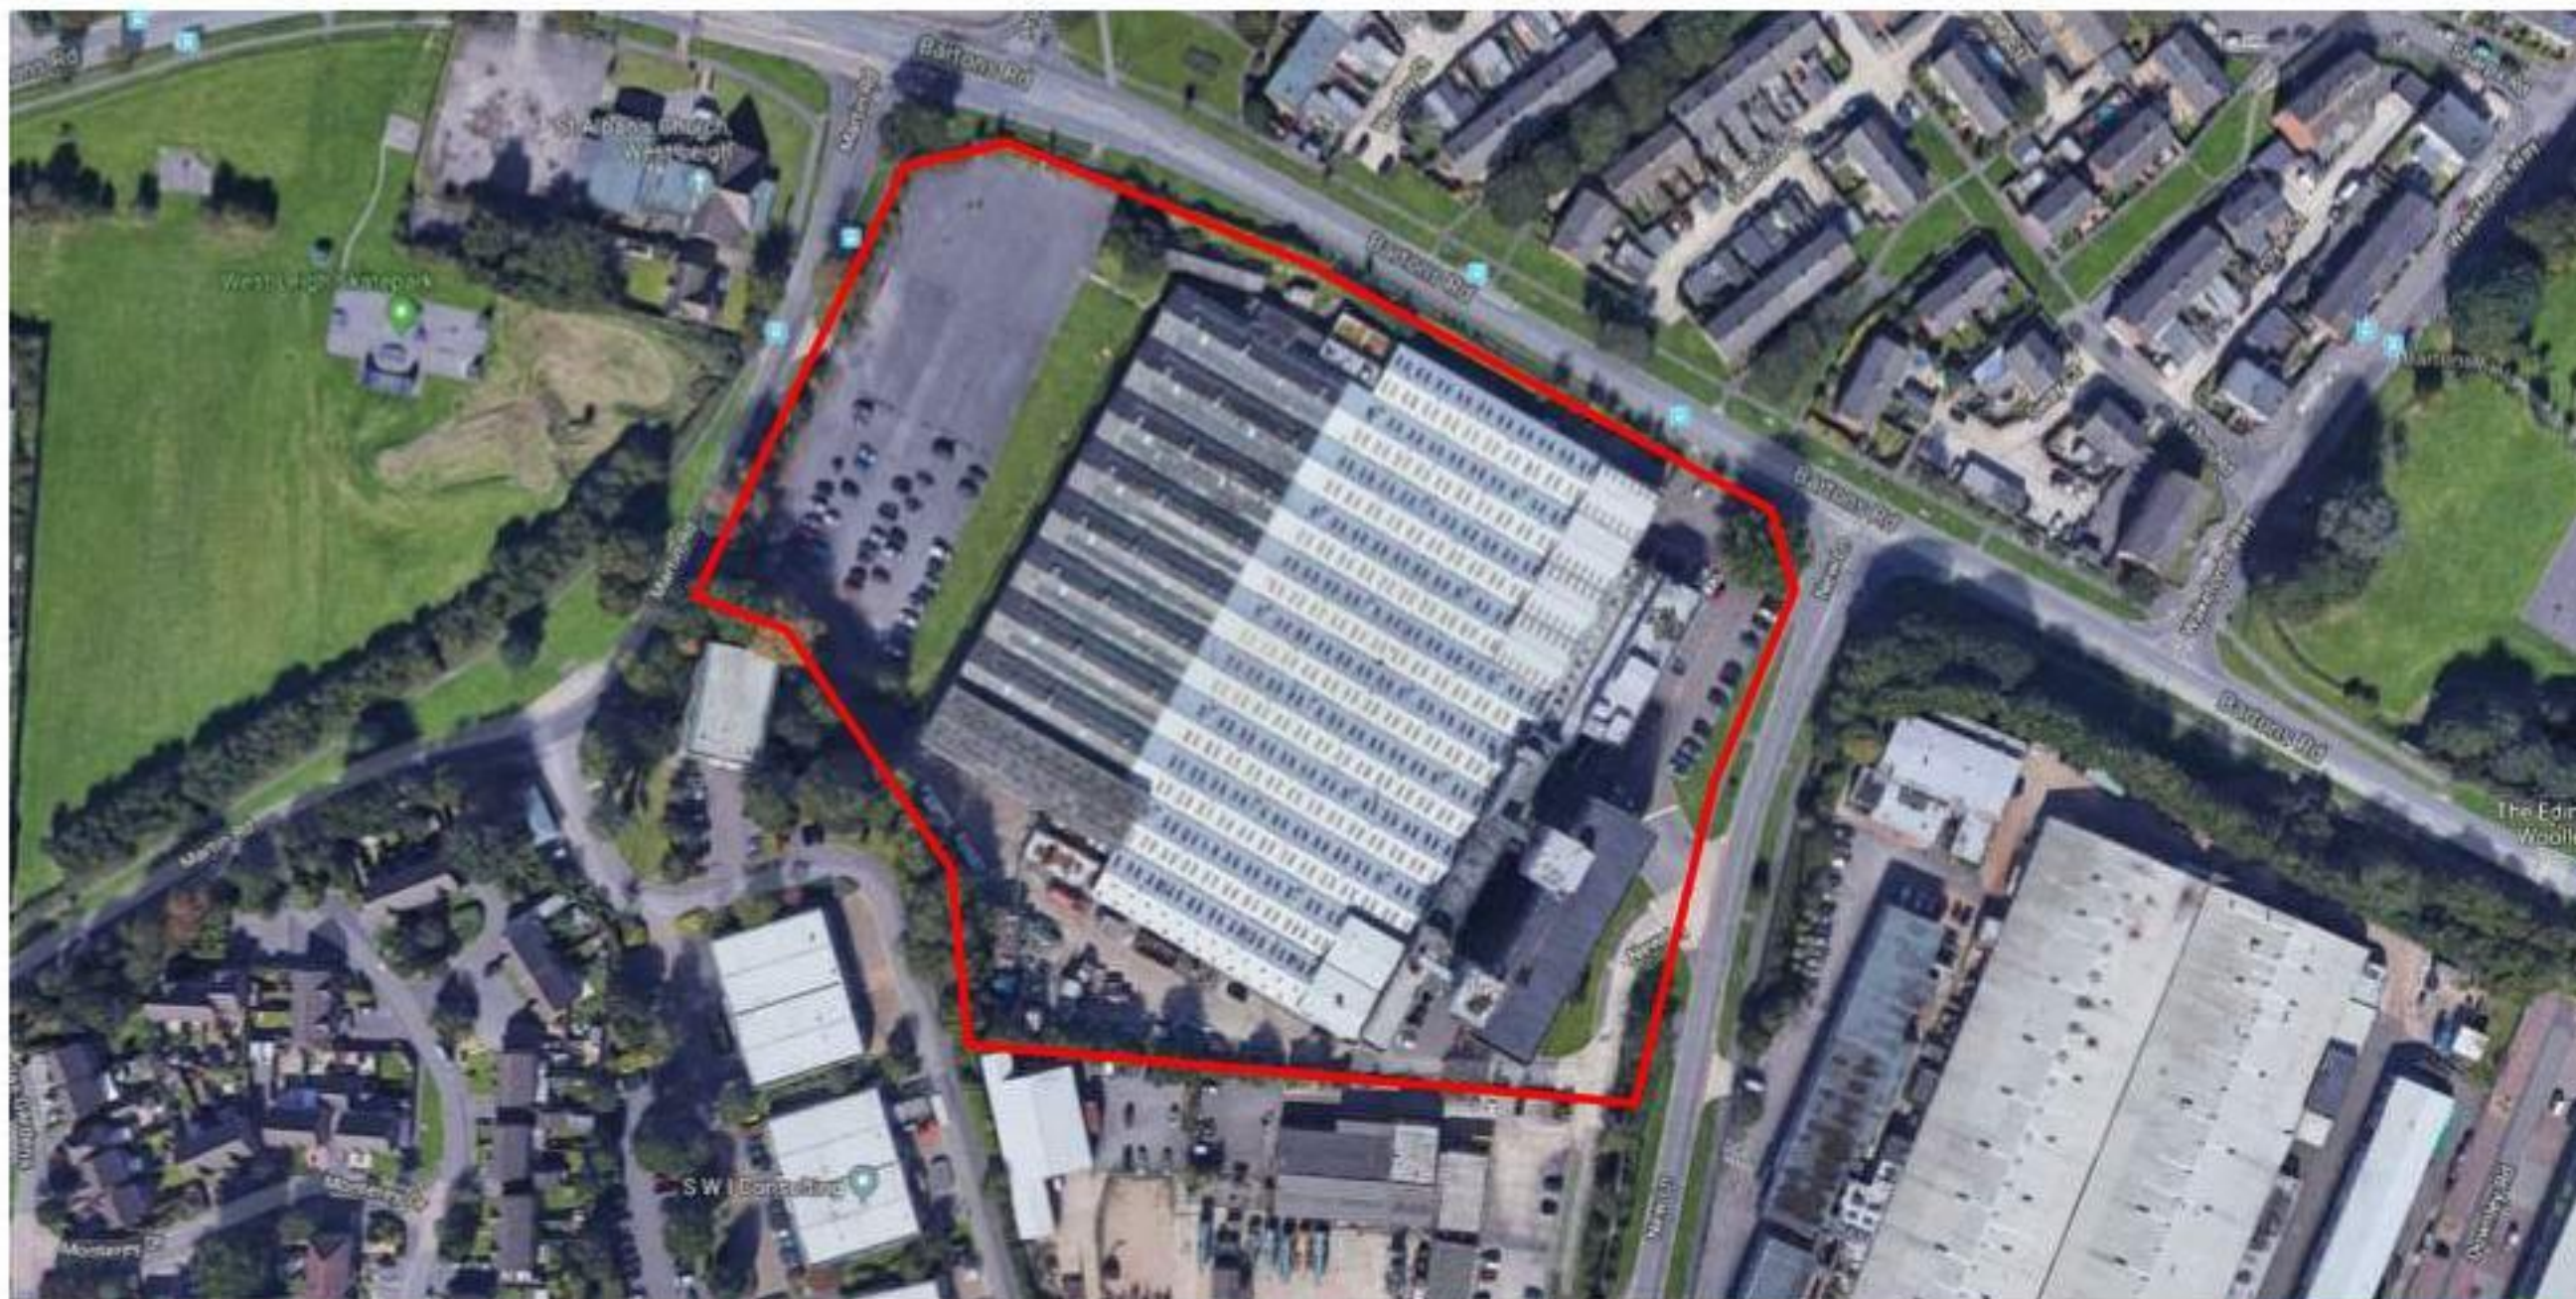
Figure 2

APPROXIMATE SITE BOUNDARY

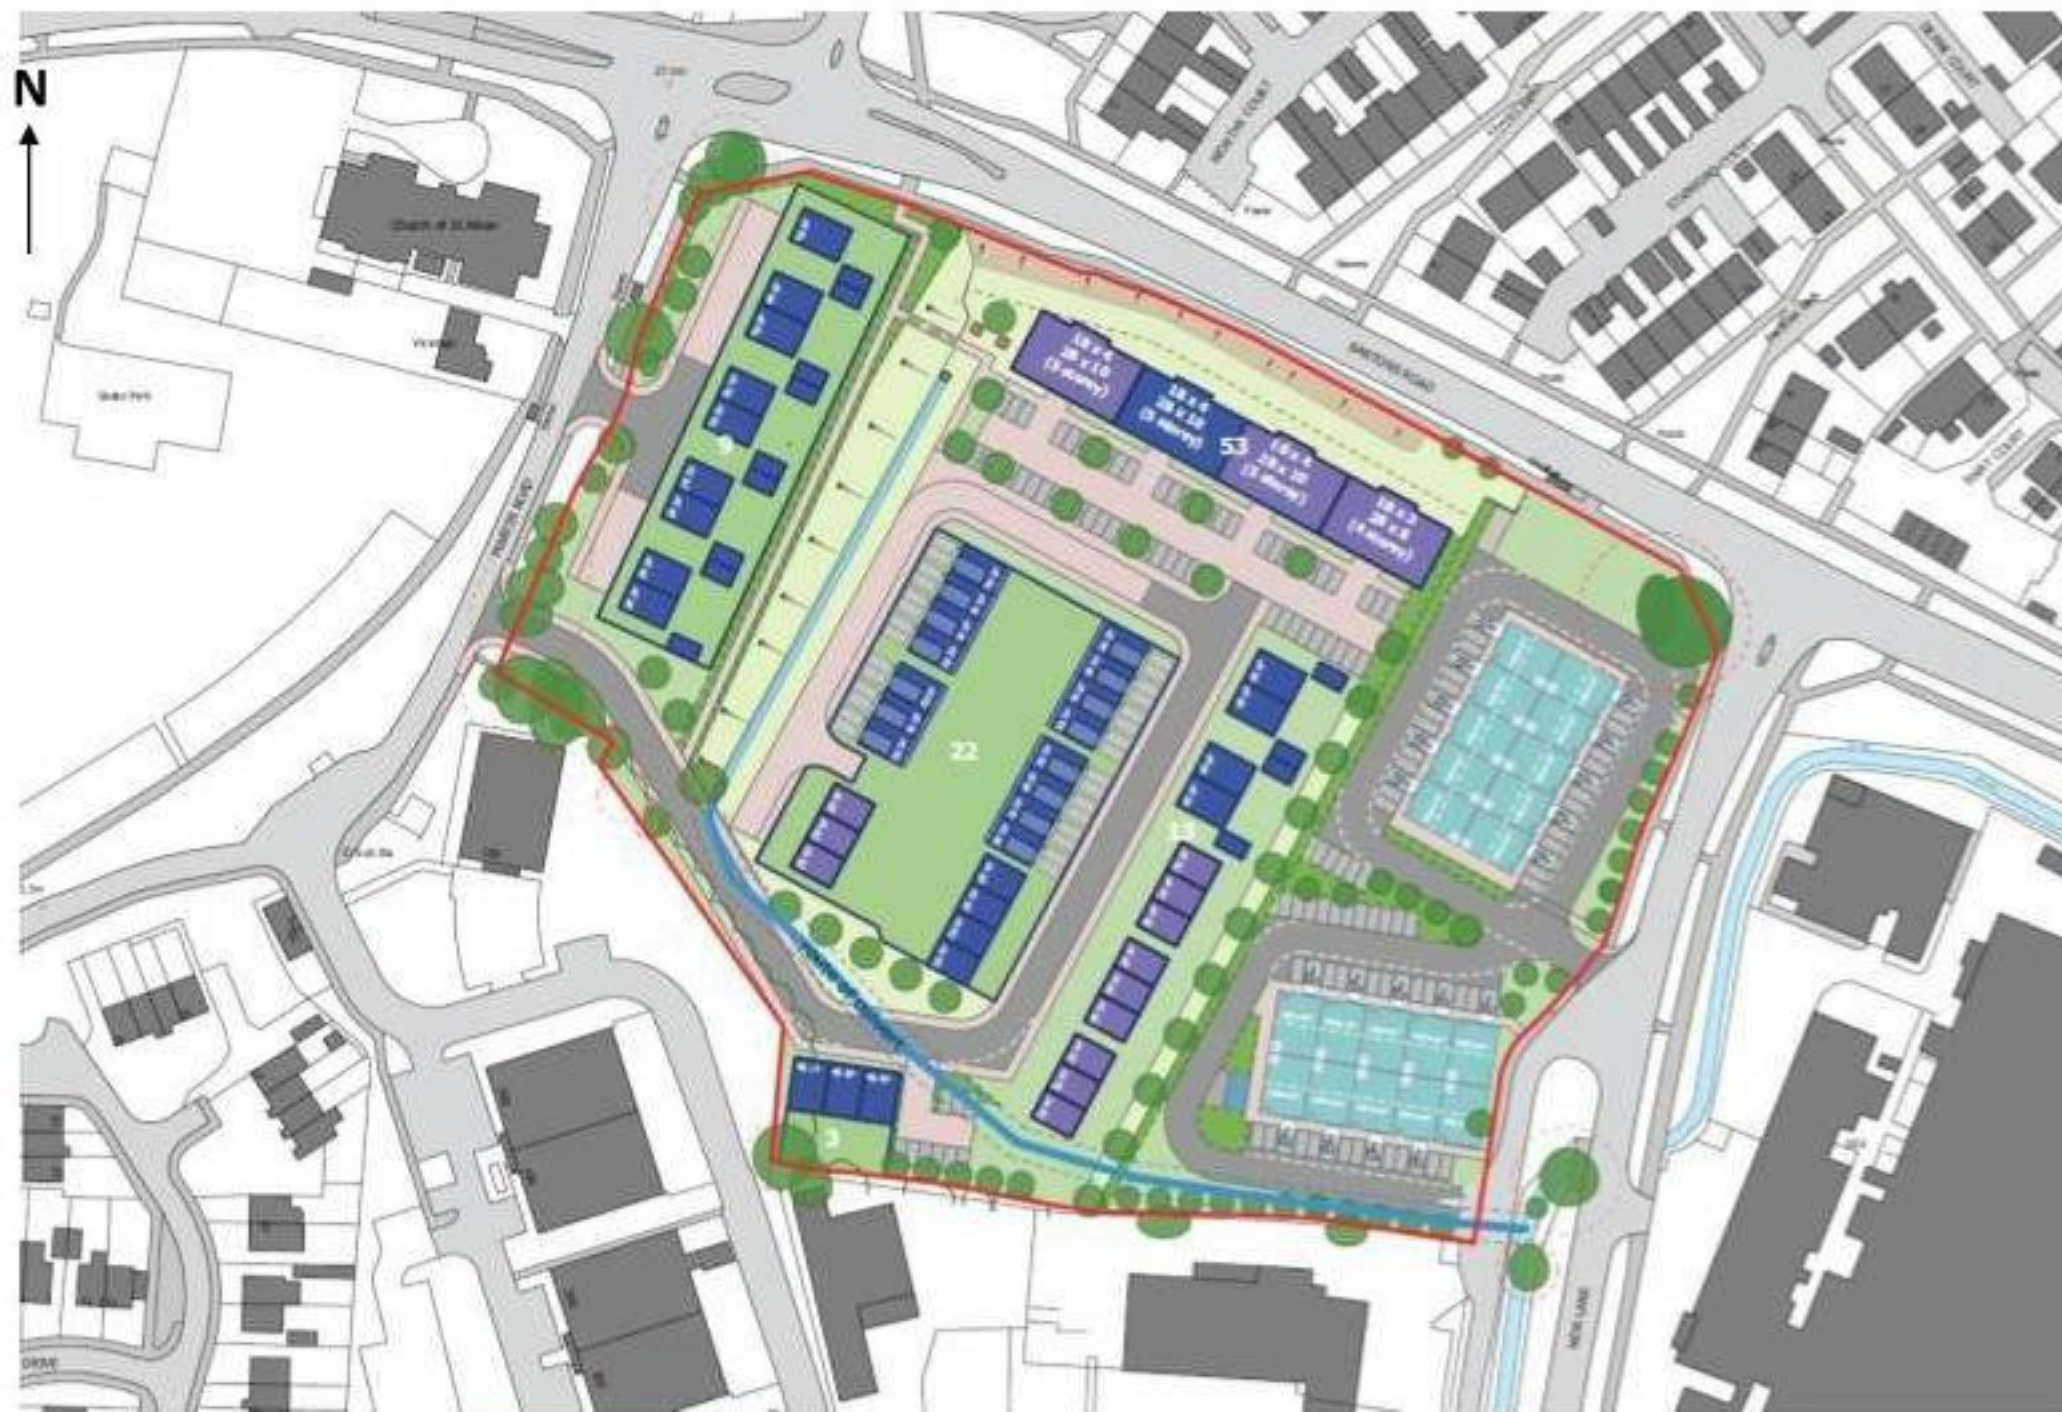
**Figure 4**

Colt International,  
New Lane, Havant  
Residential option 13

| Figure 4 | Proposed Development – Plan View |
