**Tournerbury Farm  
Tournerbury Lane  
Hayling Island**

**REPORT ON ROAD CONSTRUCTION**

**Client: The Tournerbury Woods Estate**

**9 August 2022**

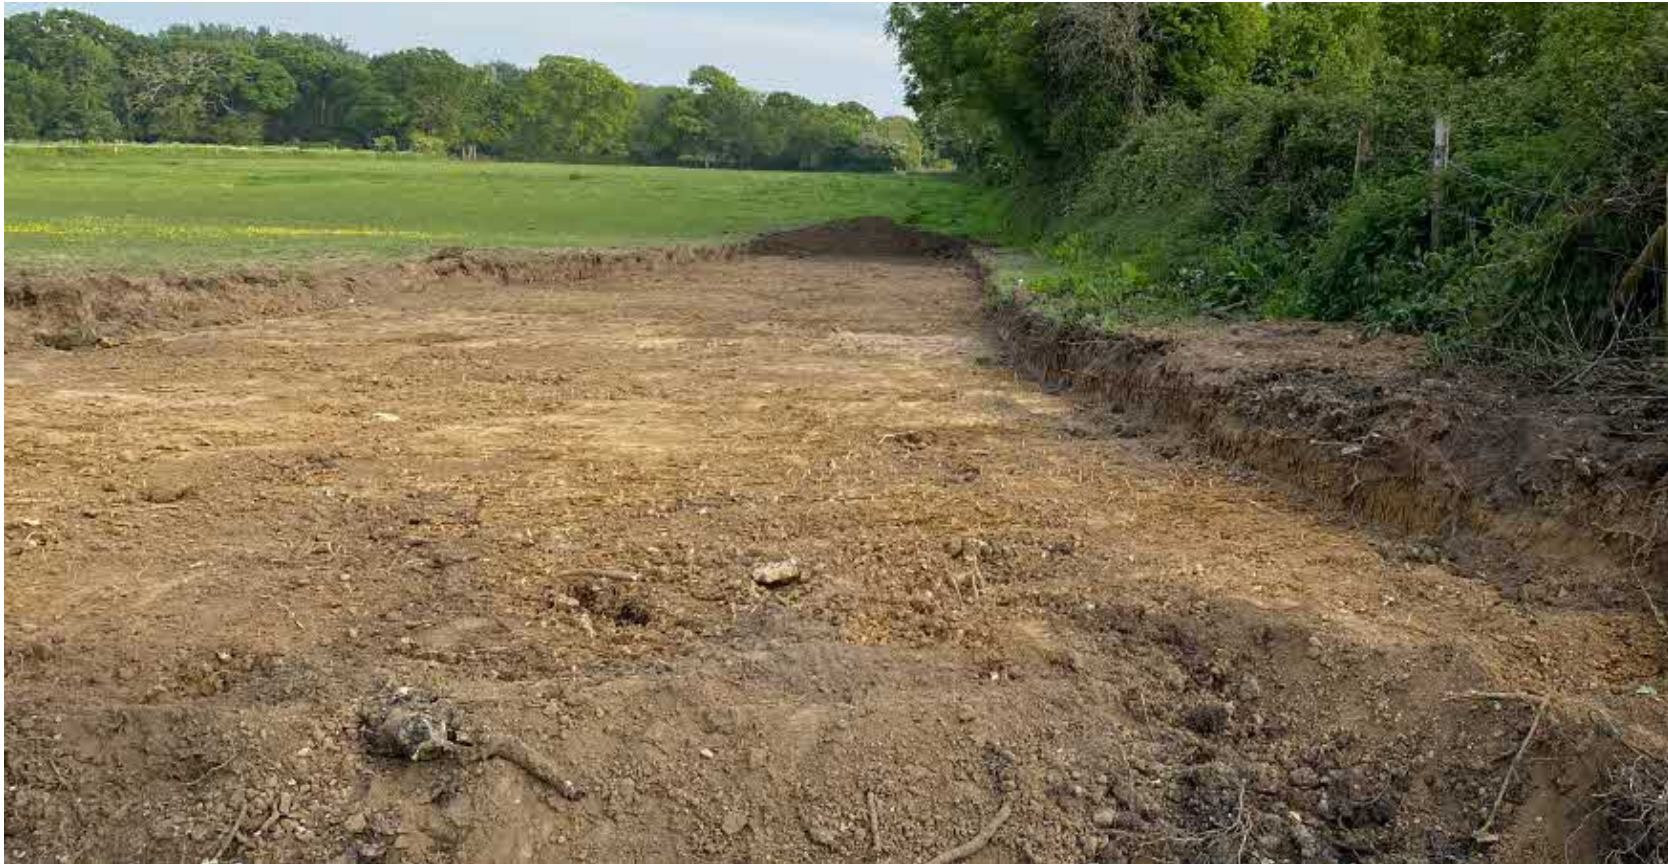
Reduced level dig for new road, no CBR testing appears to have been carried out to enable road design

From a technical perspective it would appear that no compression testing or CBR testing has been carried out to calculate the required construction build ups for the road.

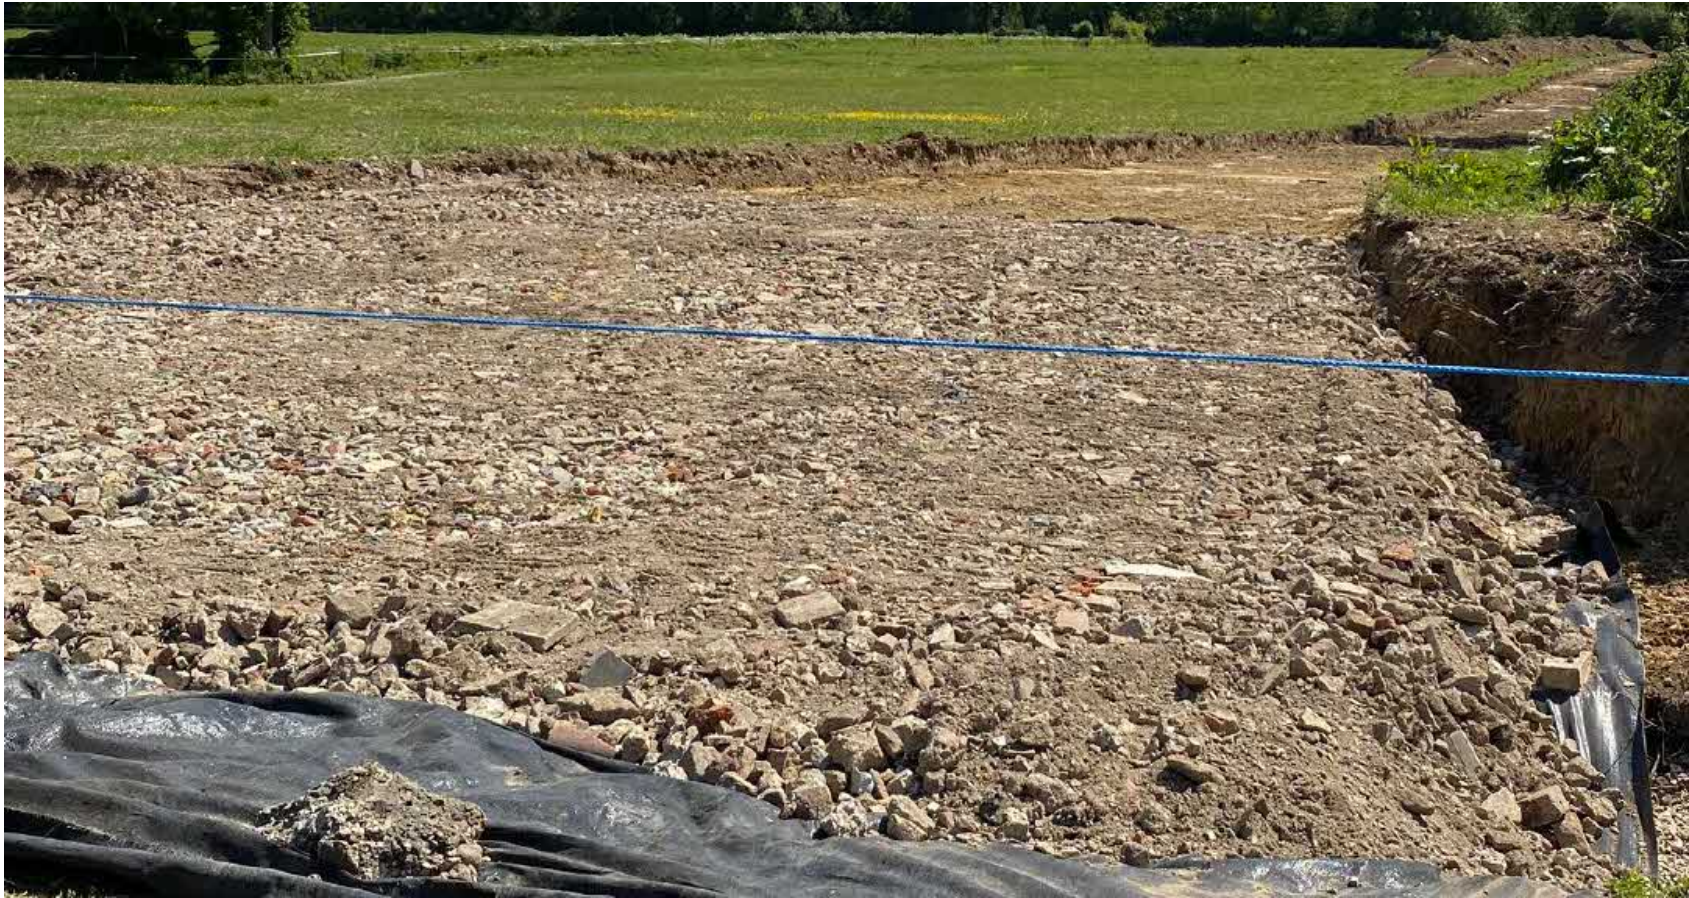
Road subbase laid on geotextile. Note presence of non uniform site material, clearly not properly graded, also clat pipes, bricks and other waste material which could degrade. Also note high level of fine material meaning road unlikely to be permeable

The photographs show, as noted by comments from a senior technician at County Highways Laboratory, that properly graded materials have not been used in the road construction.

The material used within the road contains vegetation, broken bricks and other waste material so it has clearly not been certified as Type 1 or 6F5 material as would be required in a certifiable designed access road. Further, the use of Type 1 and 6F5 materials to certain depths are specified as conditions of the planning consent for this access road (Havant Borough Council APP/17/00207 and APP/21/00536 before it can be brought into use.

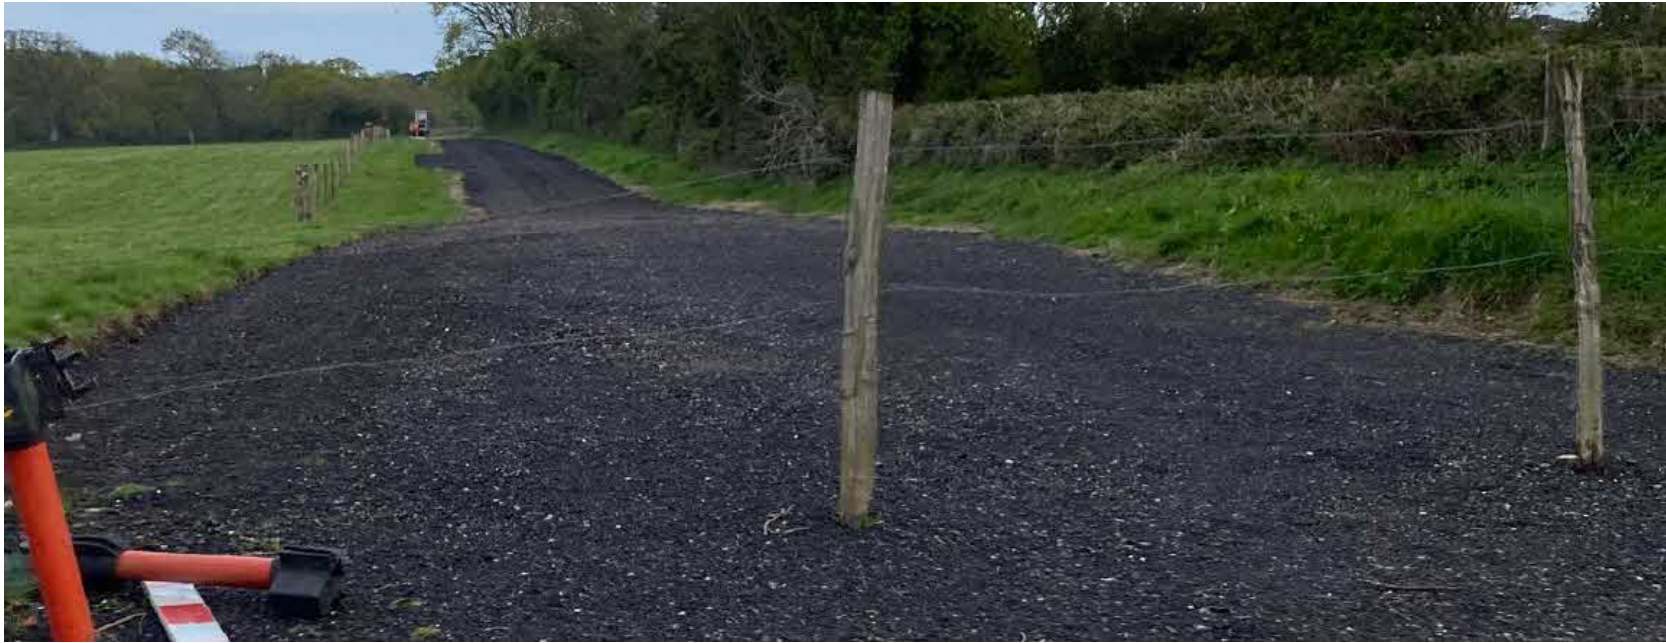
Thin layer of road planings as a finish. Clearly no drainage present to take water away from road. Edge levels also shown to be higher so water will not run off but will likely cause ponding and road degradation

Drainage does not appear to have been implemented. Water is the main reason for road degradation over time. The road itself is unlikely to be permeable due to the high level of fine material clearly present in the subbase which will not allow water to percolate. It is not clear from photographs if the road has been laid to sufficient falls but there is clearly no drainage present to take water away.
