## Verification Report – Materials Management & Remedial Earthworks

**Pfizer**  
32 New Lane  
Havant  
PO9 2NG

EPS Project Reference: UK21.5634

## PFIZER, NEW LANE, HAVANT

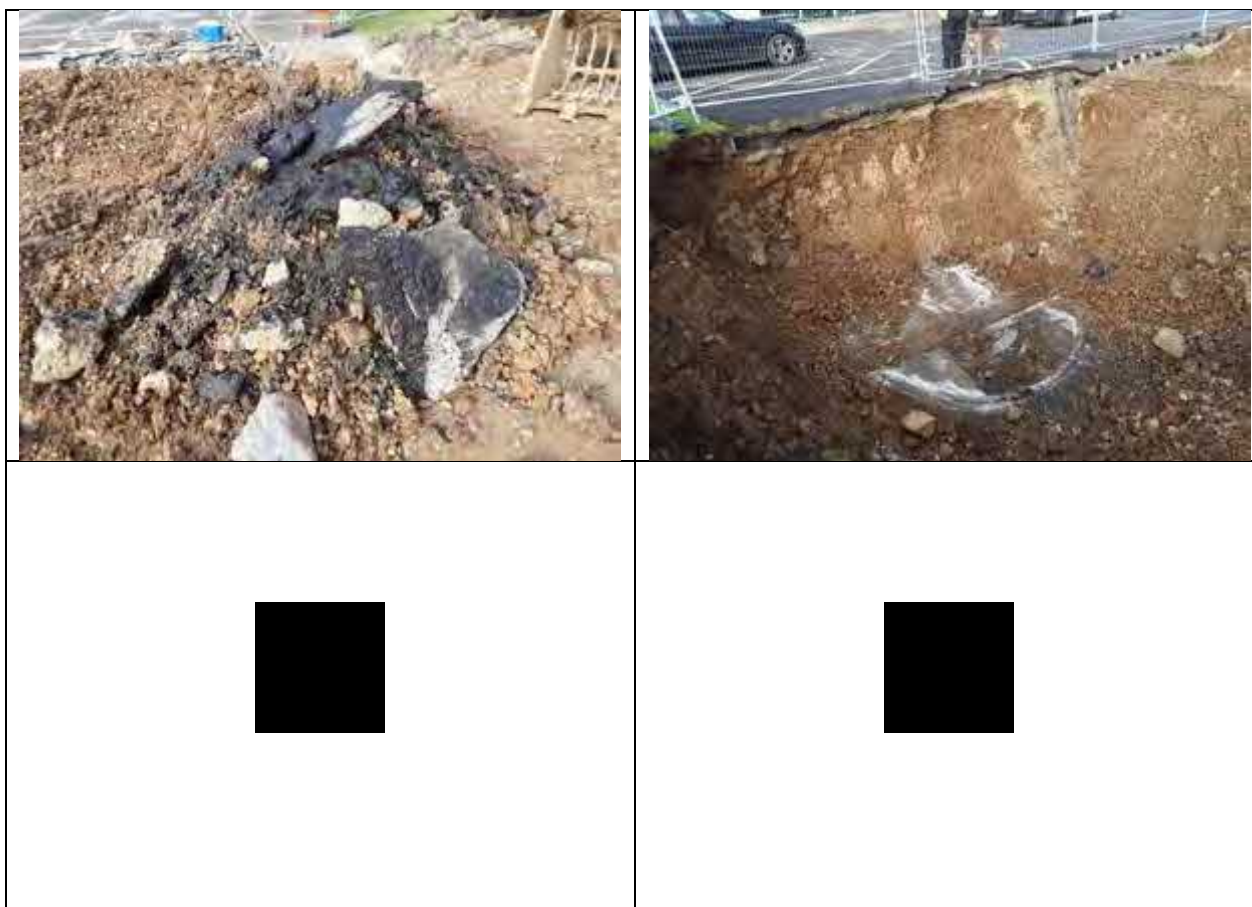
| Dark stained material added to the quarantine area. | |
