**DEMOLITION ASBESTOS SURVEY**  
**OF**  
**38-44 LONDON ROAD,**  
**PURBROOK,**  
**WATERLOOVILLE**  
**PO7 5LJ**  
**ON BEHALF OF**  
**MCCARTHY & STONE (DEVELOPMENTS) LIMITED**

The scope of work is a demolition asbestos survey of the House, Warehouse & 2 Outbuildings

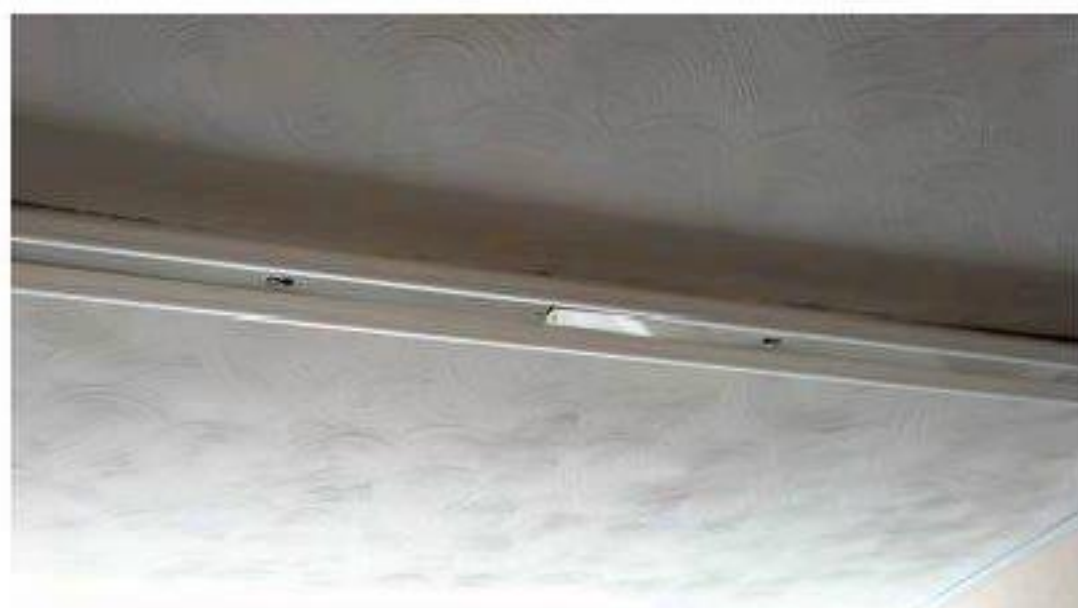
**Sample 3:** Out Building (Car Sales). Ground Floor. Kitchen. Textured coating to plasterboard ceiling

| SAMPLE NUMBER | SAMPLE DESCRIPTION | PRODUCT TYPE | ACTION REQUIRED |
|---|---|---|---|
| Sample 3 | Out Building (Car Sales). Ground Floor. G.02 Kitchen, Textured coating to plasterboard ceiling | Artex | Removal of non-licensed ACMs (Remove (non-licensed)) |

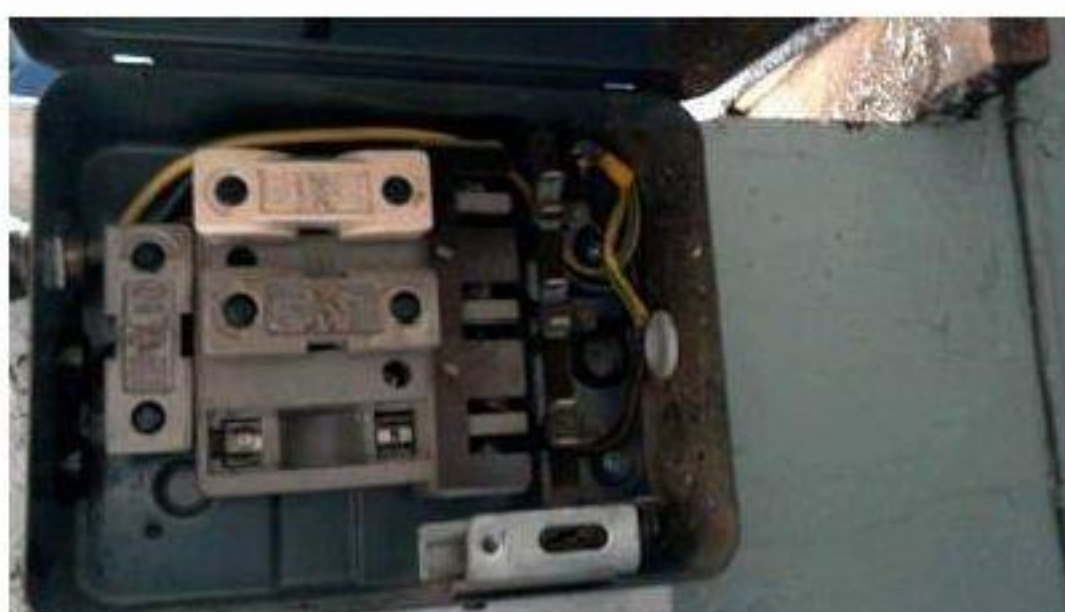
**Sample 11:** Workshop Building. Ground Floor. Office 1. Woven flash pads within fuse box

| SAMPLE NUMBER | SAMPLE DESCRIPTION | PRODUCT TYPE | ACTION REQUIRED |
|---|---|---|---|
| Sample 11 | Workshop Building. Ground Floor. G.01 Office 1, Woven flash pads within fuse box | Woven | Removal of non-licensed ACMs (Remove (non-licensed)) |

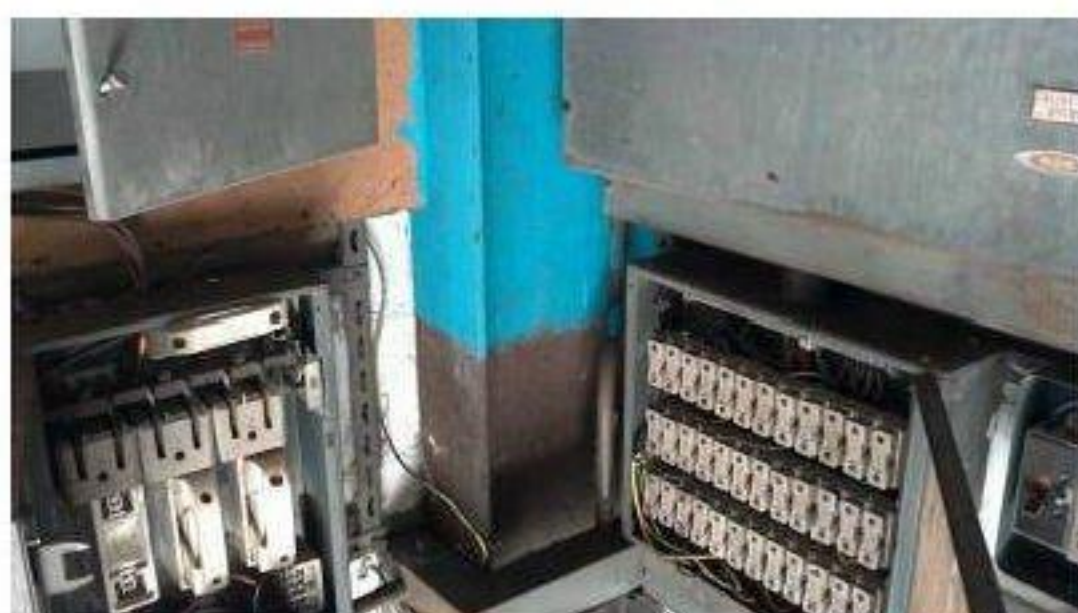
**Ref. Sample 11:** Workshop Building. Ground Floor. Bay 2. Woven flash pads within fuse boxes to north east corner

| SAMPLE NUMBER | SAMPLE DESCRIPTION | PRODUCT TYPE | ACTION REQUIRED |
|---|---|---|---|
| Ref. Sample 11 | Workshop Building. Ground Floor. G.05 Bay 2, Woven flash pads within fuse boxes to north east corner | Woven | Removal of non-licensed ACMs (Remove (non-licensed)) |

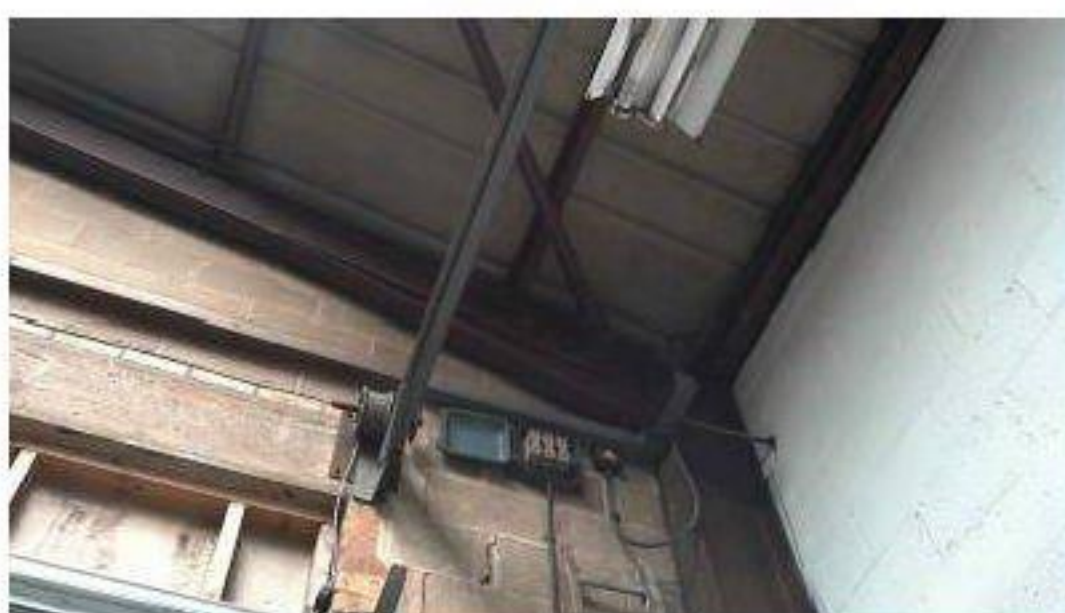
**Ref. Sample 11:** Workshop Building. Ground Floor. Bay 3. Woven flash pads within high level fuse box north west corner

| SAMPLE NUMBER | SAMPLE DESCRIPTION | PRODUCT TYPE | ACTION REQUIRED |
|---|---|---|---|
| Ref. Sample 11 | Workshop Building. Ground Floor. G.07 Bay 3, Woven flash pads within high level fuse box north west corner | Woven | Removal of non-licensed ACMs (Remove (non-licensed)) |

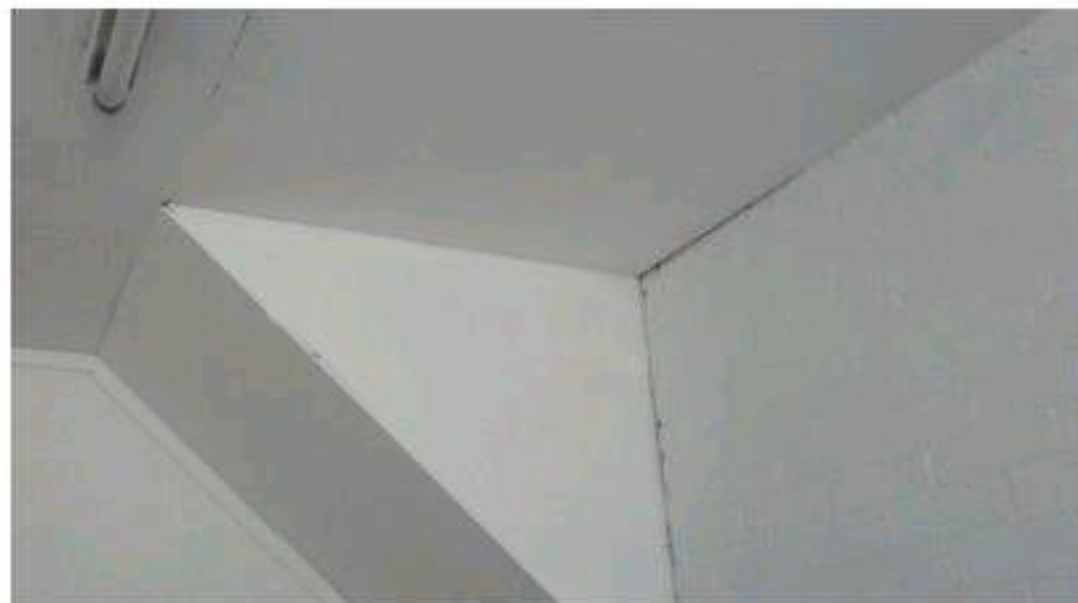
**Sample 12:** Workshop Building. Ground Floor. Office 2. Insulation board ceiling panels and panels to under side of stairs

| SAMPLE NUMBER | SAMPLE DESCRIPTION | PRODUCT TYPE | ACTION REQUIRED |
|---|---|---|---|
| Sample 12 | Workshop Building. Ground Floor. G.02 Office 2, Insulation board ceiling panels and panels to under side of stairs | Asbestos Insulating Board | Removal of licensed ACMs (Remove (licensed)) |

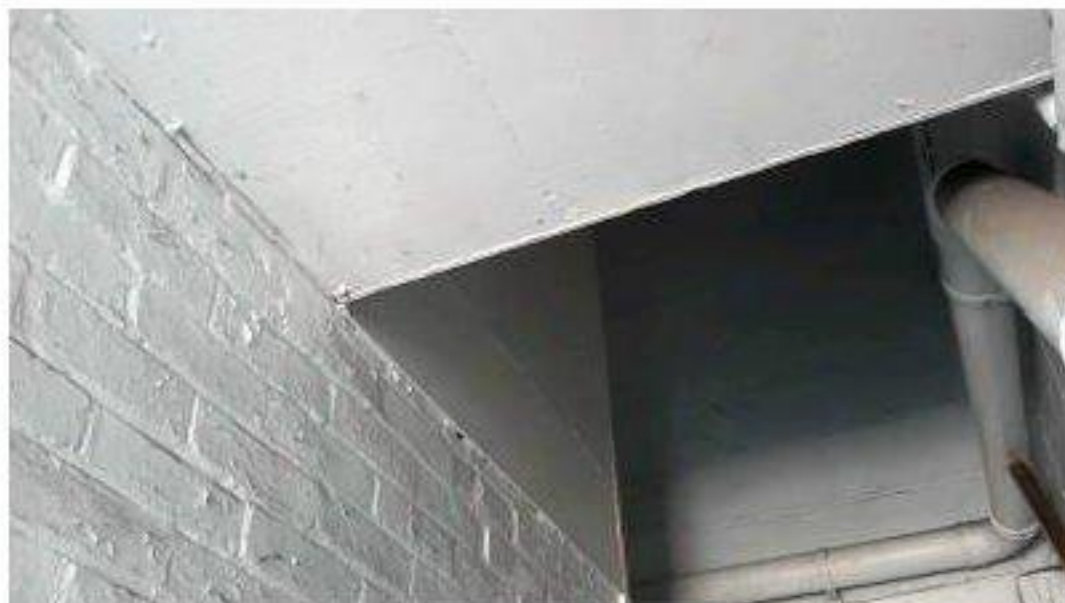
**Ref. Sample 12:** Workshop Building. Ground Floor. Lobby 1/Stairs 2. Insulation board ceiling/wall panels

| SAMPLE NUMBER | SAMPLE DESCRIPTION | PRODUCT TYPE | ACTION REQUIRED |
|---|---|---|---|
| Ref. Sample 12 | Workshop Building. Ground Floor. G.03 Lobby 1/Stairs 2, Insulation board ceiling/wall panels | Asbestos Insulating Board | Removal of licensed ACMs (Remove (licensed)) |

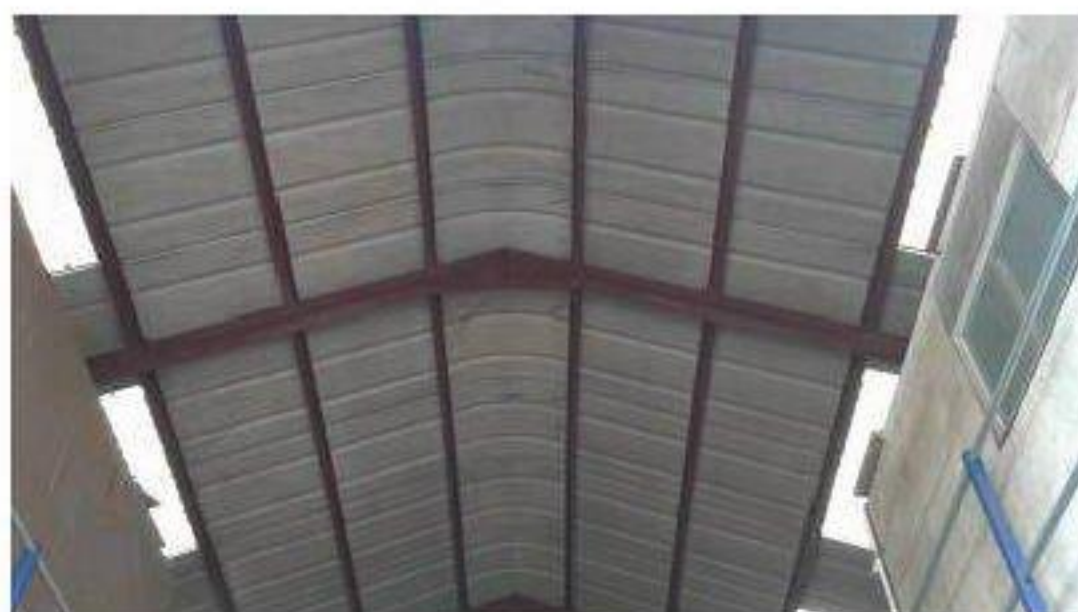
**Sample 22:** Workshop Building. External. External. Corrugated cement roof sheets covering all areas

| SAMPLE NUMBER | SAMPLE DESCRIPTION | PRODUCT TYPE | ACTION REQUIRED |
|---|---|---|---|
| Sample 22 | Workshop Building. External. E.01 External, Corrugated cement roof sheets covering all areas | Asbestos Cement | Removal of non-licensed ACMs (Remove (non-licensed)) |

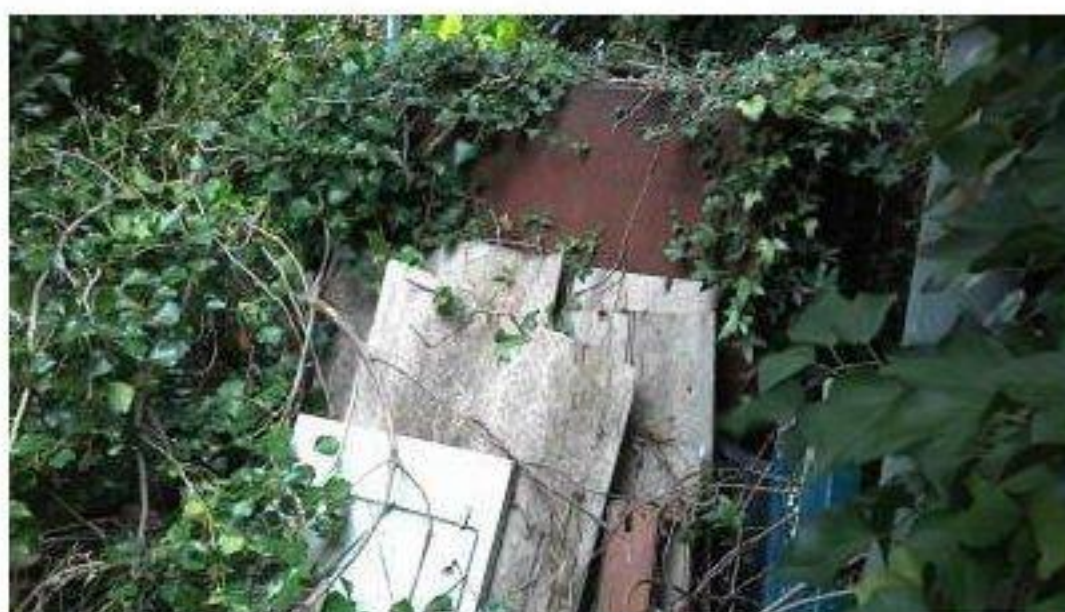
| Sample No. | Location | Level of Identification | Product Type | Asbestos Type | Extent |
|---|---|---|---|---|---|
| Sample 23 | Workshop Building, External. E.01 External, Loose corrugated cement roof sheets adjacent oil tanks | Identified | Asbestos Cement | Chrysotile | 6m <sup>2</sup> |

**Sample 23:** Workshop Building. External. External. Loose corrugated cement roof sheets adjacent oil tanks

| SAMPLE NUMBER | SAMPLE DESCRIPTION | PRODUCT TYPE | ACTION REQUIRED |
|---|---|---|---|
| Sample 23 | Workshop Building. External. E.01 External, Loose corrugated cement roof sheets adjacent oil tanks | Asbestos Cement | Removal of non-licensed ACMs (Remove (non-licensed)) |

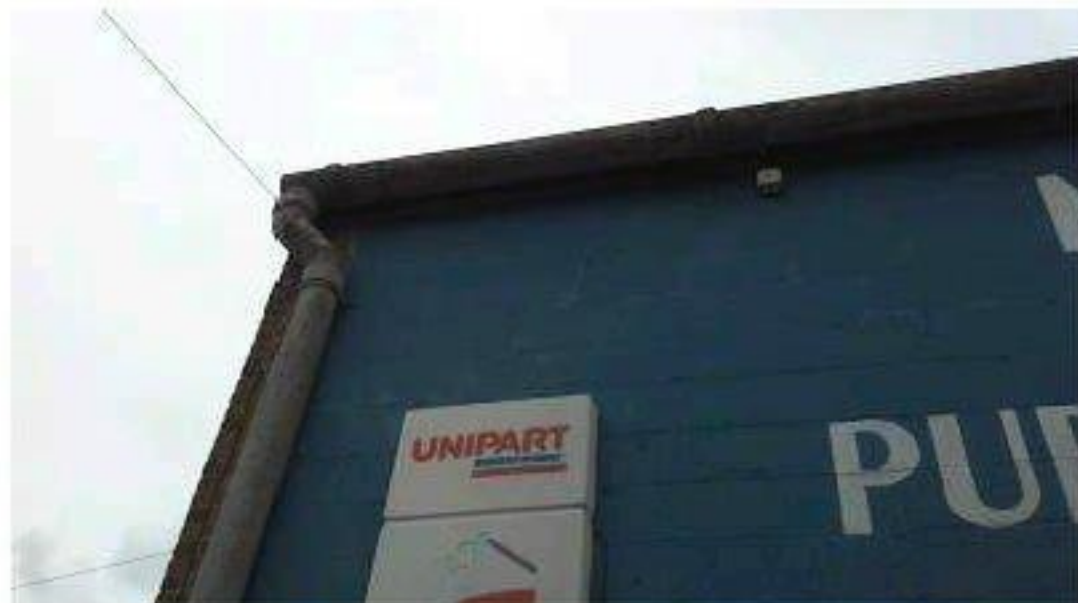
**Sample 24:** Workshop Building. External.  
External. Cement downpipe/guttering to  
east/west sides of bay 4 section

| SAMPLE NUMBER | SAMPLE DESCRIPTION | PRODUCT TYPE | ACTION REQUIRED |
|---|---|---|---|
| Sample 24 | Workshop Building. External. E.01 External, Cement downpipe/guttering to east/west sides of bay 4 section | Asbestos Cement | Removal of non-licensed ACMs (Remove (non-licensed)) |

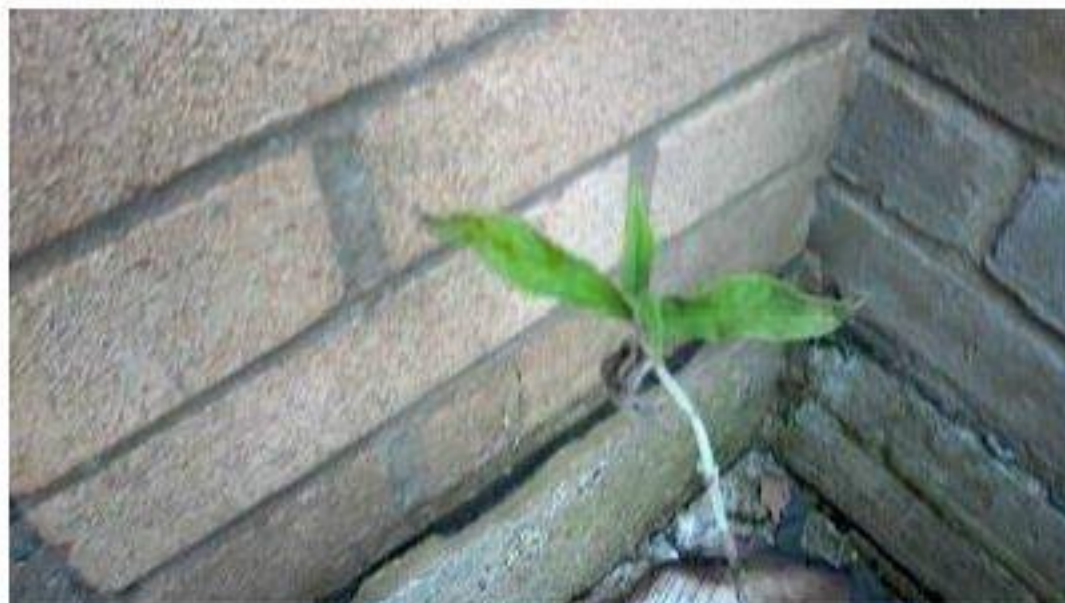
**Sample 26:** Workshop Building. External.  
External. Typical damp proof course surrounding  
building

| SAMPLE NUMBER | SAMPLE DESCRIPTION | PRODUCT TYPE | ACTION REQUIRED |
|---|---|---|---|
| Sample 26 | Workshop Building. External. E.01 External, Typical damp proof course surrounding building | Damp proof course/damp proof membrane | Removal of non-licensed ACMs (Remove (non-licensed)) |

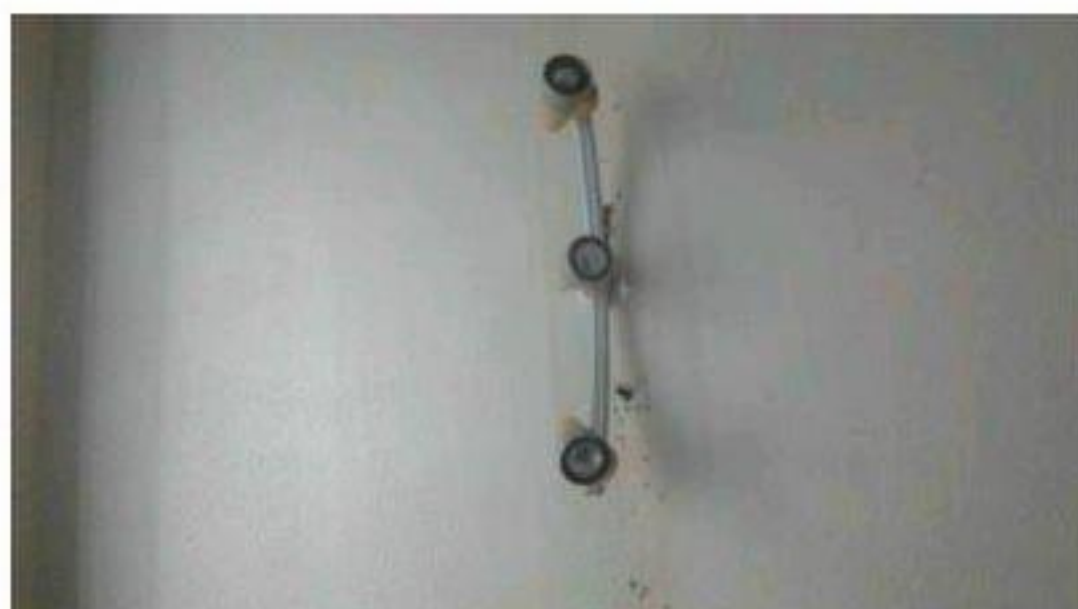
**Sample 30:** House Building. First Floor. Room  
1. Artex coating to plasterboard ceiling

| Sample 30 | House Building. First Floor. 1.01 Room 1, Artex coating to plasterboard ceiling | Artex | Removal of non-licensed ACMs (Remove (non-licensed)) |

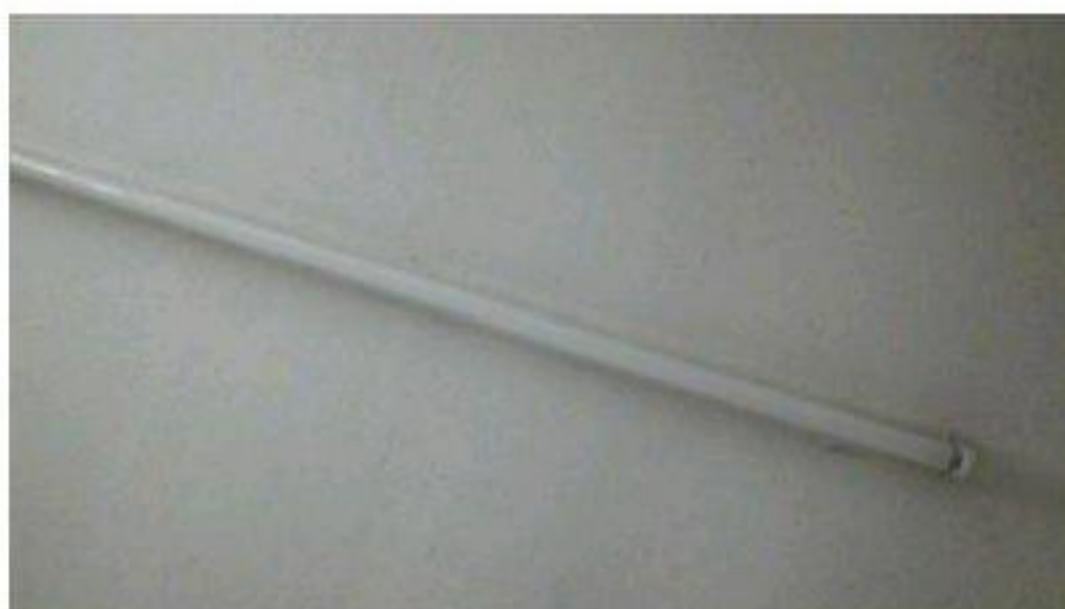
**Sample 31:** House Building. First Floor. Room  
2. Artex coating to plasterboard ceiling

| Sample 31 | House Building. First Floor. 1.02 Room 2, Artex coating to plasterboard ceiling | Artex | Removal of non-licensed ACMs (Remove (non-licensed)) |

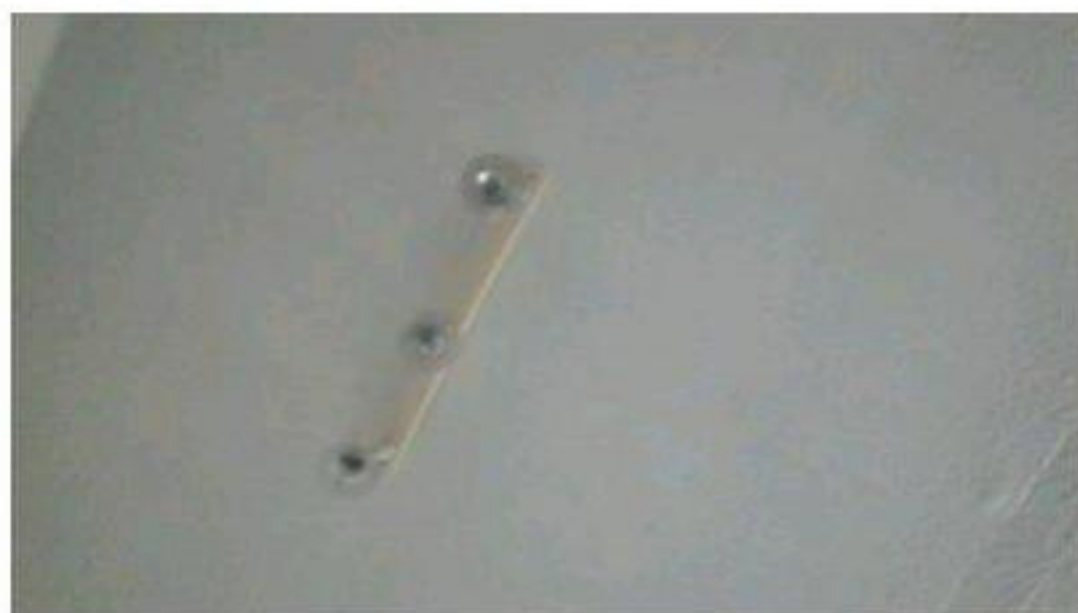
**Sample 32:** House Building. First Floor. Room 4. Artex coating to plasterboard ceiling

| Sample 32 | House Building. First Floor. 1.03 Room 4, Artex coating to plasterboard ceiling | Artex | Removal of non-licensed ACMs (Remove (non-licensed)) |

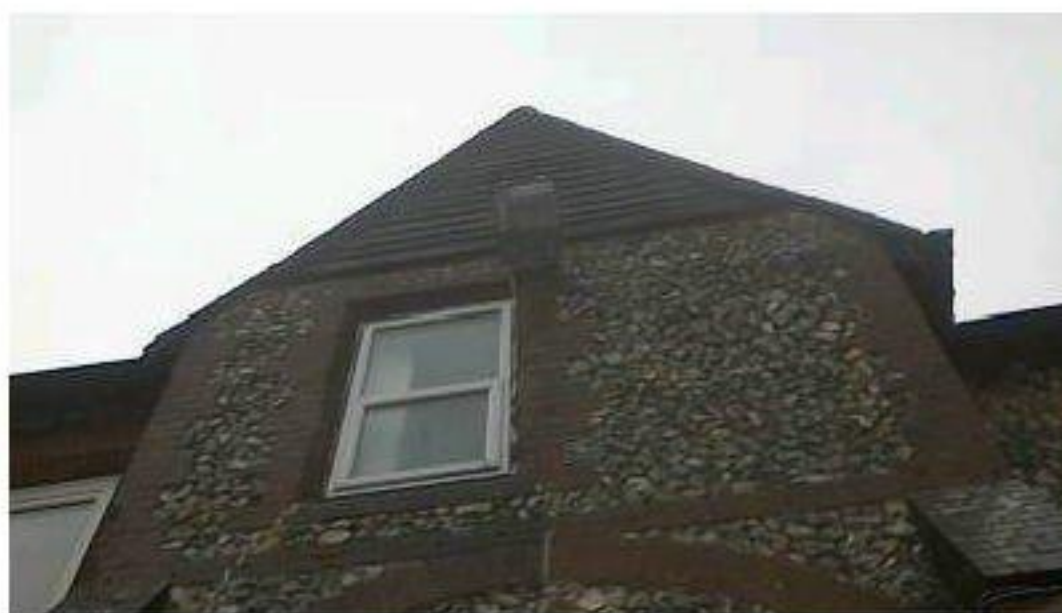
**Visual 1:** House Building. First Floor. External. Cement undercloaking to high level pitch roofs

| Visual 1 | House Building. First Floor. 1.10 External, Cement undercloaking to high level pitch roofs | Asbestos Cement | Removal of non-licensed ACMs (Remove (non-licensed)) |

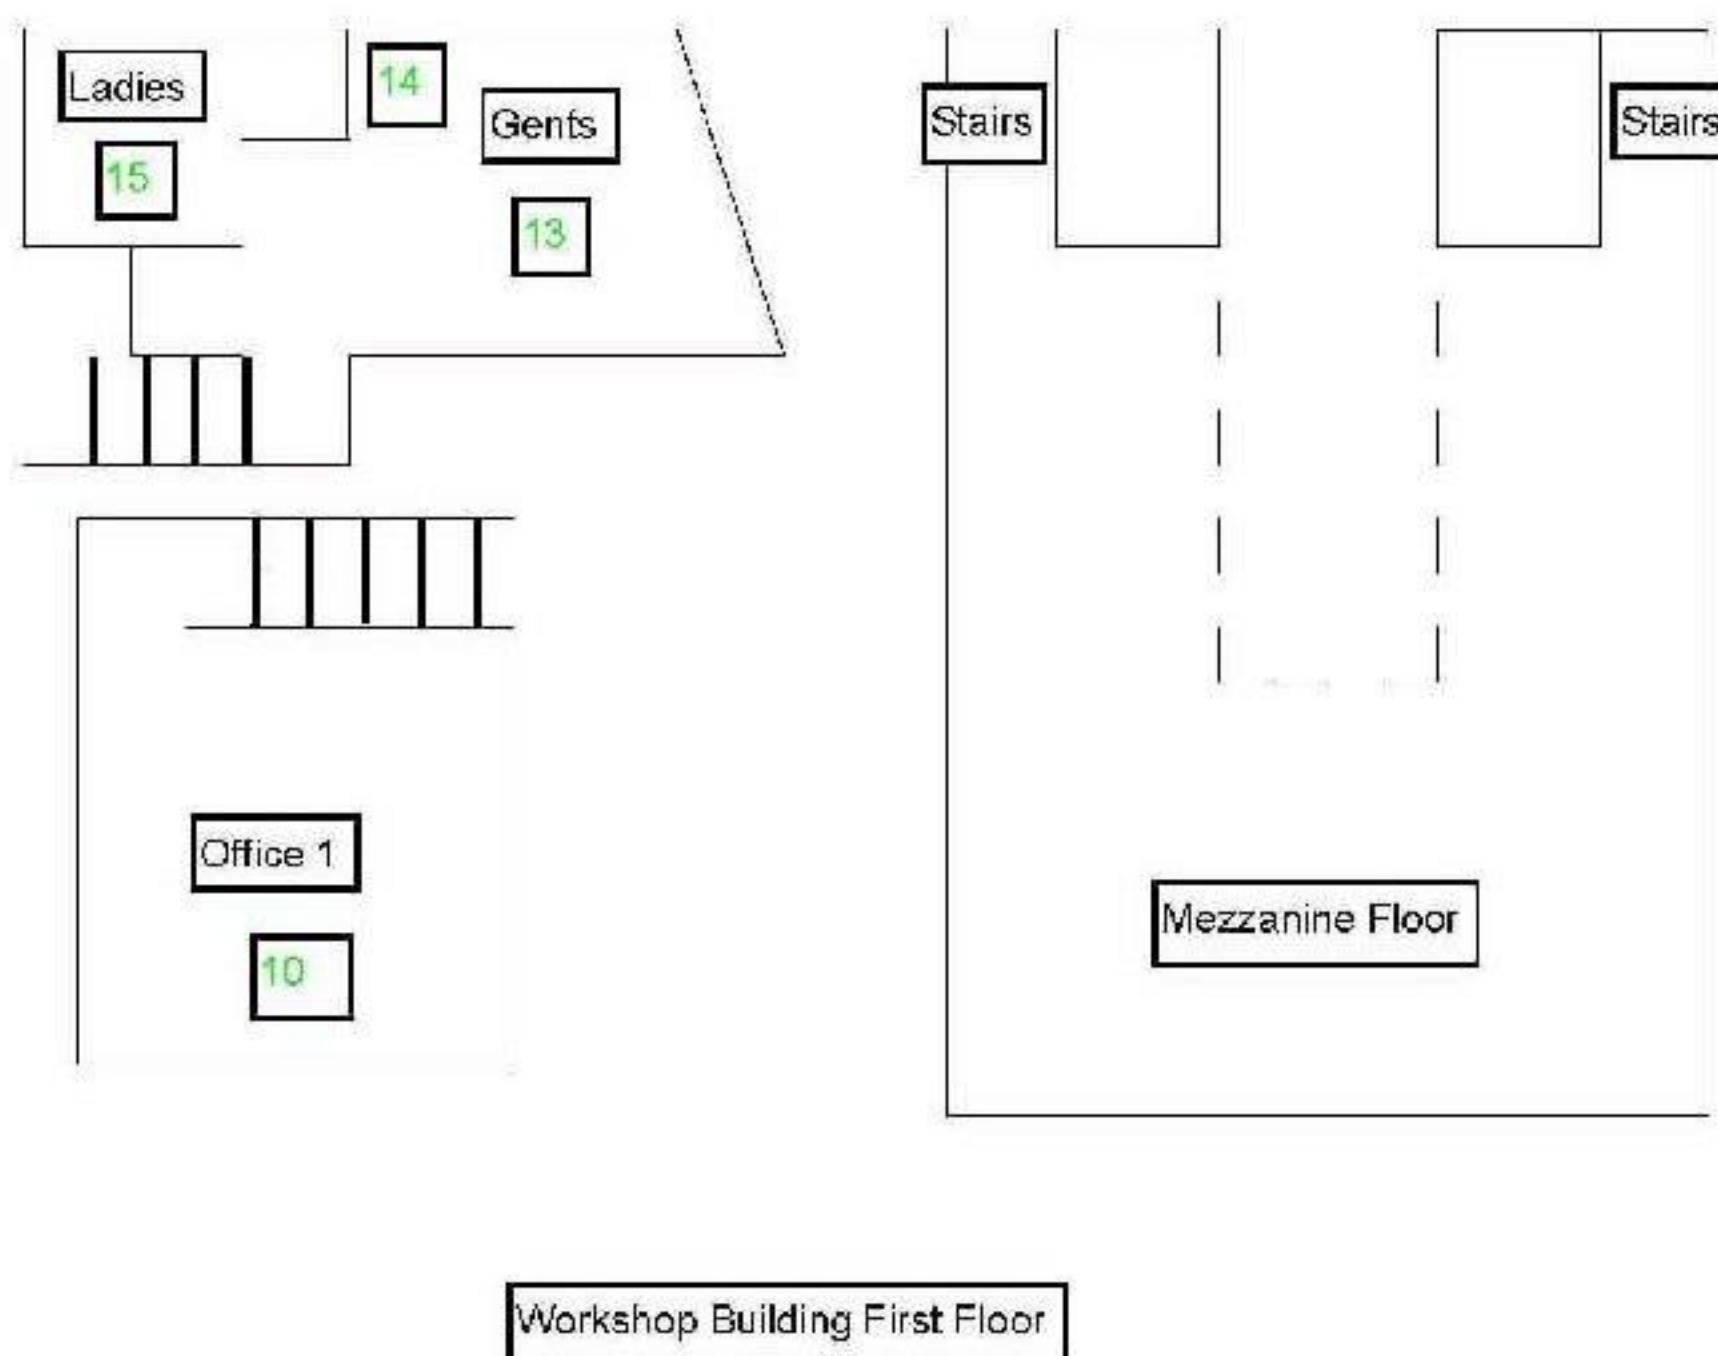
Key: 1 No asbestos identified  
1 Asbestos identified  
R1 Asbestos strongly presumed  
R1 No asbestos strongly presumed  
V1 Asbestos presumed
