**ASBESTOS MANAGEMENT PLAN**  
**for the land at**  
**WOODCROFT FARM PHASES 2B & 3,**  
**WOODCROFT LANE, LOVEDEAN,**  
**HAMPSHIRE, PO8 9QA**  
**on behalf of**  
**VISTRY HOMES SOUTHERN**

| Report: | ASBESTOS MANAGEMENT PLAN |
| Site: | WOODCROFT FARM PHASES 2B & 3, WOODCROFT LANE, LOVEDEAN, HAMPSHIRE, PO8 9QA |
| Reference: | GE18761-AMP-AUG20 |

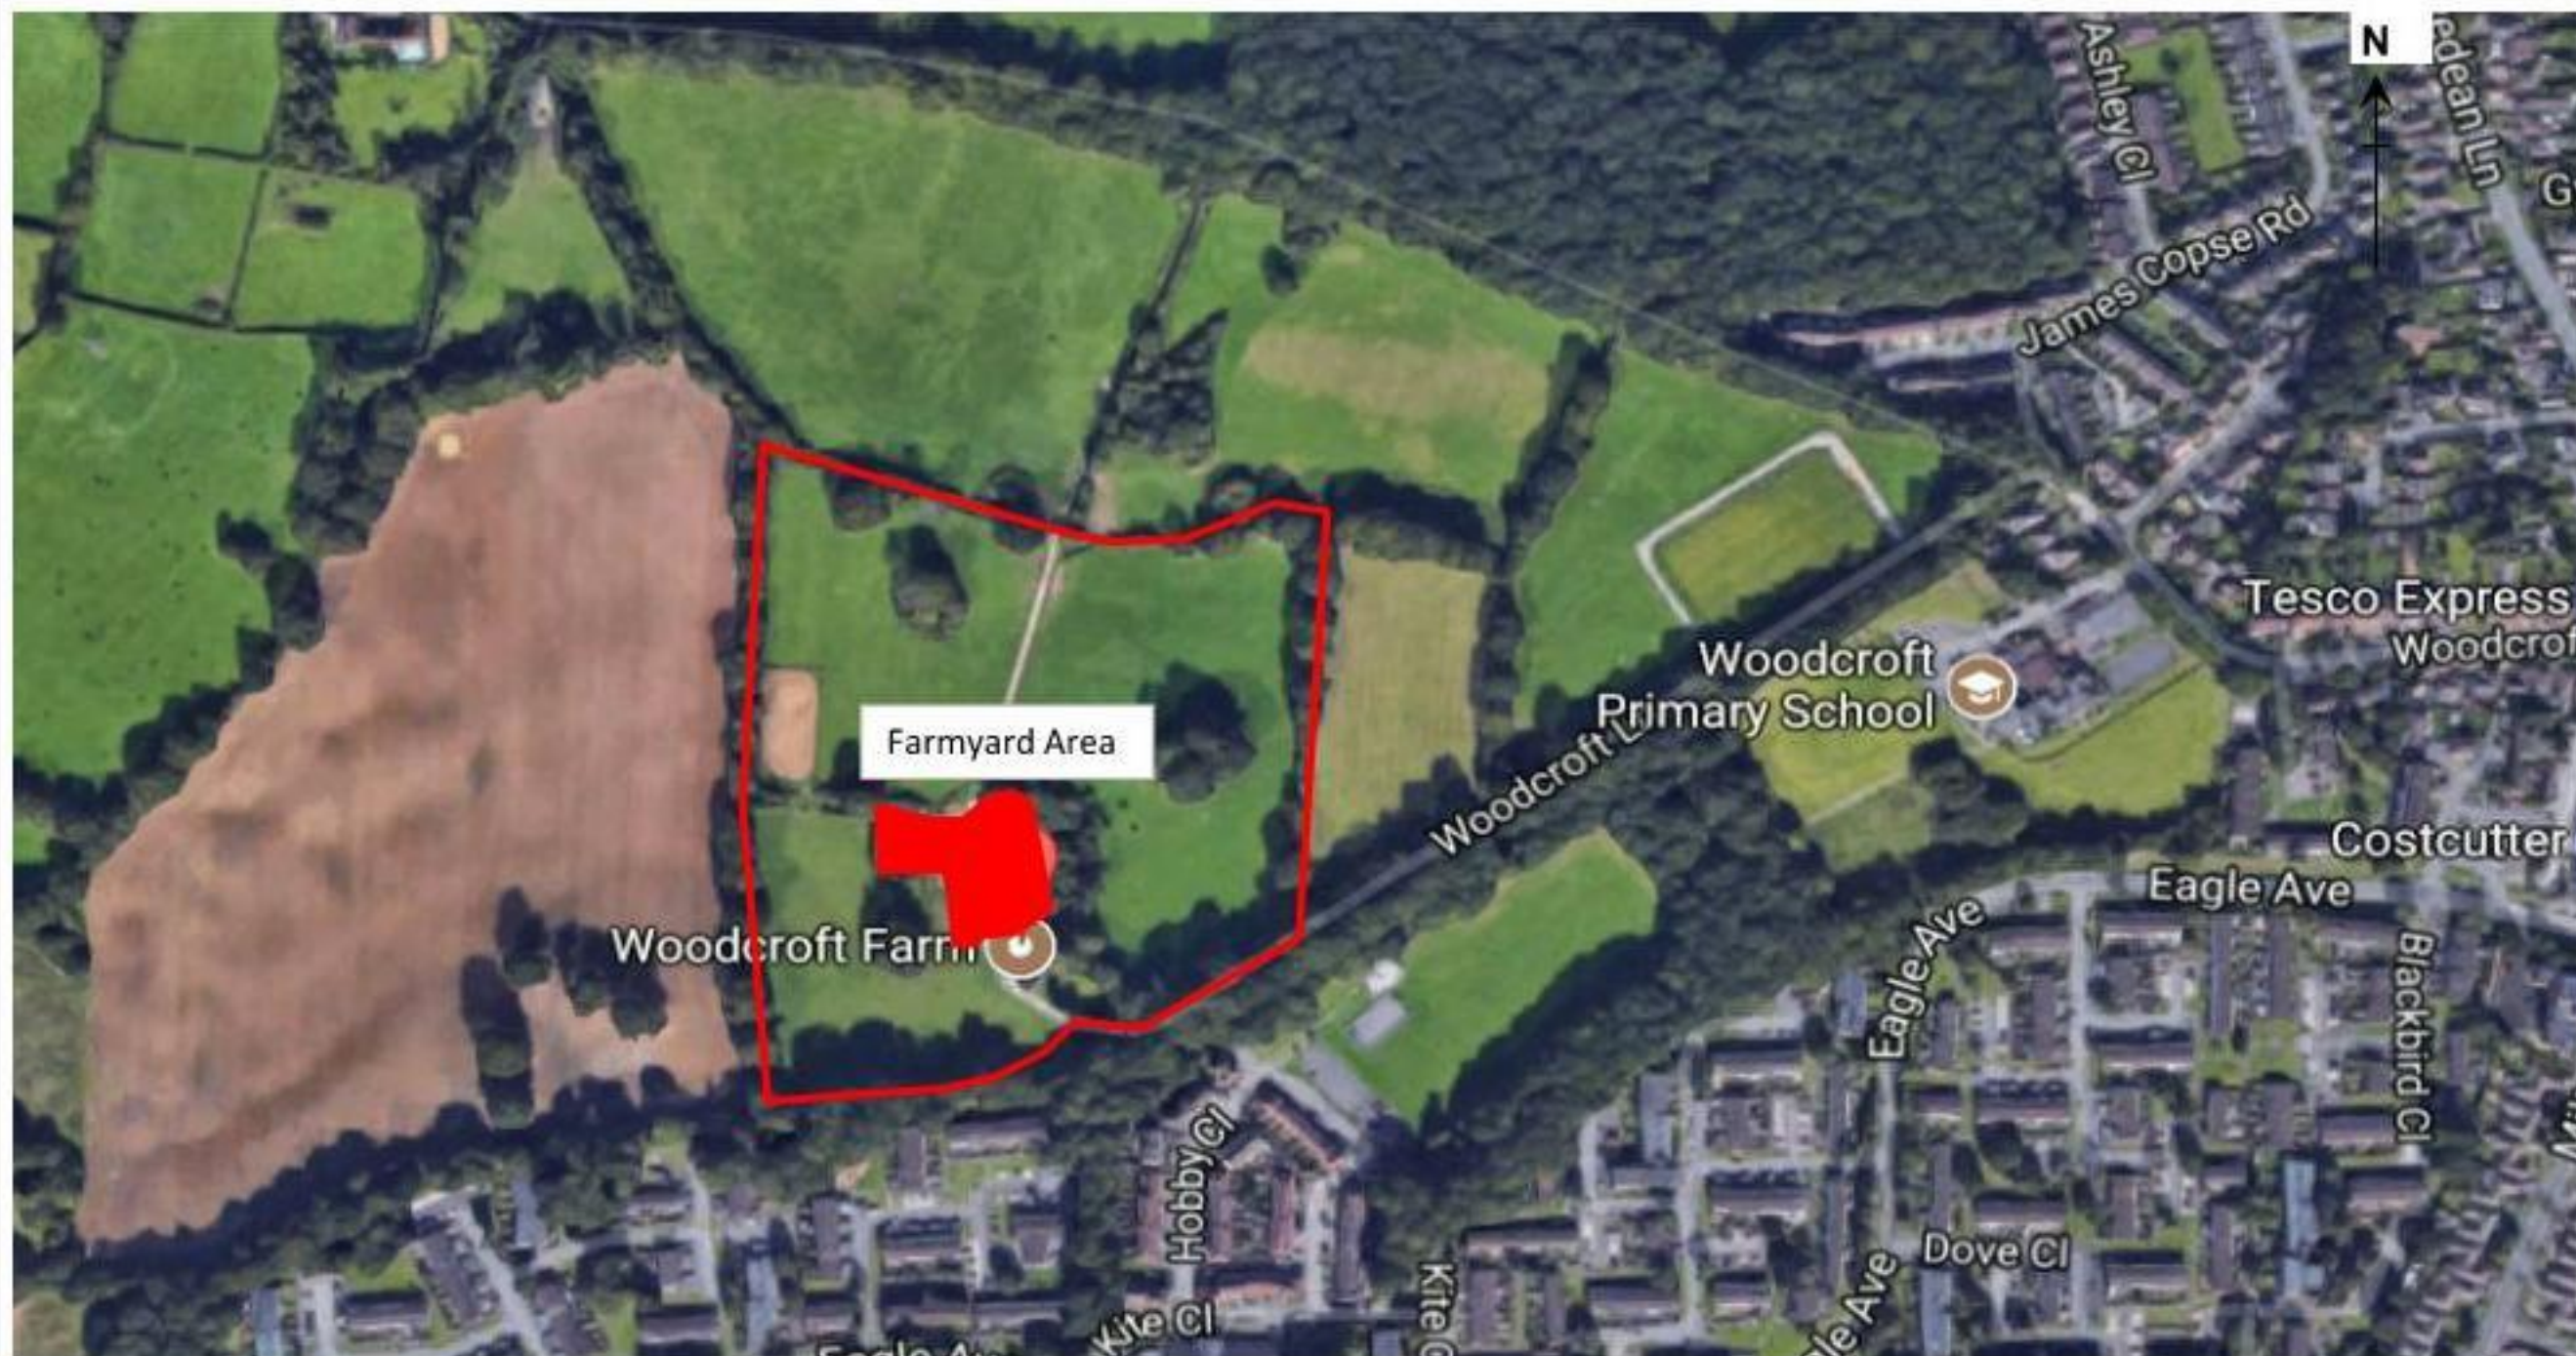
During the Geo-Environmental, August 2017, Ref: GE16662/FG02/170929 intrusive investigation, the farm complex area, shown in Figure 2, comprised a farm house located in the south east of the complex area, with private gardens to the front and rear of the property. To the north and west of the farm house were a number of stable blocks that at the time of the site investigation works were occupied by a number of horses. The stable blocks were constructed on hard standing, generally concrete, and comprised a mixture of wooden stables and stables constructed within breeze block barns. These barns were noted to have corrugated roofs that have the potential to contain asbestos.

| <b>Project:</b> | Woodcroft Farm, Lovedean, PO8 9QA | | | <b>Title</b> | Location of Farmyard Area | |

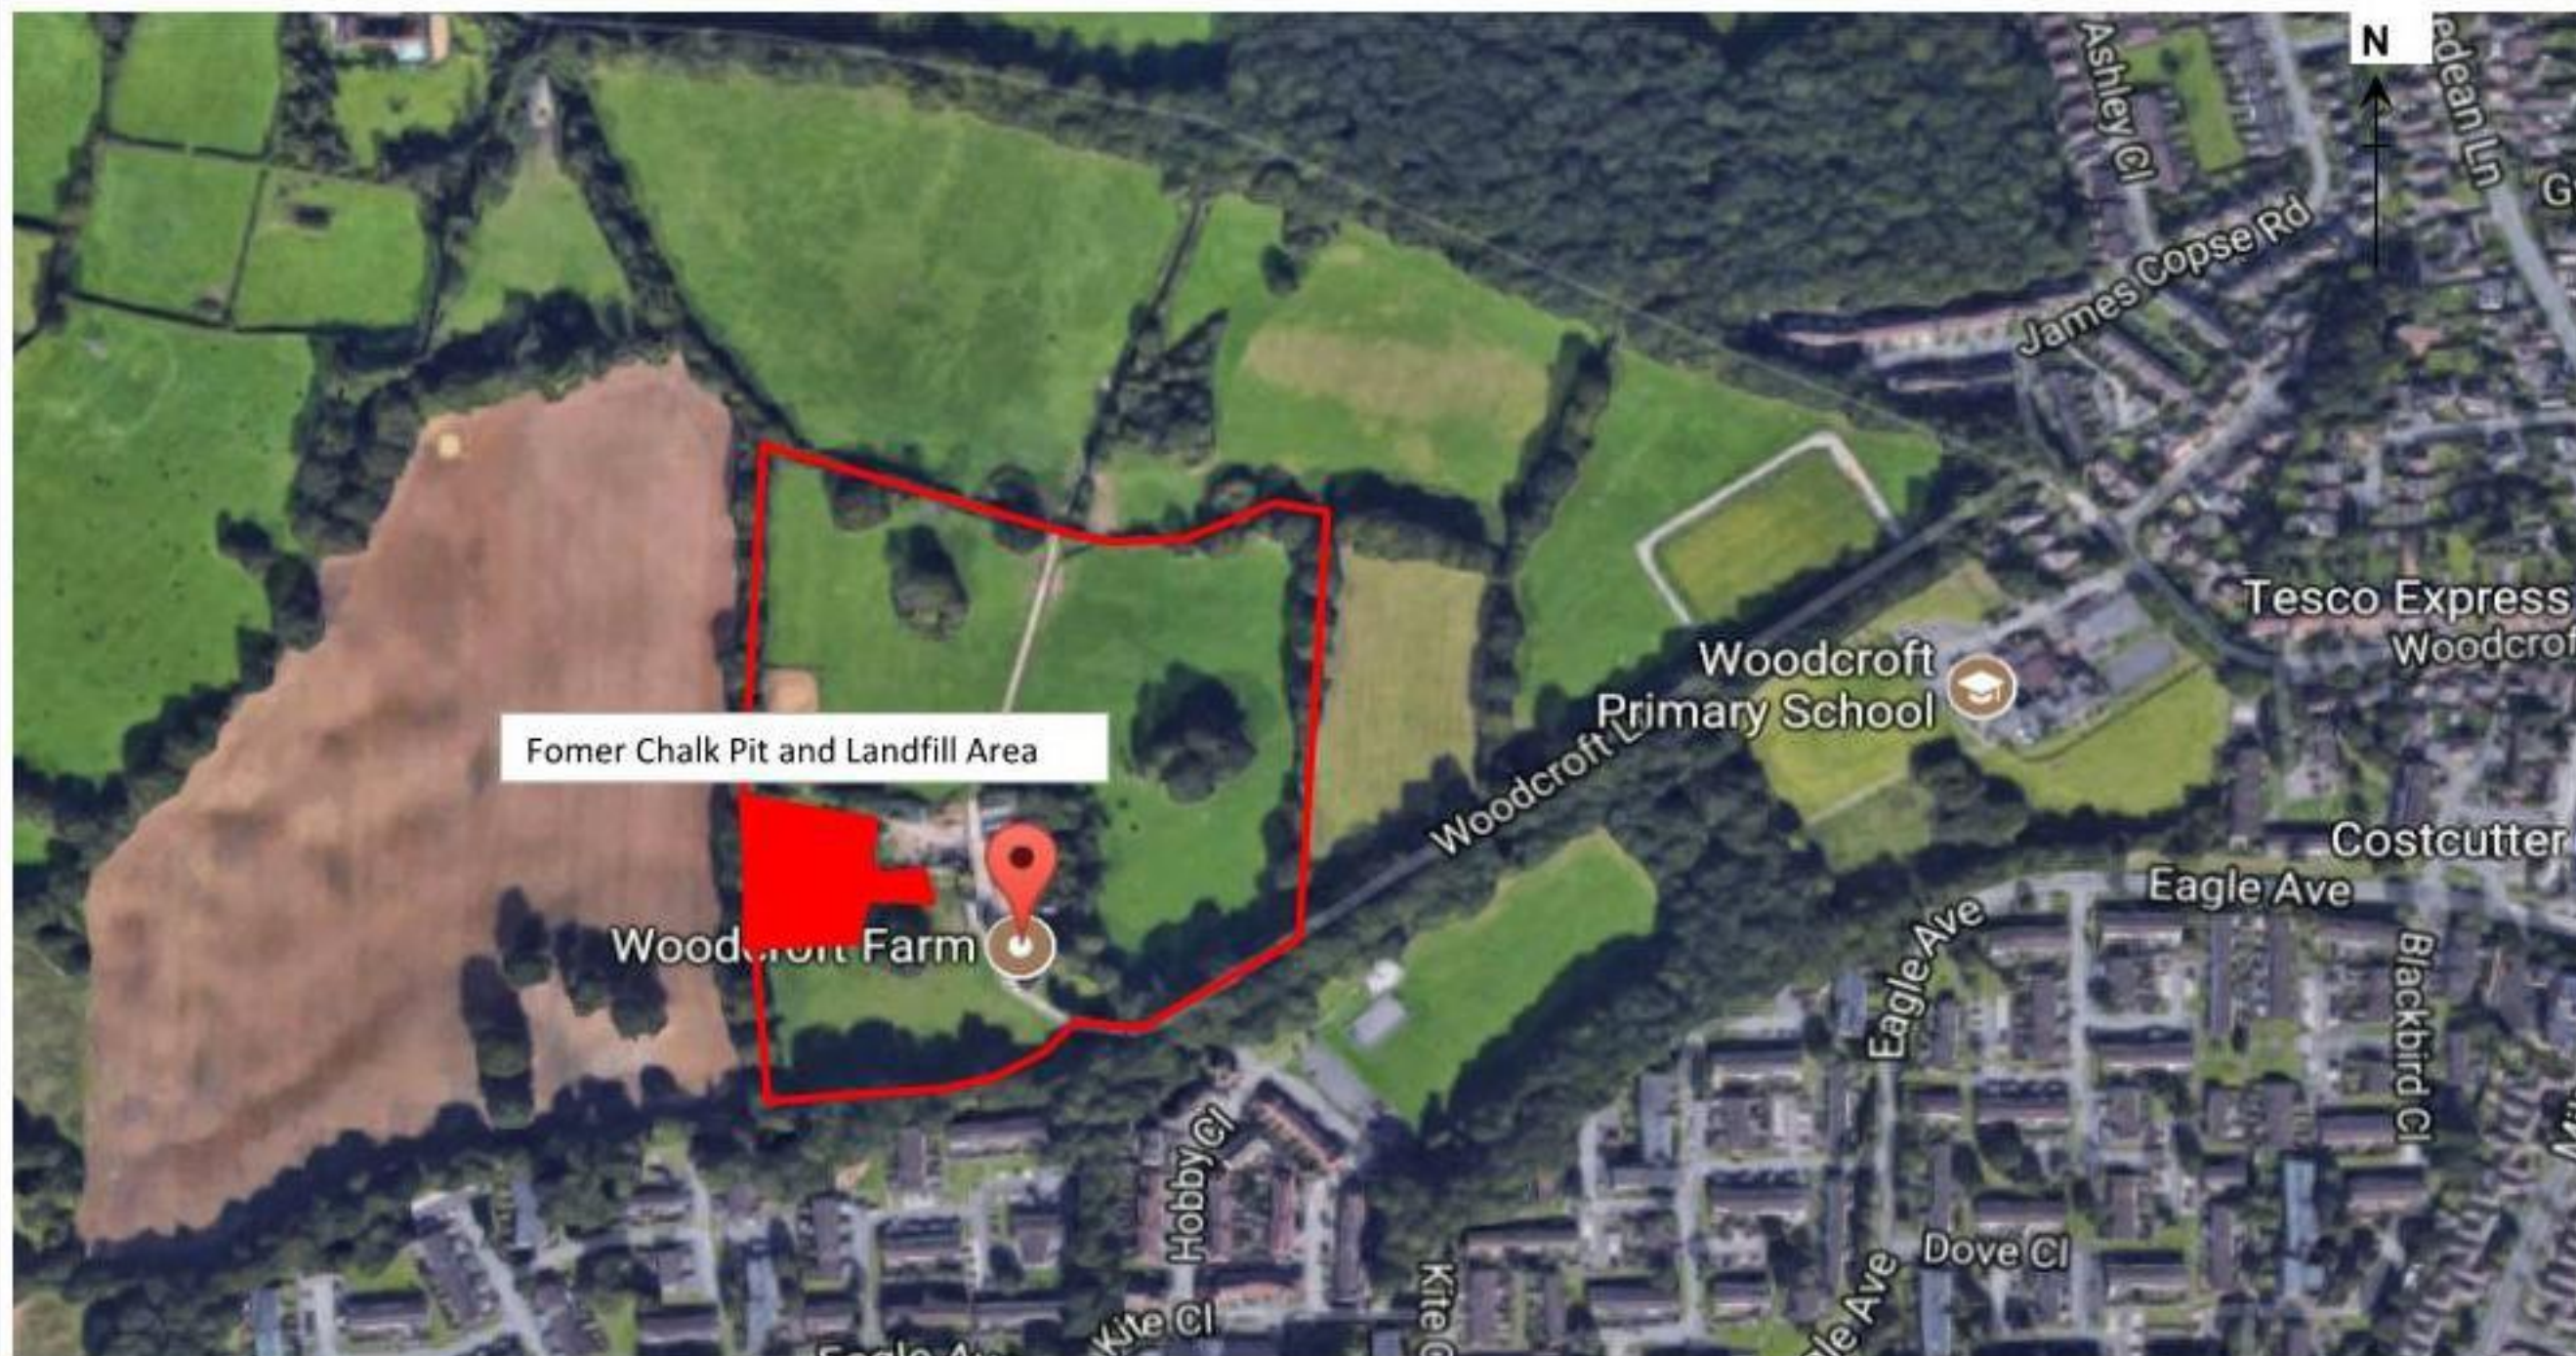
| <b>Project:</b> | Woodcroft Farm, Lovedean, PO8 9QA | | | <b>Title</b> | Location of Former Chalk Pit and Landfill Area | |

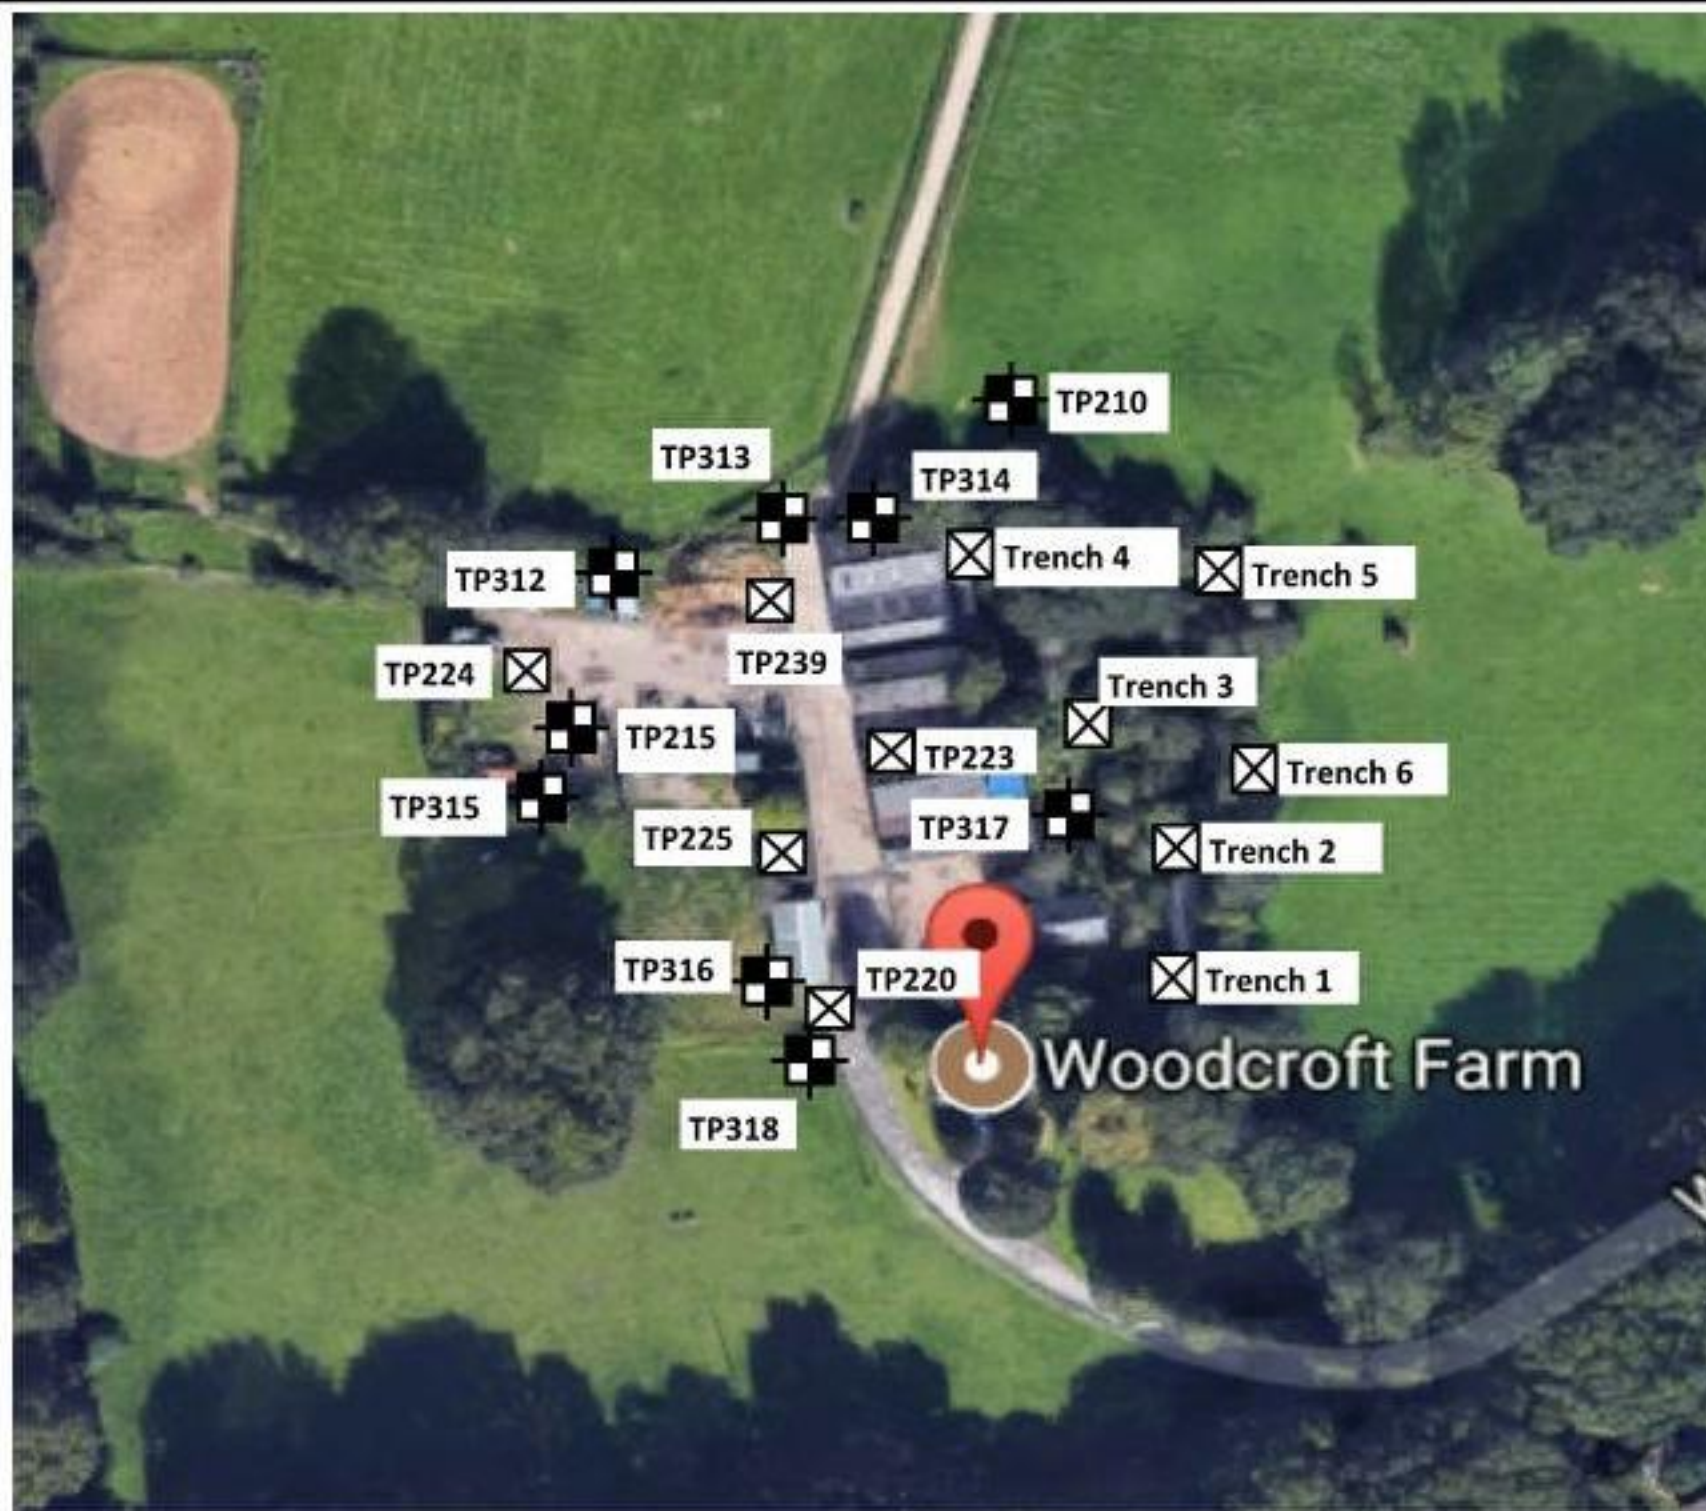
| <b>Project:</b> | Woodcroft Farm, Lovedean, PO8 9QA | | | <b>Title</b> | Exploratory Hole Locations - Farmyard Area | |

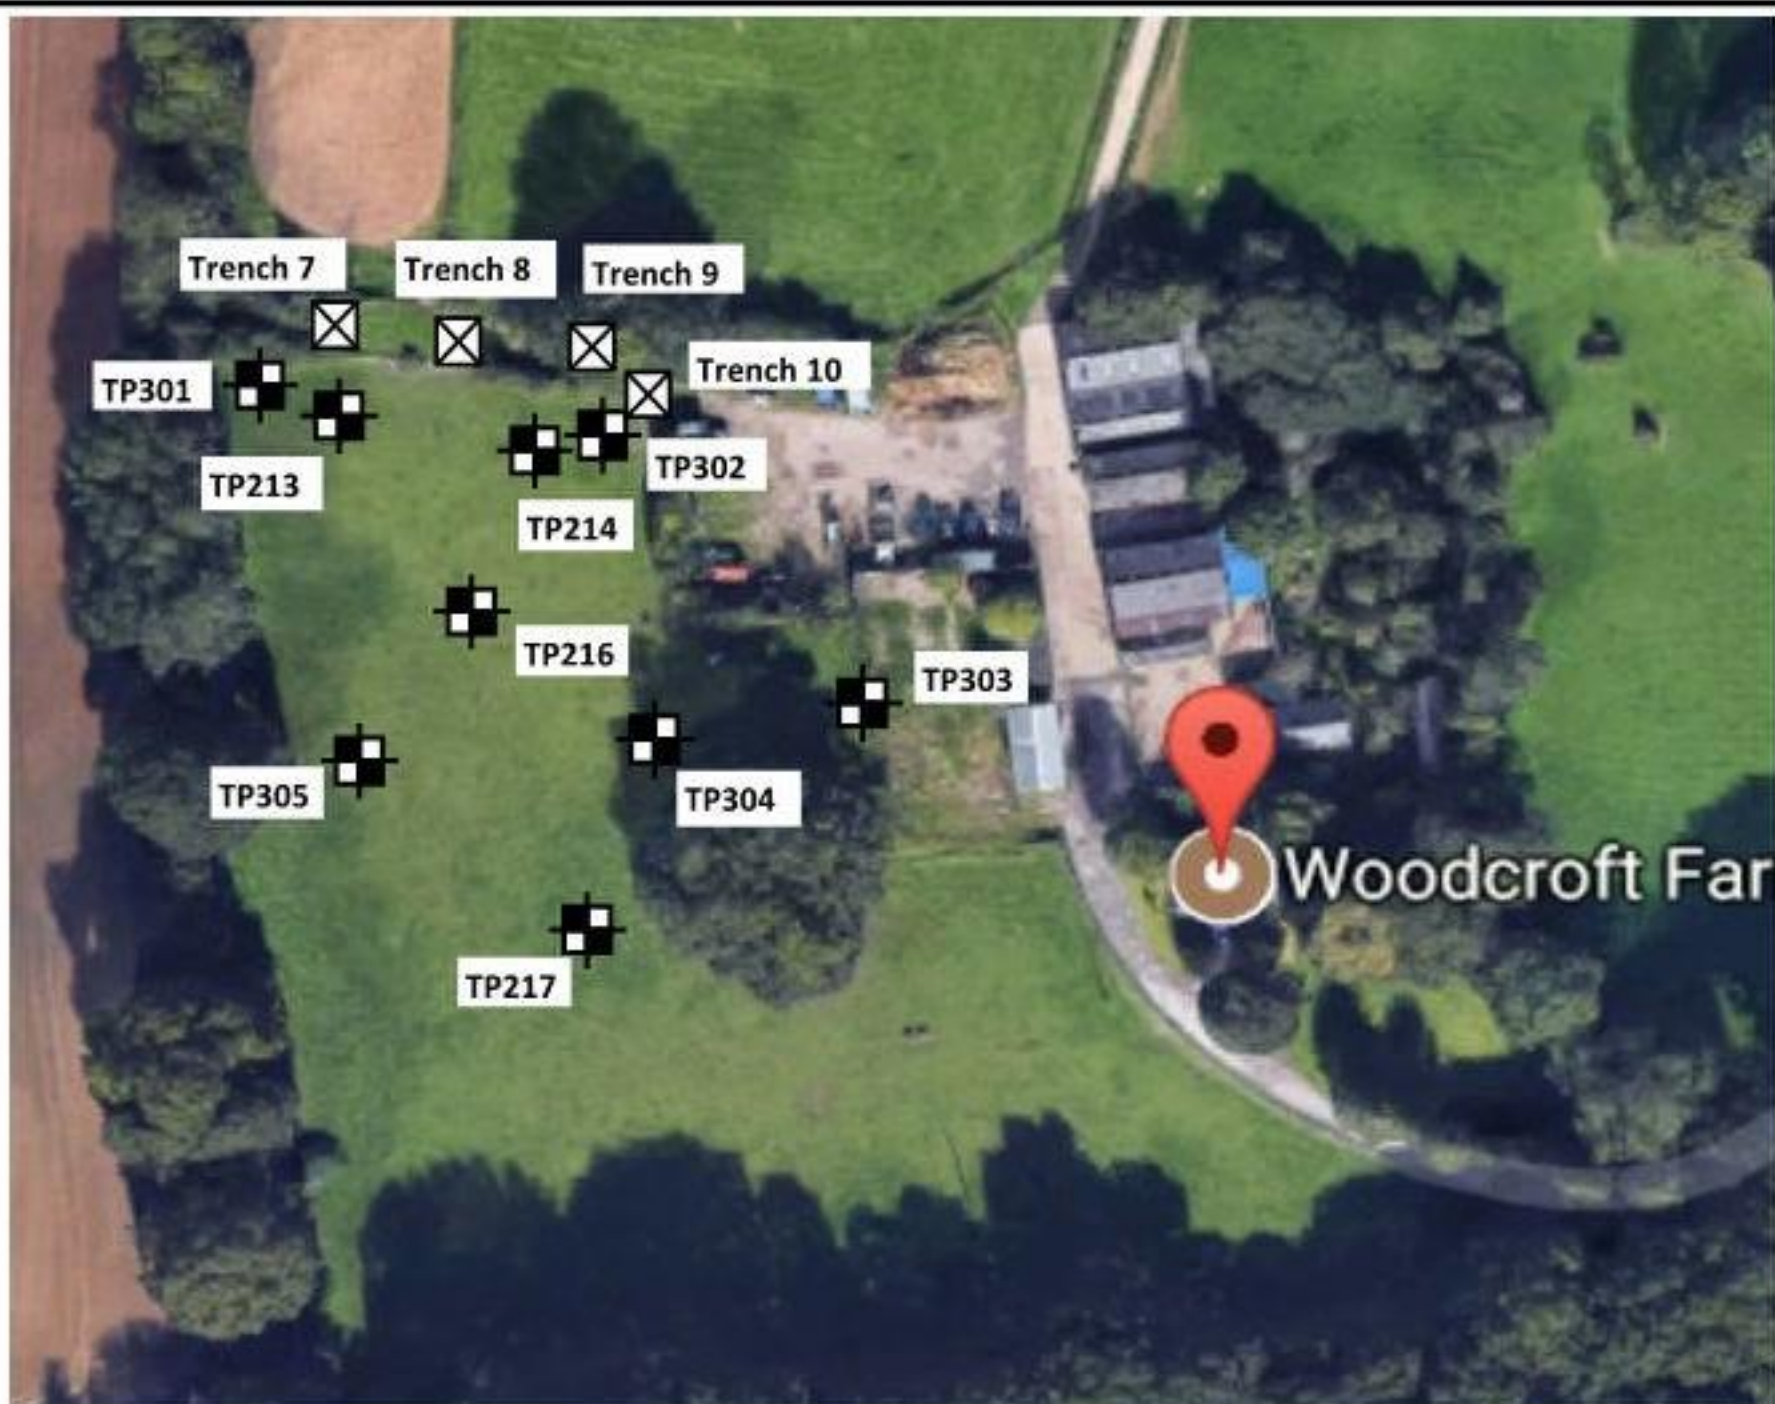
| <b>Project:</b> | Woodcroft Farm, Lovedean, PO8 9QA | | | <b>Title</b> | Exploratory Hole Locations - Trial Pit and Trenches - Landfill Area | |

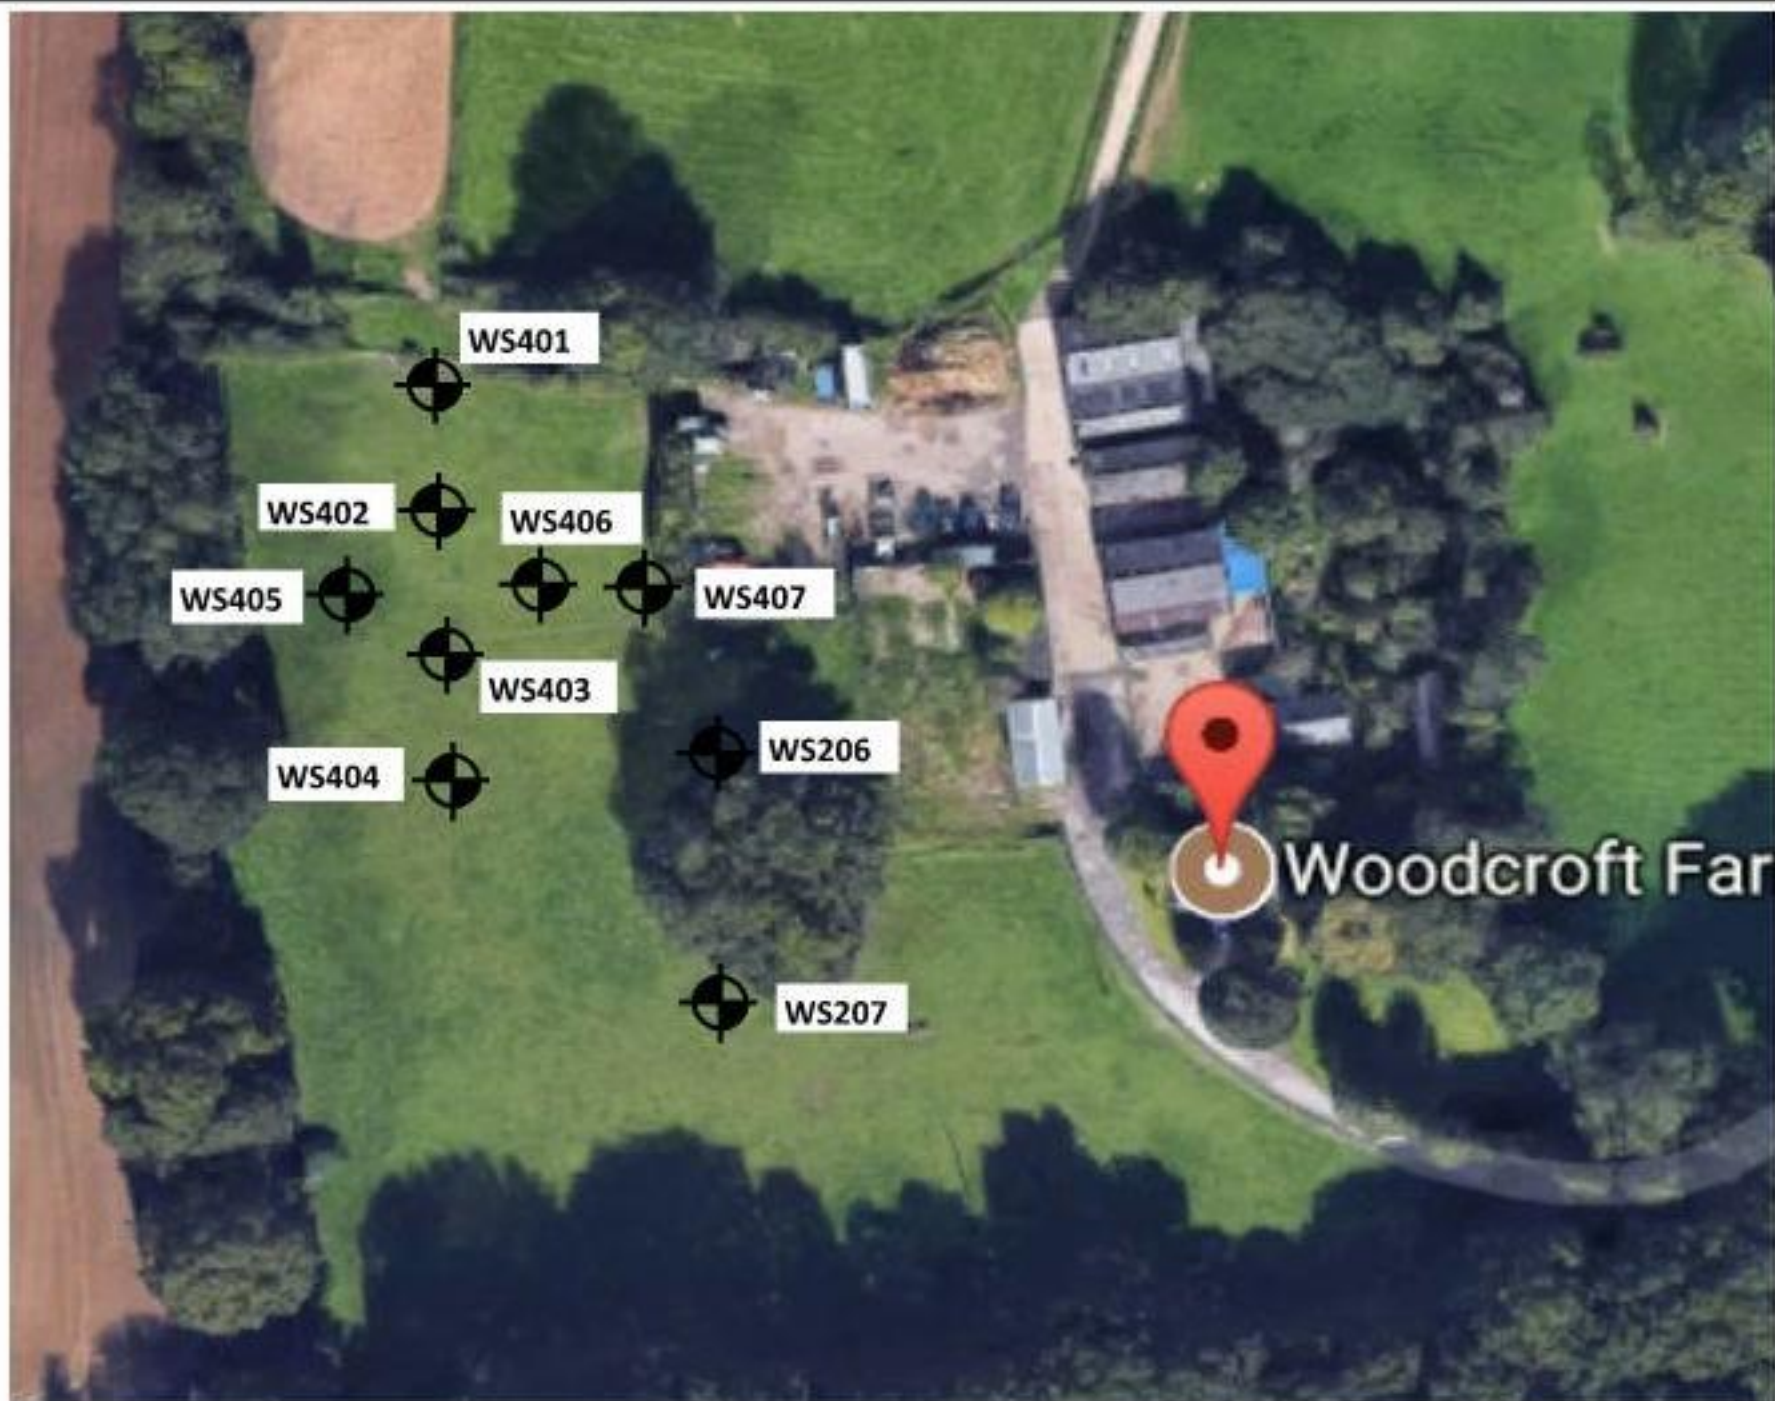
| <b>Project:</b> | Woodcroft Farm, Lovedean, PO8 9QA | | | <b>Title</b> | Extent of Made Ground - Window Sampler Boreholes - Landfill Area | |

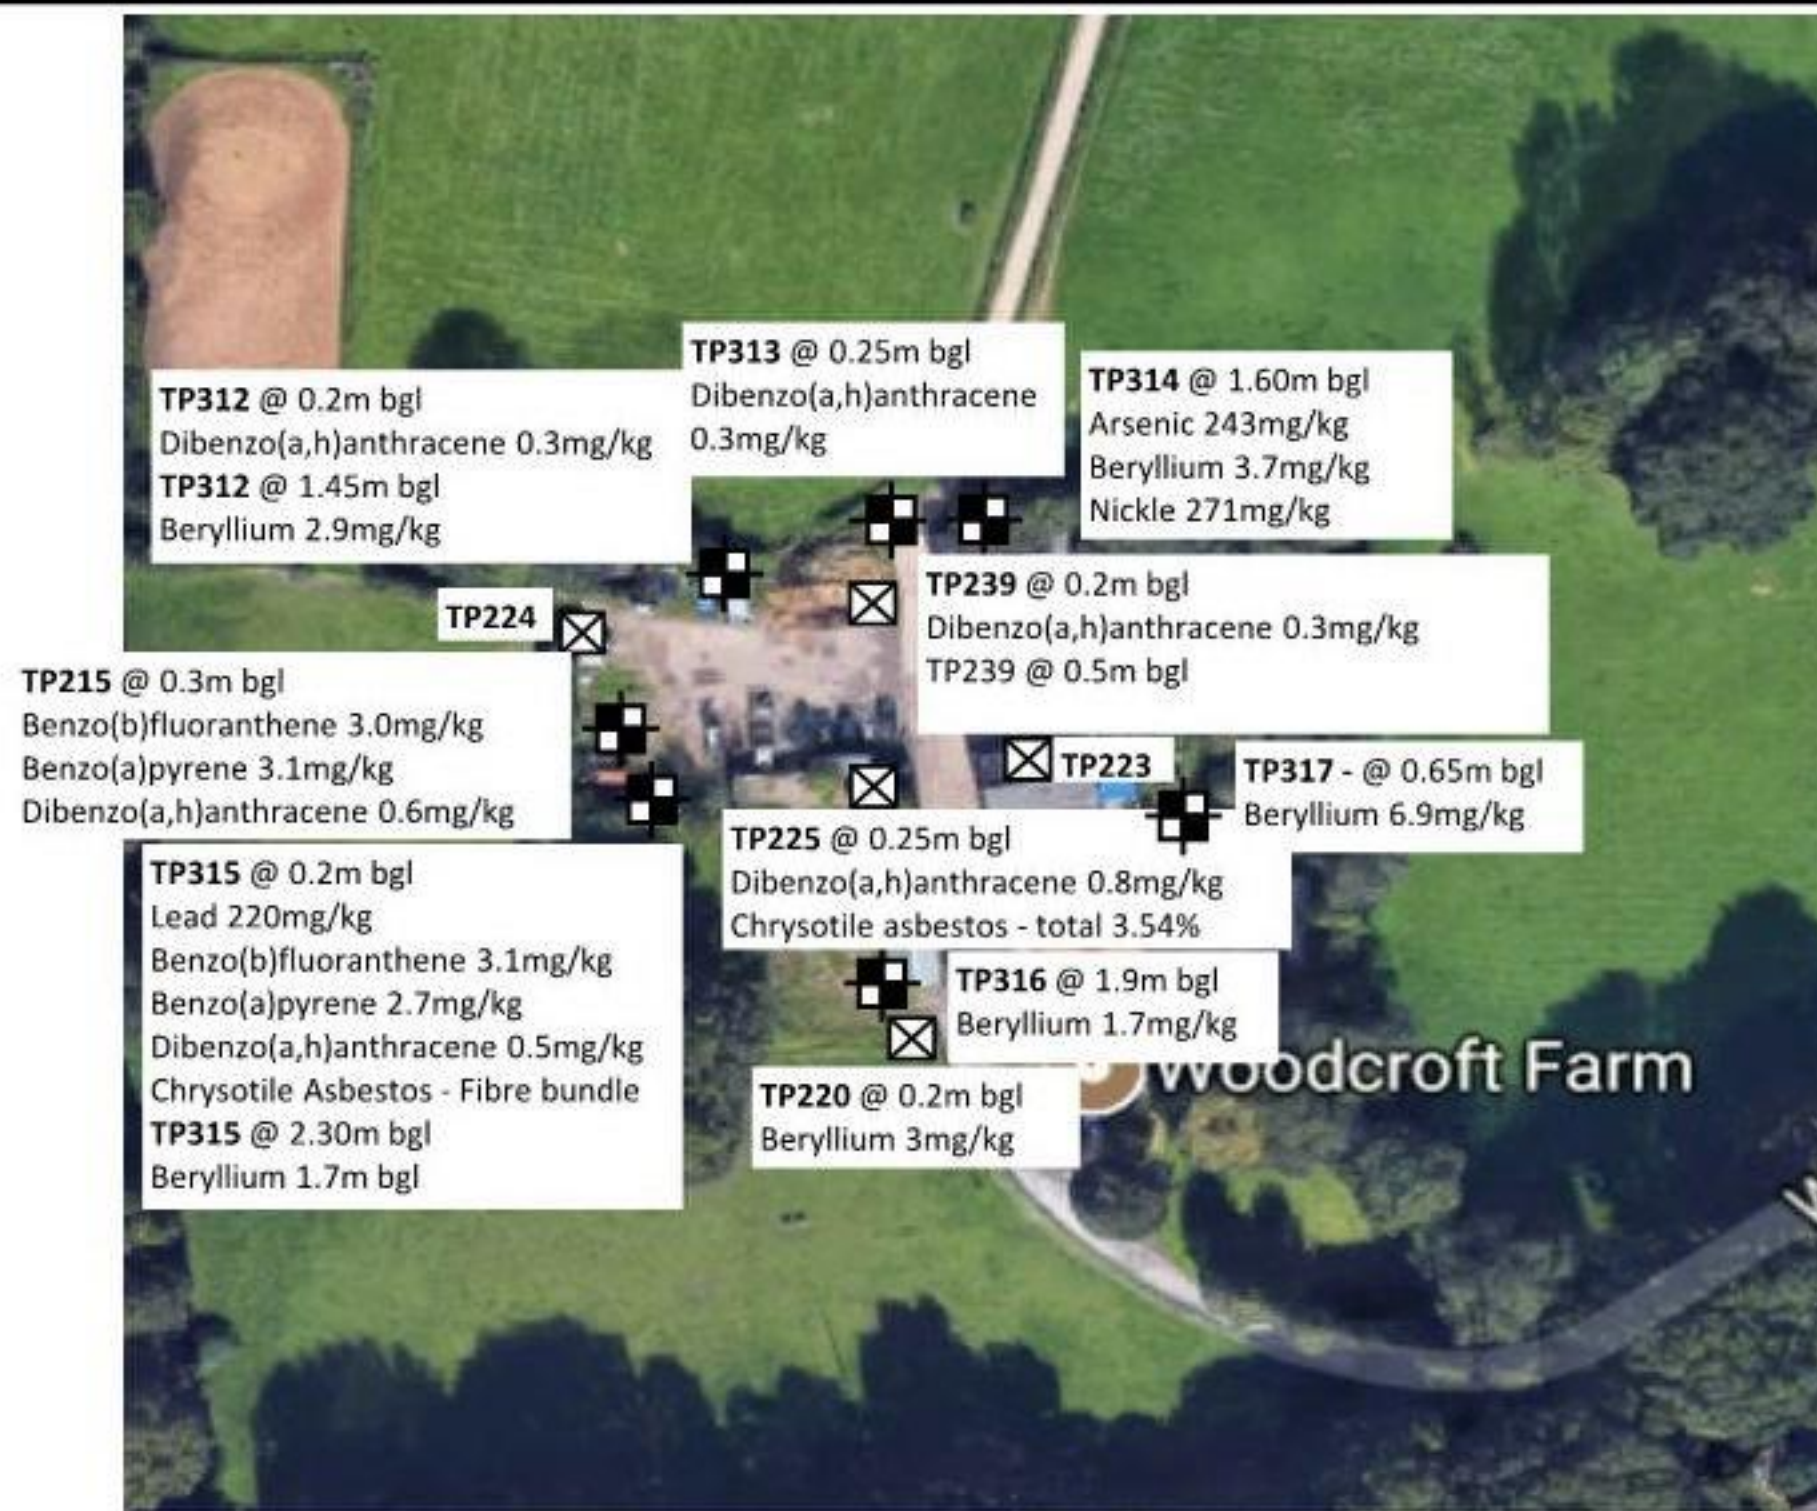
| <b>Project:</b> | Woodcroft Farm, Lovedean, PO8 9QA | | | <b>Title</b> | Soil Contamination Exceedances - Farmyard Area | |

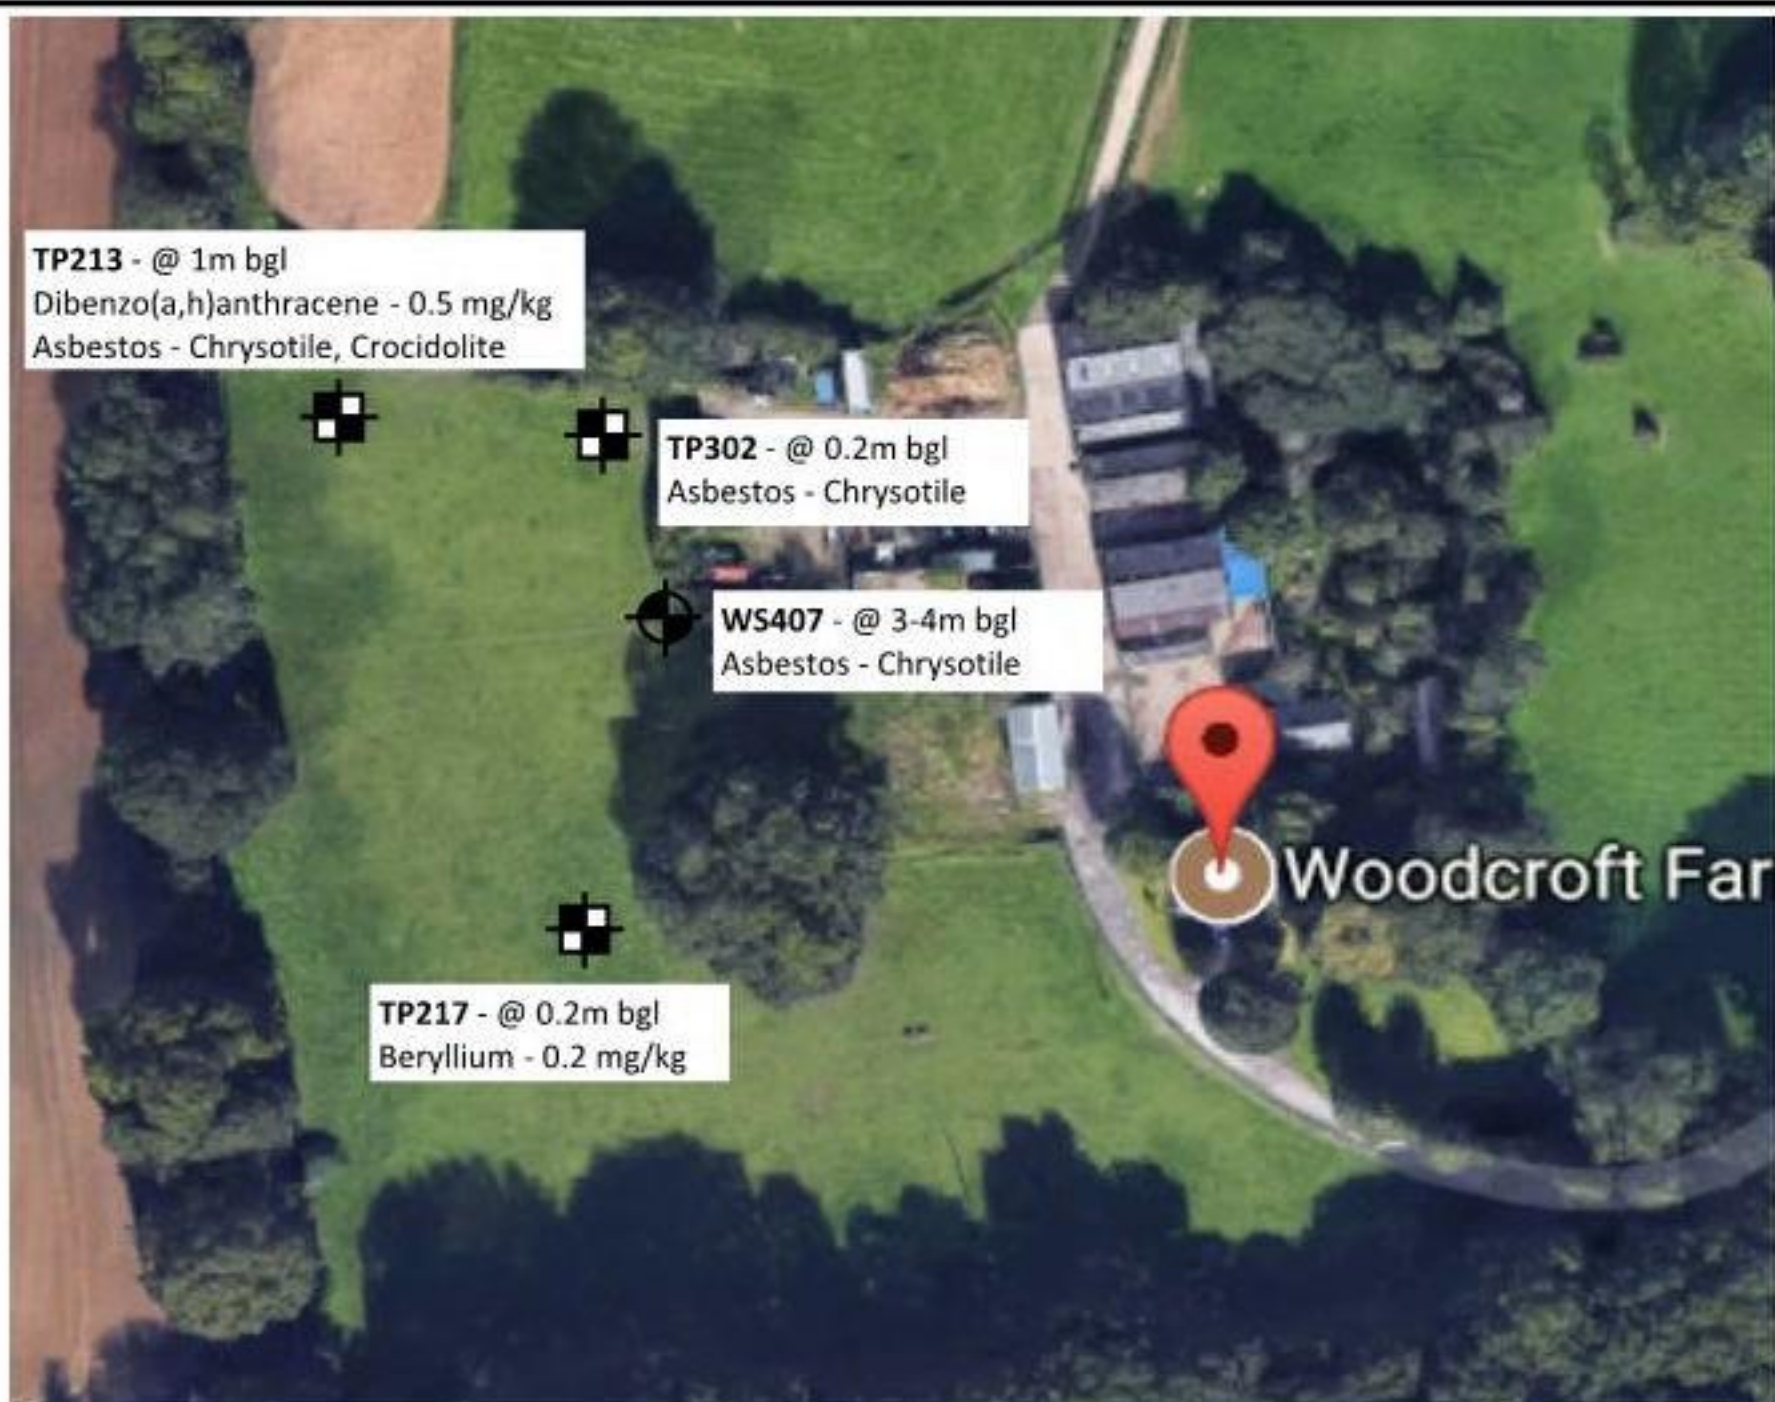
| <b>Project:</b> | Woodcroft Farm, Lovedean, PO8 9QA | | | <b>Title</b> | Soil Contamination Exceedances - Landfill Area | |
