## **Extended Phase I Habitat survey at:**

The Orchard House, Western Avenue, Emsworth, Hampshire,  
PO10 7LP

Reference Number: AE/3602

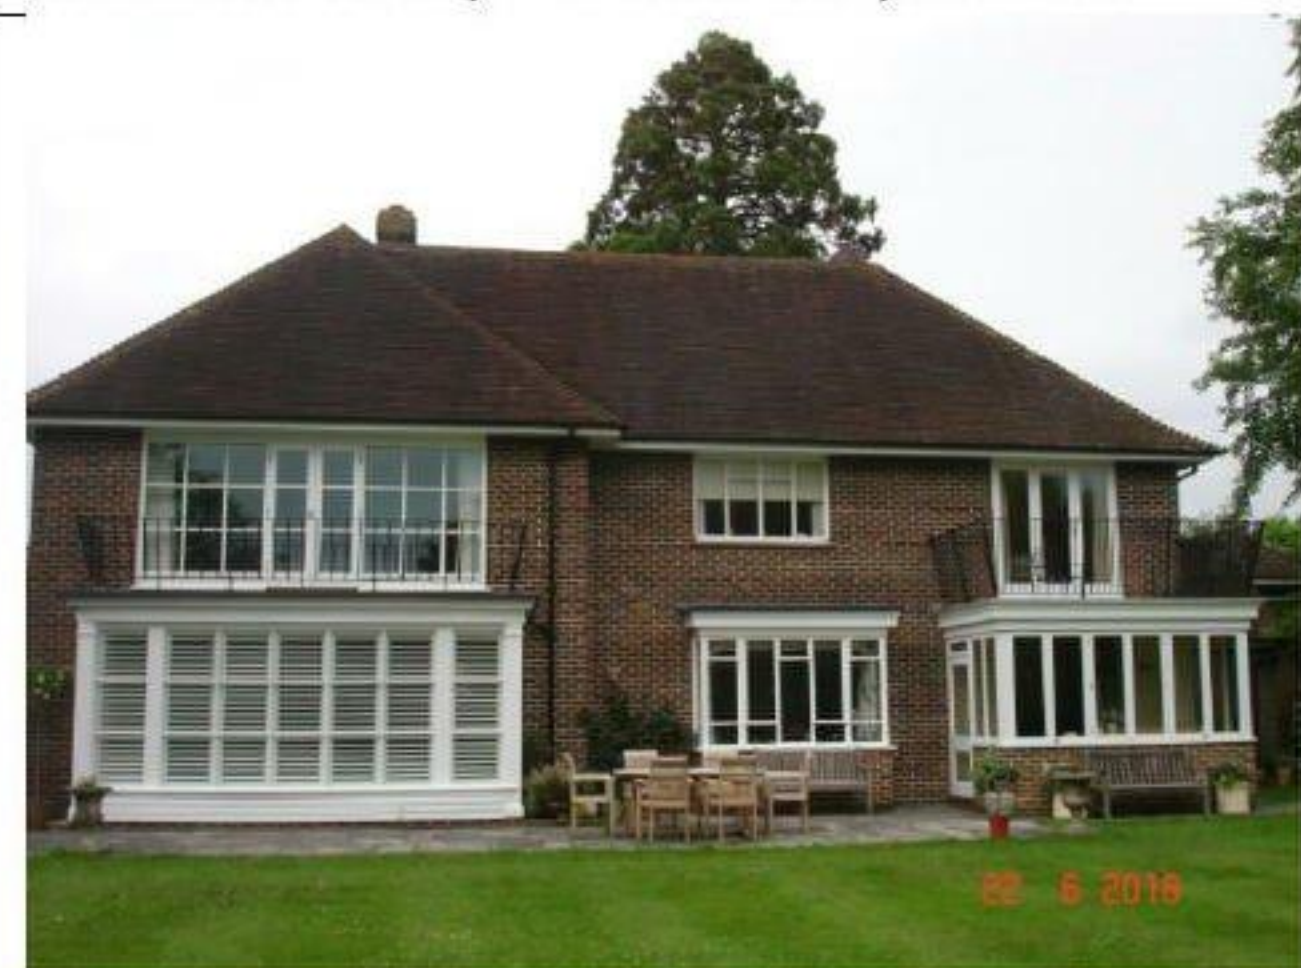
Photograph 1: View of southern aspect of residential building.

- The building is a two storey brick construction with a hipped roof.
- Flat clay tiles and clay ridge tiles are present on the roof. A number of raised and missing tiles are present on all aspects and the roof was assessed as having moderate potential for crevice dwelling bats.
- Two chimneys are present. These are lead sealed with slight gaps under the lead.
- Wooden soffits are present. These are in good condition with no gaps noted.
- Wooden windows and door frames are present. No gaps were noted.
- Metal guttering is present. This is in good condition.

- The building has one internal void that has been partially converted to internal storage space using wooden walls. The remaining void space surrounds this internal storage area and is fully accessible.
- The remaining void space measures approximately 17m in length, 8m in width and 4m in height.
- A ridge beam is present and runs over the top of the internal space.
- Bituminous felt lining is present. This is in good condition with no holes noted.
- The two chimney stacks are present and well sealed.
- The void is insulated.
- Purlin supports are present.
- No evidence of bats was recorded in the void.

- As moderate potential for crevice dwelling bats was recorded on several of the buildings during the phase 1 bat survey, phase 2 bat surveys are required on these buildings to determine whether bats are present.
- These surveys must be conducted between May and September with at least one of the surveys on each affected building being undertaken during the optimum survey period between mid-May and August.
- Depending on the results of the phase 2 surveys, an additional survey may be required on buildings where bats are confirmed as roosting.
- Depending on the results of the phase 2 surveys, a European Protected Species licence from Natural England may also be required. Appropriate mitigation such as timing of works may be included in the EPS licence.

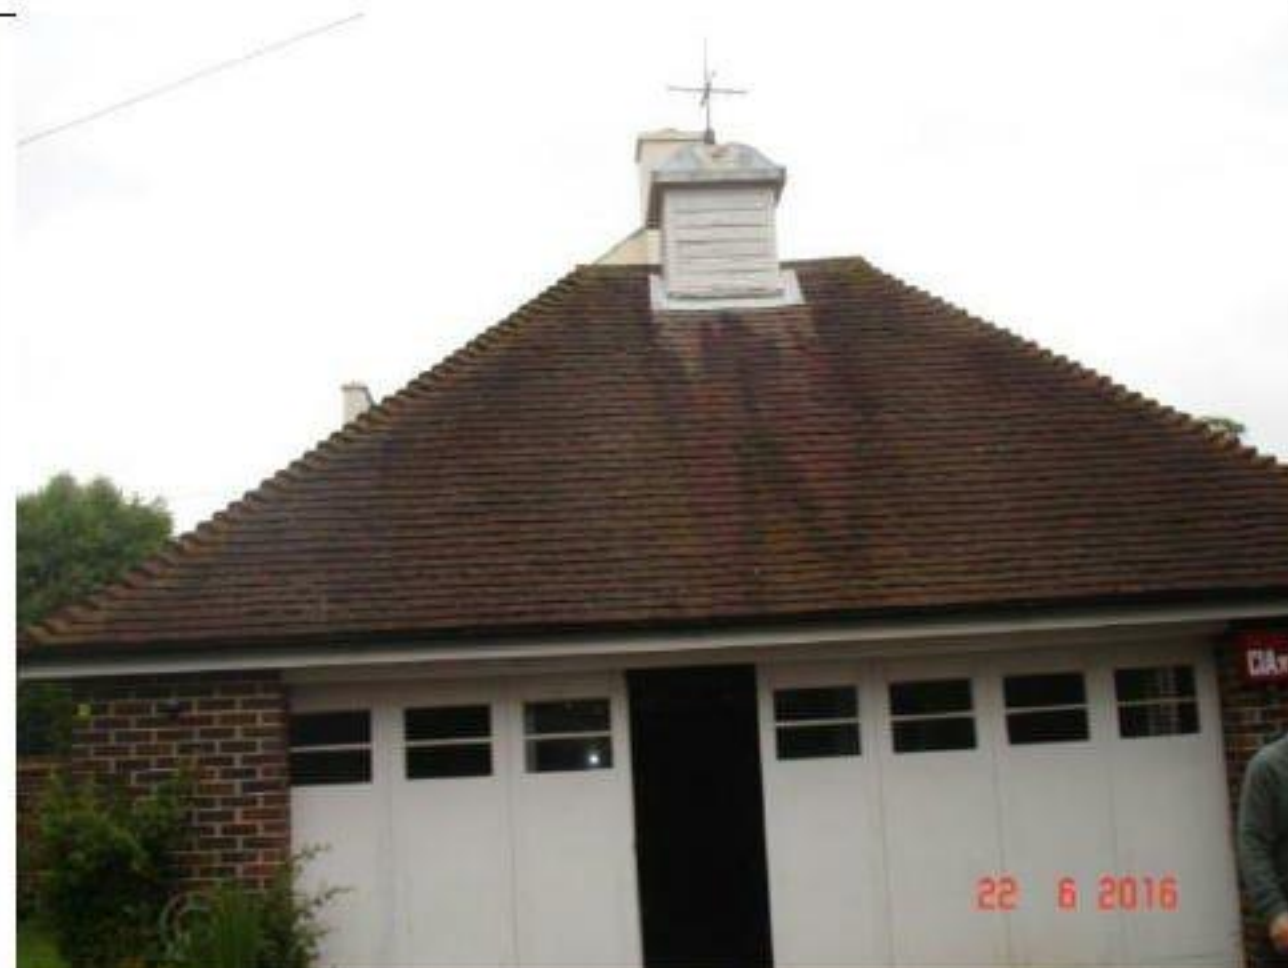
Photograph 2: View of the southern aspect of one of the detached double garages.

- The garage is a single storey brick construction with a hipped roof.
- A small wooden weathervane tower is present in the centre of the roof. This is well sealed with lead.
- Clay tiles and clay ridge tiles are present. A number of missing and raised tiles are present and the building was assessed as having moderate potential for crevice dwelling bats.
- Wooden soffits are present. These are well sealed with no gaps noted.
- A large wooden concertina door is present. This is well sealed with no gaps noted.

- The building has an internal void measuring approximately 10m in length, 8m in width and 2.75m in height.
- A ridge beam is present. This was noted as being heavily cobwebbed.
- Bituminous felt lining is present. This is in good overall condition.
- Light cobwebs were noted throughout the internal space.
- No external access points were noted.
- The void has been fully boarded and is easily accessible. A full inspection of the boards revealed no evidence of bats internally.

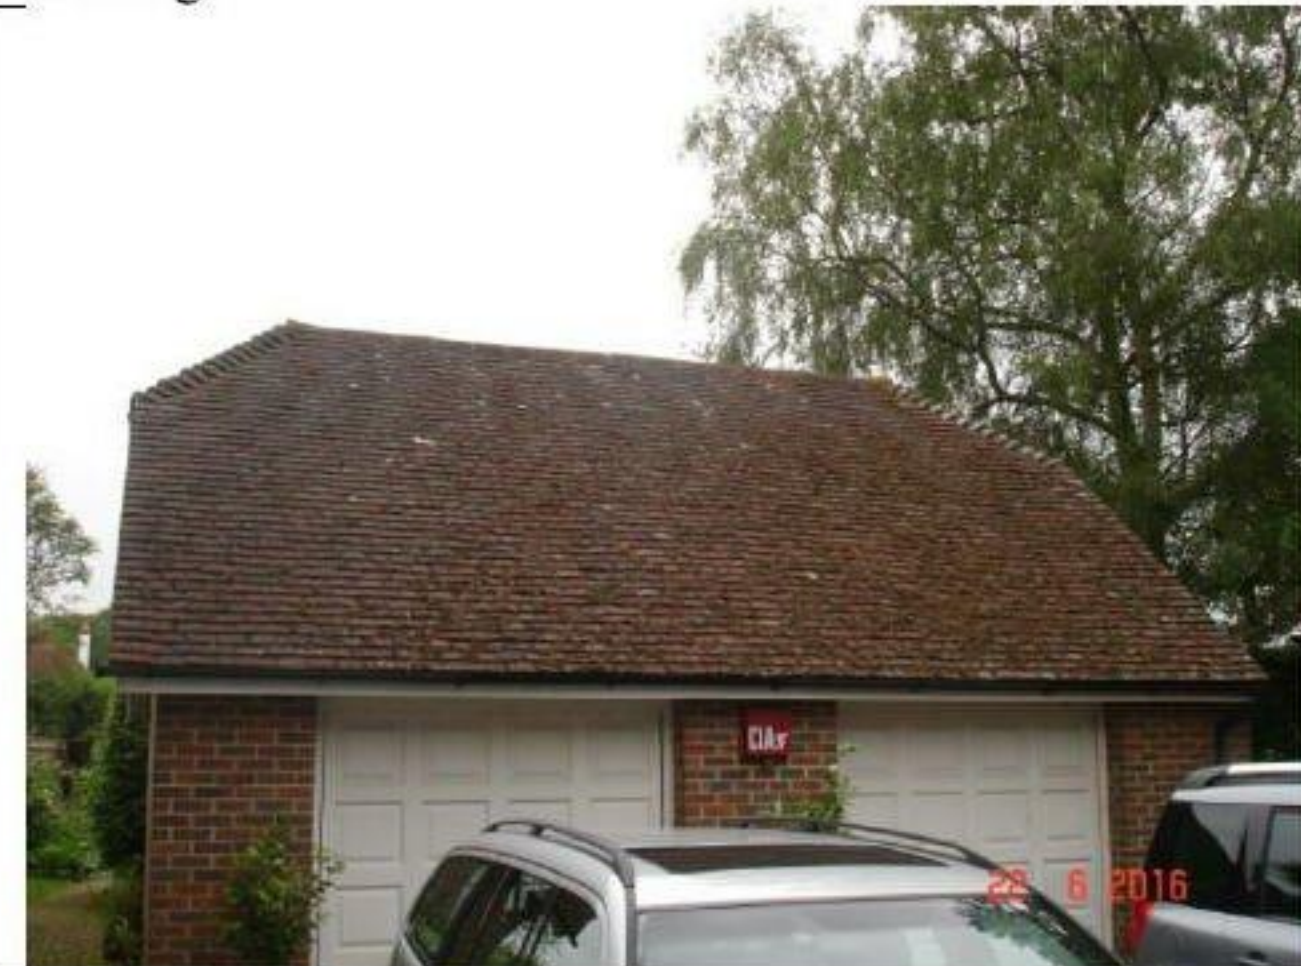
Photograph 3: View of the western aspect of the second detached garage.

- The garage is a single storey brick construction with a hipped roof.
- Clay tiles and clay ridge tiles are present. The tiles are substantially moss covered on the eastern aspect but less so on the western aspect. The western aspect was assessed as having low potential for crevice dwelling bats due to raised and missing tiles.

- Wooden soffits are present on the building. A slight gap was noted along one of the soffits but is cobwebbed over.
- Two metal garage doors are present. These are well sealed with no gaps.
- A wooden framed window is present at each gable end.

- The building has an internal void that is occasionally used and reasonably well lit from the windows.
- The void measures approximately 10m in length, 8m in width and 2.5m in height.
- A ridge beam is present.
- Bituminous felt lining is present. This is in good condition throughout.
- Purlin supports are present.
- The void is fully boarded throughout. An inspection of the boards recorded no evidence of bats.

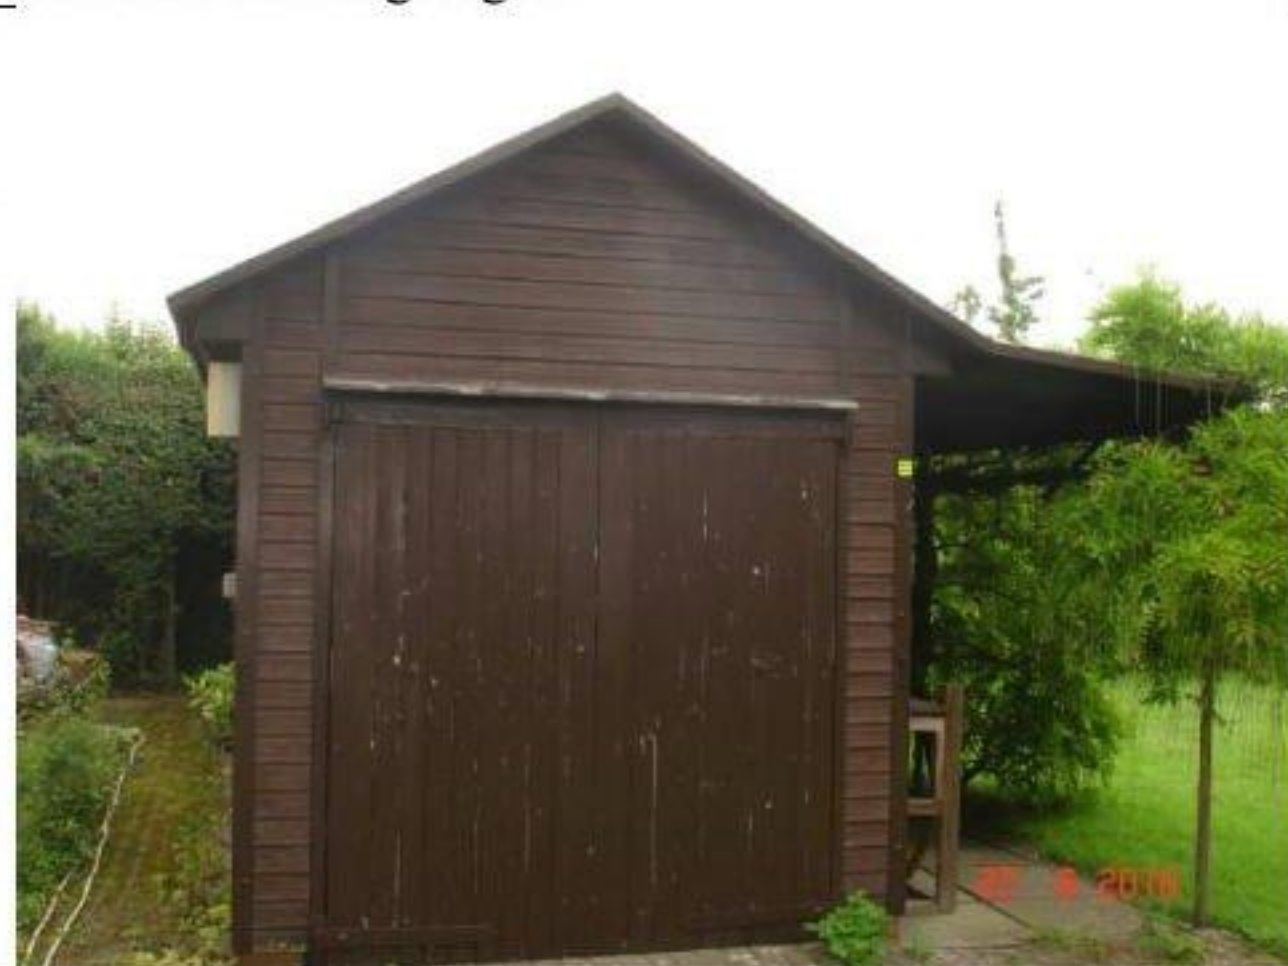
Photograph 4: View of the western end of the wooden potting shed.

- The building is a single storey wooden structure with a wooden lean-to addition.
- The building has a pitched felt roof.
- No potential access points or crevice features are present on the building. The building has negligible potential for bats.

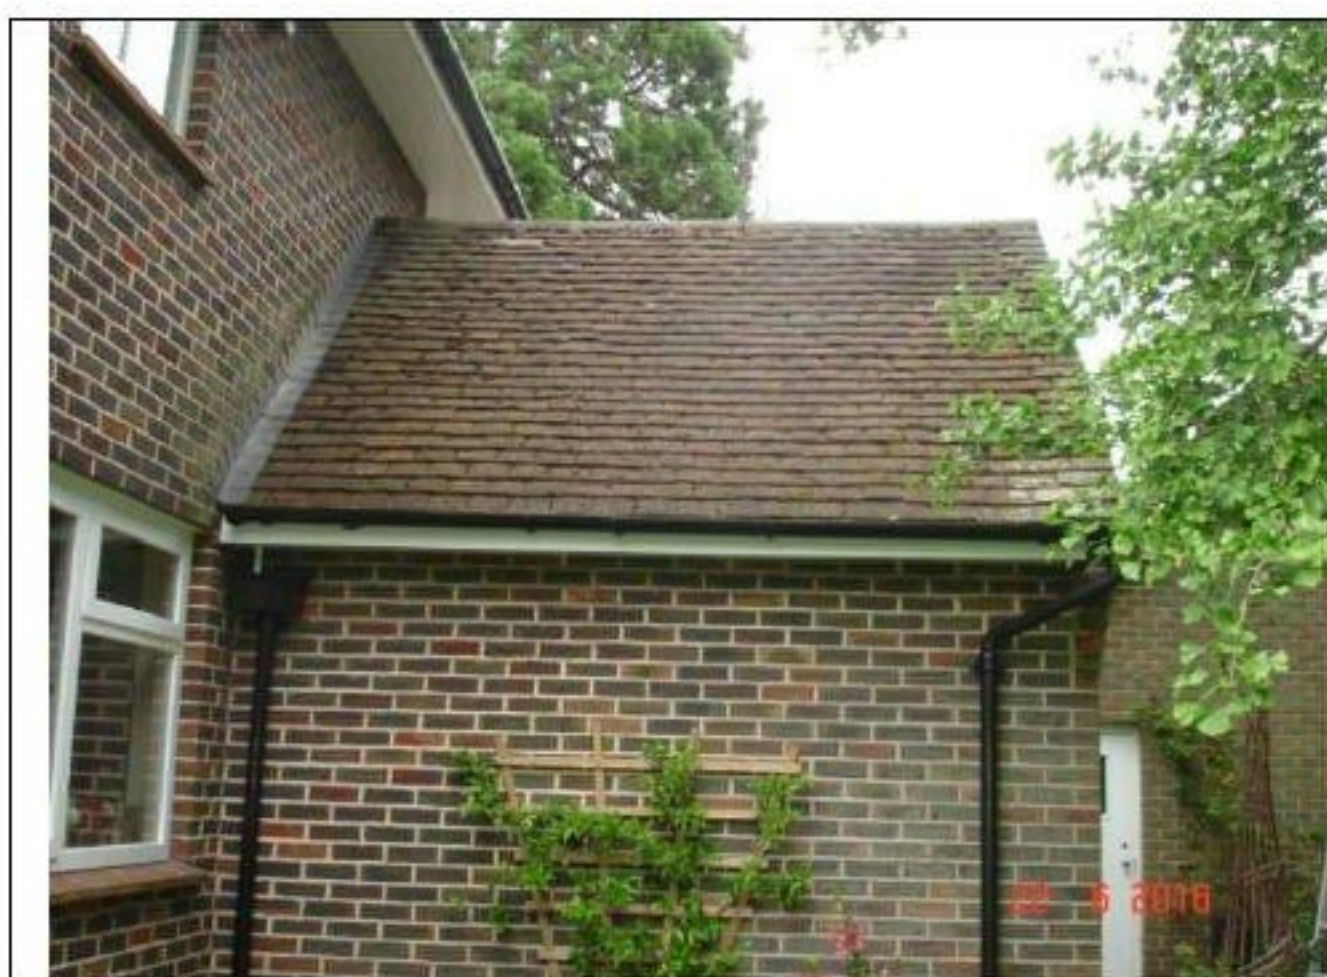
Photograph 5: View of the single storey extension.

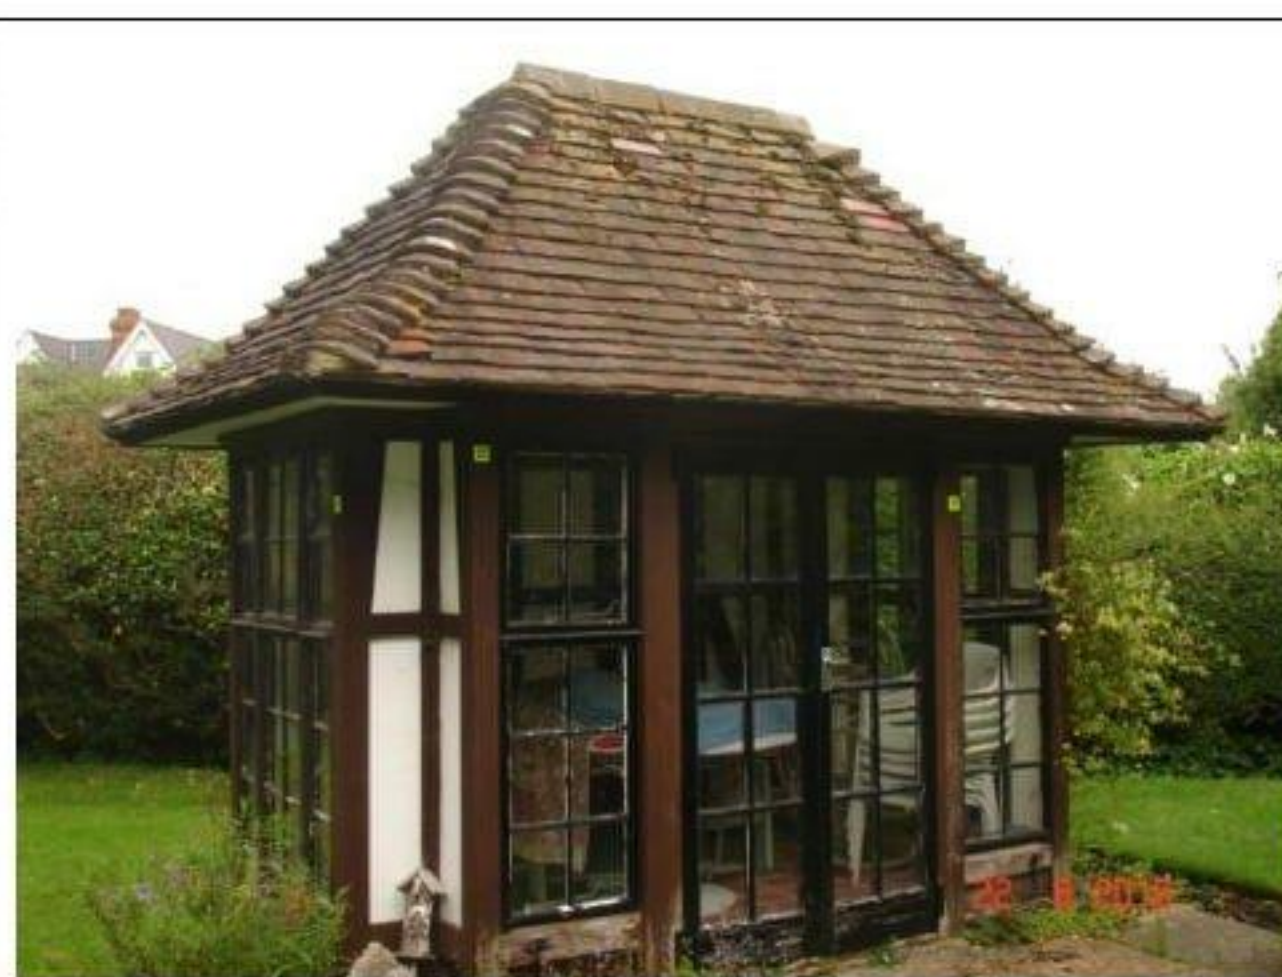
Photograph 6: A view of the summer house.

- The building is a small, single storey wooden framed structure with a hipped roof.
- Clay tiles and clay ridge tiles are present. A number of these are raised or missing and the building was assessed as having low potential for crevice dwelling bats.
- The building has no internal void. The interior of the summer house is well lit through the multiple windows

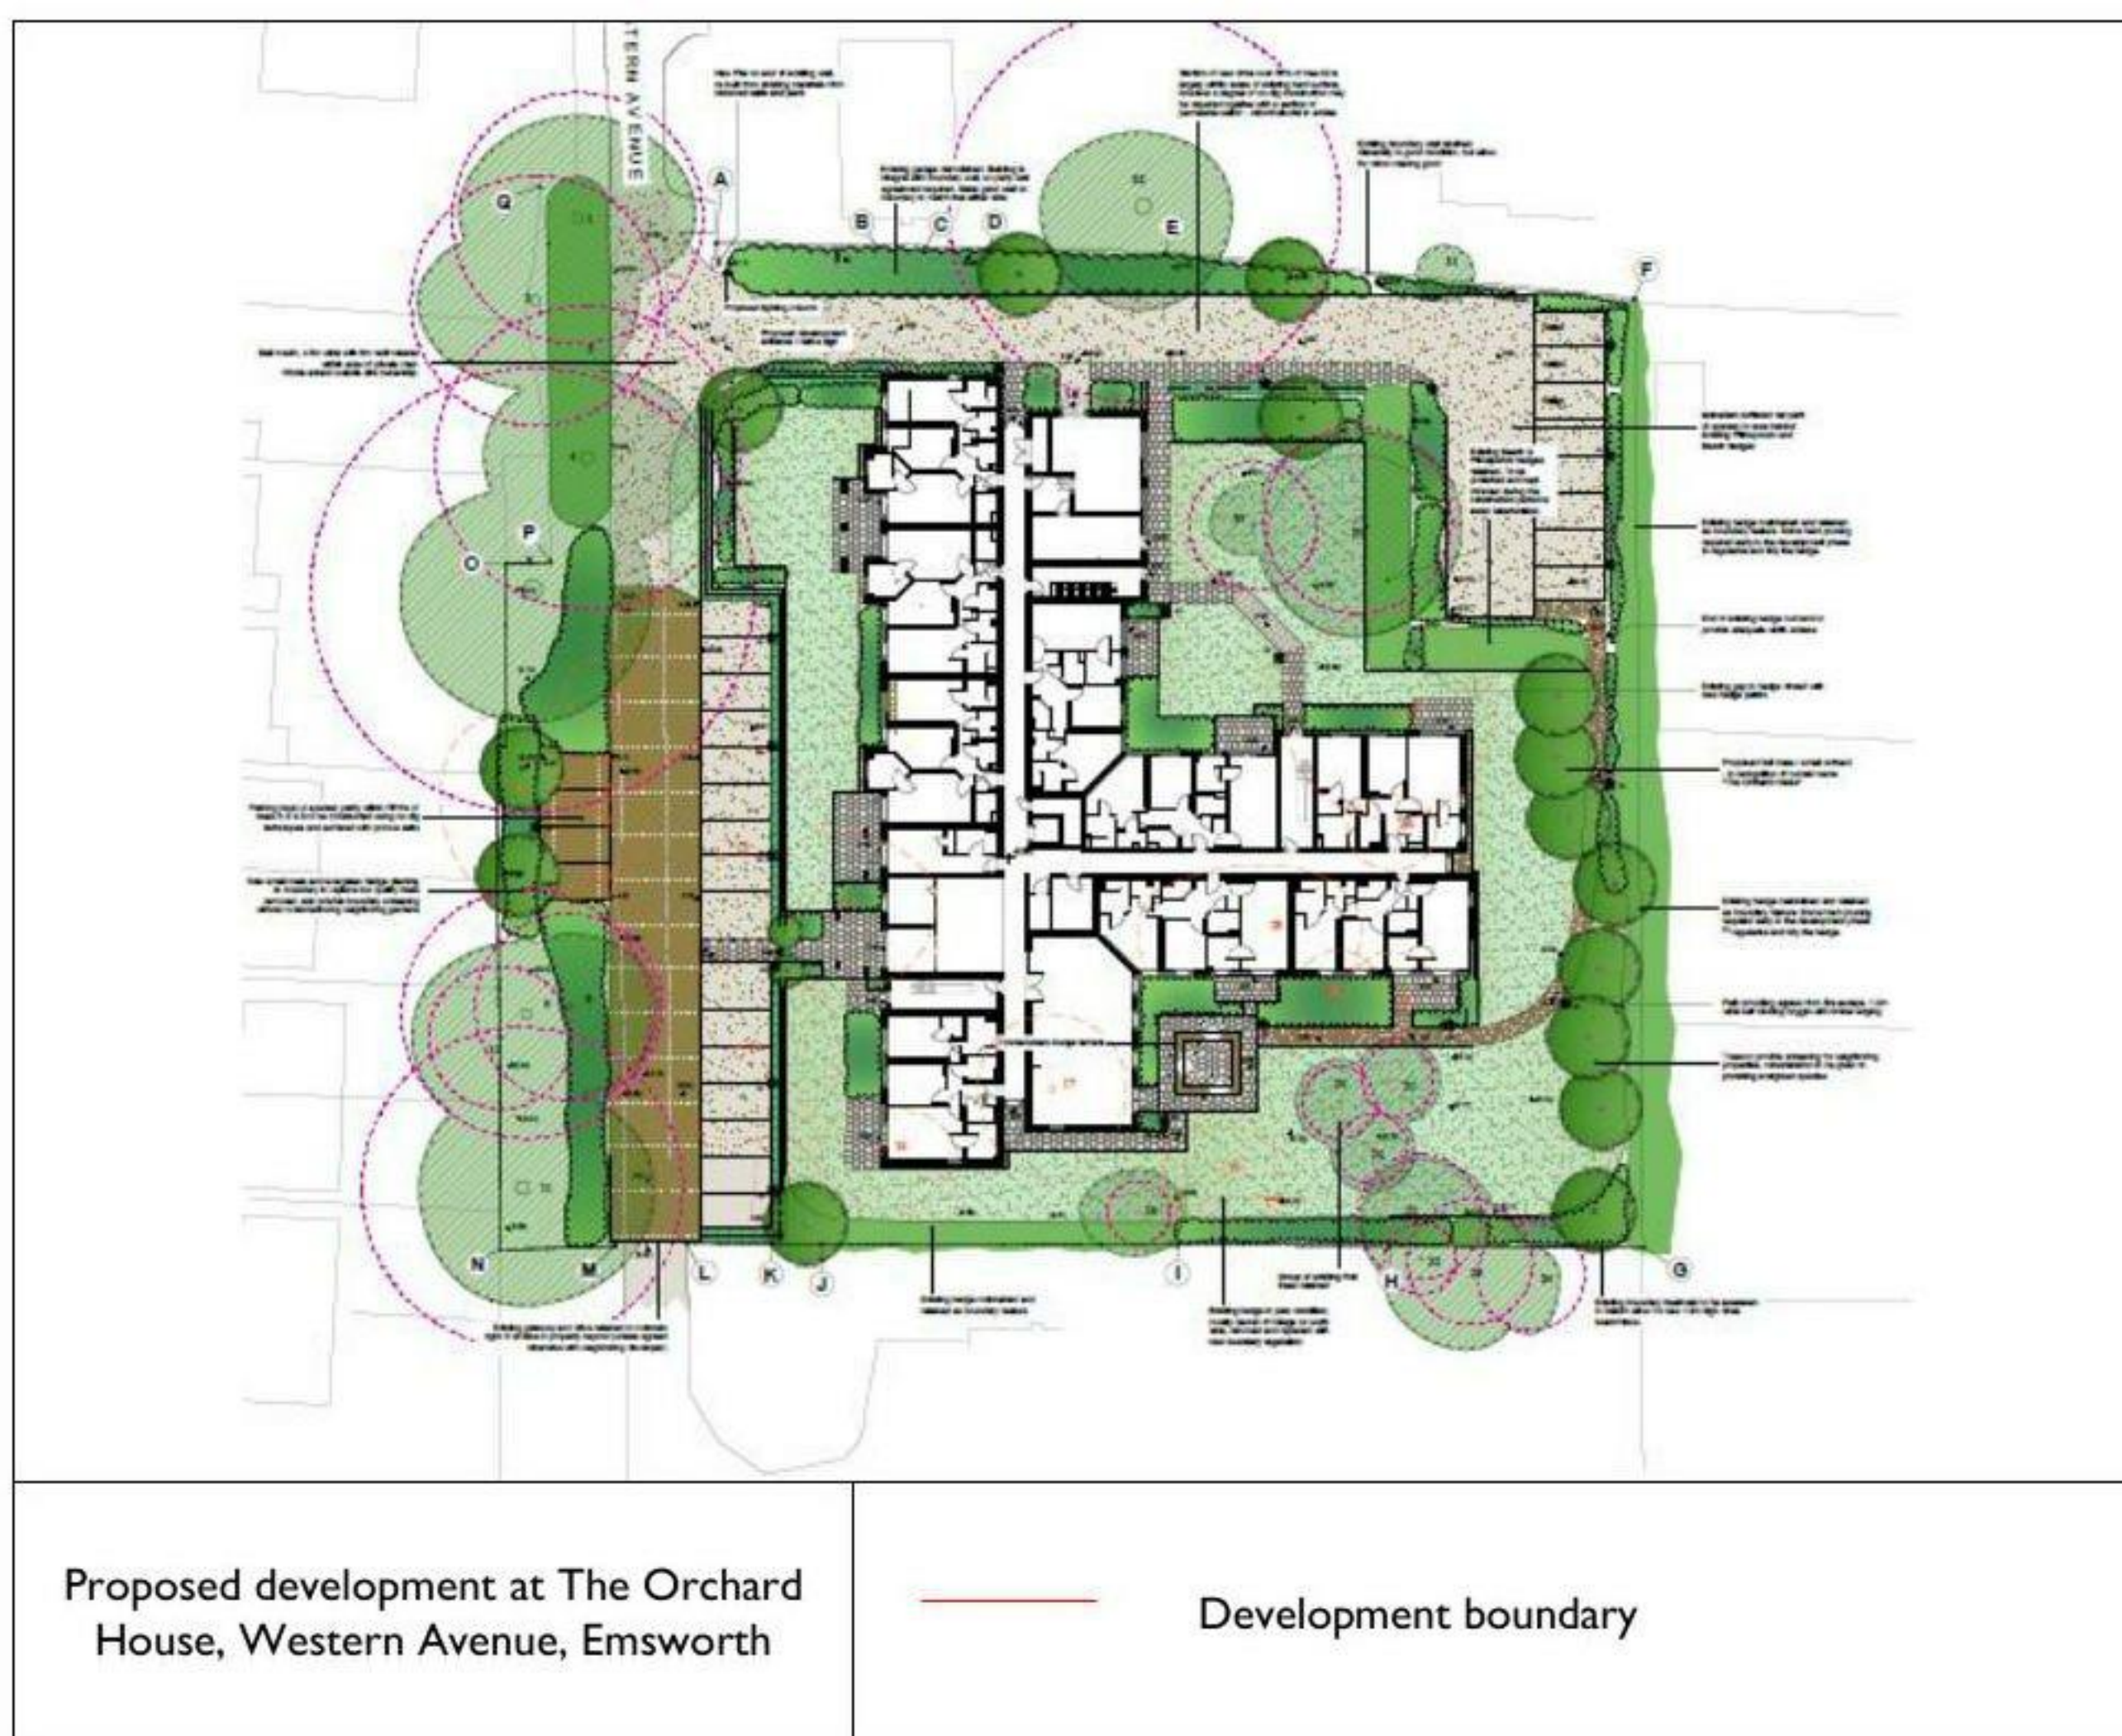
### Plan

The current outline proposals for the site include the demolition of the existing buildings and the construction of a residential care home comprising 25 units.
