# **BUSHY LEAZE HAVANT: PROPOSED SHARED FOOTPATH & CYCLEWAY**

## **Arboricultural Impact Assessment and Method Statement.**

**Prepared by Andrew Skeet ONDip Arb**

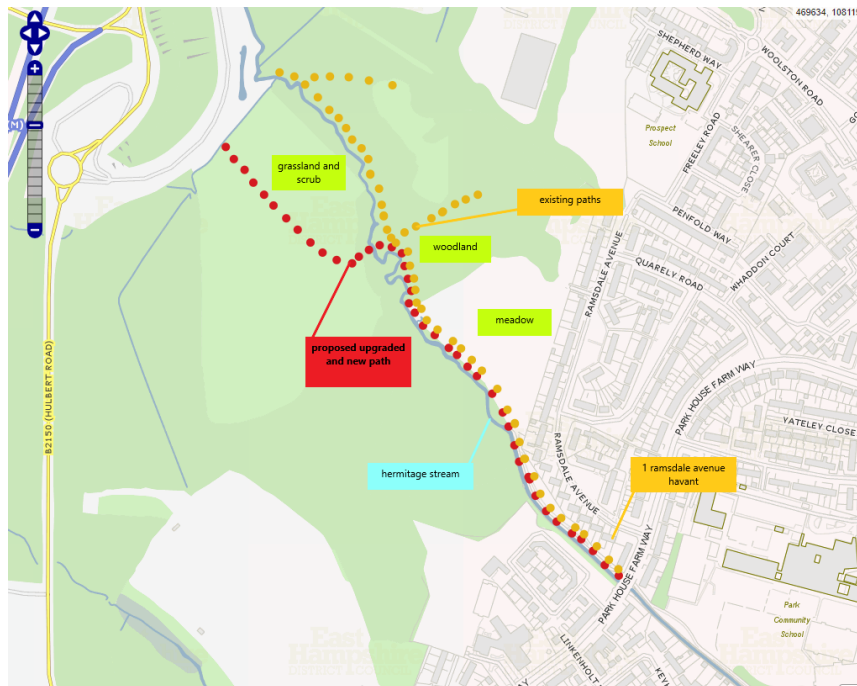
Proposed route and existing paths

This is 250m or so in length, starting at the edge of the wooded area and ending at the point where the path will bridge the stream, which is close to where a stone path branches off to the right – see figure 1.
