**270 London Road, Waterlooville,  
Hampshire PO7 7HG**

**Surface & Foul Water Drainage Strategy  
dated November 2025**

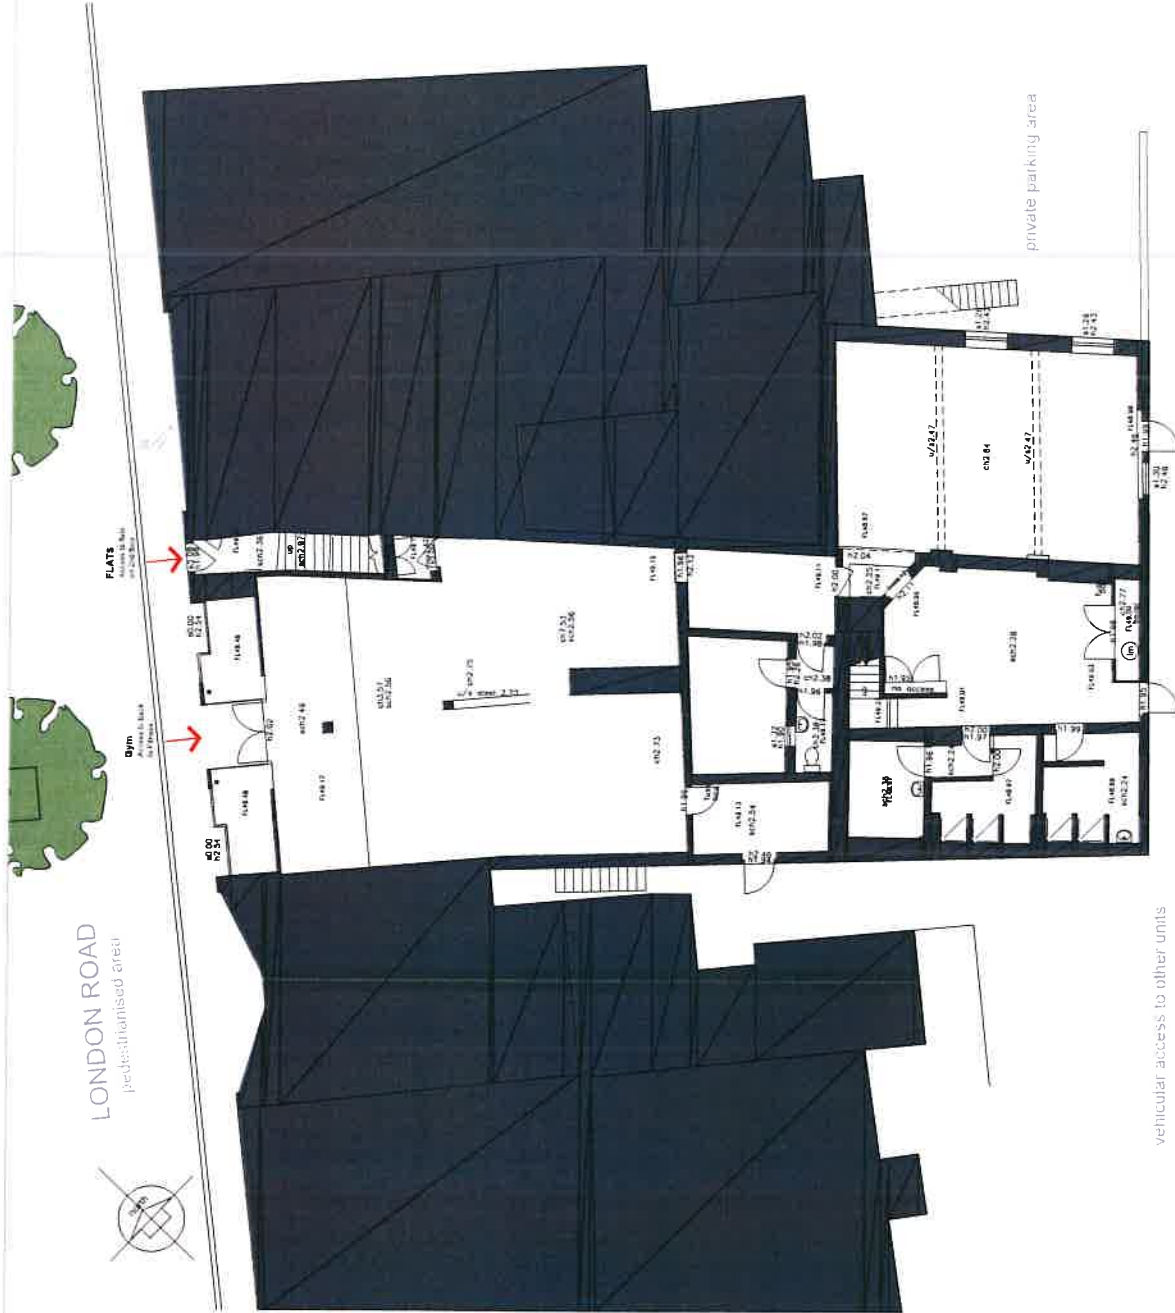
## GROUND FLOOR AS EXISTING - 1:150

Existing 2nd floor flat which is accessed via the ground floor stairwell at the front.  
No dedicated bike or bin areas currently.

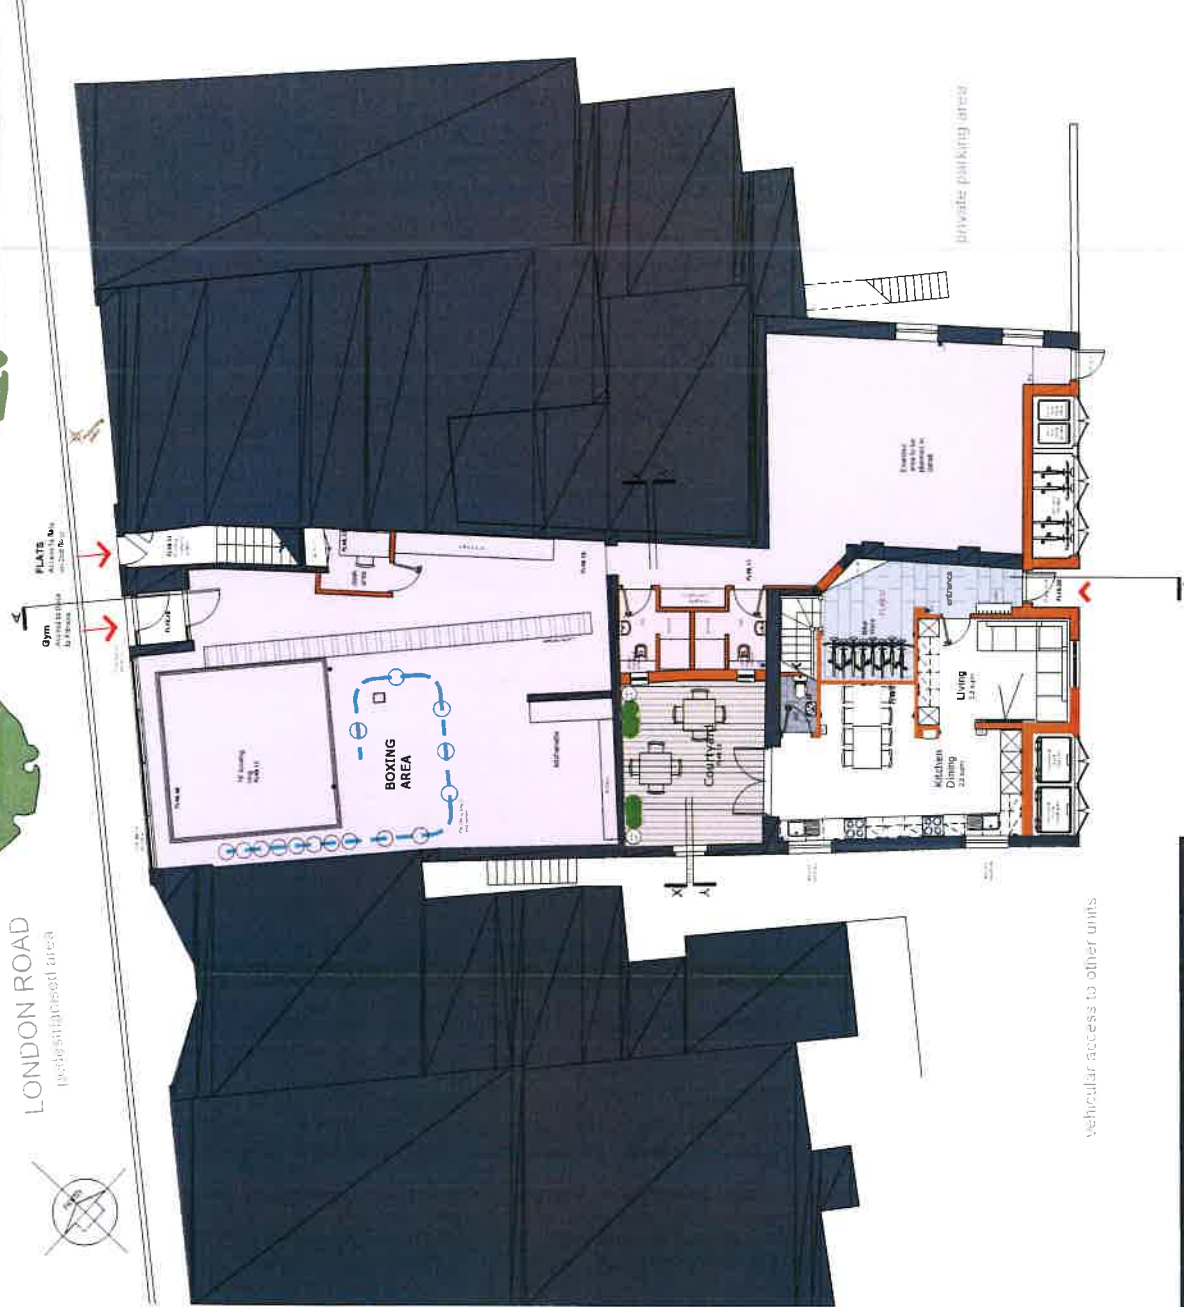
## GROUND FLOOR AS PROPOSED - 1:150

4 number studio flats (37 or 38 sqm) to be accommodated on first and second floor with an improved internal stairwell. Bike storage at the back. Communal external bin store.

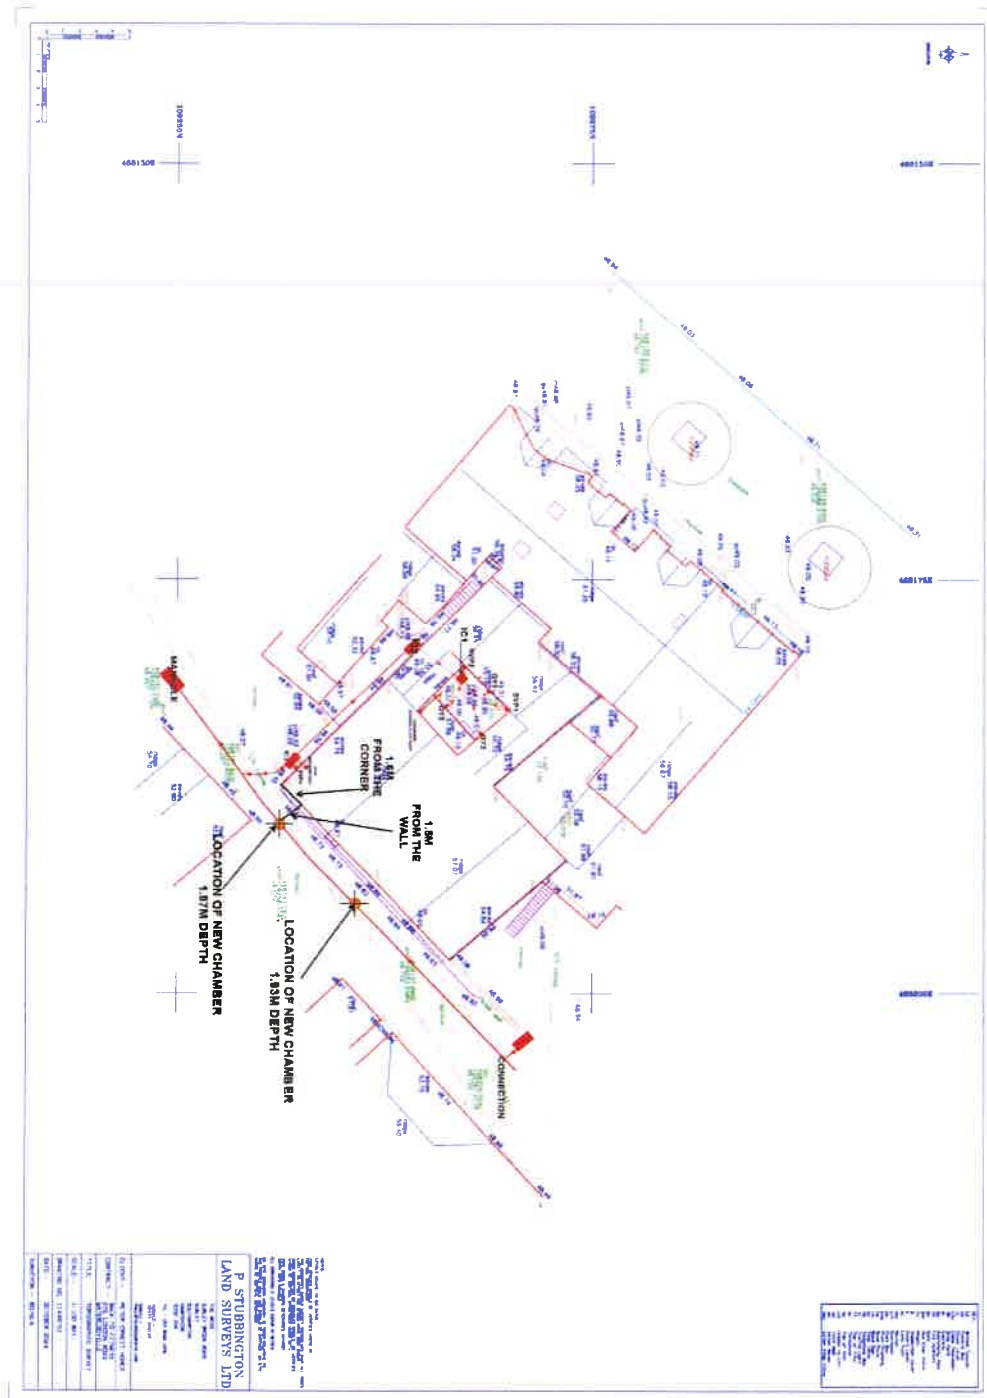
A CCTV drainage survey was carried out to ascertain the condition of the existing drainage system and to produce an accurate drawing showing the layout and location of the drainage runs.

This sketch is not to scale and does not represent the exact routing of the drainage system

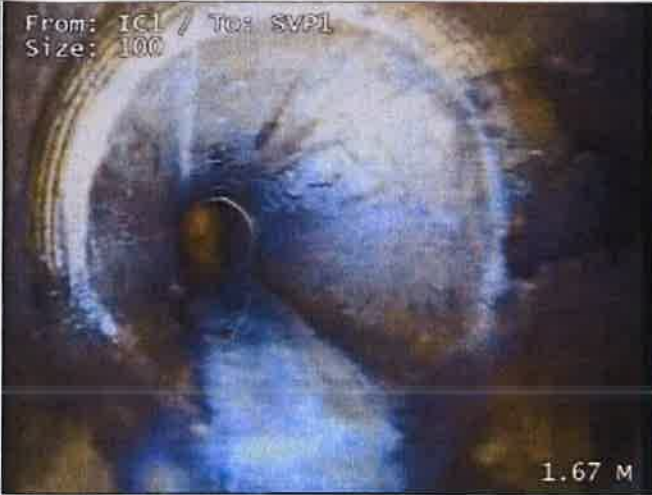
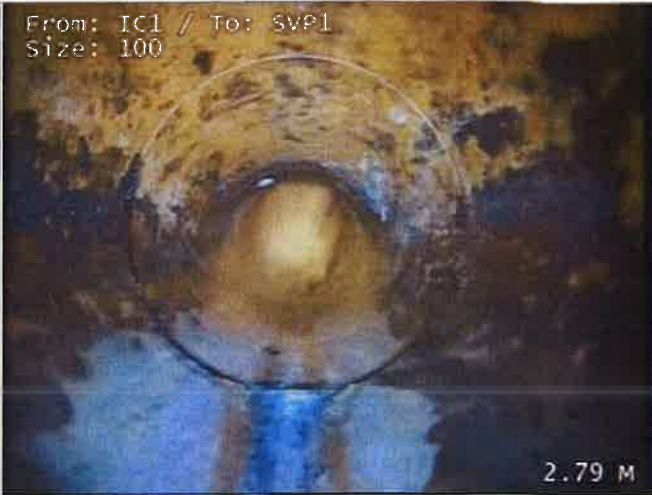
- **IC1 upstream SVP1:**  
A build-up of scale was observed within the line.
- **IC1 upstream SVP2:**  
No defects or issues identified; line is in satisfactory condition.

| Job Number<br>Post Repair Check | Surveyed by (Operator)<br>BILLY LINK | Base Unit<br>2VFCPF2N7E | Date<br>10/10/2025 |
|---|---|---|---|
| <div style="display: flex; justify-content: space-between;"> <div style="width: 48%;"> <p>Settled deposits hard or compacted 10% cross-sectional area loss, Start</p> </div> <div style="width: 48%;"> <p>Settled deposits hard or compacted 10% cross-sectional area loss, Finished</p> </div> </div> | | | |

Recommend a descale.

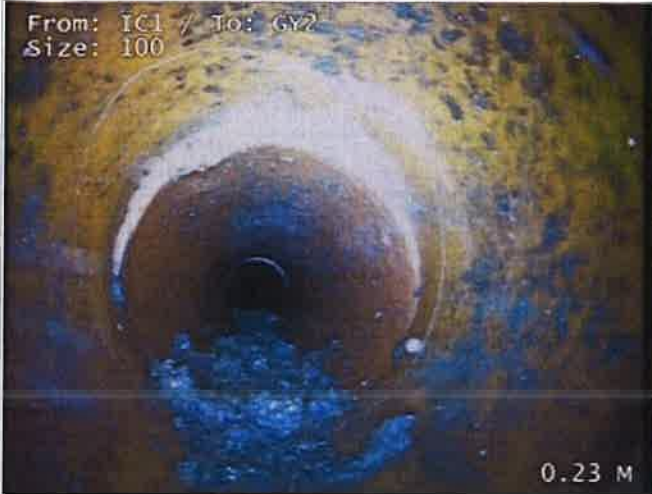
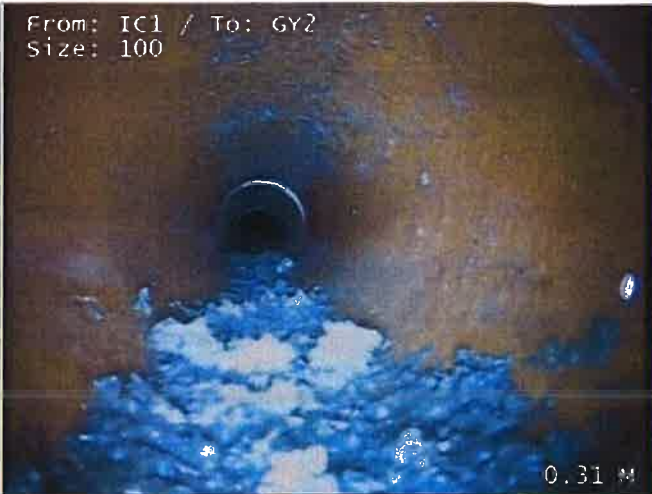
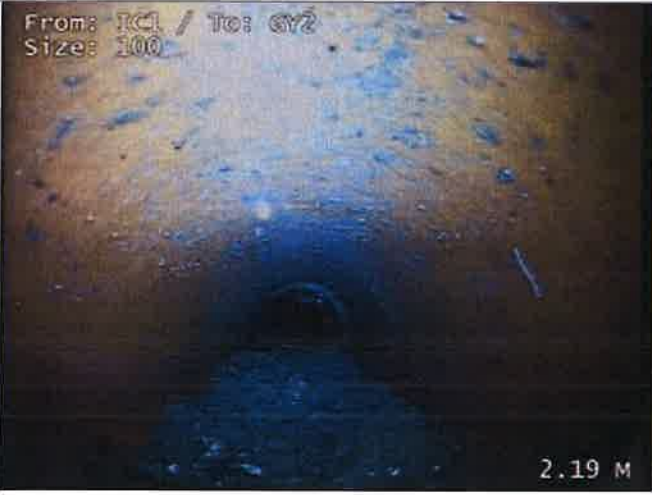
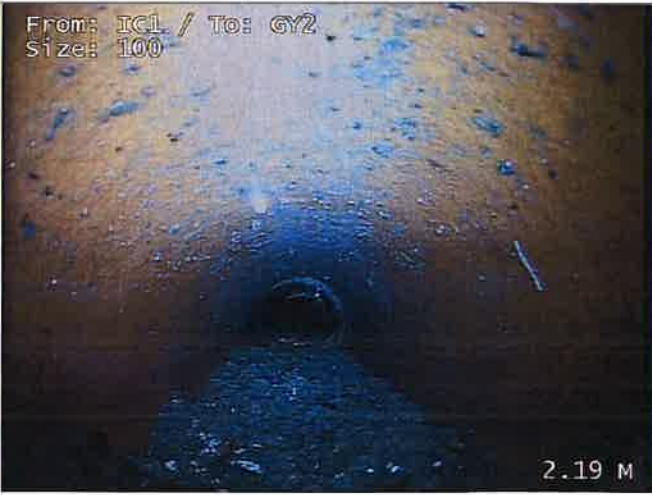
- **IC1 upstream GY2:**  
A crack was observed at **0.23m**.  
Build-up of scale noted from **0.31m**, causing the survey to be **abandoned at 2.19m** due to obstruction.

| Position | Code | Description | Photo | Type/Grade |
|---|---|---|---|---|
| 0.23 | CCJ | Crack circumferential from 8 to 4 o'clock at joint | 13302278 | Structural / 2 |

| Job Number<br>Post Repair Check | Surveyed by (Operator)<br>BILLY LINK | Base Unit<br>2VFCPF2N7E | Date<br>10/10/2025 |
|---|---|---|---|
| <div style="display: flex; justify-content: space-between;"> <div style="width: 48%;"> <p>From: IC1 / To: GY2<br/>Size: 100</p> <p style="text-align: right;">0.23 M</p> <p>Crack circumferential from 8 to 4 o'clock at joint</p> </div> <div style="width: 48%;"> <p>From: IC1 / To: GY2<br/>Size: 100</p> <p style="text-align: right;">0.31 M</p> <p>Settled deposits hard or compacted 20% cross-sectional area loss, Start</p> </div> </div> | | | |
| <div style="display: flex; justify-content: space-between;"> <div style="width: 48%;"> <p>From: IC1 / To: GY2<br/>Size: 100</p> <p style="text-align: right;">2.19 M</p> <p>Settled deposits hard or compacted 20% cross-sectional area loss,<br/>Finished</p> </div> <div style="width: 48%;"> <p>From: IC1 / To: GY2<br/>Size: 100</p> <p style="text-align: right;">2.19 M</p> <p>Survey abandoned - Remark: SILT</p> </div> </div> | | | |

Recommend a descale and further investigation.

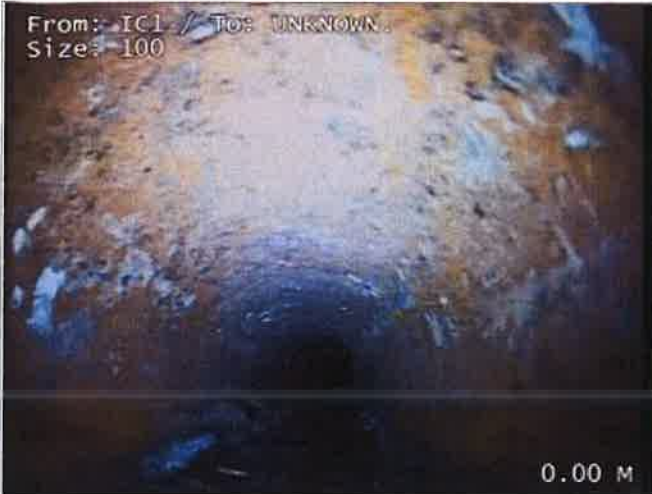
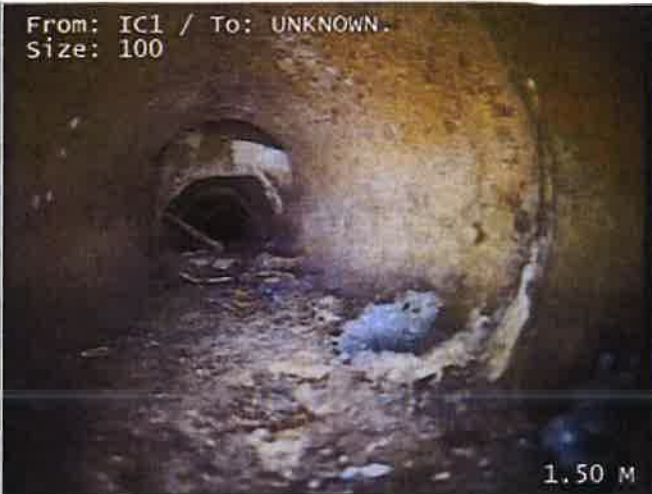
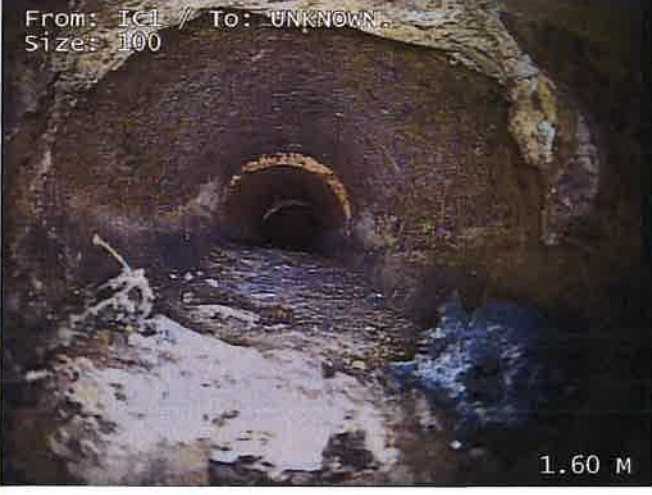
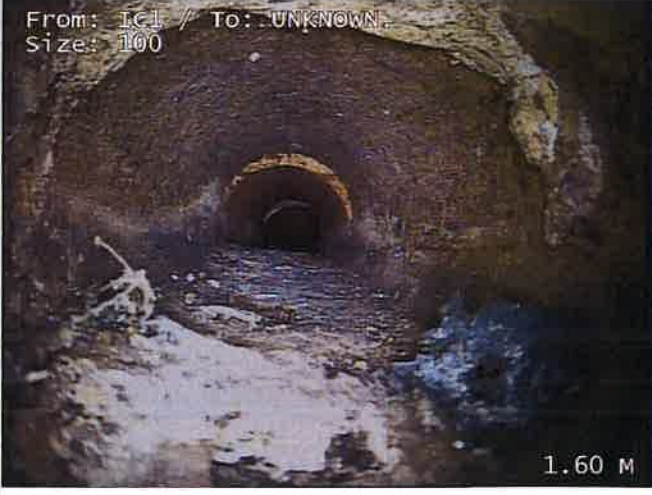
- **IC1 upstream GY3:**  
No defects or issues identified; line is in satisfactory condition.
- **IC1 upstream (Unknown):**  
Heavy build-up of scale throughout the line.  
Survey **abandoned at 1.6m** due to blockage caused by scale.

| Job Number:<br>Post Repair Check | Surveyed by (Operator)<br>BILLY LINK | Base Unit<br>2VFCPF2N7E | Date<br>10/10/2025 |
|---|---|---|---|
| <div> <div> From: ICI / To: UNKNOWN.<br/>Size: 100 </div> 0.00 M </div> <div>Settled deposits hard or compacted 20% cross-sectional area loss, Start</div> | | | |
| <div> <div> From: ICI / To: UNKNOWN.<br/>Size: 100 </div> 1.50 M </div> <div>Settled deposits hard or compacted 20% cross-sectional area loss, Finished</div> | | | |
| <div> <div> From: ICI / To: UNKNOWN.<br/>Size: 100 </div> 1.60 M </div> <div>Settled deposits hard or compacted 30% cross-sectional area loss</div> | | | |
| <div> <div> From: ICI / To: UNKNOWN.<br/>Size: 100 </div> 1.60 M </div> <div>Survey abandoned - Remark: SCALE</div> | | | |

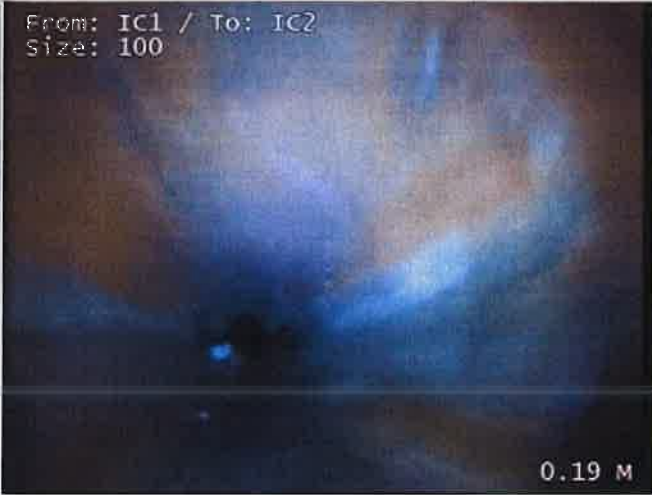
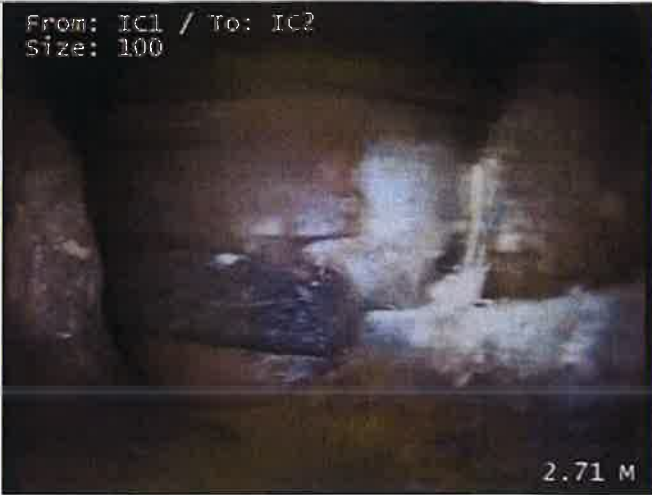
- **IC1 downstream IC2:**  
Build-up of scale observed within the line.
- **IC2 to IC3:**  
Unable to complete survey due to the line being **blocked**.
- **IC3 downstream Connection:**  
No defects or issues identified; line is in satisfactory condition.

| Job Number<br>Post Repair Check | Surveyed by (Operator)<br>BILLY LINK | Base Unit<br>2VFCPF2N7E | Date<br>10/10/2025 |
|---|---|---|---|
| <div style="display: flex; justify-content: space-between;"> <div style="width: 48%;"> <p>From: IC1 / To: IC2<br/>Size: 100</p> <p style="text-align: right;">0.19 M</p> <p>Settled deposits hard or compacted 5% cross-sectional area loss, Start</p> </div> <div style="width: 48%;"> <p>From: IC1 / To: IC2<br/>Size: 100</p> <p style="text-align: right;">2.71 M</p> <p>Settled deposits hard or compacted 5% cross-sectional area loss, Finished</p> </div> </div> | | | |

| Job Number<br>Post Repair Check | Surveyed by (Operator)<br>BILLY LINK | Base Unit<br>2VFCPF2N7E | Date<br>23/06/2025 |
|---|---|---|---|
| Manholes: <b>IC1 to IC2</b><br>Pipe Length: <b>3.02 metres</b><br>Structural Grade: <b>0</b><br>Service Grade: <b>2</b><br>Material: <b>Vitrified clay</b><br>Pipe Size: <b>100mm</b><br>Use: <b>Combined</b> | | Recommend a descale. | |

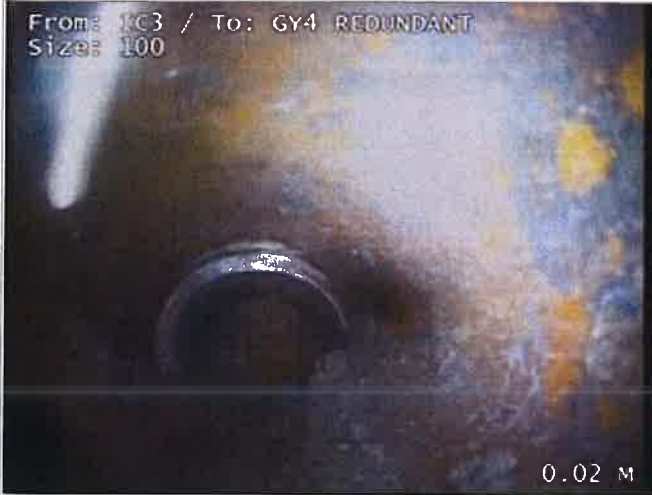
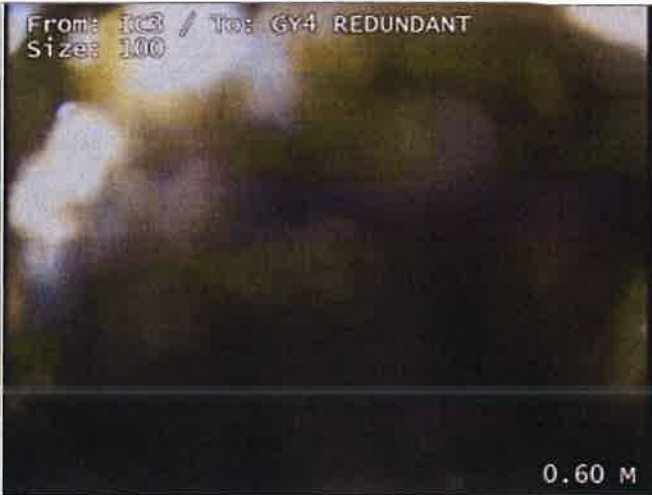
- **IC3 upstream GY4 (Redundant):**  
Build-up of **silt** observed within the line.
- **Connection downstream Manhole:**  
Heavy build-up of **scale throughout** the line.  
The main **150mm pipe** has been marked up at **14m** and **20m** (see attached drawing for reference).

| Job Number<br>Post Repair Check | Surveyed by (Operator)<br>BILLY LINK | Base Unit:<br>2VFCPF2N7E | Date<br>10/10/2025 |
|---|---|---|---|
| <div style="display: flex; justify-content: space-between;"> <div style="width: 48%;"> <p>Settled deposits fine 20% cross-sectional area loss, Start</p> </div> <div style="width: 48%;"> <p>Settled deposits fine 20% cross-sectional area loss, Finished</p> </div> </div> | | | |

| Job Number<br>Post Repair Check | Surveyed by (Operator)<br>BILLY LINK | Base Unit<br>2VFCPF2N7E | Date<br>23/06/2025 |
|---|---|---|---|
| Manholes: <b>IC3 to GY4</b><br><b>REDUNDANT</b><br>Pipe Length: <b>0.96 metres</b><br>Structural Grade: <b>0</b><br>Service Grade: <b>3</b><br>Material: <b>Vitrified clay</b><br>Pipe Size: <b>100mm</b><br>Use: <b>Foul</b> | | Redundant gully, recommend a line clean. | |

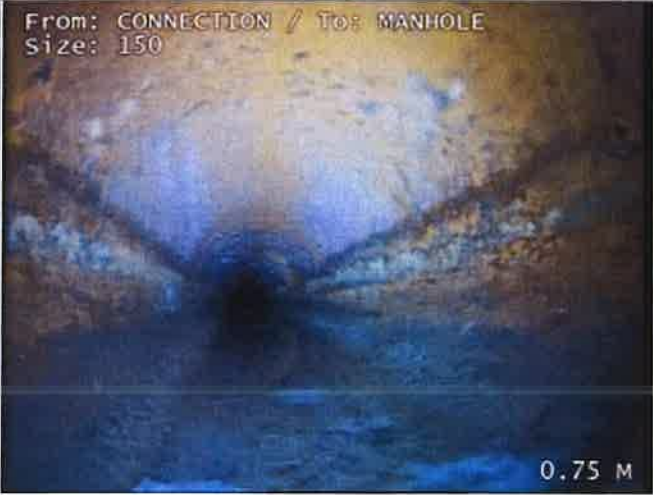
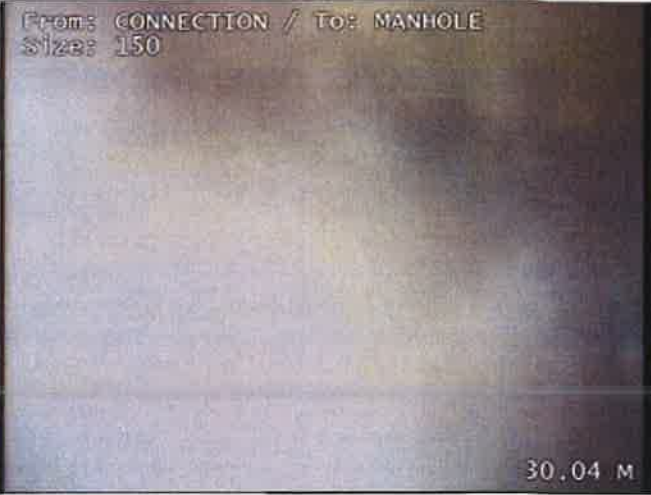
| Job Number<br>Post Repair Check | Surveyed by (Operator)<br>BILLY LINK | Base Unit<br>2VFCPF2N7E | Date<br>10/10/2025 |
|---|---|---|---|
| <div style="display: flex; justify-content: space-between;"> <div style="width: 48%;"> <p>From: CONNECTION / To: MANHOLE<br/>Size: 150</p> <p style="text-align: right;">0.75 M</p> <p>Settled deposits hard or compacted 5% cross-sectional area loss, Start</p> </div> <div style="width: 48%;"> <p>From: CONNECTION / To: MANHOLE<br/>Size: 150</p> <p style="text-align: right;">30.04 M</p> <p>Settled deposits hard or compacted 5% cross-sectional area loss, Finished</p> </div> </div> | | | |

| Job Number<br>Post Repair Check | Surveyed by (Operator)<br>BILLY LINK | Base Unit<br>2VFCPF2N7E | Date<br>23/06/2025 |
|---|---|---|---|
| Manholes: <b>CONNECTION to MANHOLE</b><br>Pipe Length: <b>30.27 metres</b><br>Structural Grade: <b>0</b><br>Service Grade: <b>2</b><br>Material: <b>Vitrified clay</b><br>Pipe Size: <b>150mm</b><br>Use: <b>Foul</b> | | No recommendation required. | |

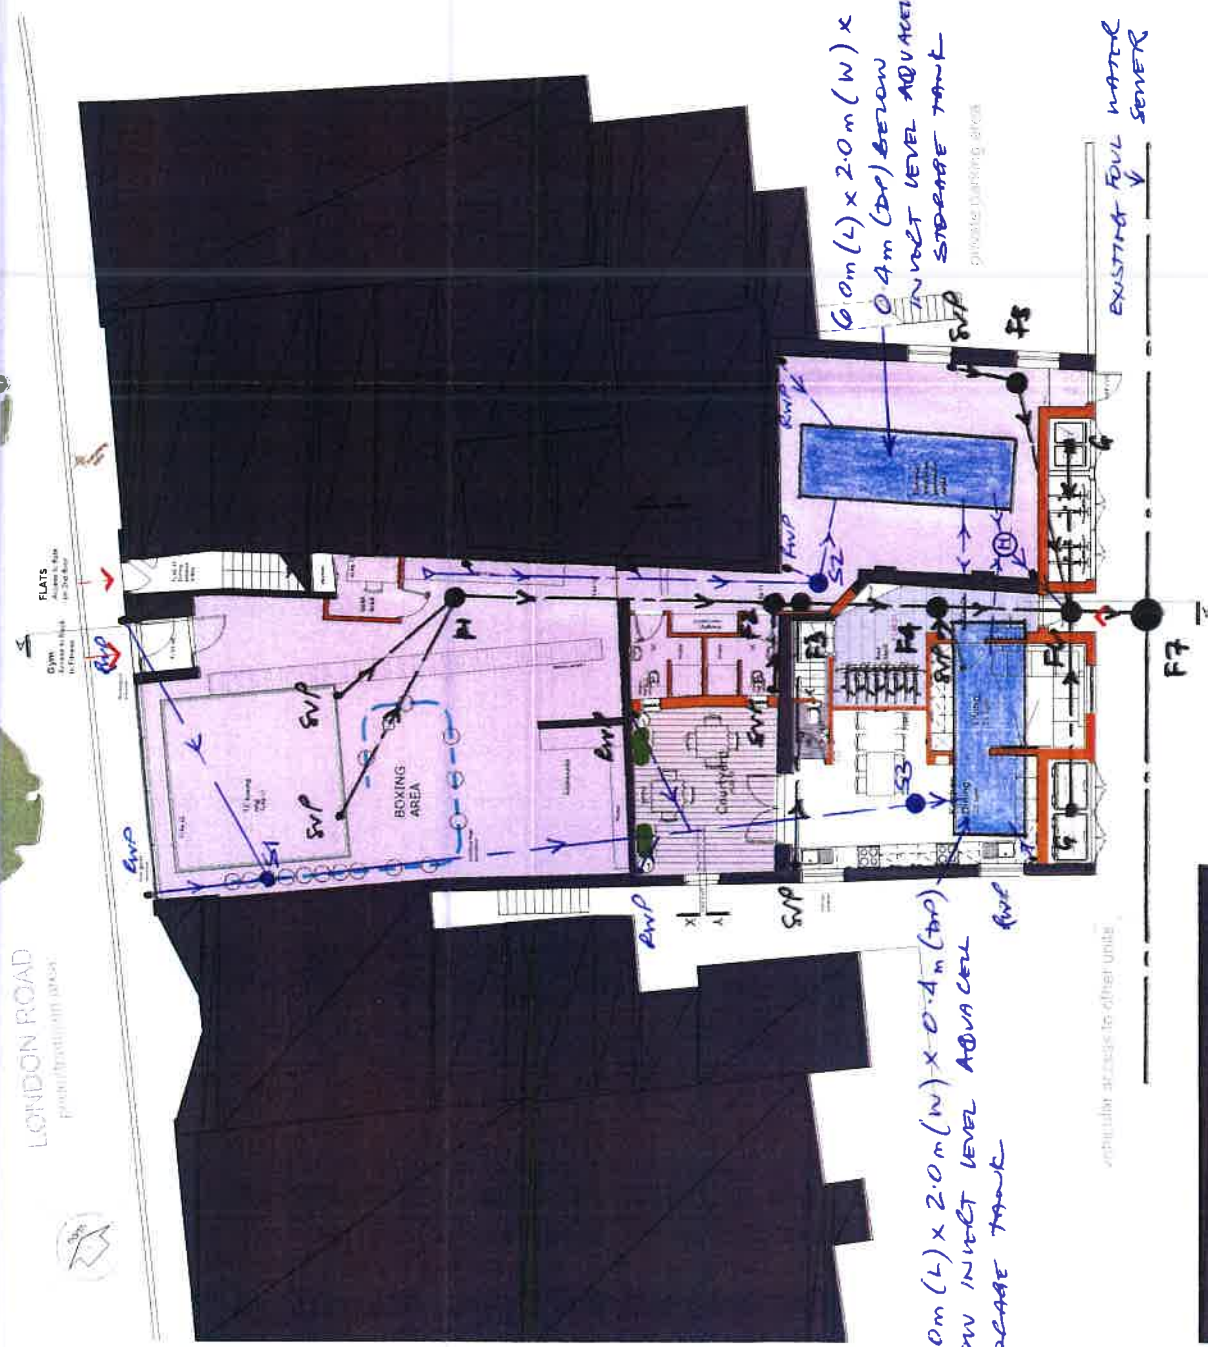
**Foul & Surface  
Water Drainage  
Layout**

- 6.1 The drawings, included within Appendix G, show that the site is to be laid out with surface water being attenuated using a hydrobreak prior to discharge to the public foul drainage network.

- 9.2 Drawings within Appendix G show the proposed foul and surface water drainage layouts.

**GROUND FLOOR  
AS PROPOSED - 1:150**
