# Stage 1: Tier 2 Site Investigation GQRA

Project Reference: P25.205GQRA  
**Lttr 70-76 West St Havant**

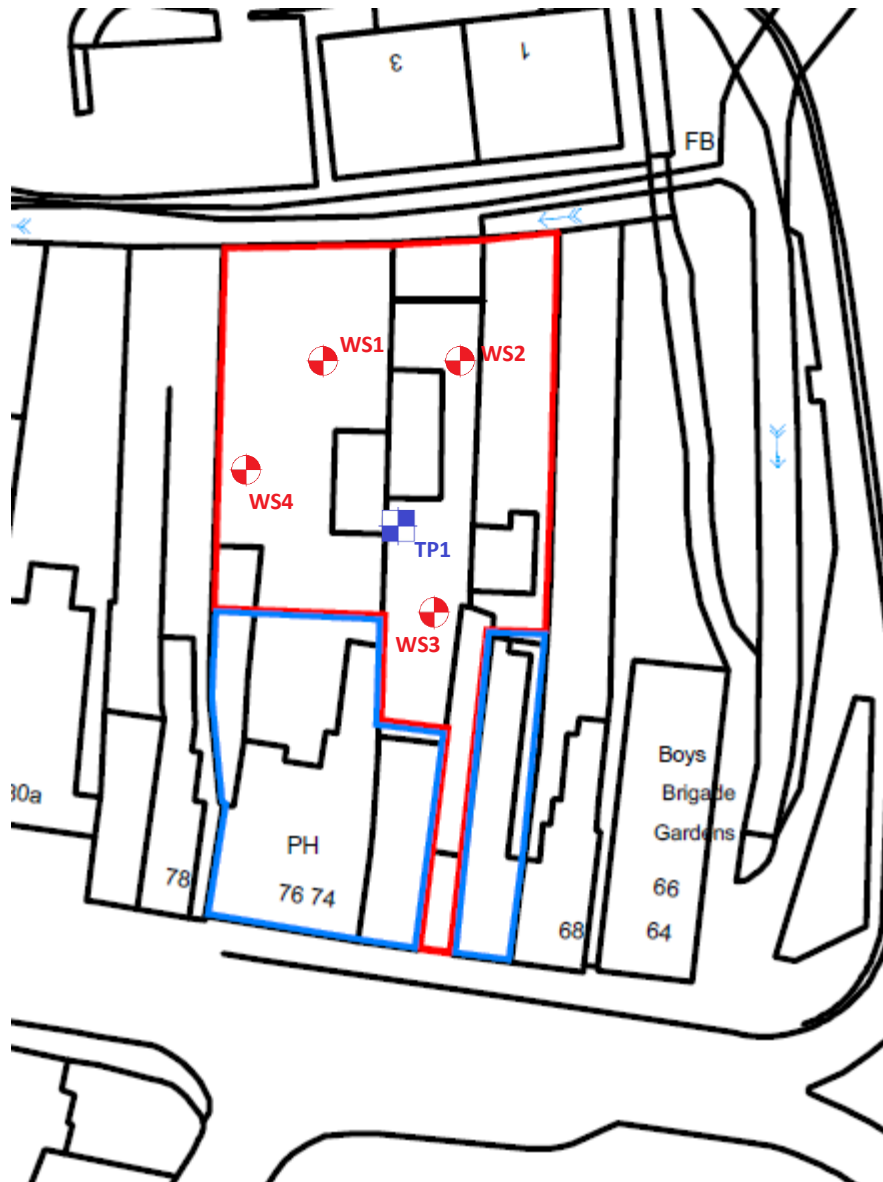
The scope was designed between the relevant parties and IGL, based on the proposed development plans. The aim of the scope was to advance intrusive locations to assist with the geo-environmental and geotechnical design recommendations in relation to the proposed development. This was to be achieved with the completion of boreholes and trial pits to assess the nature of the underlying soils and groundwater conditions, along with specified in-situ testing. Samples were collected for subsequent geotechnical and environmental laboratory analysis. A plan indicating intrusive locations can be viewed in Appendix B.

Four windowless sample boreholes (WS1-WS4) were advanced through the base of their respective inspection pits to a maximum depth of 5.00mbgl (in the case of WS4), completed using a tracked dynamic sampling rig. The primary objective was to allow for the assessment of underlying ground conditions, production of detailed engineering logs and the recovery of samples for laboratory testing. Furthermore, these boreholes allowed for in-situ testing (SPT) to provide geotechnical parameters for future use. WS3 and WS4 were installed with groundwater monitoring standpipes, constructed with 35mm diameter HDPE plain and slotted pipe, finished in flush steel covers. The remaining two boreholes were backfilled with arisings.

One hand excavated trial pit (TP1) was advanced using hand tools to a depth of 1.00mbgl. This was undertaken in order to provide additional site coverage, and to permit the recovery of samples for laboratory testing. This pit was backfilled with arisings once an assessment of underlying ground conditions was made.

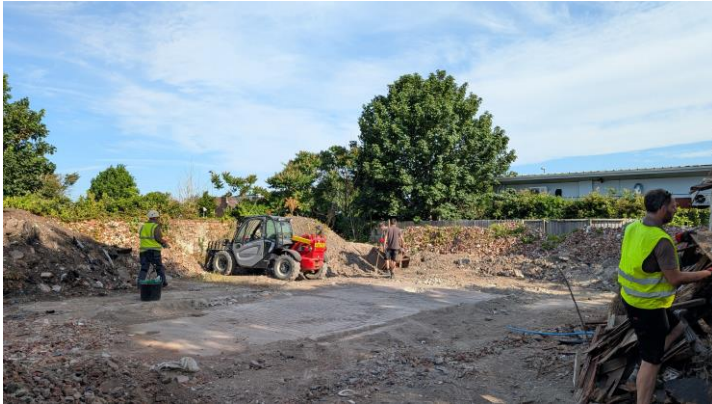
1.

| Job Number: | P25.205 | <div> <div>1.</div> <div>Existing site</div> </div> <div> <div>2.</div> <div>Existing site</div> </div> <div> <div>3.</div> <div>Existing site</div> </div> <div> <div>4.</div> <div>Existing site</div> </div> | |

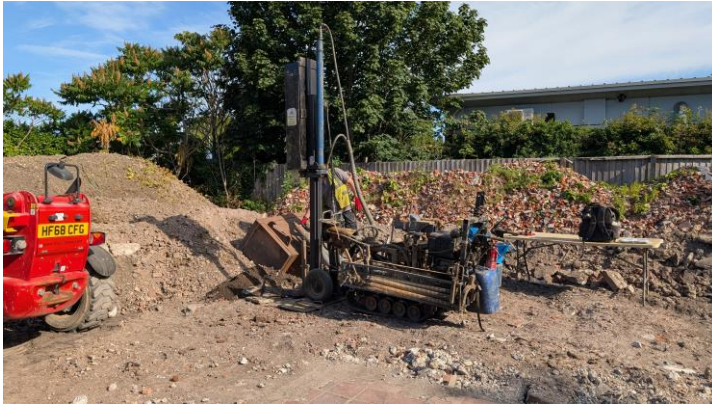
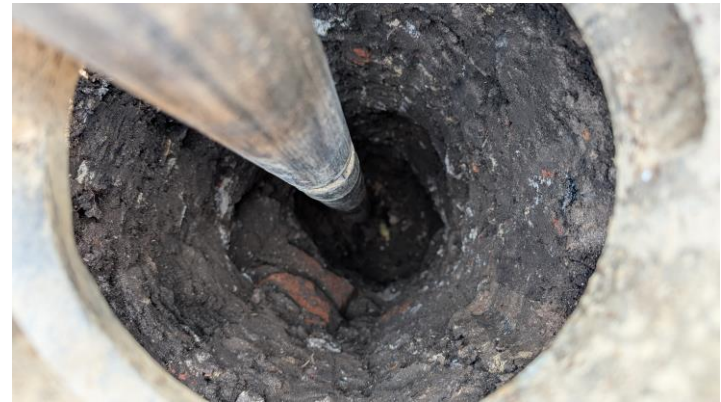
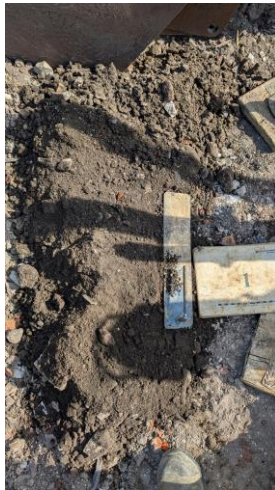
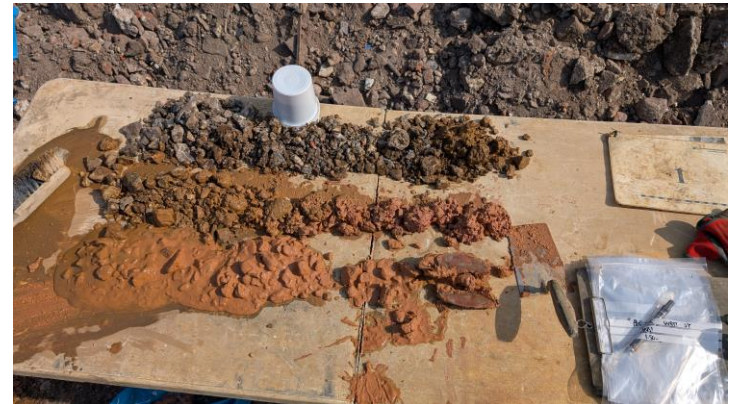
| <b>Job Number:</b> | P25.205 | 5. WS1<br>6. WS1 GL-1.00m<br>7. WS1 spoil<br>8. WS1 1.00-5.00m | | <b>IMPACT</b><br><b>GEO</b> TECHNICAL<br>Impact Geotechnical Limited<br><a href="http://www.impactgeo.co.uk">www.impactgeo.co.uk</a> |

Chrysotile and amosite asbestos fibres were identified within the Made Ground soils of WS1 at 0.60mbgl. It should be noted that IGL have not undertaken any form of asbestos quantification on this sample at this time.

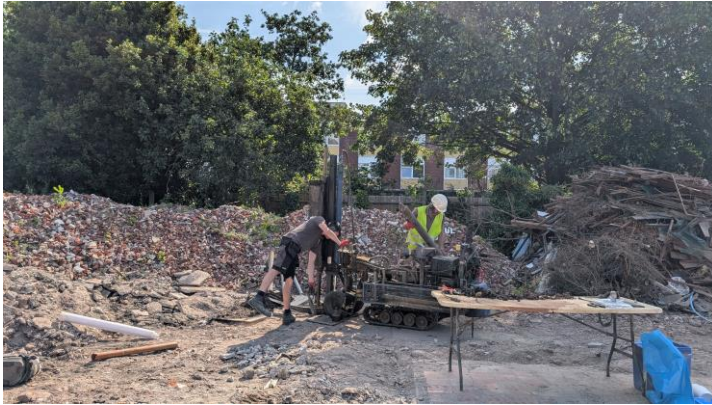
| <b>Job Number:</b> | P25.205 | 9. WS2<br>10. WS2 GL-1.00m<br>11. WS2 spoil<br>12. WS2 1.00-5.00m | | <b>IMPACT</b><br><b>GEO</b> TECHNICAL<br>Impact Geotechnical Limited<br><a href="http://www.impactgeo.co.uk">www.impactgeo.co.uk</a> |

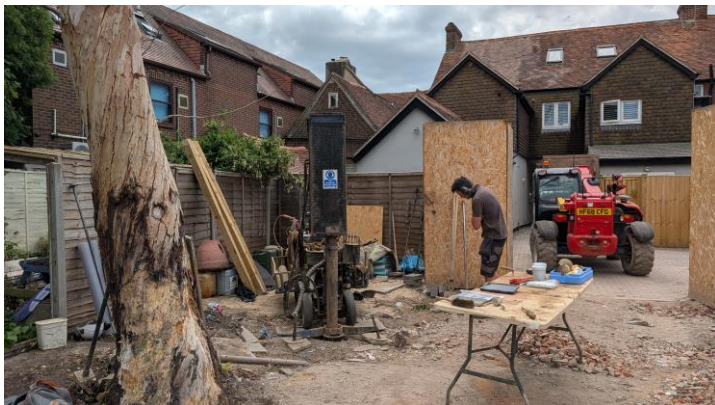
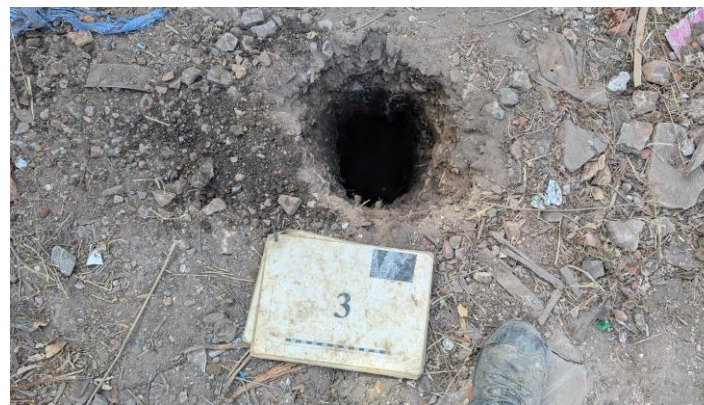
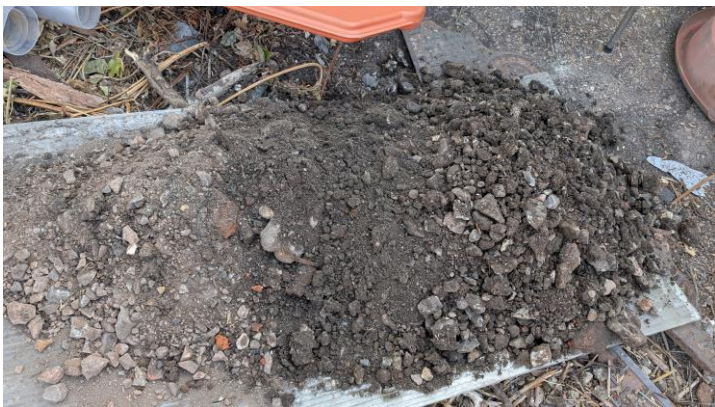
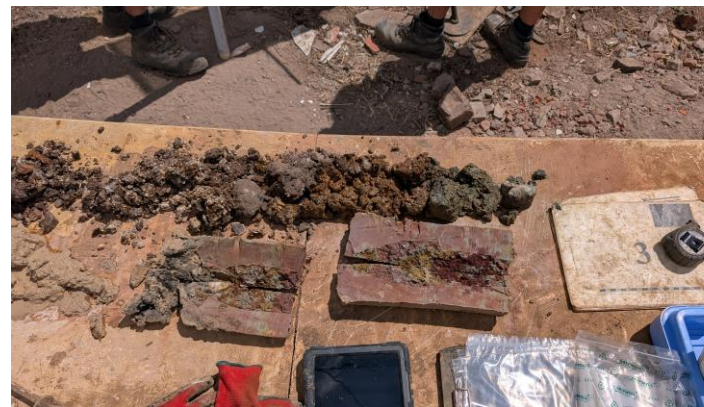
| <b>Job Number:</b> | P25.205 | 13. WS3<br>14. WS3 GL-1.00m<br>15. WS3 spoil<br>16. WS3 1.00-5.00m | <b>IMPACT</b><br><b>GEO</b> TECHNICAL<br>Impact Geotechnical Limited<br><a href="http://www.impactgeo.co.uk">www.impactgeo.co.uk</a> |

A 400mm thick layer of buff mottled grey clayey silty slightly organic fine to coarse Sand was recorded within WS3 from 2.00m to 2.40mbgl. These sandy soils have been classified as Loose, based on in-situ testing.

An organic odour was noted within the Head Deposits of WS3 at 1.90mbgl. Otherwise, with the exception of anthropogenic materials encountered within the Made Ground soils, no visual or olfactory evidence of soil or groundwater contamination was noted during the investigation works. This includes any hydrocarbon-specific contamination, such as staining and sheens.

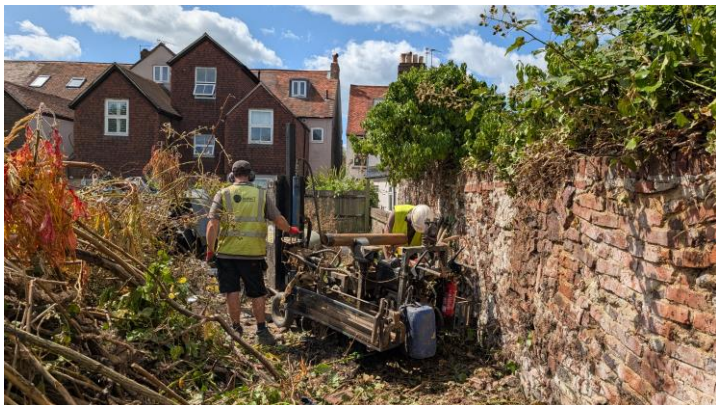
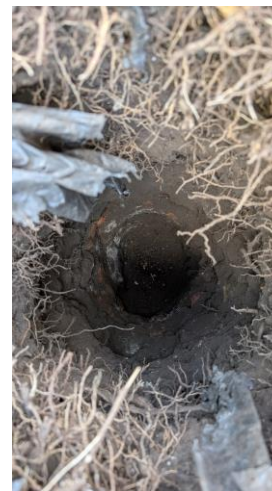
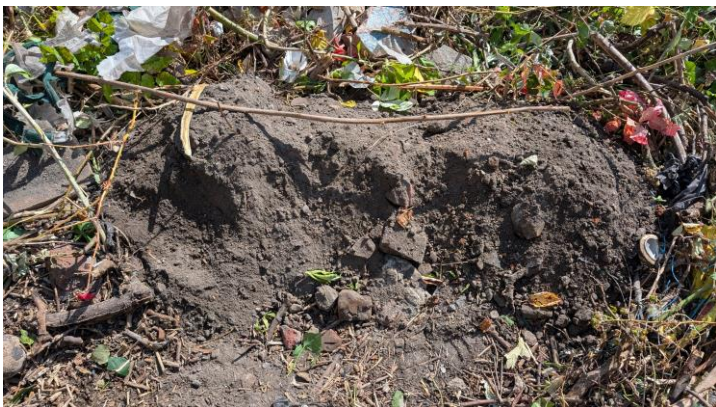
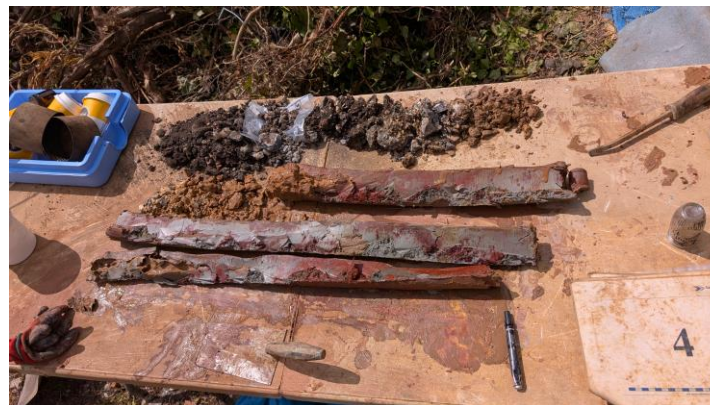
| <b>Job Number:</b> | P25.205 | 17. WS4<br>18. WS4 GL-1.00m<br>19. WS4 spoil<br>20. WS4 1.00-5.00m | | <br>Impact Geotechnical Limited<br><a href="http://www.impactgeo.co.uk">www.impactgeo.co.uk</a> |

An exceedance of the conservative UK Drinking Water Standards (DWS) - Water Supply Regulations (WSR) (2000) – was reported for lead from one sample (WS4 at 0.20m), with a recorded concentration of lead as 11ug/l. The criteria limit of lead for WSR (2000) is 10ug/l, and as such the exceedance is 10% above this limit. The concentration of leachable lead from WS4 at 0.20m does not exceed the New Dutch List (Dutch Target and Intervention Values, 2000) value of 75ug/l. It should be noted that that leachable lead from the deeper sample within WS4 (at 1.20m) was recorded <0.60ug/l (i.e. laboratory LOD). There were no other recorded exceedances of the leachate assessment criteria for lead from the remaining five samples.
