## DESIGN ACCESS AND HERITAGE STATEMENT

Barn at Manor Farm  
Manor Road  
Hayling Island  
Hampshire  
PO11 0QW

Project: Retrospective application to remove a section of wall to form a new access.

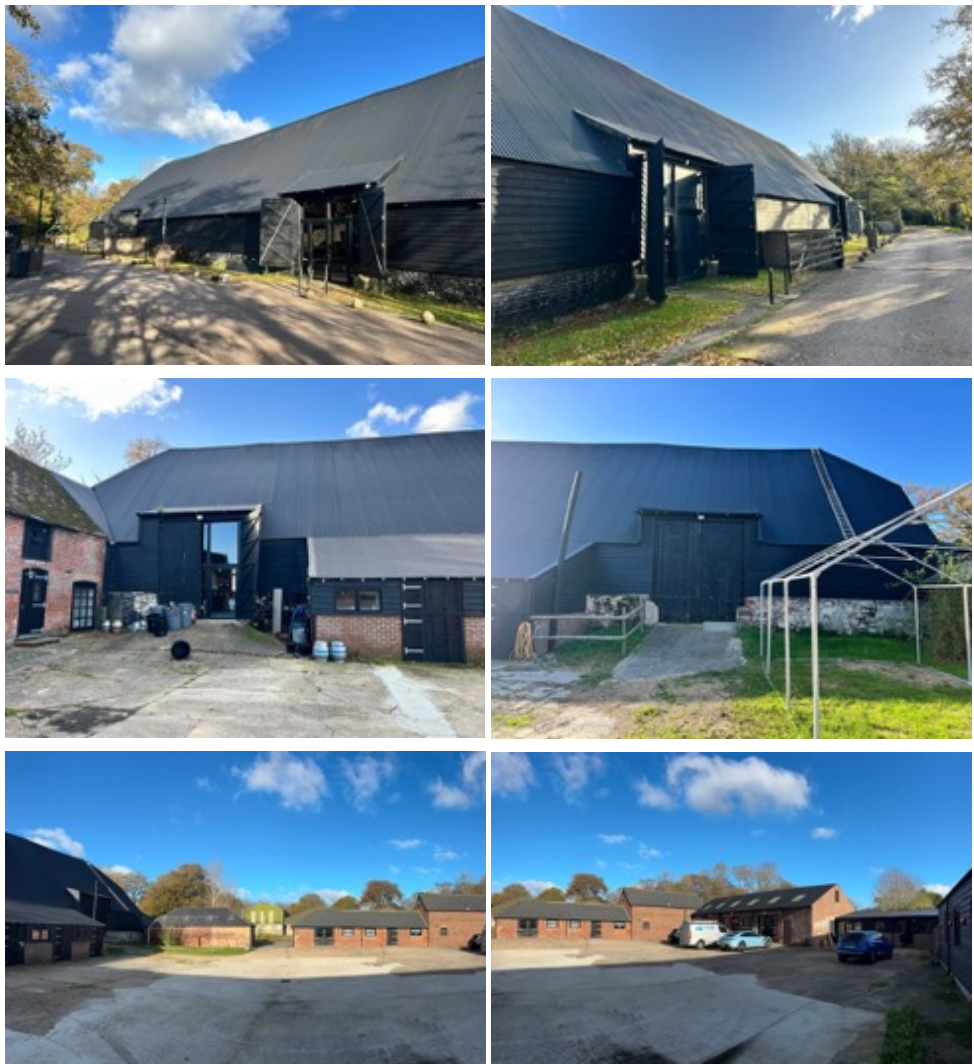
- 2.3. There are two large historic openings in the western elevation which are both glazed with the large timber doors retained. On the east elevation is a large opening which is also glazed with a ramp sloping down into the courtyard. This corresponds with the southern opening in the west.

The west and east elevations of the barn and courtyard viewed from the south.

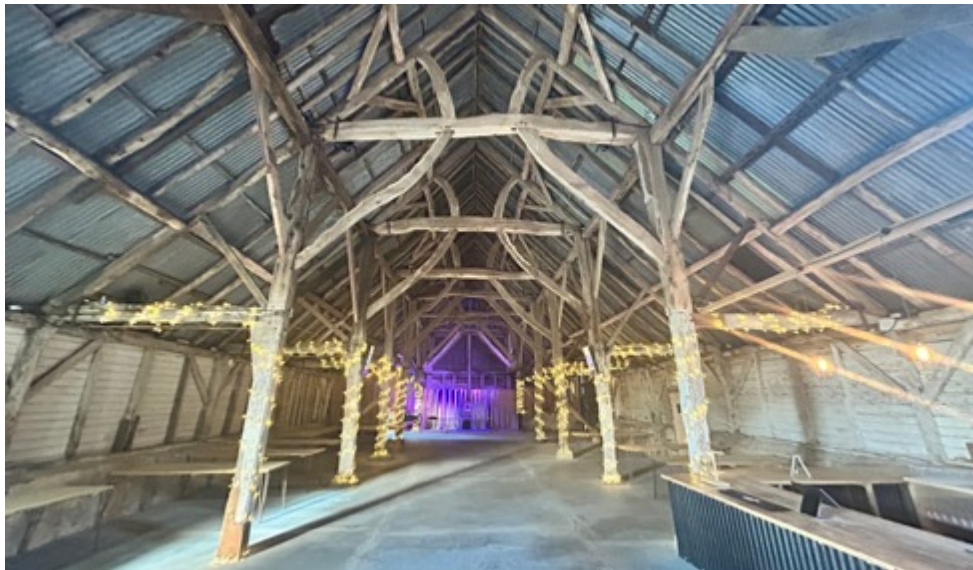
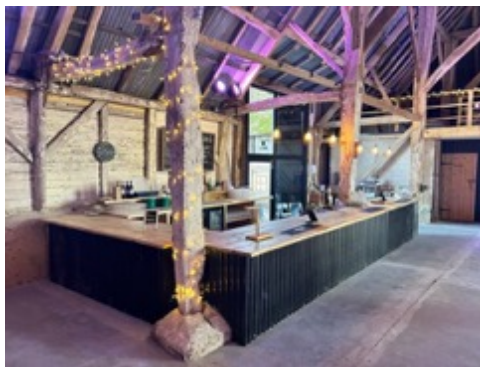
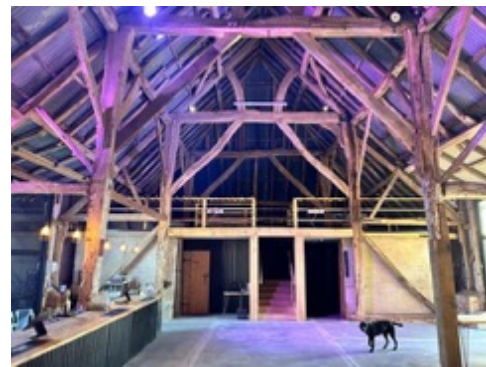
**The interior of the main barn.**

- 2.5. Internally the main barn is dominated by the striking timber structure with long thin curved braces and corresponding struts. At the southern end is a mezzanine floor which is accessed via a central stair and enclosed by a timber balustrade. Toilets are situated below. At the back is the concrete wall which is a remnant of the grain store that once existed here.
- 2.6. Also, in the southern half of the barn there is a bar and to the north of this the door opening which is the subject of this application.

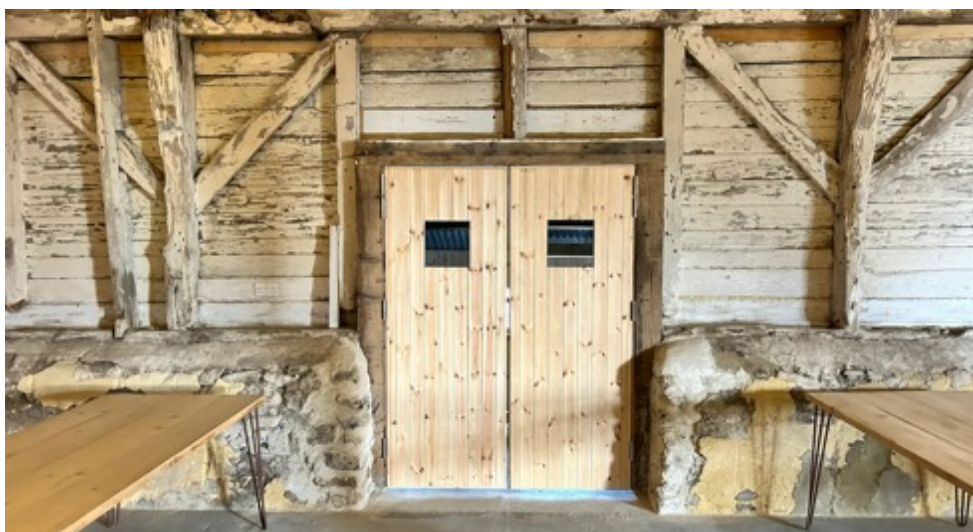
**The new opening which connects the barn with the extension to the east.**

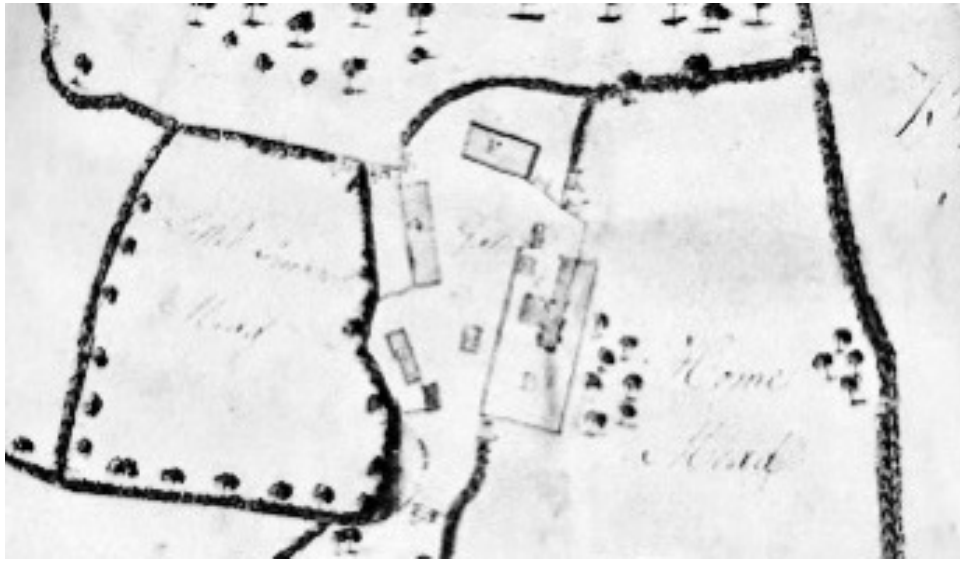
- 4.2. A detail of the map, illustrated below, shows the eight-bay barn oriented north-south, with a further large barn to the northeast and a house to the southeast. The two barns form a loose courtyard plan which was common before farmyards became more conceptualised.

Detail of a map made for the Duke of Norfolk, probably in the 18<sup>th</sup> century, but before 1777.

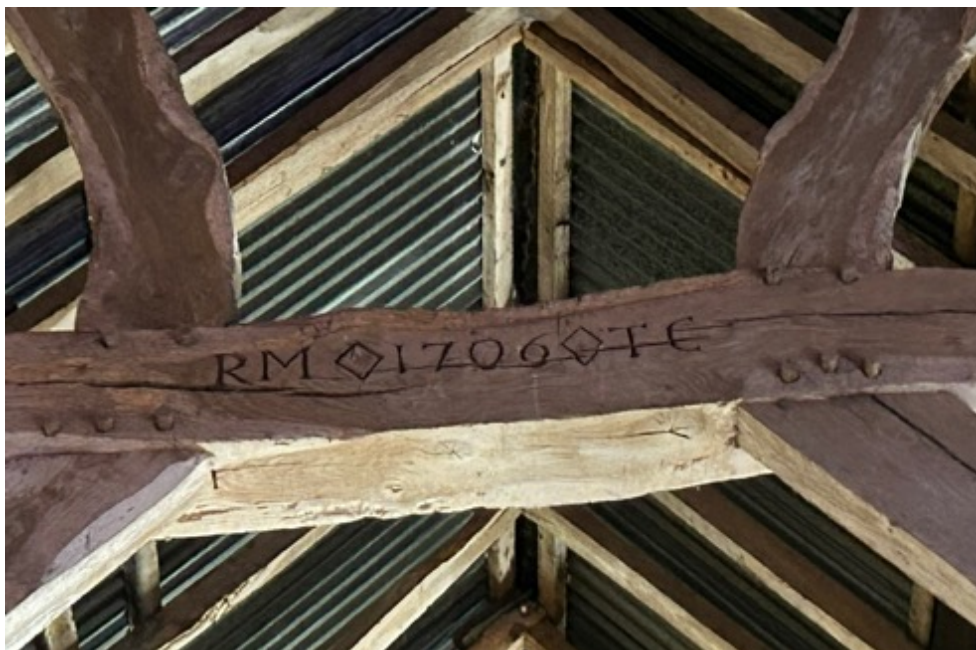
The date of 1706 carved into a beam and initialled 'RM' and 'TC'.

- 4.6. The timbers are thought to have been salvaged from a shipwreck having been on their way to France from Germany. The curved nature of the braces and struts are not typical of frames of this period which tended to be shorter and straighter. The farm at this time was part of the Duke of Norfolk's estate, who as mentioned above, built the Manor House nearby in 1777.
- 4.7. Over time, some of the timbers have been replaced or repaired with metal strapping, though much of the frame remains intact and well looked after.
- 4.8. The base of the barn, which is made up of a mixture of largely stone, brick and flint, has also been damaged over time with the south wall harmed by the concrete grain wall and some of the buttressing lost. The northwest corner has been reconstructed in brick.

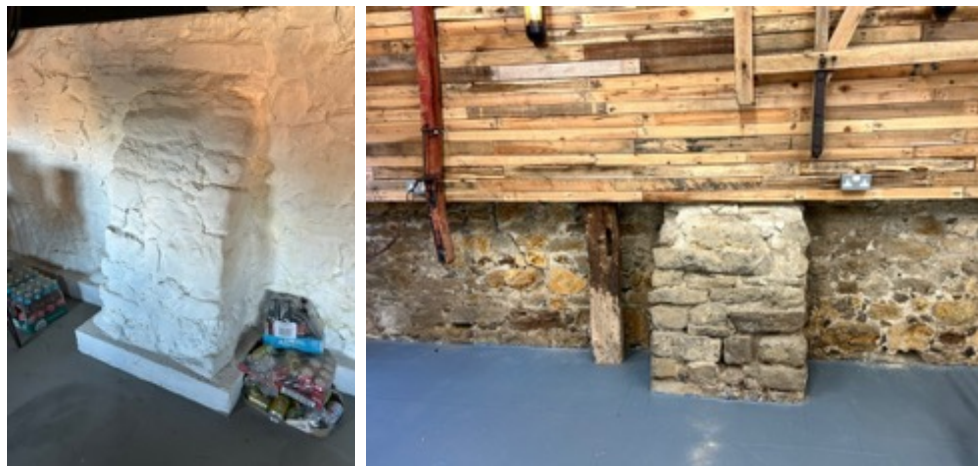
**Remnants of the buttressing in the east and north walls.**

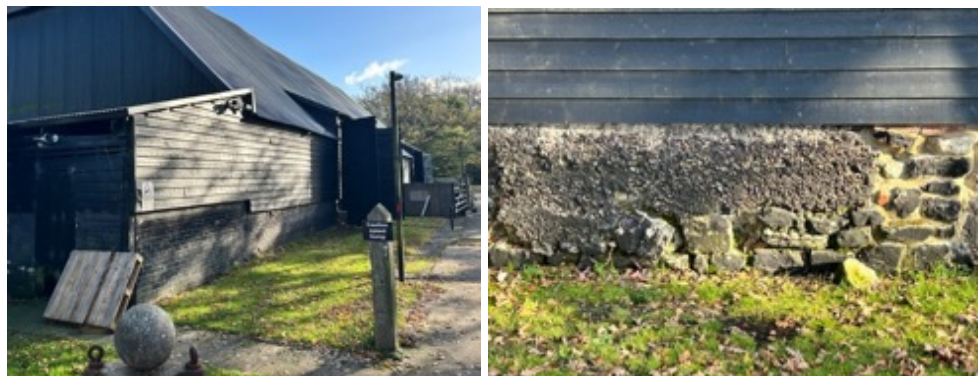
**The northwest corner wall replaced in brick and a concrete repair.**

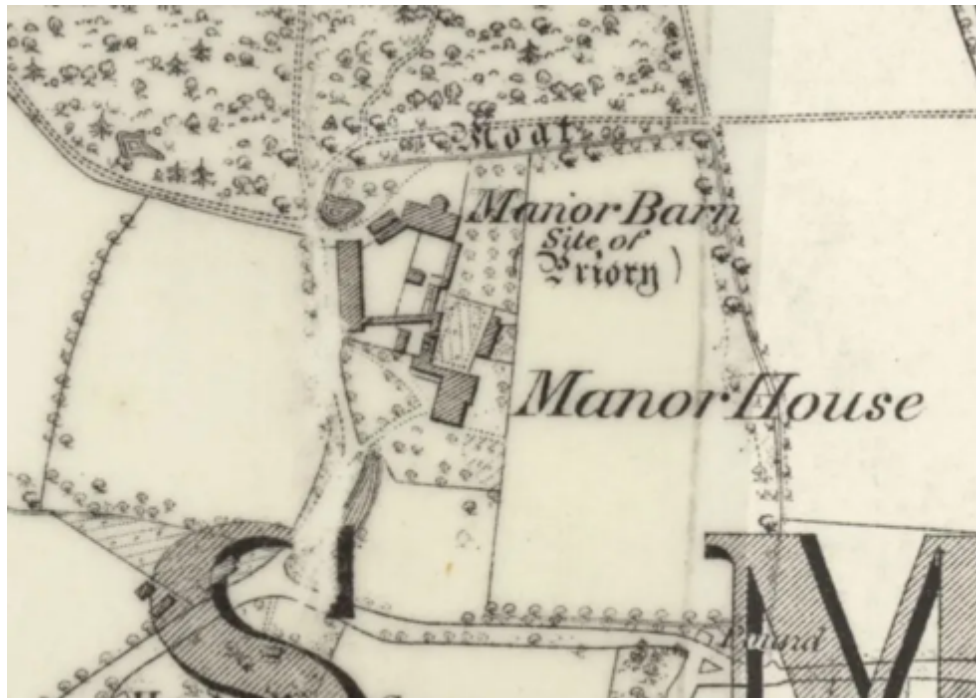
- 4.9. The First Edition OS mapping of 1866 (see below) shows the farmyard plan with the two large barns from the 18<sup>th</sup> century mapping retained, though now with buildings along the south and east forming a more enclosed courtyard. The Manor House is also visible to the south. The entrance into the yard meanwhile was further west than it is today at the corner of the main barn. The yard was subdivided with a small building at its centre.
- 4.10. The development here corresponds with the great farming period of 1750-1880 which peaked between 1840 and 1870 and was hugely influenced by the housing of cattle, mechanisation and the use of fertilizers. The process of farming was thus being more clearly reflected in the planning of farm buildings resulting in more formal layouts.

The First Edition OS map of 1866. Reproduced with permission from the National Library of Scotland.

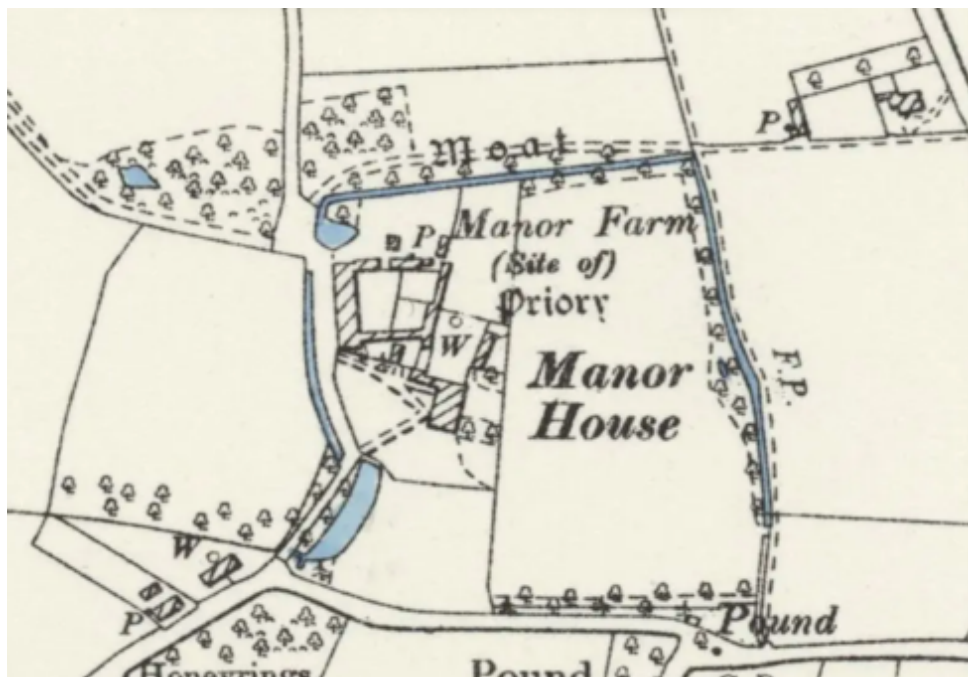
- 4.11. By the time of the Second Edition OS mapping of 1895 (see below), the three barns to the north had been demolished and replaced with an even more rational arrangement. This consisted of a narrow barn being built off the northeast corner of the main barn and a corresponding structure to the west which resulted in a squared-off yard. After 1880 it was really only large estates that were undertaking these types of changes as the depression hit most normal farmers with many moving towards meat and dairy.

The Second Edition OS map of 1895. Reproduced with permission from the National Library of Scotland.

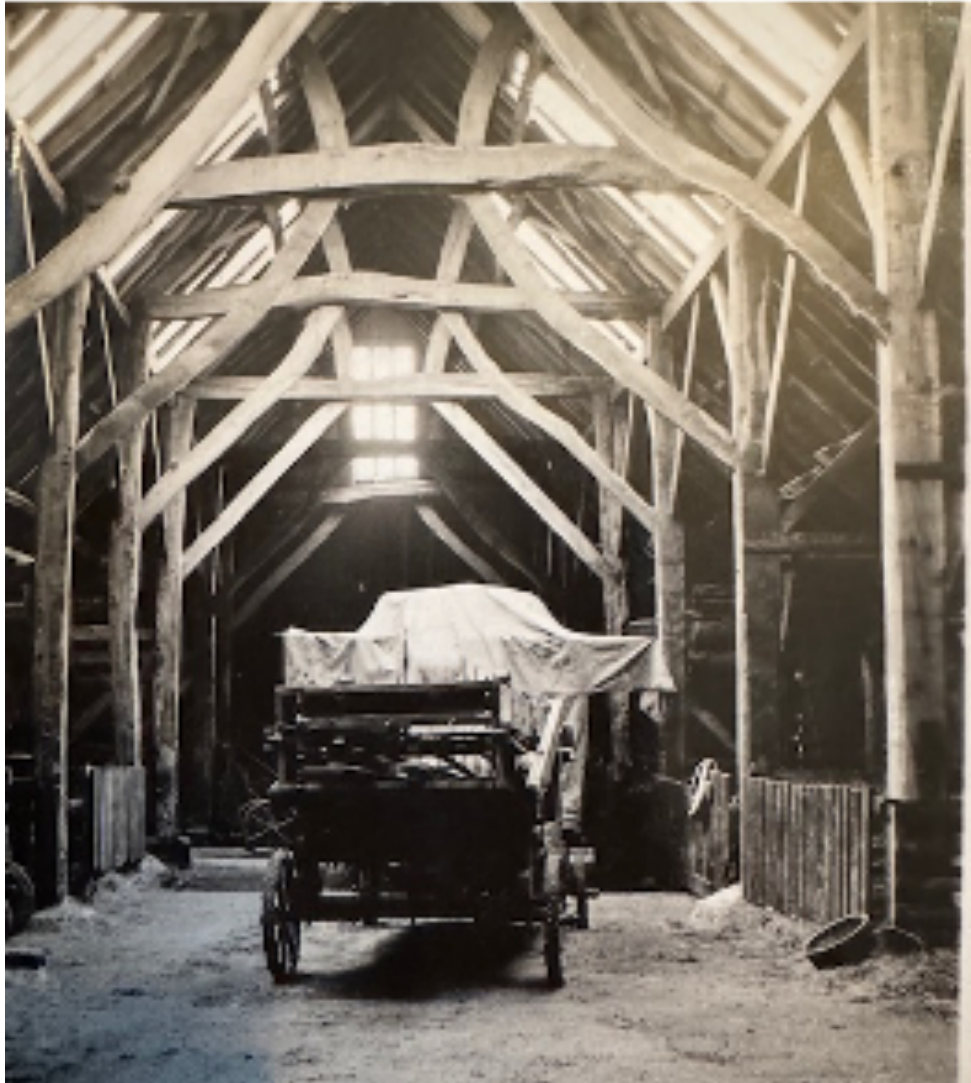
- 4.12. As we can see on the map regression above, the farm layout did not change significantly after 1866 with only the single-storey addition to the east of the main barn being built between 1907 and 1938. This was a stock shed and later converted into stables and today is a store and food preparation area for events.
- 4.13. The historic thatched roof of the large barn would have given way to a metal roof, probably in the early 20<sup>th</sup> century when corrugated roofing was transitioning from iron to steel. Early on, the roof contained large windows along both roof slopes and in the gable end which is illustrated

below. These have since been removed following a roof replacement. The roof at this time was painted black and known as the 'black barn'.

**The barn with a corrugated roof and windows along both roof slopes as well as in the gable end.**

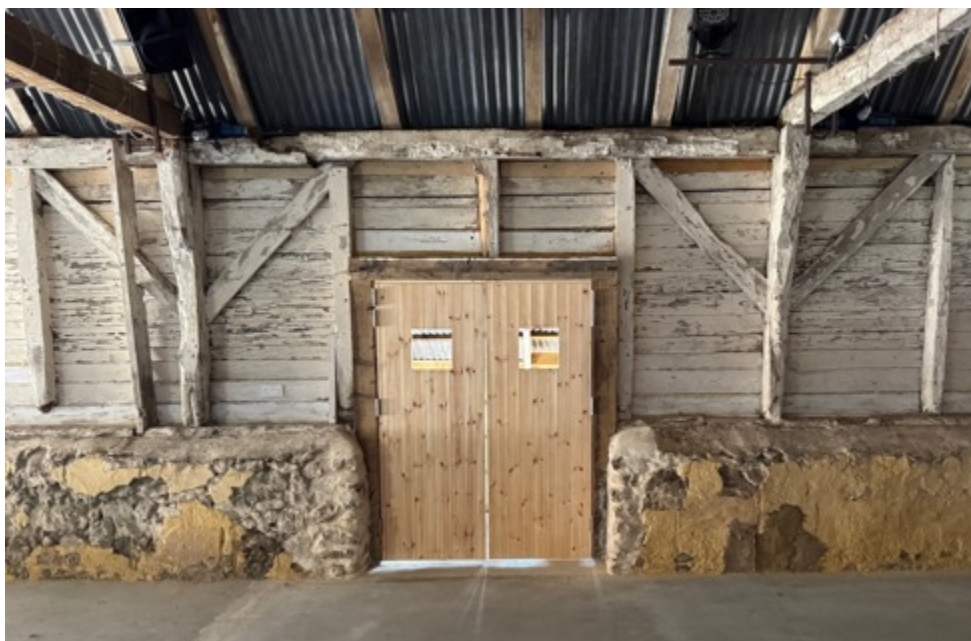
The doors as implemented and seen from within the barn.

- 6.2. Due to the change in ground level, which is significant, only the top half of the wall has been removed. This equates to 90cm of fabric being removed from a wall that from the external ground floor to the top is 150cm. The top section of wall tapers in from both sides so the loss as a ratio of the whole section is reduced.

- 6.3. The creation of the opening also required a section of post to be removed and some boarding with a new door frame being constructed from large sections of timber that correspond with the beams in the main barn. The doors are formed from tongue and groove panelling with each door having a window around head height.

- 6.5. **Impacts:** the new door results in the loss of historic fabric in the form of part of the masonry wall and some timber-frame and boarding. The section of wall removed equates to 1.5m x .9m which is 1.35 sq metres. This harm is not visible externally, though obviously visible from within the barn.

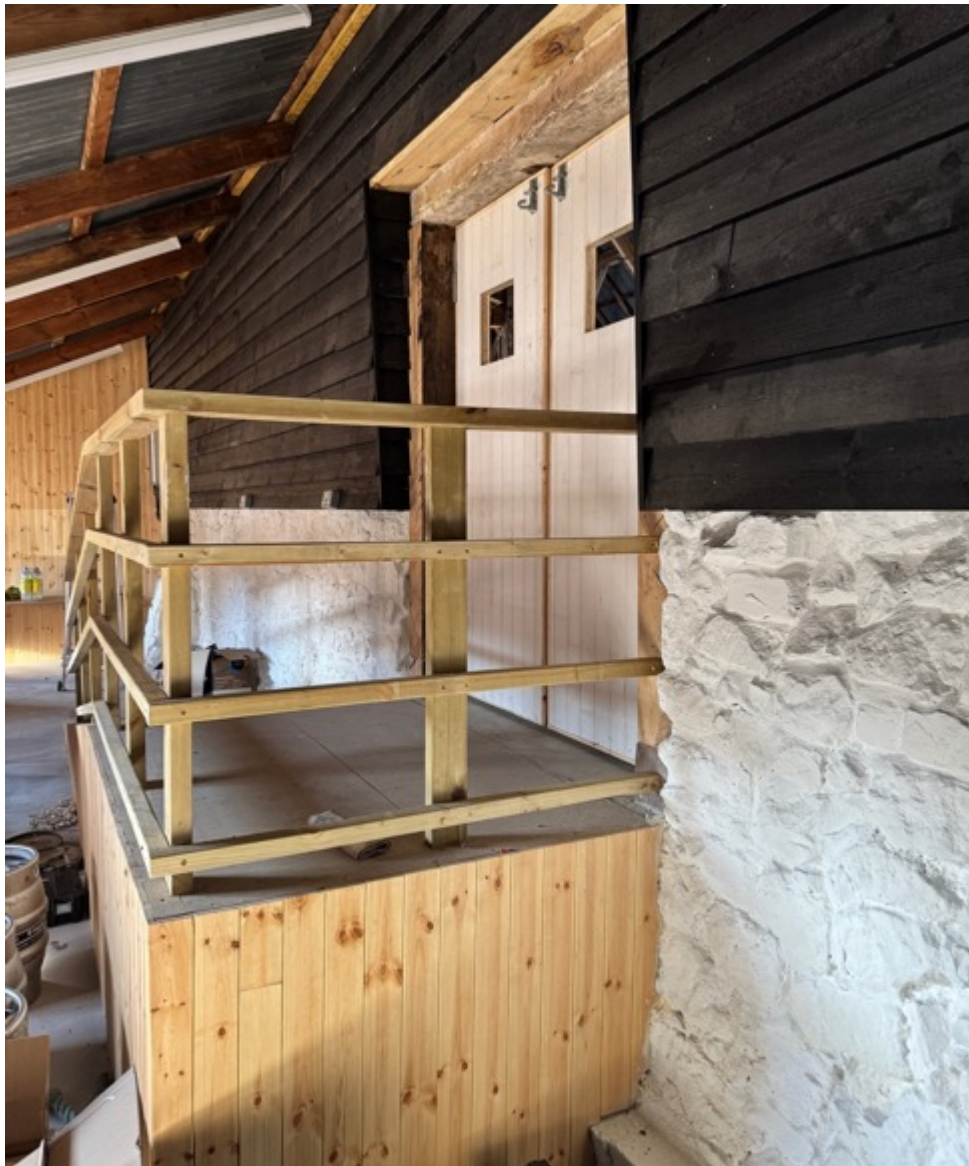
- 6.4. The change in floor level also required a ramp structure to be built for the outside wall. This is effectively freestanding and not attached to the listed building, or the ground for that matter.

The doors and ramp view from within the extension to the east.
