# Preliminary Ecological Appraisal and Roost Assessment

Premier inn Portsmouth (Havant) 65 Bedhampton Hill, Havant PO9 3JN

Whitbread Group PLC

The construction of a 30-bedroom annexe to the existing Premier Inn building alongside the demolition of the existing restaurant to facilitate a new 37-bedroom annexe, and a Solus 1.5 restaurant conversion of 7 bedrooms is proposed at the ground floor of the existing hotel [Unsubmitted]

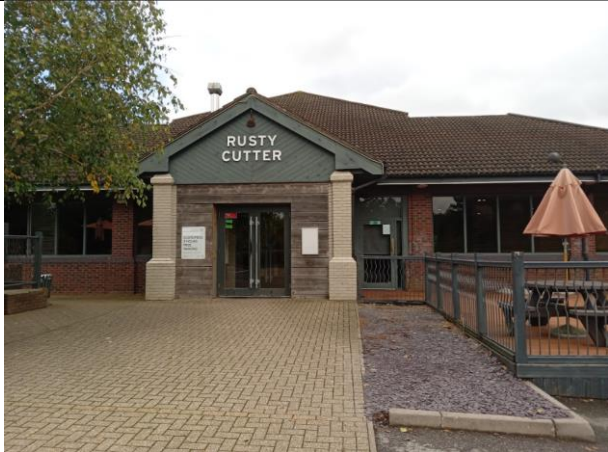
| <b>B1 Building description</b> | | | <b>Photographs</b> |
|---|---|---|---|
| <p><i>Summary</i></p> <p>B1 is a single storey detached brick-built restaurant. B1 includes a combination of hipped, gable and dormer roofs, with a projecting gable at the entrance, featuring brown clay effect interlocking tiles. The elevations mainly comprise red brick with a blue engineered soldier course banding and grey aluminium windows. The entrance features cream painted brick and some timber horizontal weatherboard and diagonal, grey-painted weatherboard above the entrance. The building has <b>moderate habitat value</b>.</p> <p><b>B1 is due to be demolished.</b></p> | | | |

| <i>Recommendations</i> | <p><b>Roosting habitat [Buildings]</b></p> <p><b>B1</b><br/>Two bat emergence/re-entry surveys are required on B1 during the active bat season (May – September) to confirm presence/likely-absence of bats roosting in or on the building. These survey visits should be completed during the optimal survey period mid-May to August inclusive. The survey visits should be at least three weeks apart.<br/>Four surveyors are required to provide full coverage of the building’s elevations to look for emerging/re-entering bats. An infrared camera should also be employed as part of the survey to cover all elevations.<br/>Lighting mitigation may be required based on the outcome of the night bat surveys.<br/>If any bat roosts are confirmed from this survey schedule, a bat licence would be required to demolish the buildings as it would involve the destruction of roosts. This is applied for with the help of a class 2 licensed bat ecologist after planning permission is granted, but before commencement of works.<br/>If bat roosts are confirmed in the building an EPSL application will be required to Natural England. The EPSL application requires that all surveys have been undertaken within the most recent active bat season and planning permission must have been granted and all relevant wildlife-related conditions have been discharged prior to submission.</p> |

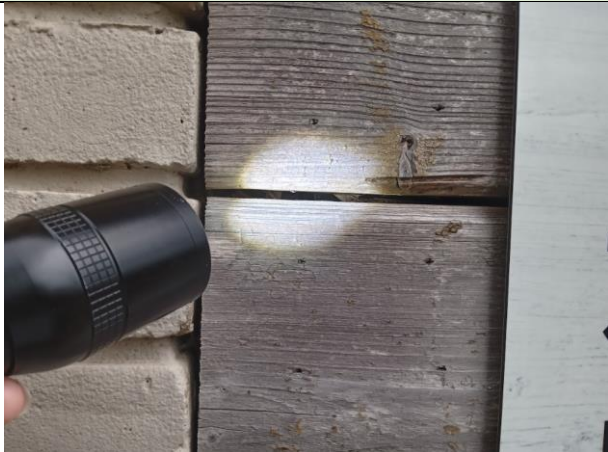
| <b>B1 Building description</b> | | | <b>Photographs</b> |
|---|---|---|---|
| Walls | Brick, timber | <p><b>Condition/description</b></p> <p>Numerous raised boards around the entrance on the north-western elevation of B1.</p> <p><b>Suitability/access/evidence of bats</b></p> <p>Raised external boards provide ideal roosting habitat for crevice dwelling bats. No evidence found but recent and current rain would wash this away externally.</p> | |

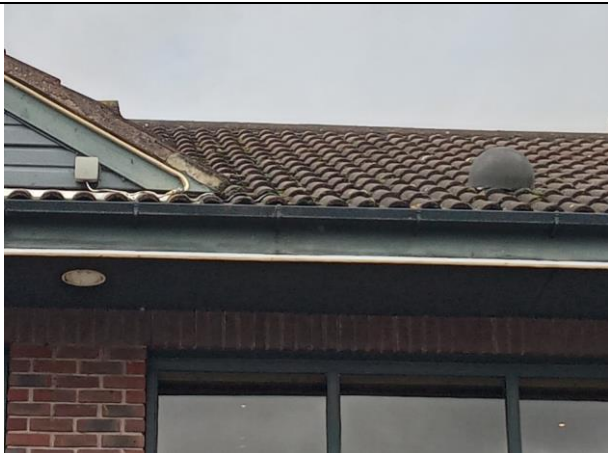
| Roof | Clay | <p><b>Condition/description</b><br/>Gabled roof- split level. Raised tiles present on the north-western and south-western elevation.</p> <p><b>Suitability/access/evidence of bats</b><br/>Space under tiles could accommodate crevice dwelling bats alongside access points under the ridge tiles on the north-eastern elevation. No evidence found but recent and current rain would wash this away externally</p> | |

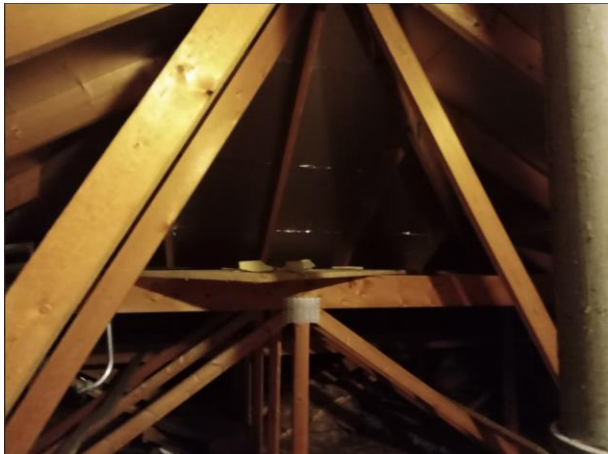
| Internal voids | Timber rafters and ridge beam. | <p><b>Condition/description</b><br/>Internal space measures approx. 9.4m long, 7.2m wide, floor to ridge height approx. 2.6m.</p> <p>Multiple access points directly into the loft space.</p> <p><b>No evidence of bats was identified internally.</b></p> | |

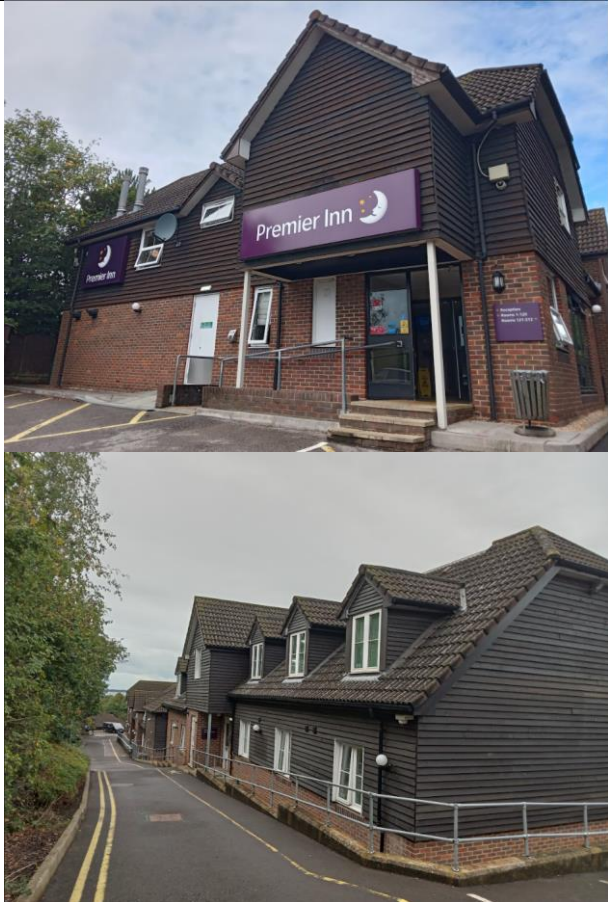
| B2 Building description | Photographs |
|---|---|
| <p><i>Summary</i></p> <p>B2 is a two storey brick built dwelling with a combination of hipped, gable and dormer roofs clad in brown clay effect interlocking tiles. All elevations are either part clad, or fully clad in timber weatherboards which have numerous gaps providing roosting opportunities for crevice dwelling bats.</p> <p>The building has <b>high habitat value</b>.</p> | |

| | <p><b>B2</b></p> <p>Three bat emergence/re-entry surveys are required on B2 during the active bat season (May – September) to confirm presence/likely-absence of bats roosting in or on the building.</p> <p>These survey visits should be completed during the optimal survey period mid-May to August inclusive. The survey visits should be at least three weeks apart.</p> <p>Four surveyors are required to provide full coverage of the building's elevations to look for emerging/re-entering bats. An infrared camera should also be employed as part of the survey to cover all elevations.</p> <p>Lighting mitigation may be required based on the outcome of the night bat survey(s).</p> <p>If any bat roosts are confirmed from this survey schedule, a bat licence would be required to demolish the buildings as it would involve the destruction of roosts. This is applied for with the help of a class 2 licensed bat ecologist after planning permission is granted, but before commencement of works.</p> <p>If bat roosts are confirmed in the building an EPSL application will be required to Natural England. The EPSL application requires that all surveys have been undertaken within the most recent active bat season and planning permission must have been granted and all relevant wildlife-related conditions have been discharged prior to submission.</p> <p><b>Roosting habitat [Trees]</b></p> <p>In the unlikely event that a bat or evidence of bats is discovered during the development all work must stop and a bat licensed ecologist contacted for further advice.</p> <p><b>Foraging and commuting habitat</b></p> <p>No further surveys are required.</p> <p><b>Artificial lighting</b></p> <p>A low impact lighting strategy will be adopted for the site during post-development which outlines the areas of the site that will be retained as dark corridors. Parameters can be found on the Bat Conservation Trust website:<br/> <a href="https://www.bats.org.uk/our-work/buildings-planning-and-development/lighting-2">https://www.bats.org.uk/our-work/buildings-planning-and-development/lighting-2</a></p> <p><b>Suggested biodiversity enhancements</b></p> <p>Enhancements are dependent on the outcome of further surveys.</p> |

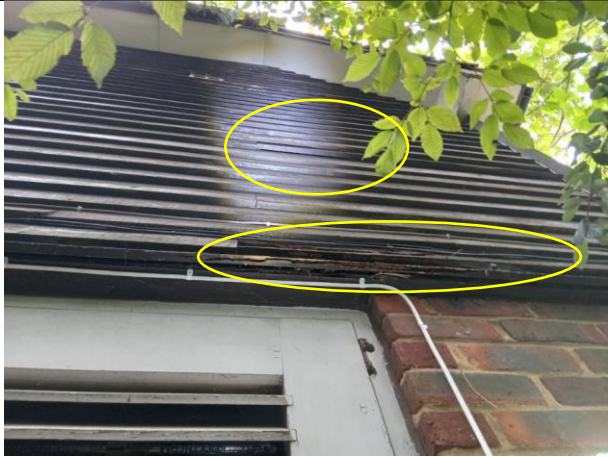
| Feature | Materials | Condition/description/suitability | Photograph(s) |
|---|---|---|---|
| Walls | Brick, timber | <p><b>Condition/description</b><br/>Numerous raised boards on the north-west, south-west and south-east elevation</p> <p><b>Suitability/access/evidence of bats</b><br/>Raised external boards provide ideal roosting habitat for crevice dwelling bats and could support maternity roosts. No evidence found but recent and current rain would wash this away externally.</p> | |

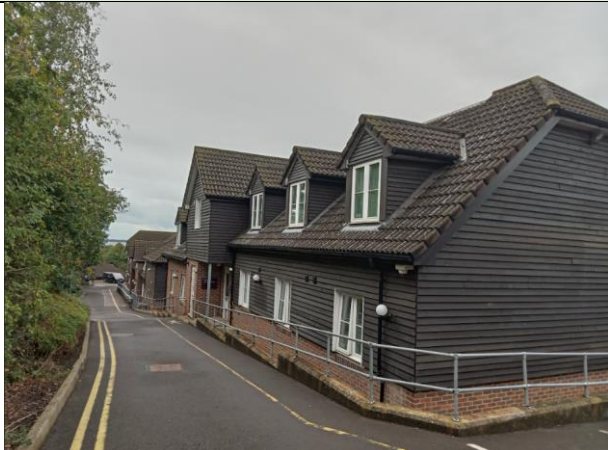
| Buildings | | | |
|---|--|---|--|
| | | Figure 1: The hotel (B2) on site | |
