# **Road Safety Audit Stage 1**

**Bartons Road Access, S278 and S38  
Works, Havant**

**Client: Stonebond Properties (Guildford) Ltd**

**Road Safety Answers reference no: RSA1123**

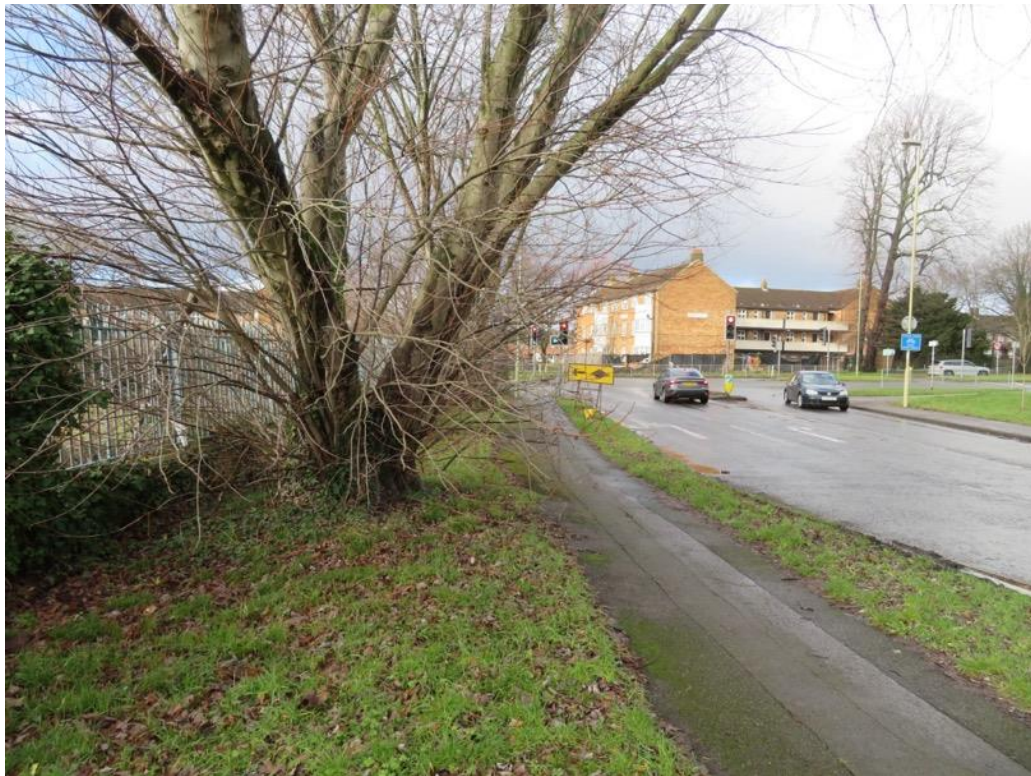
**Photo 1: Looking west along Barton Road towards Petersfield Road**

Summary: Risk of trees falling onto the highway.

The widened shared facility is shown passing very close to the mature trees (photo 1), the construction of which may damage the roots of the two mature trees, compromising their stability and increasing the risk of them falling onto passers-by and vehicles during periods of high wind.

The tree roots should not be damaged during the construction of the widened, shared cycle/footway.

| Audit Team No. | Audit Team Observation | Audit Team Recommendation | C&A Designers Response | Client Comment |
|---|---|---|---|---|
| 3.1 | <p><b>Problem</b></p> <p><b>Location: A</b> – Southern Side of Bartons Road, approaching the Toucan Crossing (Dwg. 24-097/016 Rev. A).</p> <p><b>Summary:</b> Risk of trees falling onto the highway.</p> <p>The widened shared facility is shown passing very close to the mature trees (photo 1), the construction of which may damage the roots of the two mature trees, compromising their stability and increasing the risk of them falling onto passers-by and vehicles during periods of high wind.</p> | <p><b>Recommendation:</b></p> <p>The tree roots should not be damaged during the construction of the widened, shared cycle/footway.</p> | <p><b>Agree:</b></p> <p>This is a matter for the detailed design stage. It will be addressed by confirming with the Arboriculturist that any minor root damage would not be detrimental to the trees. If required, a root protection system would be implemented. No changes are required at this stage.</p> | |

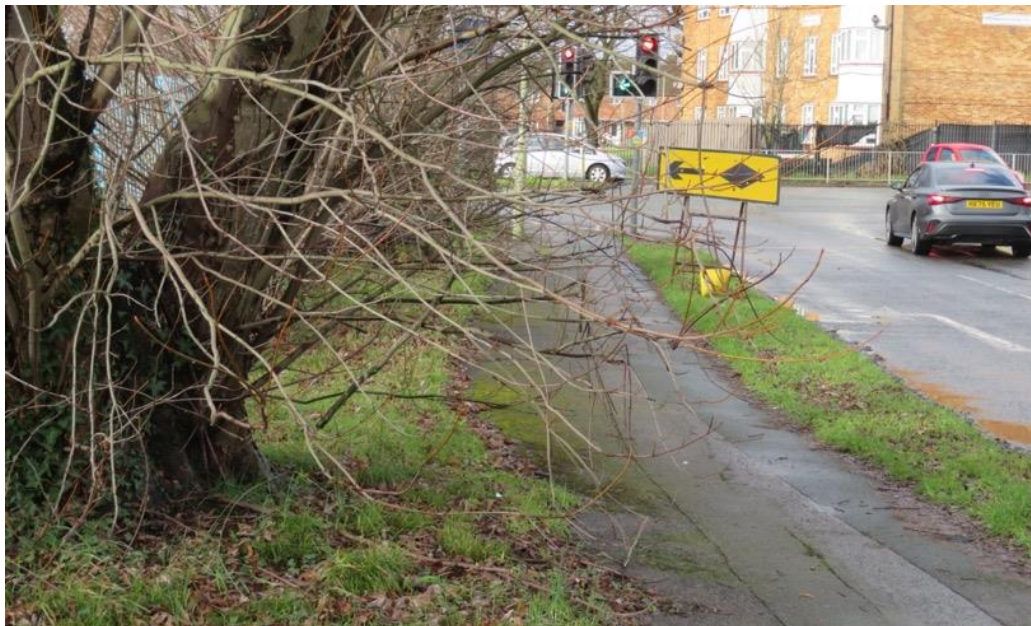
**Photo 2: Looking west along Barton Road towards Petersfield Road junction**

Summary: Risk of injury to cyclists using the shared cycle path due to overhanging vegetation.

Low-hanging branches and overhanging vegetation along the southern side of Bartons Road are encroaching onto the proposed cycle path and shared-use facility (photo 2). This creates a potential hazard for cyclists, particularly those travelling at speed, who may not have sufficient time or space to react and avoid contact. The obstruction could result in collisions with the vegetation, leading to loss of control, injury, or deviation into pedestrians also using the path.

It is recommended that the overhanging branches and vegetation be cut back to provide clear and unobstructed headroom along the full length of the proposed facility. A regular maintenance regime should also be implemented to ensure vegetation does not re-encroach into the path in the future.

| Audit Team No. | Audit Team Observation | Audit Team Recommendation | C&A Designers Response | Client Comment |
|---|---|---|---|---|
| 3.2 | <p><b>Problem</b></p> <p><b>Location: B</b> – Southern side of Bartons Road, Approaching the Toucan Crossing (Dwg. 24-097/016 Rev. A).</p> <p><b>Summary:</b> Risk of injury to cyclists using the shared cycle path due to overhanging vegetation.</p> <p>Low-hanging branches and overhanging vegetation along the southern side of Bartons Road are encroaching onto the proposed cycle path and shared-use facility (photo 2). This creates a potential hazard for cyclists, particularly those travelling at speed, who may not have</p> | <p><b>Recommendation:</b></p> <p>It is recommended that the overhanging branches and vegetation be cut back to provide clear and unobstructed headroom along the full length of the proposed facility. A regular maintenance regime should also be implemented to ensure vegetation does not re-encroach into the path in the future.</p> | <p><b>Agree:</b></p> <p>Overhanging branches and vegetation should be regularly trimmed by LHA to maintain clear and unobstructed headroom along the full length of the proposed shared footway/cycleway.</p> | |

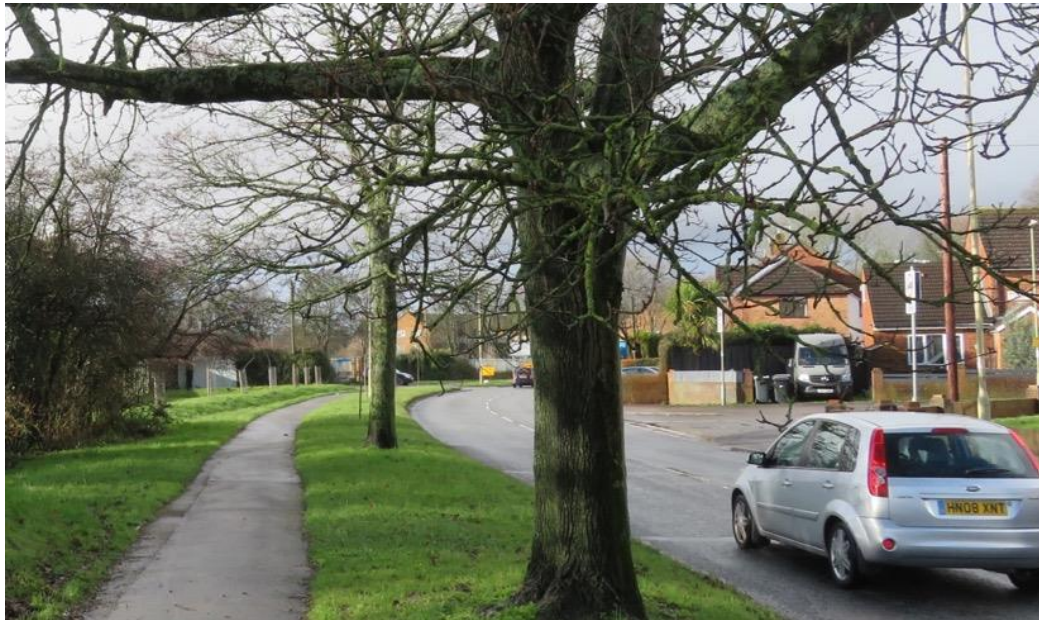
**Photo 3: Looking west along Bartons Road, opposite nos. 21 to 27**

Summary: Risk of cyclists colliding with low branches.

Low branches from the existing mature tree (photo 3) are likely to obstruct the shared cycle/footway.

The low branches should be removed, allowing a minimum 2.3m headroom for cyclists.

| 3.8 | <p><b>Problem</b></p> <p><b>Location: H</b> – Tree opposite nos. 21 to 27 Bartons Road (Dwg. 24-097/017).</p> <p><b>Summary:</b></p> | <p><b>Recommendation:</b></p> <p>The low branches should be removed, allowing a minimum 2.3m headroom for cyclists.</p> | <p><b>Agree:</b></p> <p>Low overhanging branches should be regularly trimmed by LHA to maintain clear and unobstructed headroom for cyclists.</p> | |

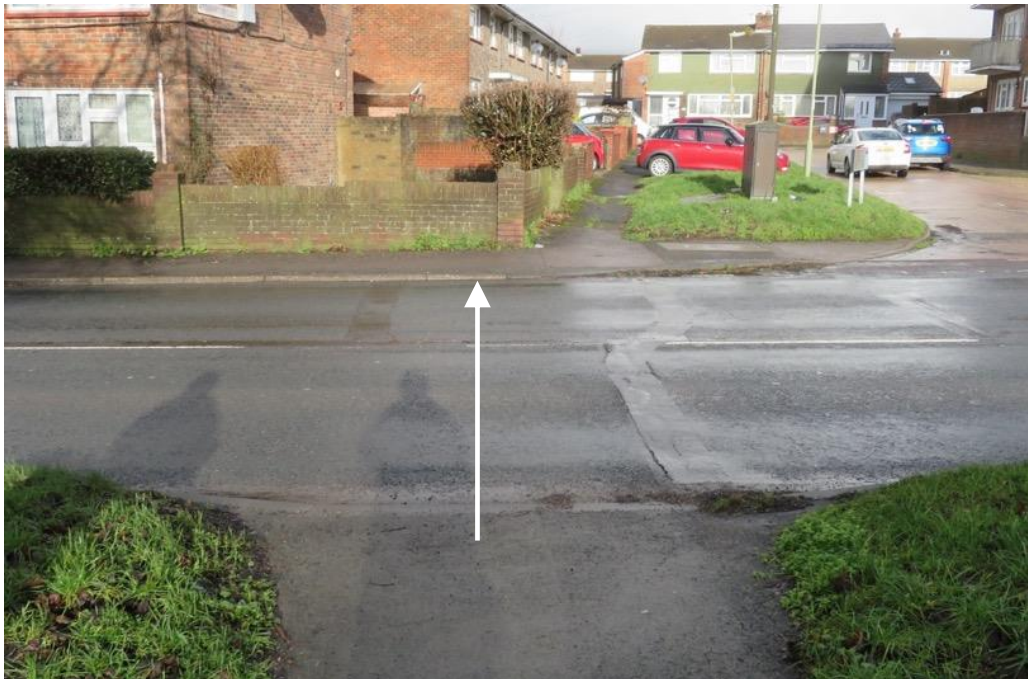
**Photo 4: Proposed tactile paving will be abutting a full height kerbline and a transition kerb (head of the arrow)**

Summary: Risk of pedestrian trips and falls on the transition kerbs and full height kerbs.

The existing dropped kerbs at this crossing point are not opposite one another (photo 4). If the tactile paving is installed in the location shown on the drawing, without altering the dropped kerbs on the northern side, blind pedestrians crossing from south to north will be guided into the transition and full height kerbs, increasing their risk of trips and falls.

On the north side of Bartons Road the kerbs should be dropped adjacent to the proposed tactile paving and the existing dropped kerbs raised to full height away from the crossing point.

| 3.9 | <p><b>Problem</b></p> <p><b>Location: I</b> – The uncontrolled pedestrian crossing of Barton Road, just west of Witchampton Close (Dwg. 24-097/017).</p> <p><b>Summary:</b></p> <p>Risk of pedestrian trips and falls on the transition kerbs and full height kerbs.</p> <p>The existing dropped kerbs at this crossing point are not opposite one another (photo 4). If the tactile paving is installed in the location shown on the drawing, without altering the dropped kerbs on the northern side, blind pedestrians crossing from south to north will be guided into the transition and full height kerbs, increasing their risk of trips and falls.</p> | <p><b>Recommendation:</b></p> <p>On the north side of Bartons Road the kerbs should be dropped adjacent to the proposed tactile paving and the existing dropped kerbs raised to full height away from the crossing point.</p> | <p><b>Agree:</b></p> <p>Dropped kerb to be provided adjacent to the proposed tactile paving and the existing dropped kerbs raised to full height away from the crossing point, as illustrated in Drawing 24-097/017 Rev B.</p> | |

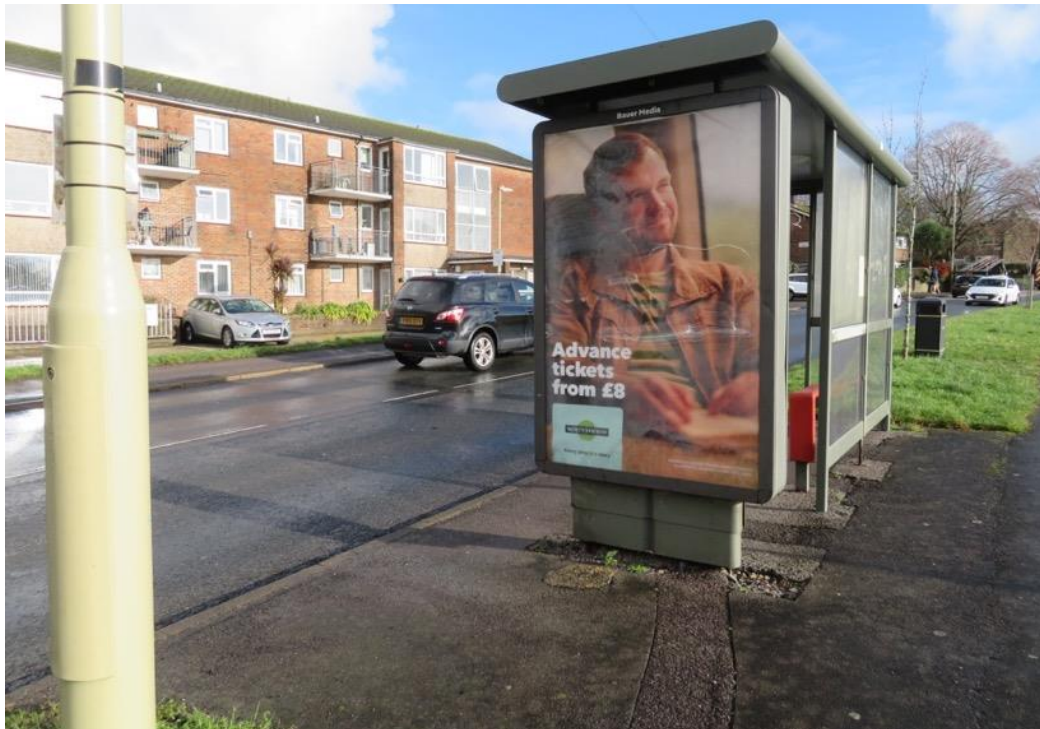
**Photo 5: The shared cycle/footway will extend to the back edge of the bus shelter**

Summary: Risk of collisions between blind pedestrians and cyclists on the shared facility.

Blind and partially sighted pedestrians alighting from the bus should be reminded that they are walking onto a shared cycle/footway as they pass the gaps within, and to the side of, the bus shelter (photo 5), so that they can orientate themselves on the facility to minimise their risk of collisions with cyclists: blind pedestrians are taught to follow the edge of a shared cycle footway rather than the centre when they are entering a footway.

Corduroy paving should be installed within, and adjacent to, the bus shelter abutting the northern edge of the cycle/footway.

| 3.10 | <p><b>Problem</b></p> <p><b>Location: J</b> – The westbound bus stop and shelter (Dwg. 24-097/017).</p> <p><b>Summary:</b></p> <p>Risk of collision between blind pedestrians and cyclists on the shared facility.</p> | <p><b>Recommendation:</b></p> <p>Corduroy paving should be installed within, and adjacent to the bus shelter abutting the northern edge of the cycle/footway.</p> | <p><b>Agree:</b></p> <p>Corduroy paving to be provided within, and adjacent to the bus shelter abutting the northern edge of the cycle/footway, as illustrated in Drawing 24-097/017 Rev B.</p> | |

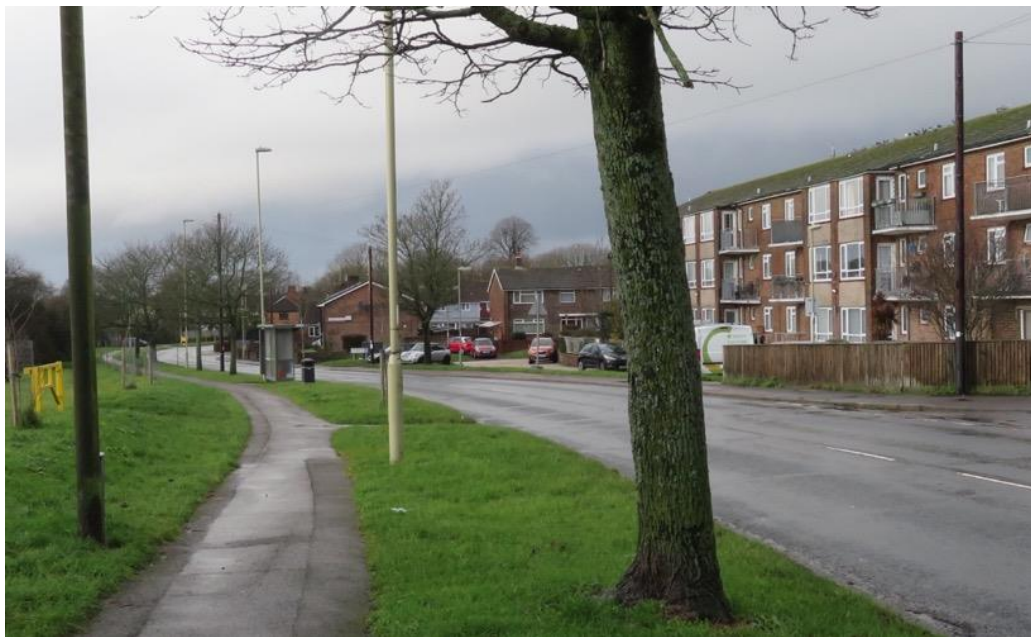
**Photo 6: Lamp column will be within the cycle/footway**

Summary: Risk of cycle collisions with a lamp column.

An existing lamp column, currently in the verge (photo 6), is likely to be within the shared cycle/footway increasing the risk of cyclists colliding with it.

The lamp column should be relocated away from the cycle/footway i.e. near the carriageway of Bartons Road.

| 3.12 | <p><b>Problem</b></p> <p><b>Location: L</b> – Southern side of Bartons Road opposite Forestside Avenue (Dwg. 24-097/017).</p> <p><b>Summary:</b></p> | <p><b>Recommendation:</b></p> <p>The lamp column should be relocated away from the cycle/footway i.e. near the carriageway of Bartons Road.</p> | <p><b>Agree:</b></p> <p>Proposed footway to have localised narrowing if required to prevent risk of collision with existing lamp column as illustrated in Drawing 24-097/017 Rev B.</p> | |

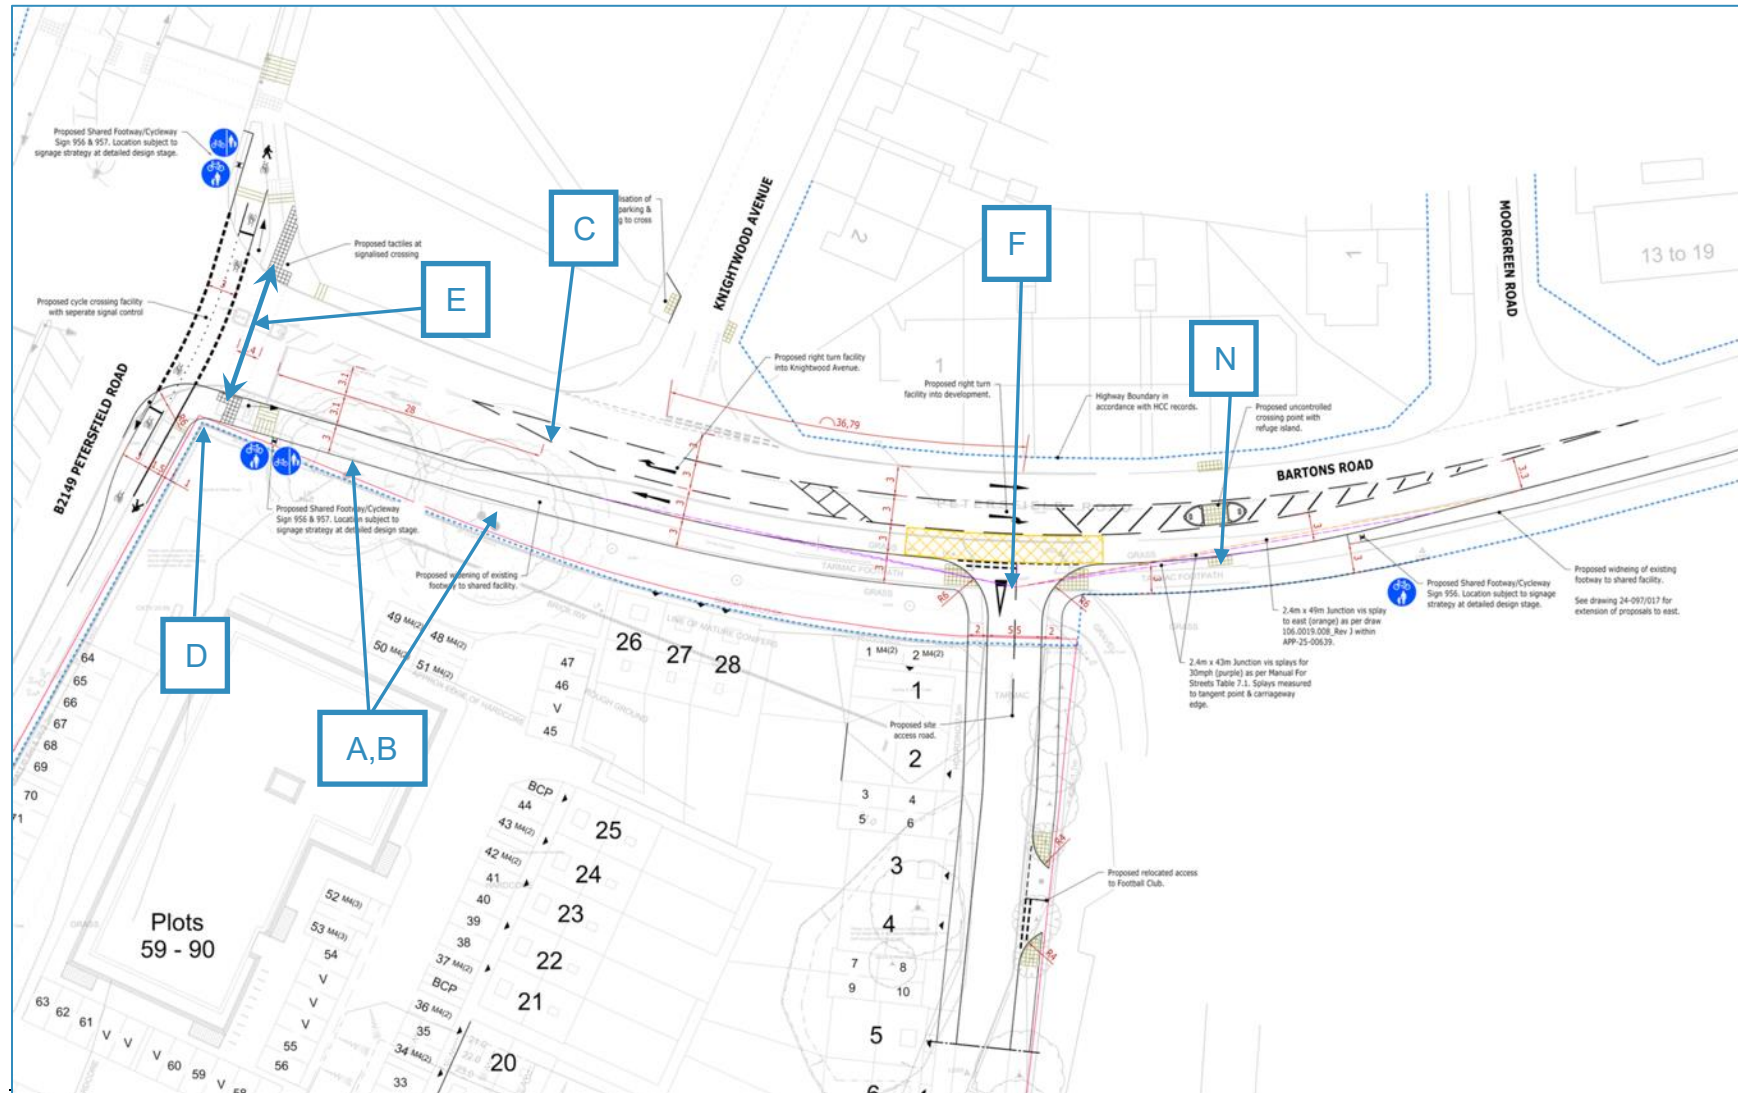
## Problems Location Plans

**1.5** All the problems described in this report are considered by the audit team to require action to improve the safety of the scheme and minimise accident occurrence. Plans showing the scheme and the locations of any problems found during the audit are shown in **Appendix B**.
