| <p>SITE SURVEY</p> | <p>Title</p> |
| <p>01SQ01 (Sheet 25 of 34)</p> | <p>Drawing Number</p> |

# GROUND INVESTIGATION REPORT (FACTUAL)

Southleigh Road,  
Havant,  
Portsmouth,  
Hampshire,  
PO9 2NX

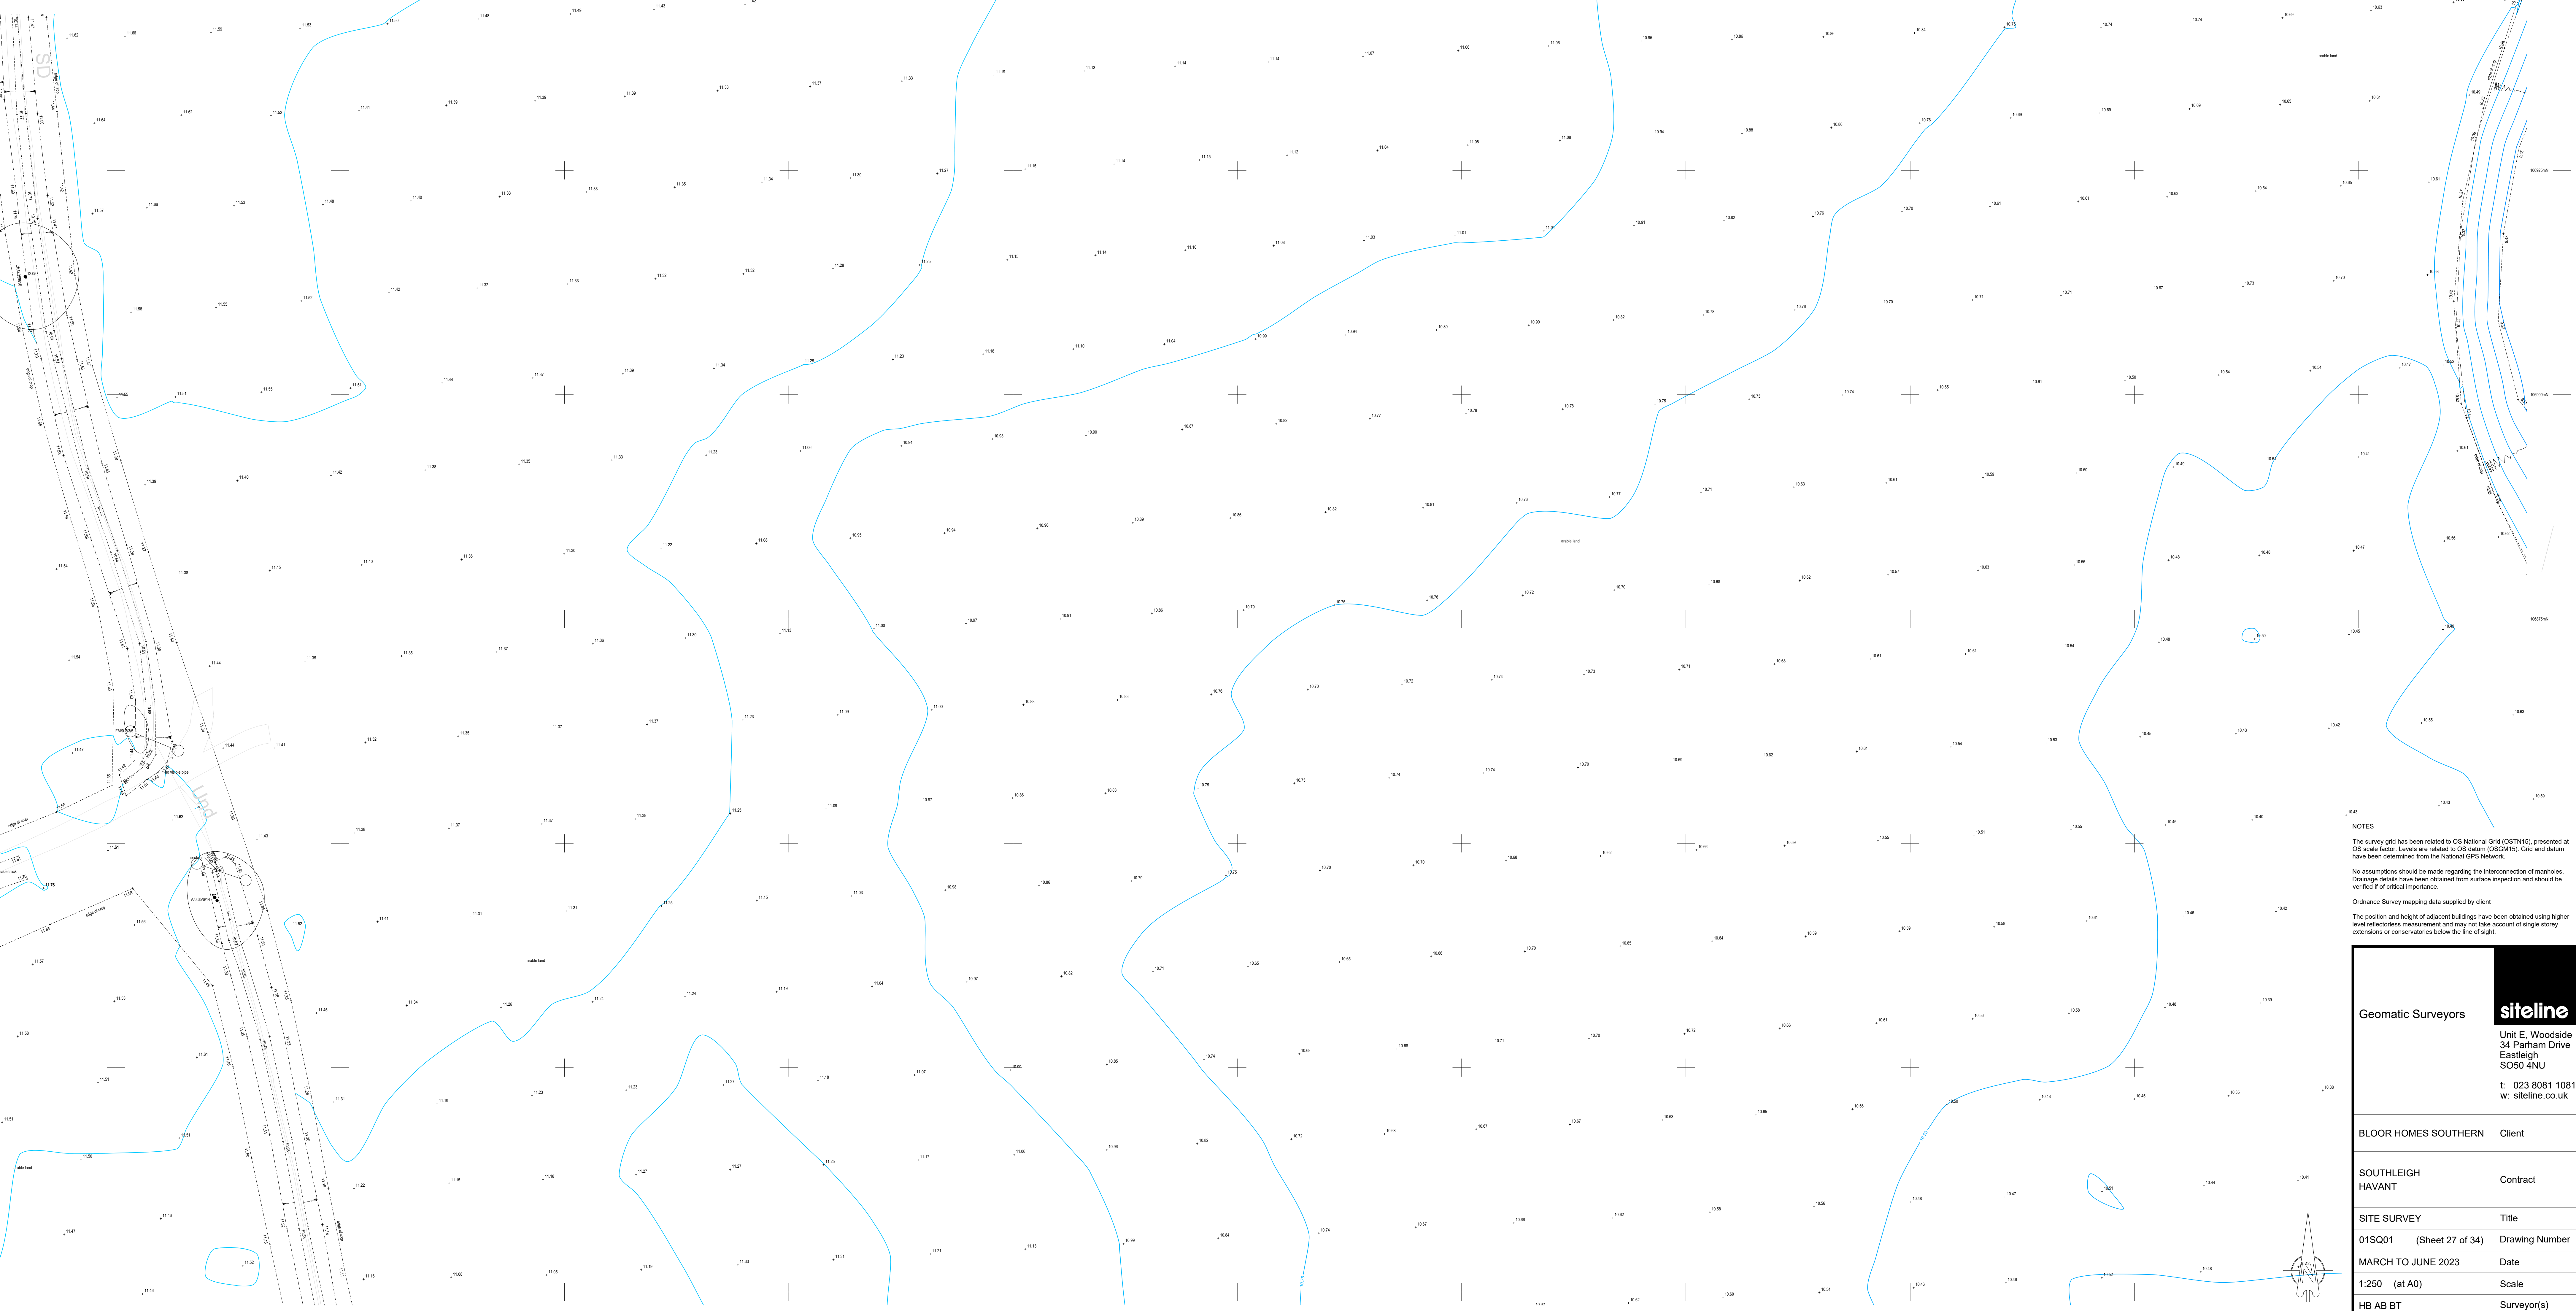
NOTES  
The survey grid has been related to OS National Grid (OSTN15), presented at OS scale factor. Levels are related to OS datum (OSGM15). Grid and datum have been determined from the National GPS Network.  
No assumptions should be made regarding the interconnection of manholes. Drainage details have been obtained from surface inspection and should be verified if of critical importance.  
Ordnance Survey mapping data supplied by client.  
The position and height of adjacent buildings have been obtained using higher level reflectorless measurement and may not take account of single storey extensions or conservatories below the line of sight.

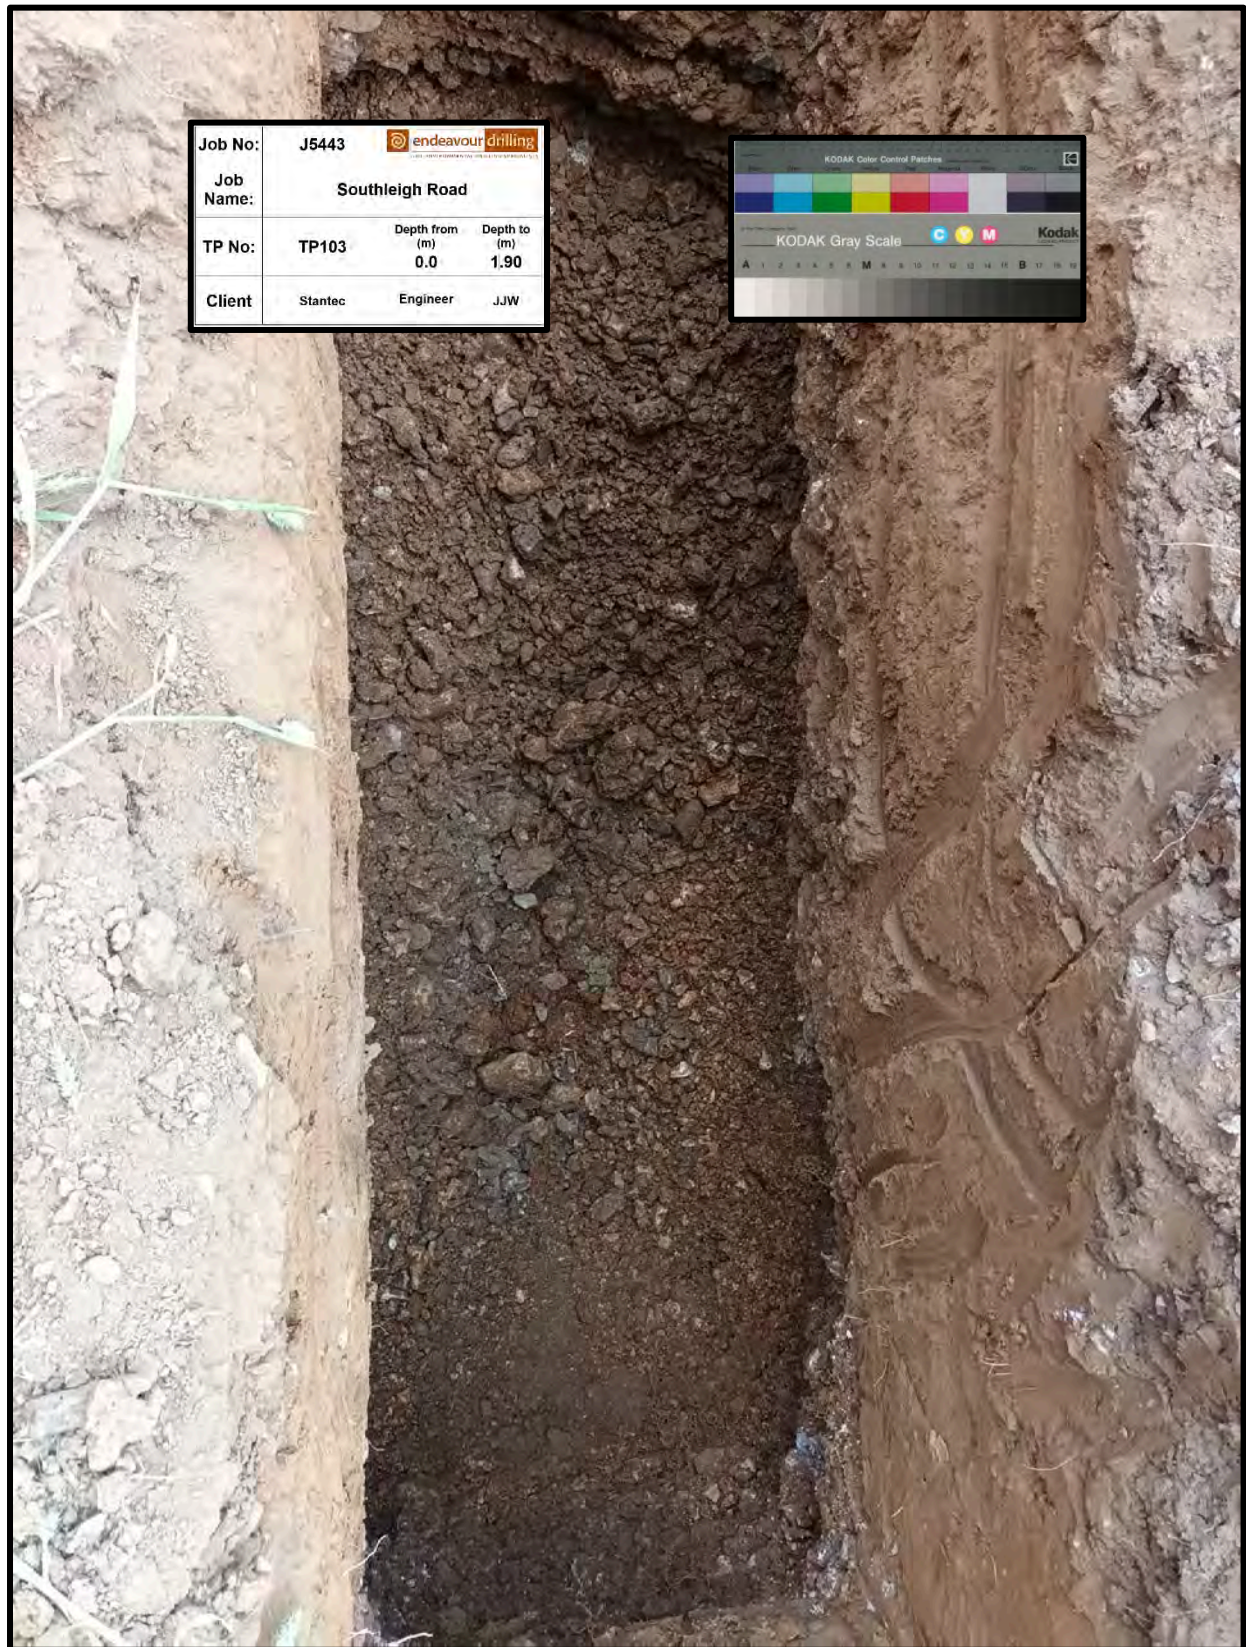
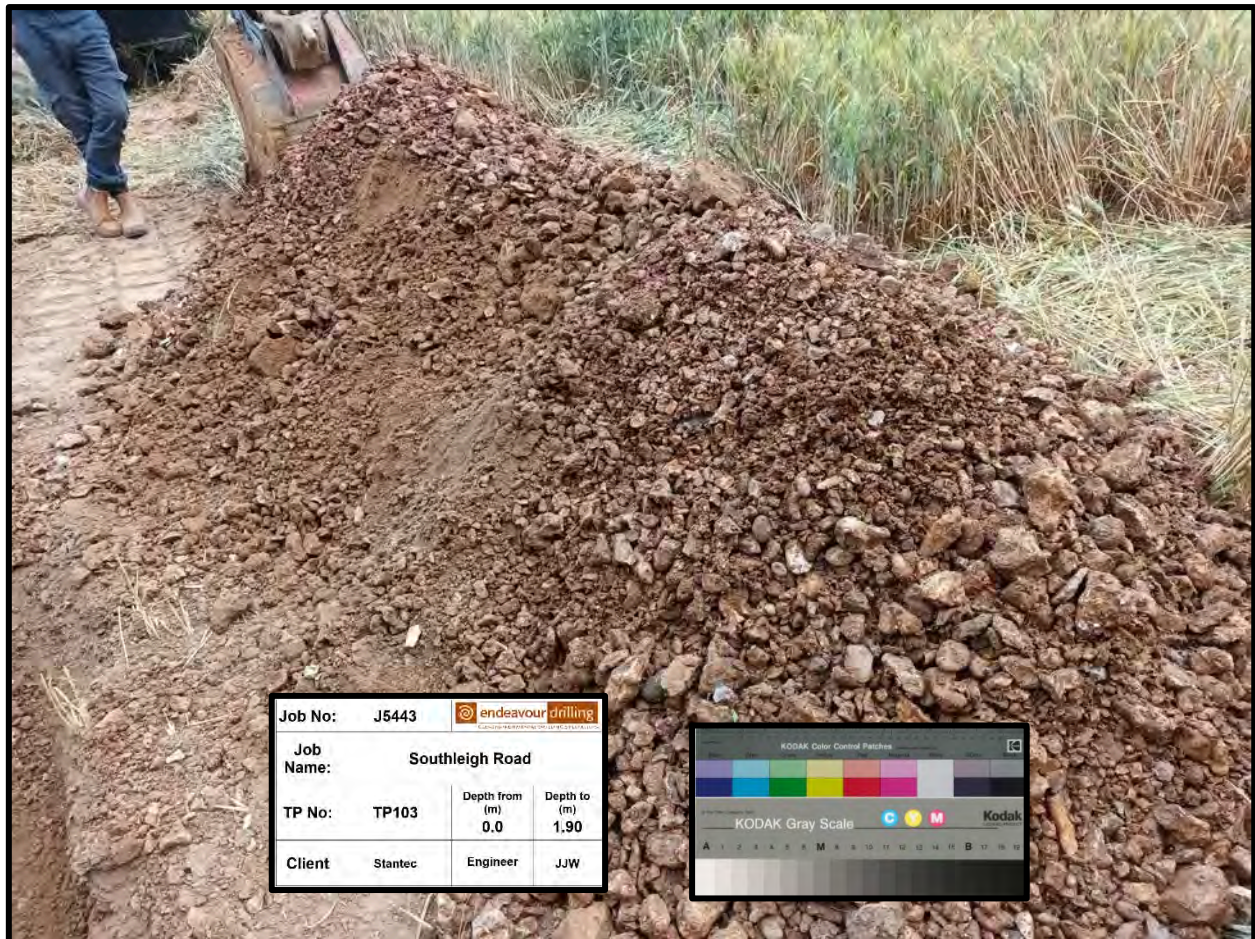
TP103 – 0.0mbgl to 1.90mbgl

| Final Depth: 1.90m | | | | | 1. Position machine excavated to 1.90mbgl. 2. No groundwater encountered. 3. Position backfilled with arisings and compacted upon completion. | | | | | | | |

Soakaway testing was undertaken in general accordance with BRE Digest 365 “Soakaway Design” 2016 within trial pit TP103, 104, and 106a. The dimensions of the pit were measured and then filled with water, the fall in water level was measured at regular intervals in order that infiltration rates may be calculated.

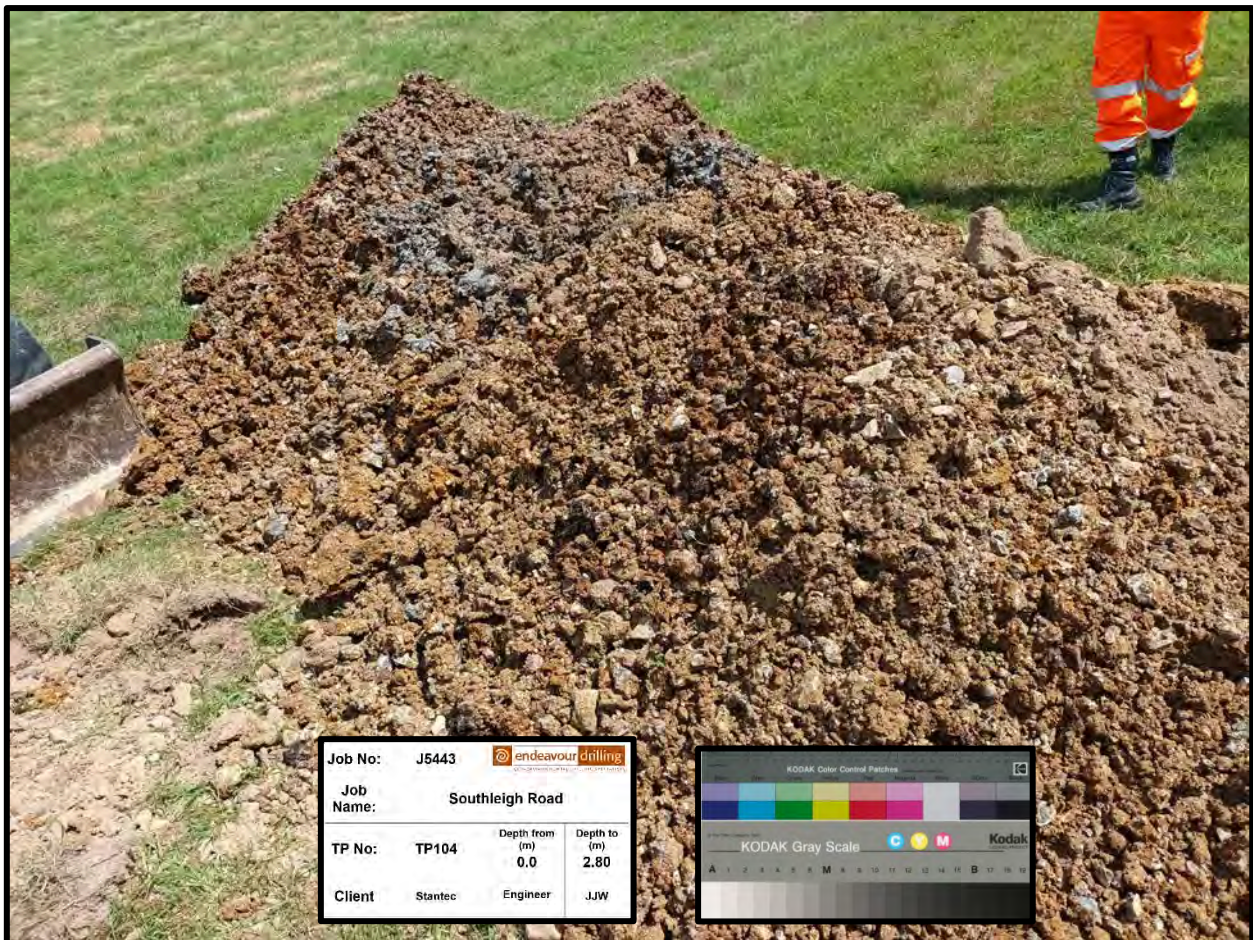
TP104 – 0.0mbgl to 2.80mbgl

| Final Depth: 2.80m | | | | | 1. Position machine excavated to 2.80mbgl. 2. Groundwater encountered at 2.80mbgl (slow infill, no rise). 3. Position backfilled with arisings and compacted upon completion. | | | | |

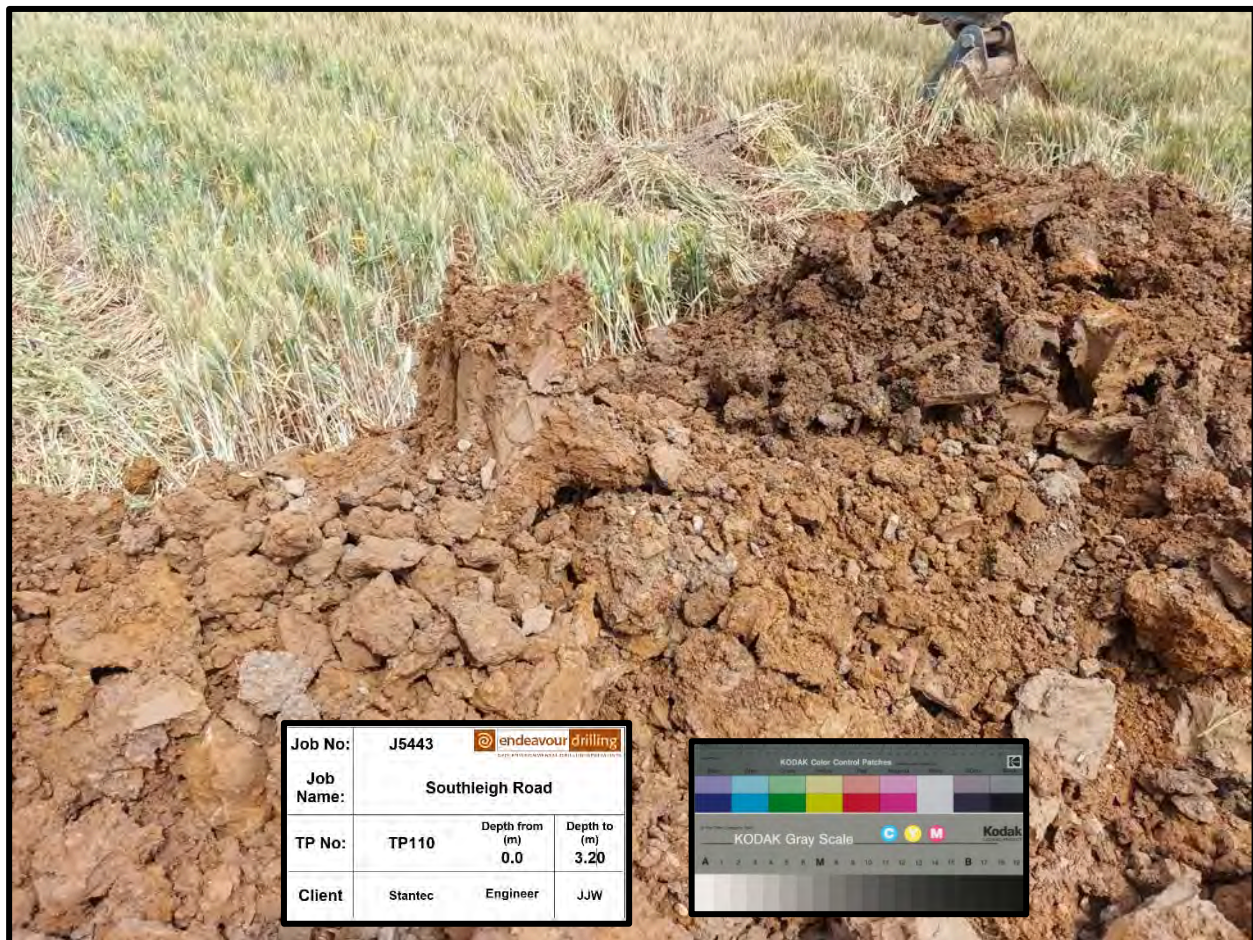
TP110 – 0.0mbgl to 3.20mbgl

| Final Depth: 3.20m | | | | | 1. Position machine excavated to 3.20mbgl. 2. No groundwater encountered. 3. Position backfilled with arisings and compacted upon completion. | | | | | |

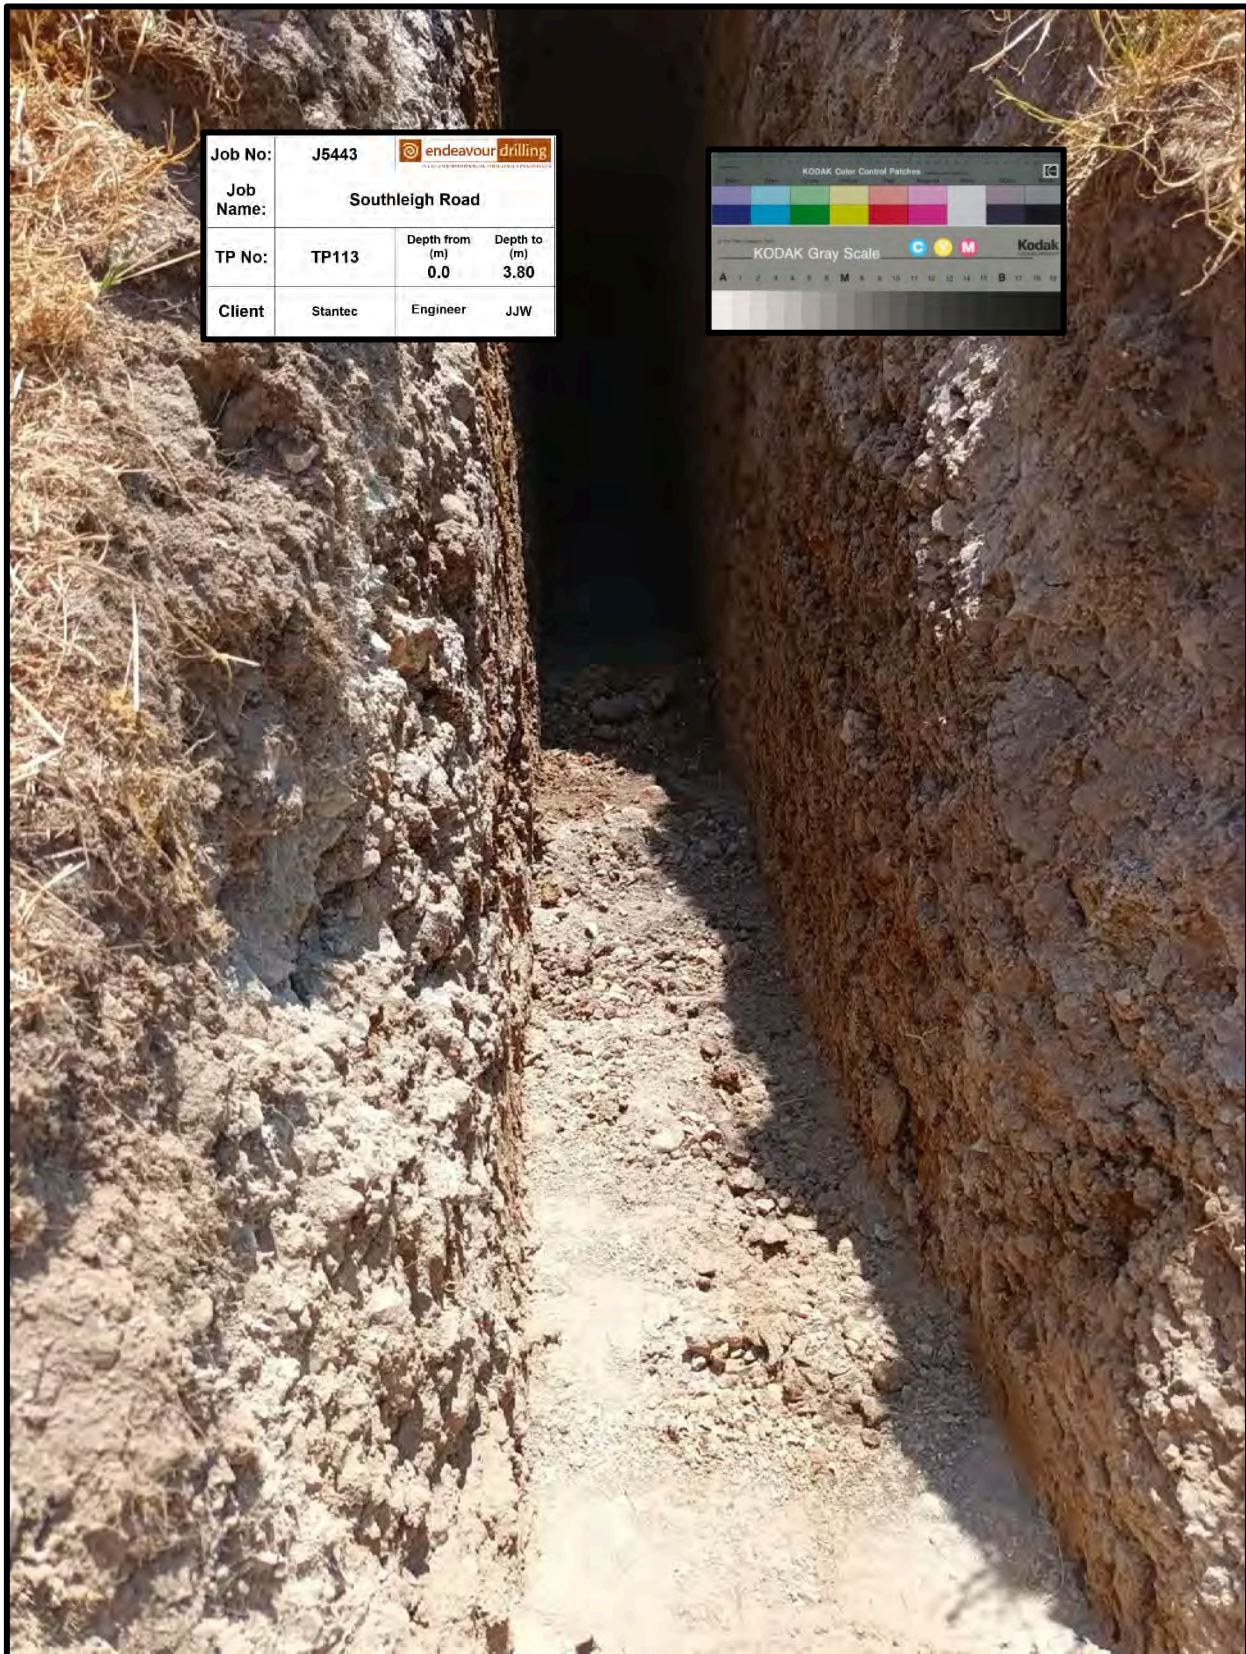
TP113 – 0.0mbgl to 3.80mbgl

| Final Depth: 3.80m | | | | | | 1. Position machine excavated to 3.80mbgl. 2. Groundwater encountered at 3.80mbgl (slow infill, rising to 3.70mbgl). 3. Position backfilled with arisings and compacted upon completion. | | | |
